**NATIONAL TRANSPORTATION SAFETY BOARD**

**Attachment 8 –Airbus No. 2 Engine/Pylon Fuel Connection Materials**

**DCA18LA163**

## A330 MSN 578 DAL fire event- RH Engine/Pylon Fuel Connection

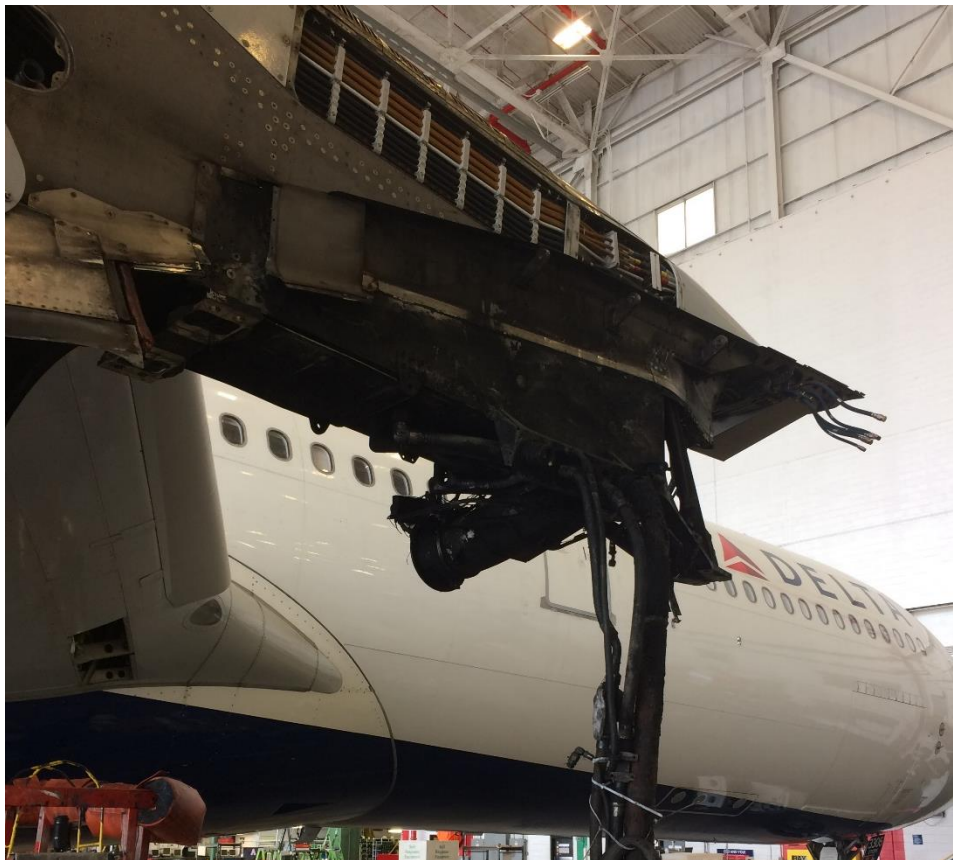
**Figure 1: Overview of pylon area after removal of the affected engine**

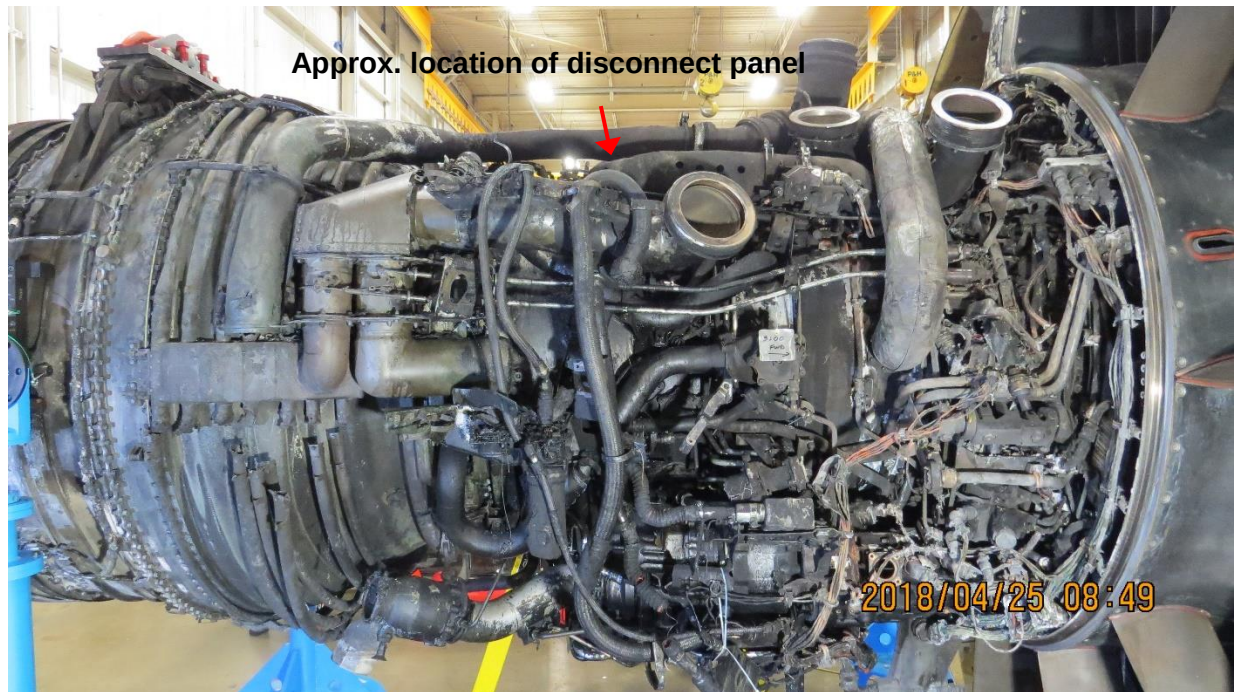
**Figure 2: Overview of engine after dismounting, Engine #2 – Outboard side**

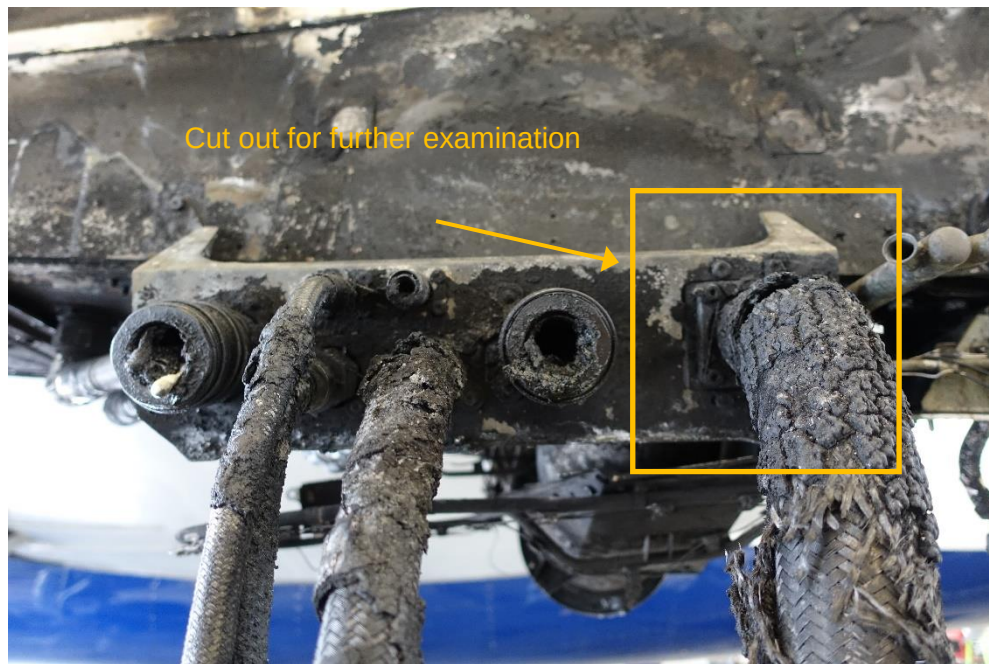
**Figure 3: Overview of cut-out brought for examination**

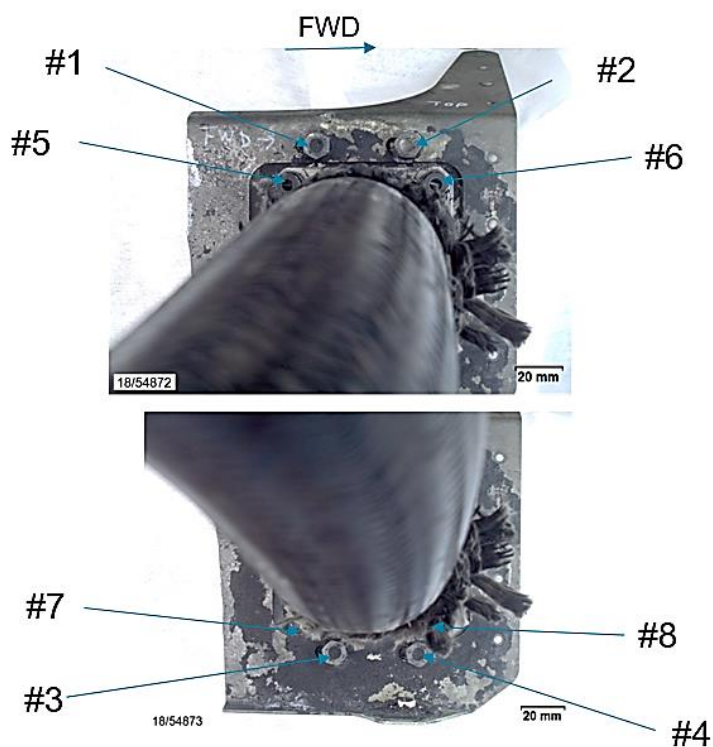
All bolts were labeled for examination purpose as shown in (Figure 16).

Figure 16: View from outboard side onto the fuel/hydraulic disconnect panel – labeling of bolts

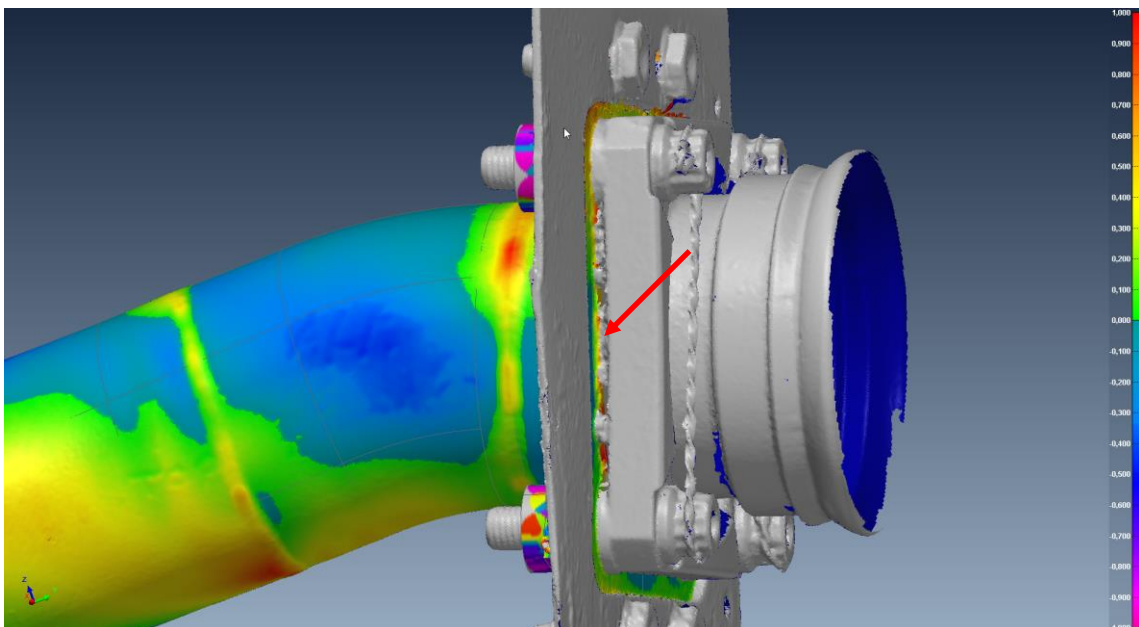
The 3D scan shows the flex line sleeve in view parallel to the pylon fuel rigid pipe flange and the fuel/hydraulic disconnect panel. This means the flex line sleeve is assembled in plane condition (Figure 19 and Figure 20). This observation was confirmed after disassembling (Figure 35).

**Figure 19: Position of the flex line flange towards the pylon fuel rigid pipe flange and fuel/hydraulic disconnect panel – view 1**

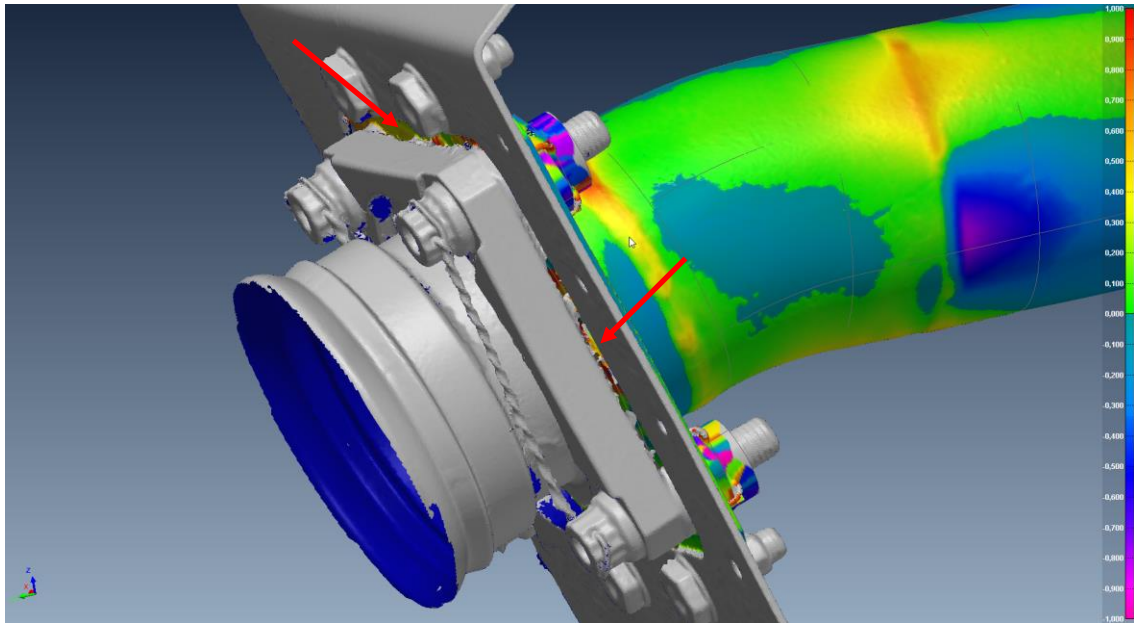
**Figure 20: Position of the flex line flange towards the pylon fuel rigid pipe flange and fuel/hydraulic disconnect panel – view 2**

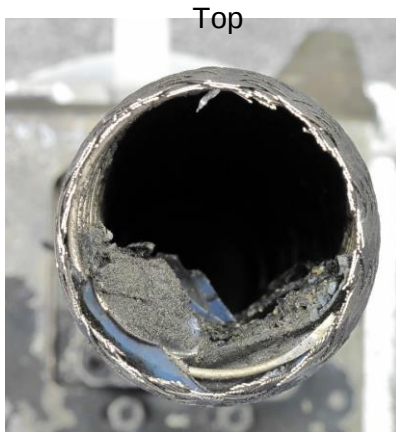
Due to the event the PTFE tube has no longer its original structure and melted material was found on the bottom side of the flex line at the cut location.

**Figure 24: Accumulation of PTFE melted on the lower side of the tube.**

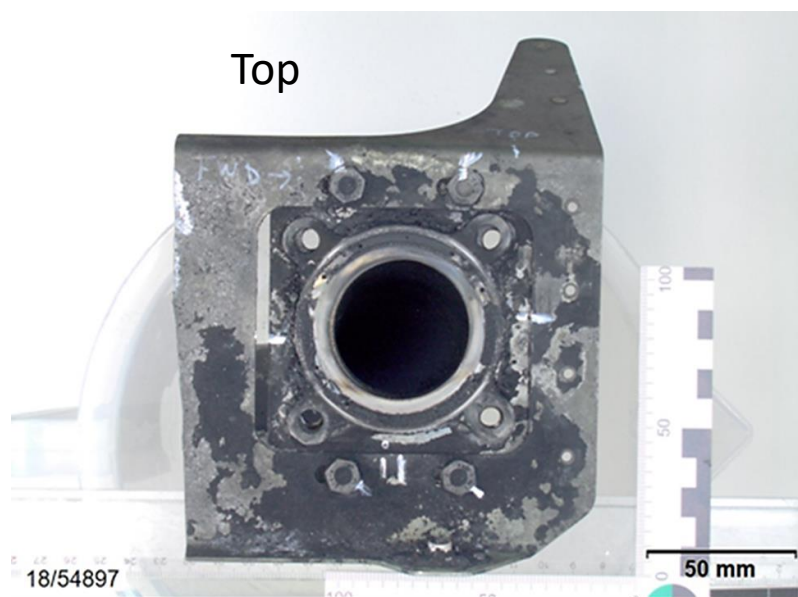
Step 1: Disassembly of flex line (pylon fuel rigid pipe flange/gasket). The fuel/hydraulic disconnect panel was not disassembled, see Figure 26:

- Related to the cut-out of the fuel/hydraulic disconnect panel, the installation of the pylon fuel rigid pipe flange were orientated more in FWD direction.
- Residues in the rubber seal groove of the gasket has been found. It is supposed they are remains of the installed rubber seal. Thus, the rubber seal was no longer acting as seal after the fire event, explaining the leak reported in Chapter 3 (Figure 7).

**Figure 26: Pylon fuel rigid pipe flange + gasket + fuel/hydraulic disconnect panel, view from outboard side before cleaning**

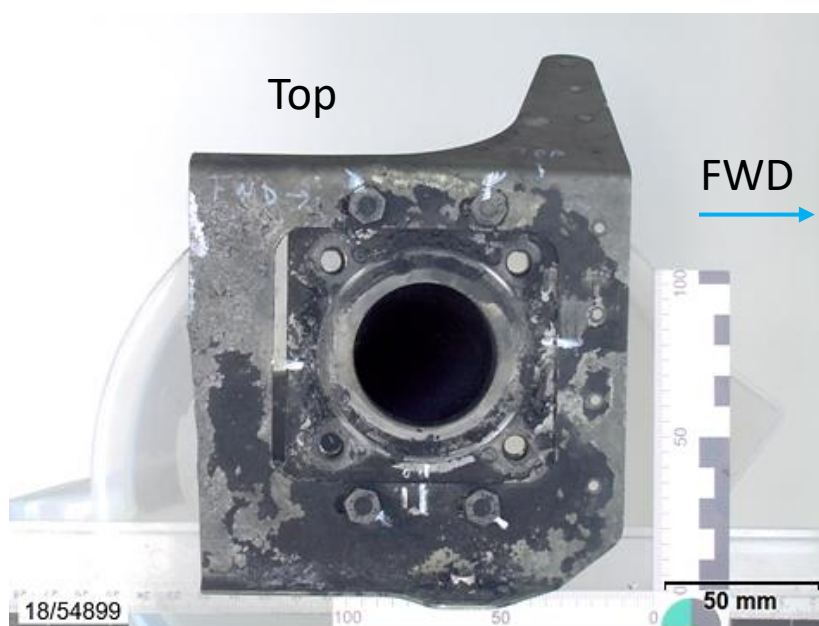
Step 2: Removal of gasket (pylon fuel rigid pipe flange/ fuel/hydraulic disconnect panel panel), see Figure 27:

- The pylon fuel rigid pipe flange shows residues on the sealing area which proves that the gasket was initially assembled with a rubber seal. However the seal was no longer acting as seal after the fire event.
- The gaskets pylon fuel rigid pipe and flex line side sealing surfaces show residues on the sealing surface area. These are probably caused by rubber seal, see Figure 28. However the seal was no longer acting as seal after the fire event.

**Figure 27: Pylon fuel rigid pipe flange + fuel/hydraulic disconnect panel, view from outboard side before cleaning**

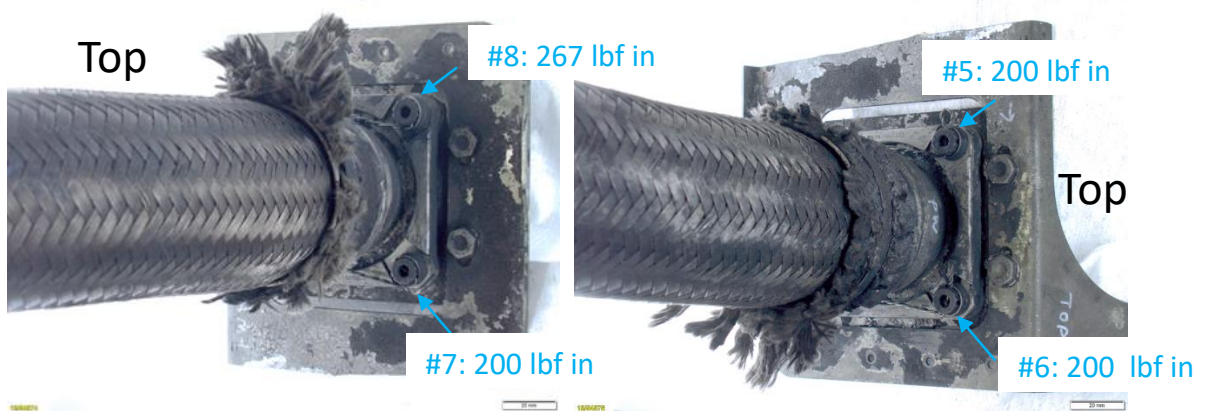
According to “AMM 73-11-18-400-801-A Installation of the Main Fuel Supply Line” document the torque tension for bolts #5, #6, #7 and #8 should be in a range between 180 lbf.in and 200 lbf.in.

**Figure 31: Breakaway torque of the bolt connections connecting the flanges and the gasket - gasket slightly moved during removal of flex line – view from outboard side**

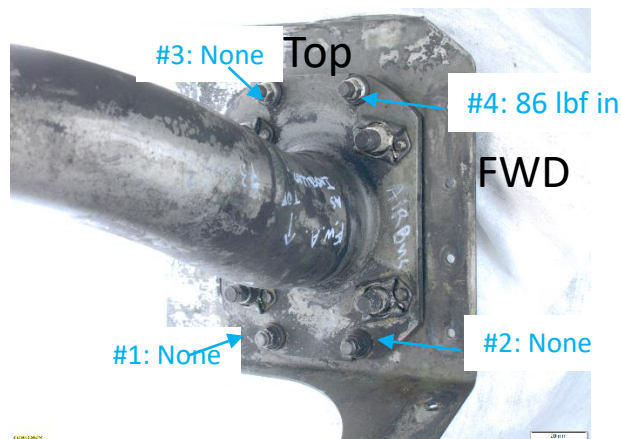
According to the production torque values the torque tension for bolts #1, #2, #3 and #4 should be in a range between 73 lbf.in and 94 lbf.in.

**Figure 32: Breakaway torque of the bolt connections connecting the pylon fuel rigid pipe flange and the fuel/hydraulic disconnect panel – view from outboard side**

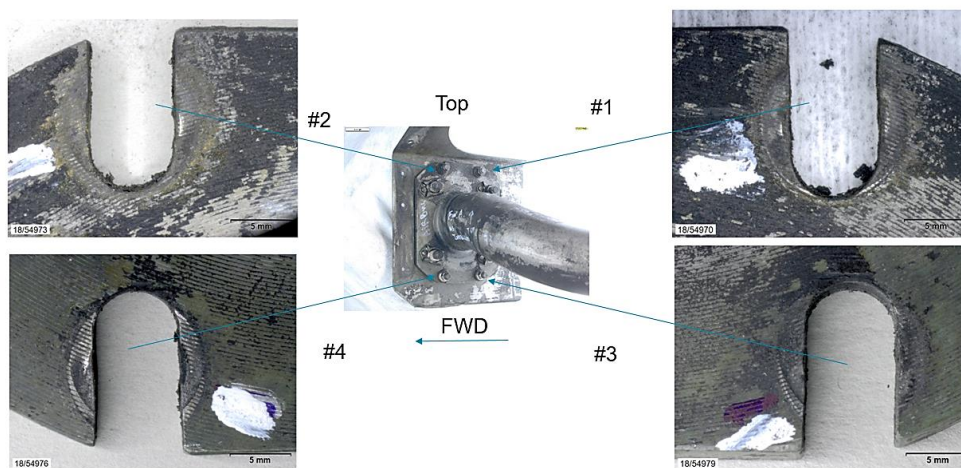
The pylon fuel rigid pipe flange has presented various marks produced by the fuel/hydraulic disconnect panel assembly and the gasket, see Figure 34.

**Figure 34: Pylon fuel rigid pipe flange after cleaning**

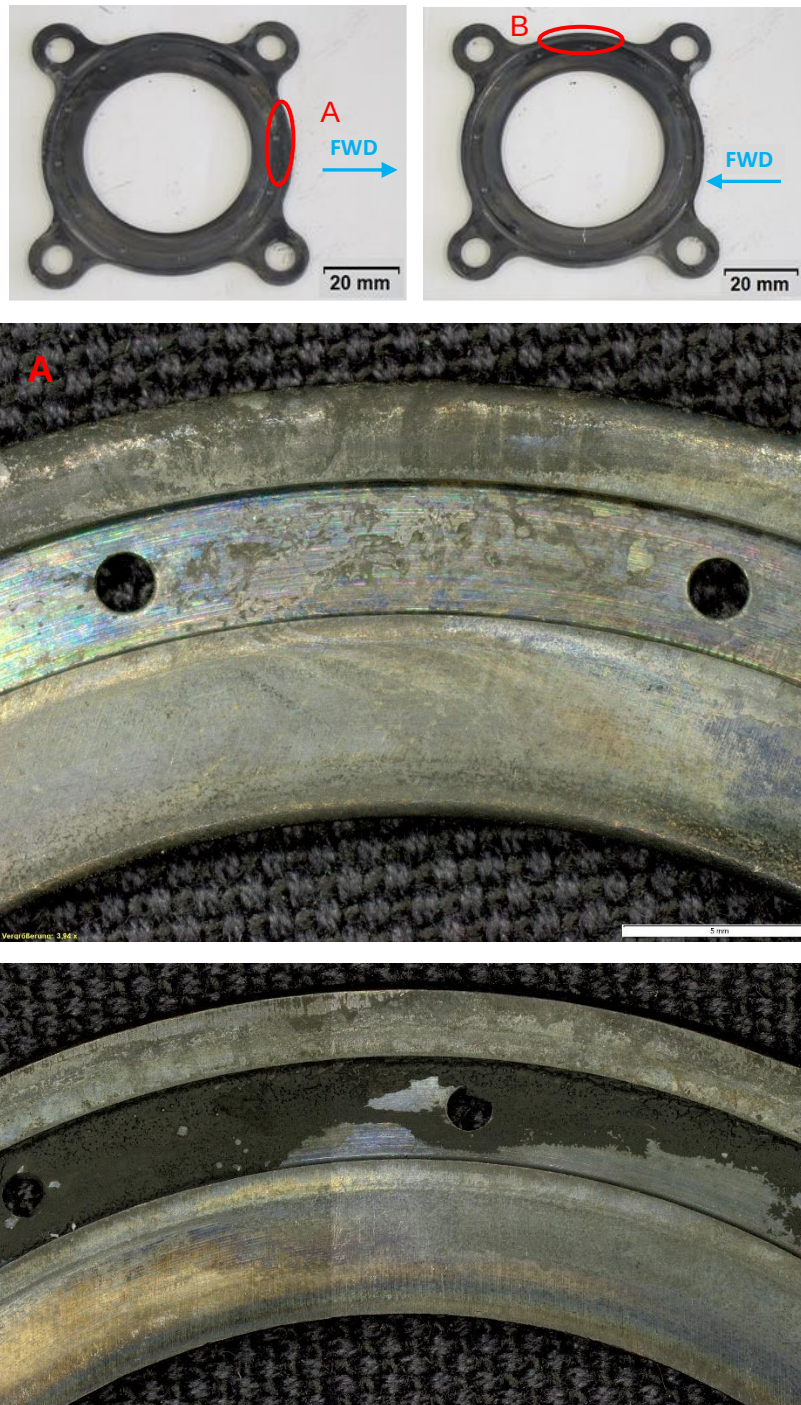
After cleaning of the gasket in one area possible remained traces of a part number can be identified but not readable. Another area shows an imprint of the manufacturer, see Figure 37.

**Figure 37: Possible remains of part identification and manufacturer imprint**

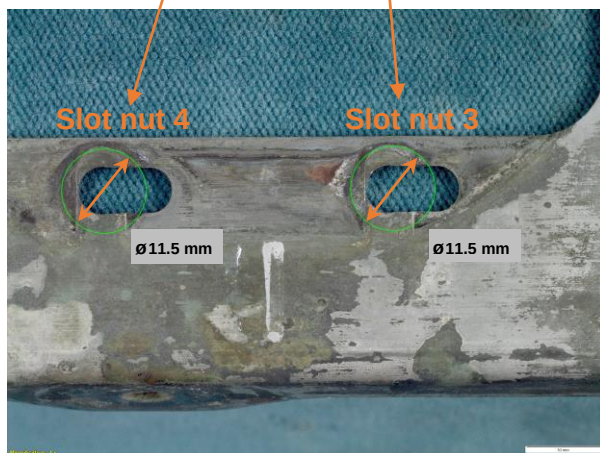
*Outcome:* The two imprints found on Face A (Figure 41) have the same approximate diameter as the imprints found on Face C (Figure 42).

Figure 41: Face A- Measurements of imprints on the fuel/hydraulic disconnect panel

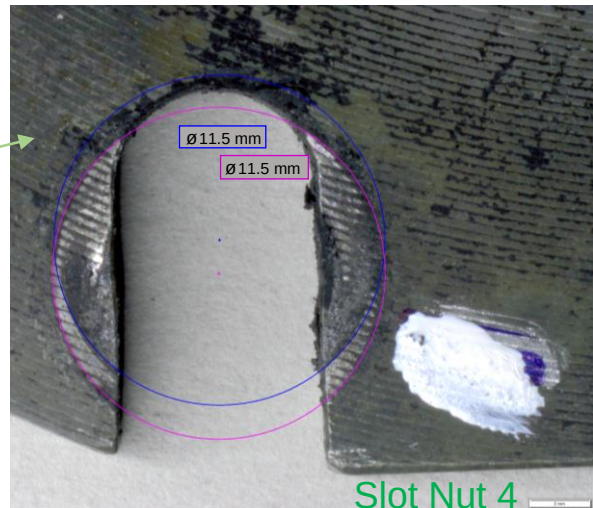
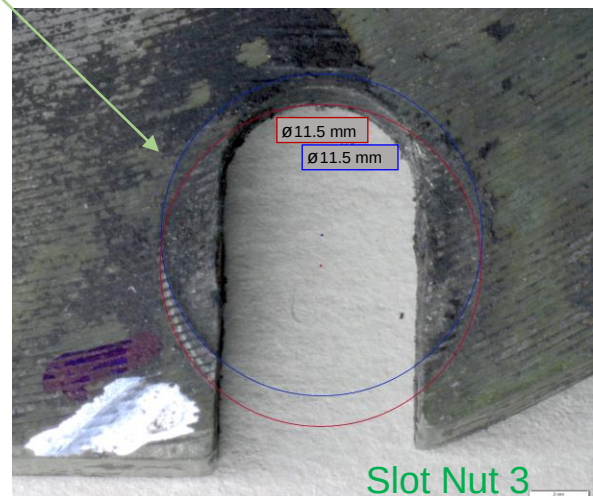
- Both Face A and C presents contact with the nut, confirming the assembly as per drawing at some point in time.
- The measurements of the markings ( $\varnothing 11.5\text{mm}$ ) confirms the as per drawing installation at some point in time.
- Figure 42 confirms two installations not as per drawing.

Figure 42: Face C- Measurements of imprints on the pylon fuel rigid pipe flange

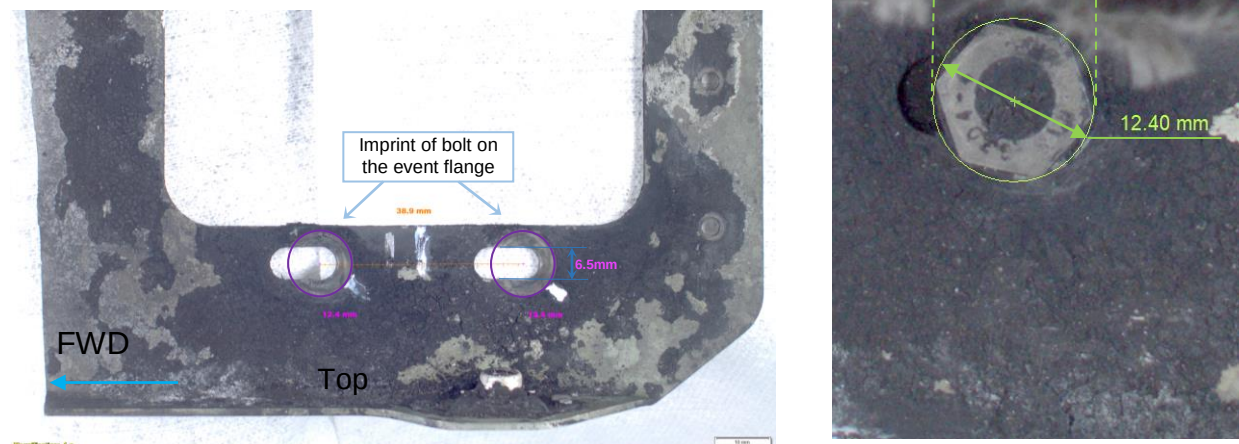
In the case of a as per drawing installation, the pylon fuel rigid pipe flange should display signs of the bolt imprint the same size as the fuel/hydraulic disconnect panel connect side Figure 46).

**Outcome:** The pylon fuel rigid pipe flange (Face D) shows imprints with the same size ( $\varnothing 12.4\text{mm}$ ) as the bolt head and matching with the imprints on the fuel/hydraulic disconnect panel (Face B). It can also be observed that the imprint from the pylon fuel rigid pipe flange shows a deep mark highlighting the round pattern of the bolt head.

Figure 46: Face B- Fuel/hydraulic disconnect panel bolt measurements

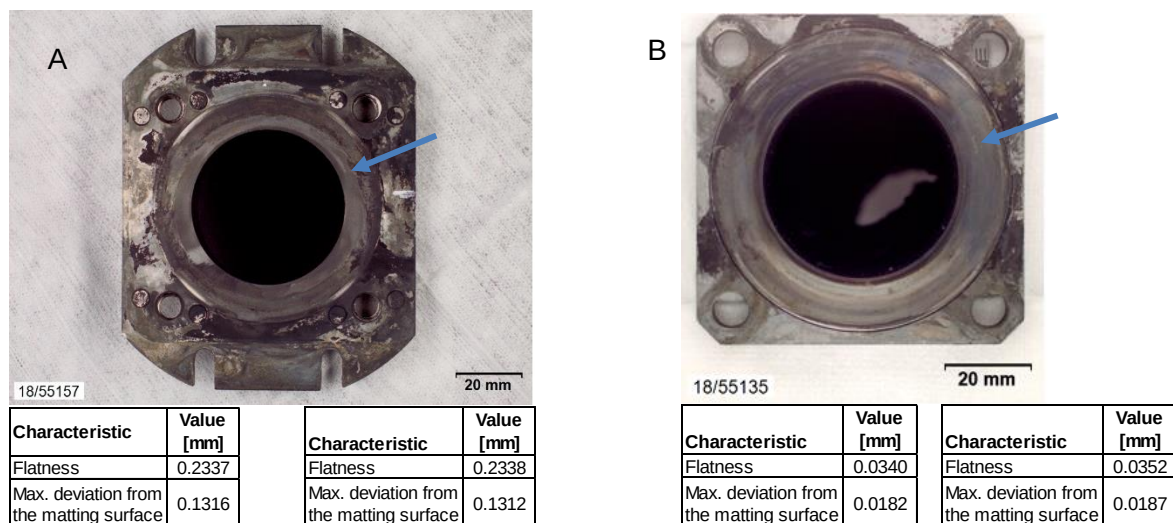
The Pylon fuel rigid pipe flange sealing surface has shown a maximum deviation from the matting surface of 0.131 mm and a flatness (distance of lowest and highest theoretical plane) of 0.233 mm (Figure 47 A)

The flex line flange sealing surface has shown a maximum deviation from the matting surface of 0.018 mm and a flatness of 0.034 mm (Figure 47 B).

An observation is, that the flatness values of the sealing surfaces of the flanges could not be compared with the requirements as these are not available.

**Figure 47: Flatness check performed for the pylon fuel rigid pipe and Flex Line Flange**

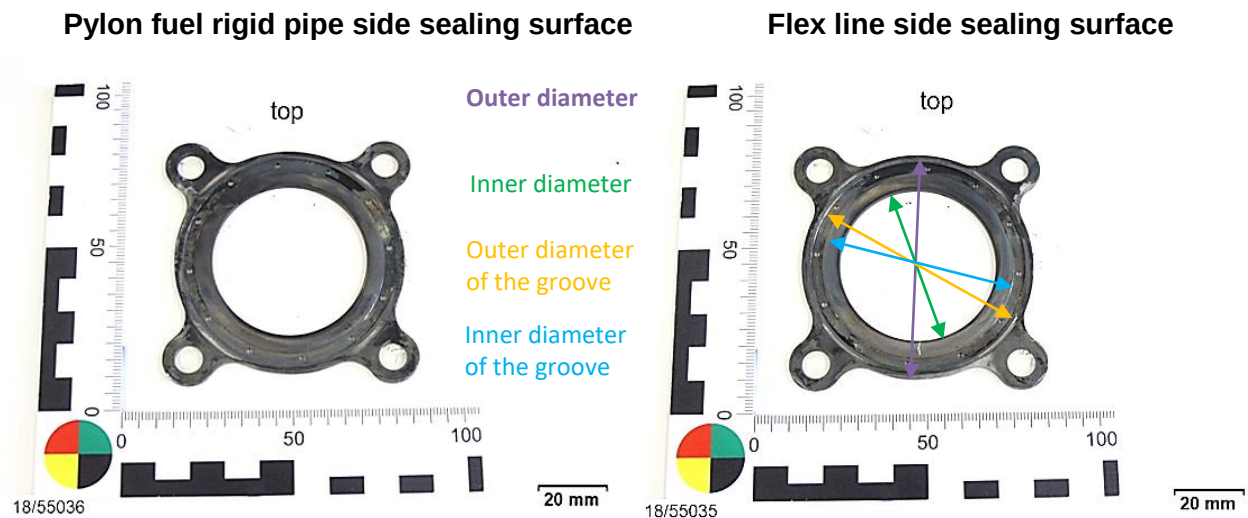
Acc. to Pratt and Whitney Illustrated Part Catalog the gasket with part no. MS27196-32 (Parker) is assembled in the engine/pylon fuel connection. The rubber seal of the gasket is installed acc. to AS27196 rev. B. The question is if a incorrect goemetry of the gaskets seal groove might have caused a leakage. Therefore a geometrical check of the gasket seal groove was performed reporting back the results in Table 3 and Table 4. It has to be taken into account that the gasket, although it was cleaned, is still affected by carbon black which could not be removed.

Figure 49: Gasket pylon fuel rigid pipe side sealing surface and flex line side sealing surface

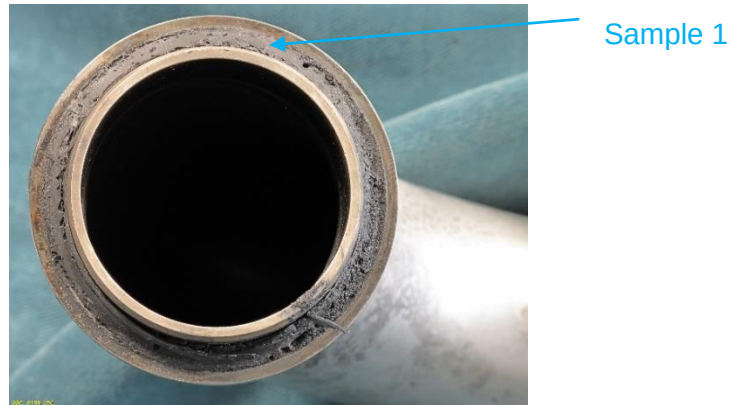
Figure 50: IR Sample 1: on the pylon fuel rigid pipe pylon site

It was possible to collect acceptable spectra from Sample 1 and Sample 2. The peaks in these spectra are weak, this may derive from the black, non-reflective material and a possible partial

thermal decomposition. Nevertheless, a match with fluorinated rubber was found as material which is a typical rubber seal material.

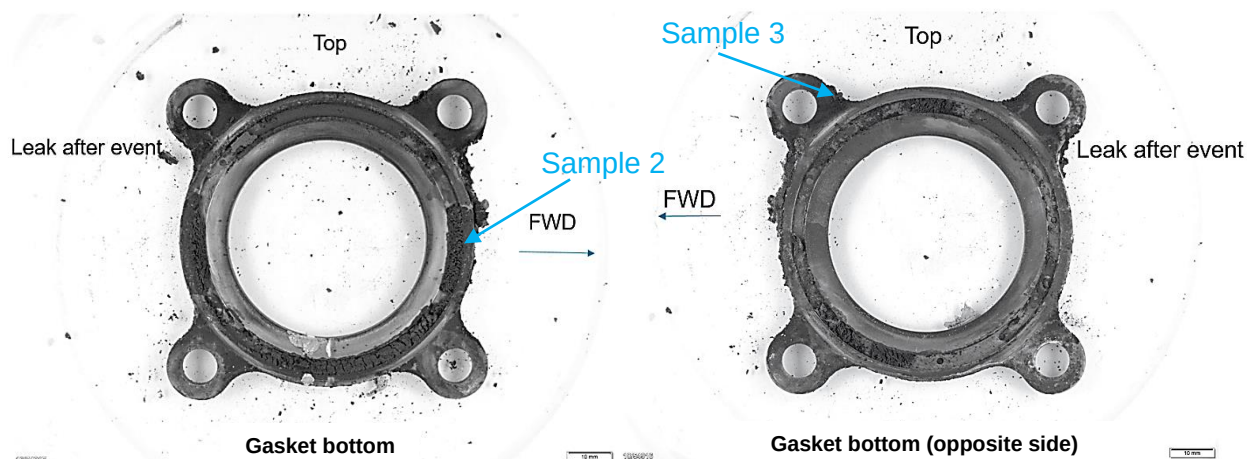
Figure 51: IR Sample 2 and 3: gasket in the area of seal and in the area of sleeve

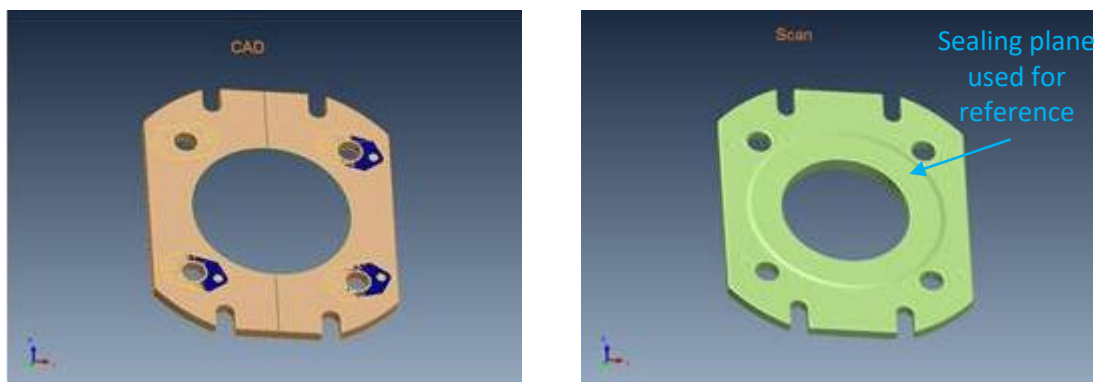
The CAD model deviates from the real part meaning that the upper geometry in the sealing area is not available compared to the real part (Figure 54). For this reason for the overlay of CAD and 3D scan, the sealing plane (area of interest for leakage) was chosen as reference plane.

**Figure 54: Pylon fuel rigid pipe Flange CAD version versus 3D Scan**

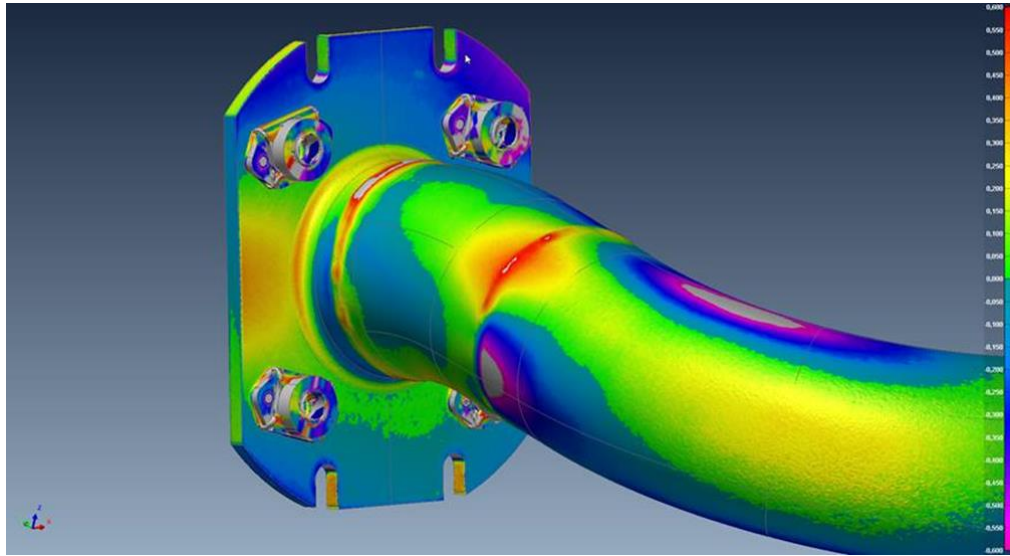
Taking the boundary conditions mentioned above into account the flatness of the circular mating surface of the pylon fuel rigid pipe flange is identified as being out of plane by 0.201 mm. The outer deformation is identified via 3D scan as 0.501 mm (Figure 55).

**Figure 56: Pylon fuel rigid pipe flange deviation from CAD model represented by 3D scan, inboard side**

If it is relevant for further analysis, the 3D scans of the flex line flange and gasket CAD model are needed.
