**NATIONAL TRANSPORTATION SAFETY BOARD**  
**Office of Aviation Safety**  
**Washington, D.C. 20594**

**Powerplants Group Chairman's Factual Report**  
**NTSB No: DCA18LA163**

Location: Hartsfield-Jackson Atlanta International Airport (ATL) – Atlanta, Georgia

Aircraft: Airbus A330-323, N806NW, Delta Air Lines Flight 30

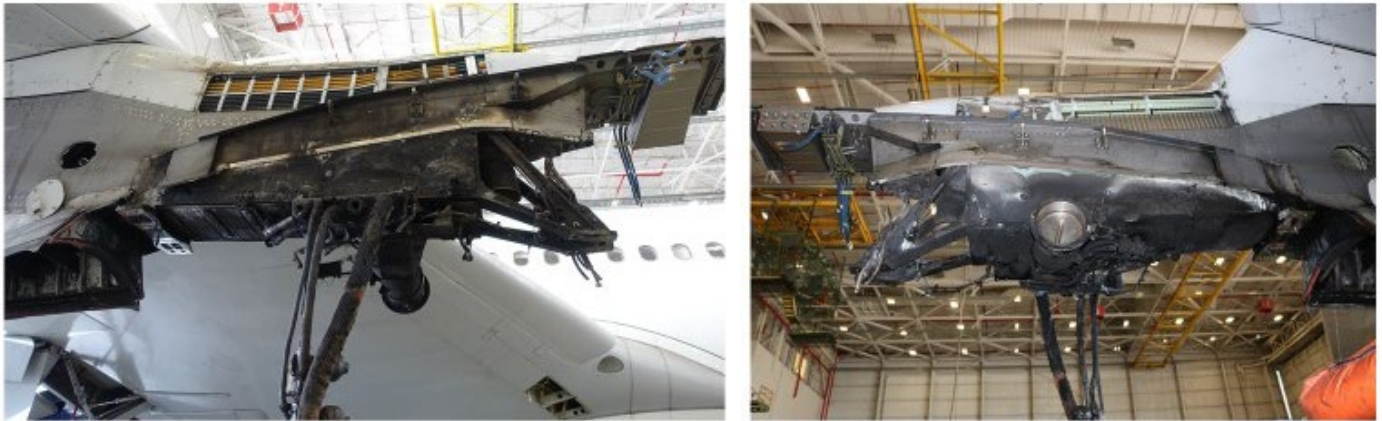
**Photo 6- (L) No. 2 Engine Pylon, Outboard Side (R) Inboard Side**

After engine removal, the FM-13 hose, yellow hydraulic pressure line, green hydraulic pressure line, and the yellow hydraulic case drain line were left connected to the pylon hydraulic interface panel. The pylon was intact, but all surfaces were heavily sooted and thermally damaged (**Photo 6**). The green and yellow hydraulic suction lines and the green hydraulic case drain line were separated on the pylon (outboard) side of the pylon hydraulic interface panel during the accident flight and what remained of each line was thermally damaged (**Photo 7**). A fractured section of the yellow hydraulic system EDP remained attached to the lower end of the yellow hydraulic pressure line. All separated hydraulic lines were recovered from the nacelle and retained for analysis.

DAL AMTs performed hardness checks on the pylon as part of the airplane return to service inspections. Several hardness measurements were out of limit and there was visible warping on the pylon right side panel. The No. 2 engine pylon assembly was removed and replaced.

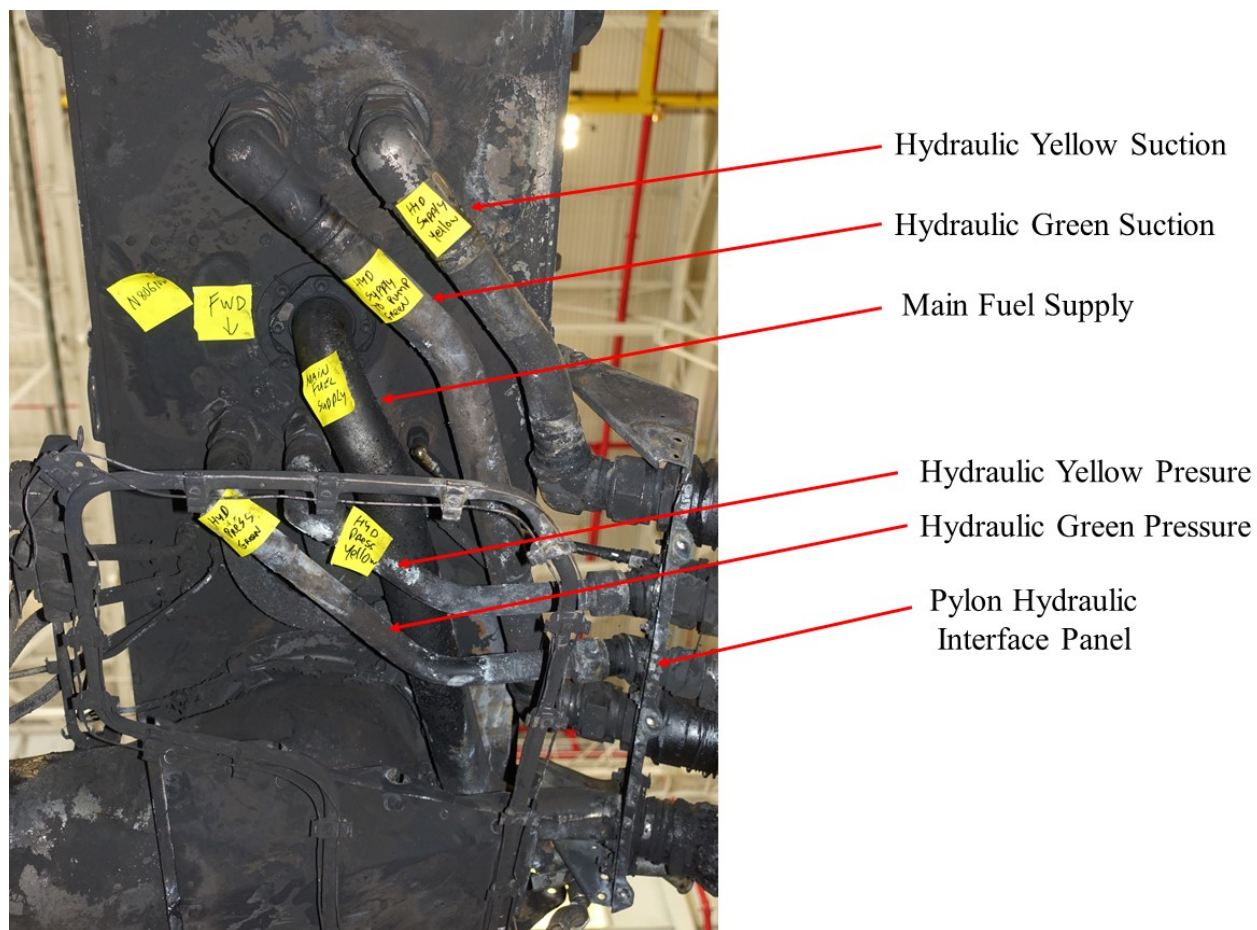
**Photo 8- Rigid Pipes Between Bottom of Pylon Box Structure and Pylon Hydraulic Interface Panel**

The rigid hydraulic pipes and rigid fuel pipe between the pylon hydraulic interface panel and the underside of the pylon box were coated in dark residue and soot (**Photo 8**). The fluid drip pan<sup>13</sup> installed

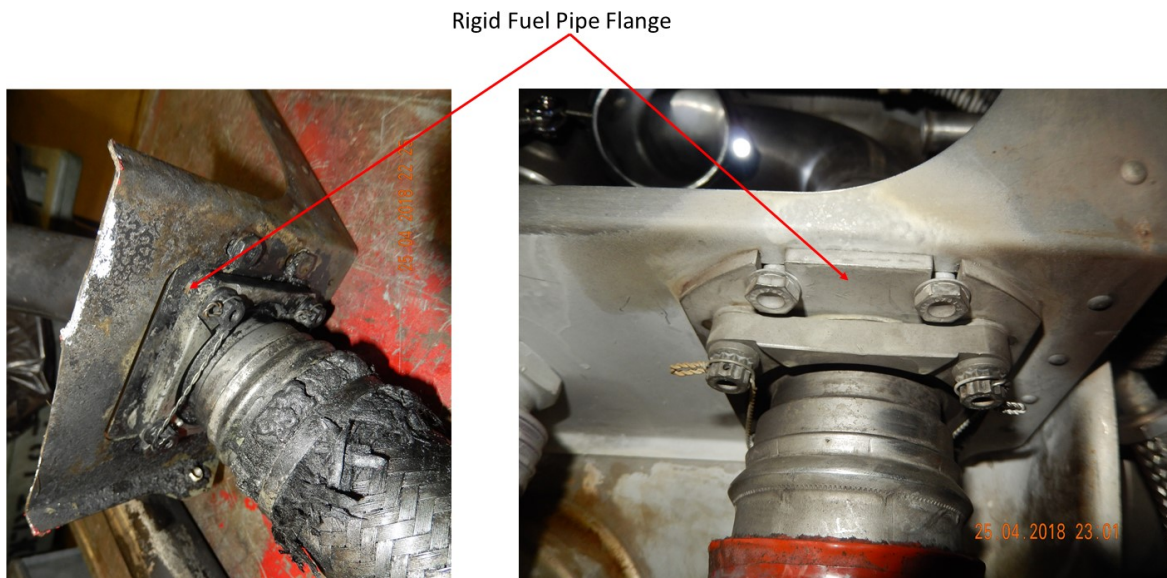
**Photo 11- Pylon Hydraulic Interface Panel Rigid Fuel Pipe Flange Position, (L) No. 2 (Right) Engine, (R) No. 1 (Left) Engine, Installed in Accordance with Airbus Drawings.**

The rigid fuel pipe lower flange was installed on the pylon (right) side<sup>14</sup> of the pylon hydraulic interface panel on the No. 1 engine and on the engine (left) side of the hydraulic interface panel on the No. 2 engine (**Photo 11 and Figure 11**). Airbus compared these findings with the installation drawings and then visually inspected several A330-300 airplanes hangared in Toulouse, France and confirmed the lower rigid fuel pipe flange was installed incorrectly on the No. 2 engine at the time of the event.

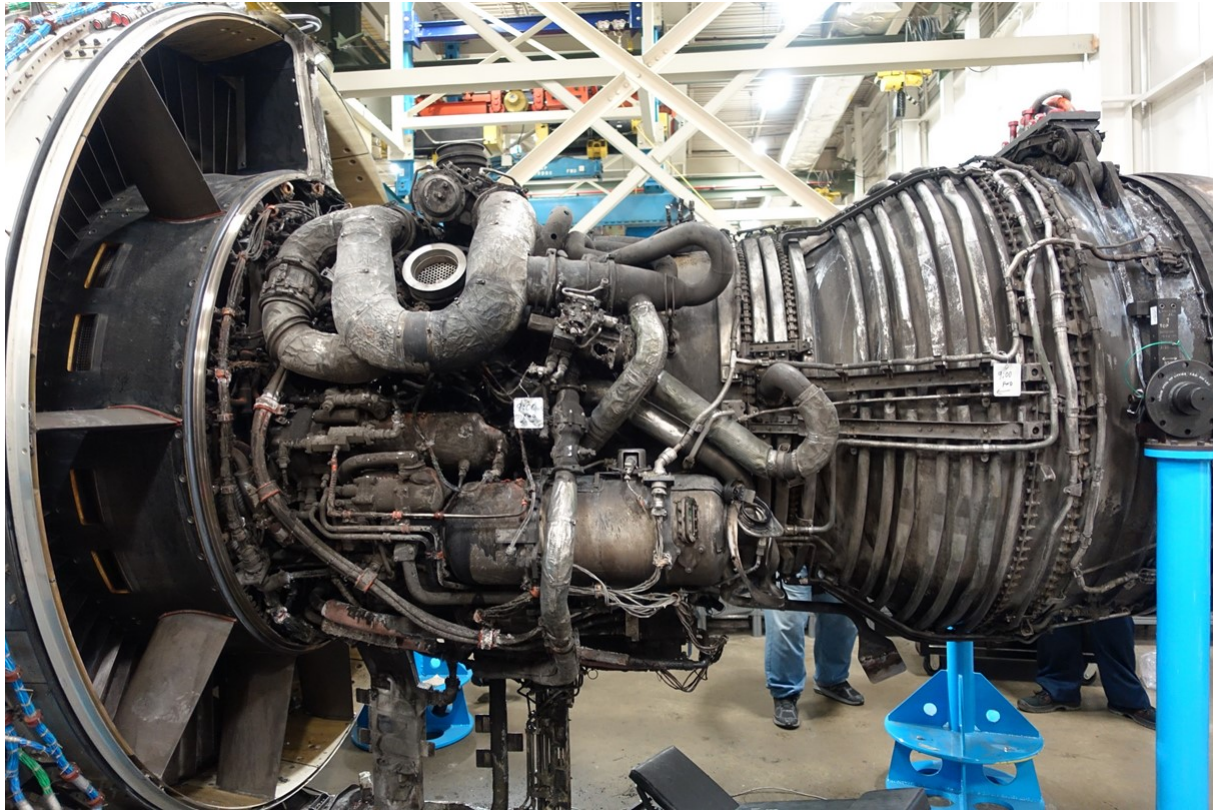
**Photo 12- Left Side of Engine, As Received**

The engine was installed in work pedestals when the investigation team arrived (**Photos 12, 13, and 14**). An initial visual examination of the engine was completed to document the as-received condition. The engine oil tank had oil visible to the top of the yellow line on the sight glass and contained

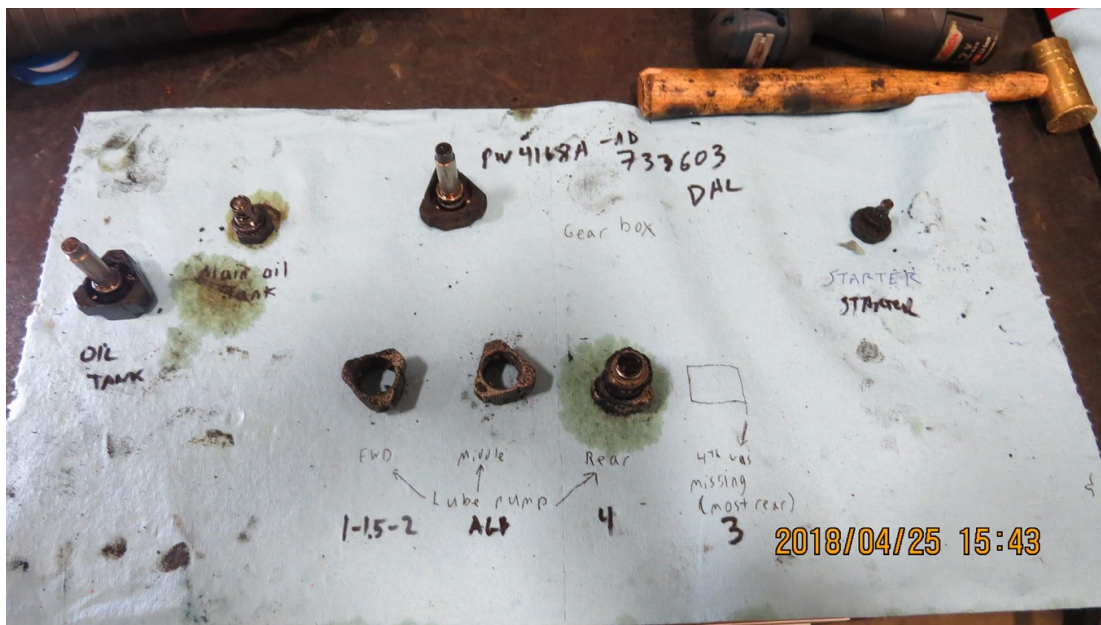
**Photo 15- Magnetic Chip Detectors**

7.5 gallons (28.4 liters) of oil when drained. There was no oil visible in the integrated drive generator (IDG) sight glass, and about 1 gallon (3.8 liters) was drained. The No. 3 bearing compartment magnetic chip detector (MCD) on the main oil pump (MOP) was not present. The No. 1-1.5-2 bearing compartment, No. 4 bearing compartment, and angle gearbox MCD bayonets were separated and only the MCD bayonet housings remained threaded in the MCD ports located on the main gearbox (MGBX). The check valves located within the MCD housing on the MOP were depressed and had spring tension. The condition of the o-rings in the check valve assemblies could not be confirmed. The No. 3 bearing compartment MCD was thermally damaged but complete and did not have any debris accumulation. The starter and oil tank MCDs also had no metal debris accumulation (**Photo 15**).

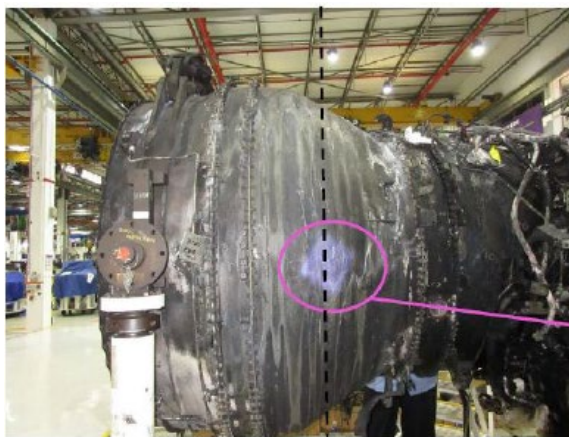
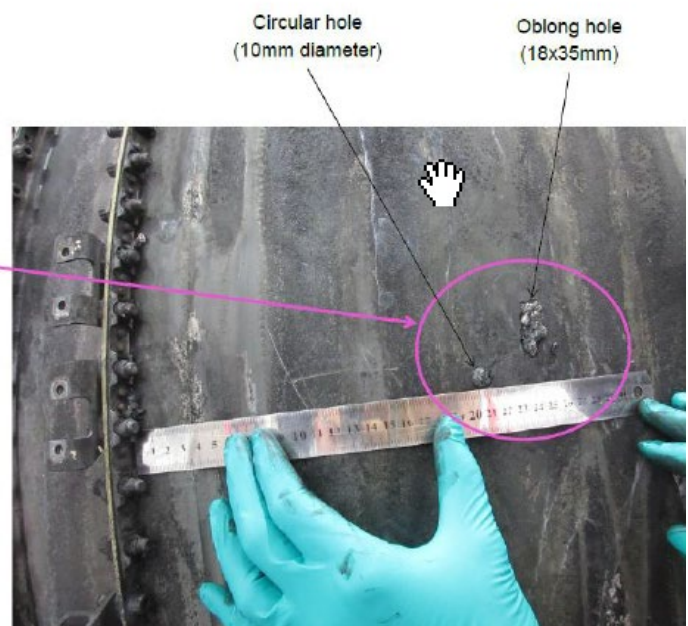
**Photo 19- No. 2 Engine LPT Case Damage, Right Side of Engine (Photos Courtesy of Airbus)**

LPT2 rotor axial  
position (TBC)

Circular hole  
(10mm diameter)

Oblong hole  
(18x35mm)

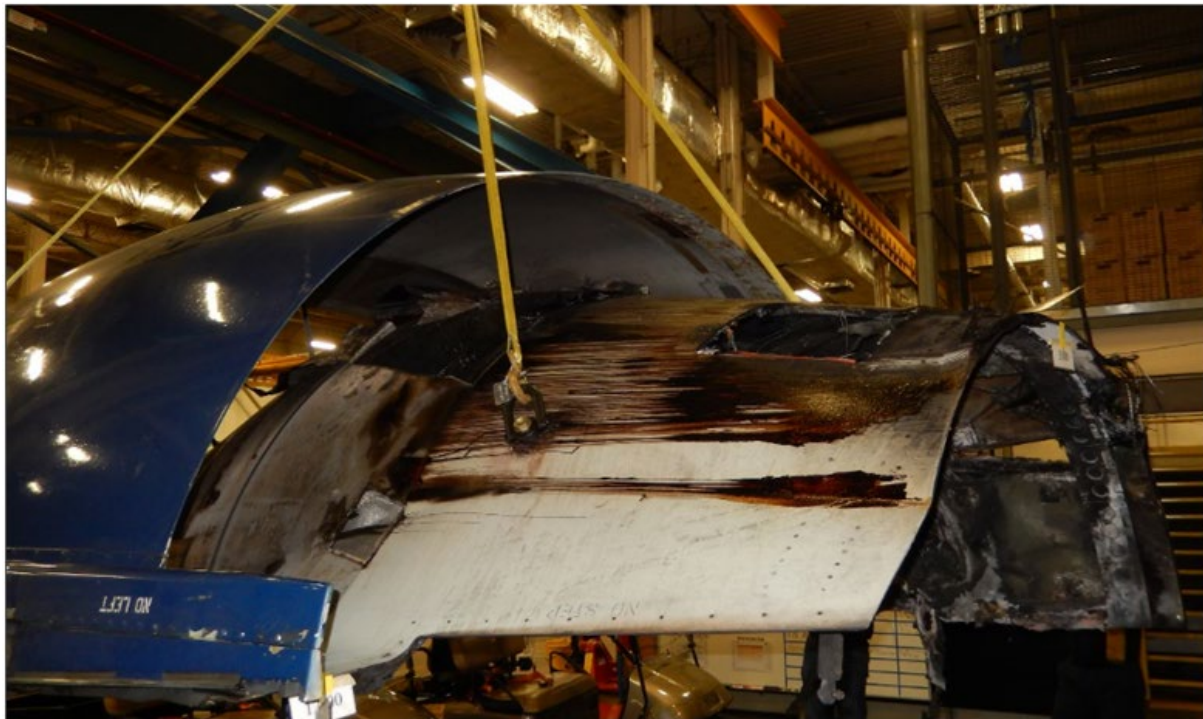
**Photo 21- No. 2 Engine Right (Outboard) Thrust Reverser Door IFS**

The outboard TR door torque box was in good condition. The outboard translating sleeve was complete, and the only visible damage noted was thermal damage at an access panel located at the 6 o'clock position. The access panel thermal damage was concentrated near the latch assembly where paint discoloration, burn-through holes, and torn/distorted material. The PRD was separated and dropped along the flight path and later recovered near Stone Mountain, Georgia. The lower PRD was in the fully open position. The hydraulic filter access door was separated. The IFS inner barrel fire blanket exhibited fire damage, sooting, dark discoloration, and streaking (**Photo 21**). The IFS composite structure was thermally damaged and was burned through/collapsed at the 2 o'clock position, forward of the upper PRD (**Photo 22**). The IFS outer skin that was in contact with the fan bypass airflow had dark sludge and streaking most concentrated between the 1 and 5 o'clock positions along the length of the IFS. The streaking on the IFS skin continued into PRD and access door openings. The fire detection loops sustained severe thermal damage and were severed at multiple locations. A majority of the fire detector loop isolator grommets were thermally consumed, and a section of the loop was detached from the IFS. The fire detector responder unit was thermally damaged, charred, and missing material (**Photo 23**).

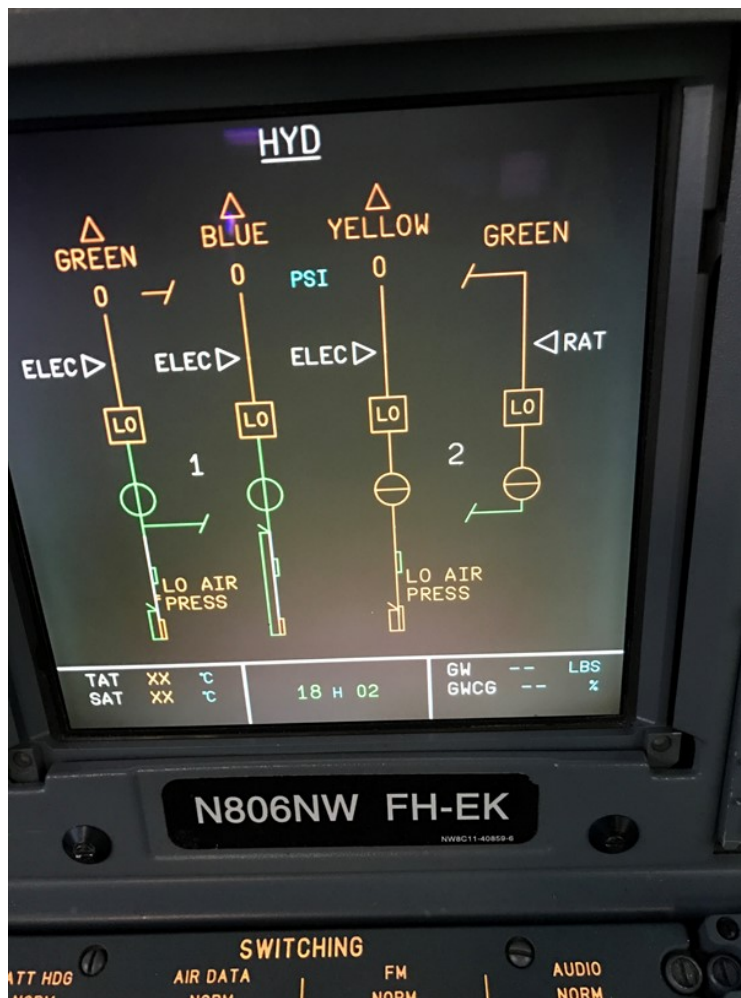
Photo 26- Cockpit Hydraulic System Display

The hydraulic page on the system display in the cockpit indicated yellow hydraulic quantity was at the bottom of the scale, green hydraulic quantity was slightly above the minimum, and blue hydraulic quantity was at the top of the scale (**Photo 26**). The hydraulic service panel under the airplane indicated yellow hydraulic quantity at -5, green hydraulic quantity at -5, and blue hydraulic quantity at +5<sup>18</sup> (**Photo 27**). Hydraulic fluid was not visible in either the yellow or green hydraulic reservoir sight glasses and was at the top of the sight glass on the blue hydraulic reservoir (**Photo 28**). The green and yellow hydraulic fluid reservoirs were drained and contained 4.5 gallons (17.0 liters) and 1.5 gallons (5.7 liters) respectively. According to Airbus engineering, the nominal reservoir fill volumes as marked on each reservoir sight glass were, green reservoir - 26 liters (6.9 gallons) and yellow reservoir - 14 liters (3.7 gallons). The blue hydraulic reservoir was not drained because the blue hydraulic system is not connected to the No. 2 engine and there was no evidence of fluid loss on the cockpit display, reservoir indicator or sight glass.

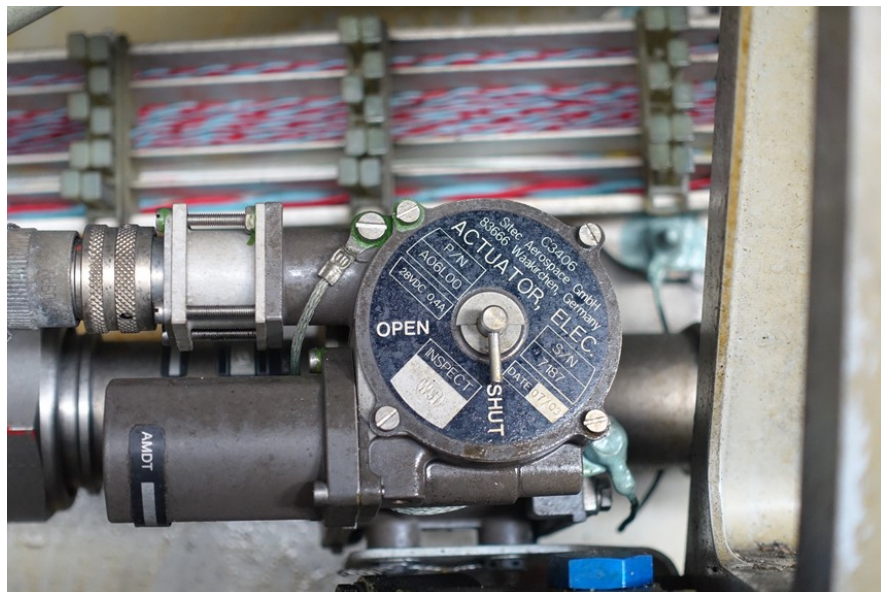
**Photo 29- No. 2 Engine Hydraulic Fire Shut-Off Valve, Installed in Right Wing**

The green and yellow hydraulic FSOVs were functionally tested while installed in the aircraft in accordance with Airbus instruction. The dial indicator on the outside of each valve cycled open and closed properly and the FSOVs were then removed for additional testing (**Photo 29**). The FSOVs dial indicator position was not recorded prior to the main fuel supply line pressurization check.

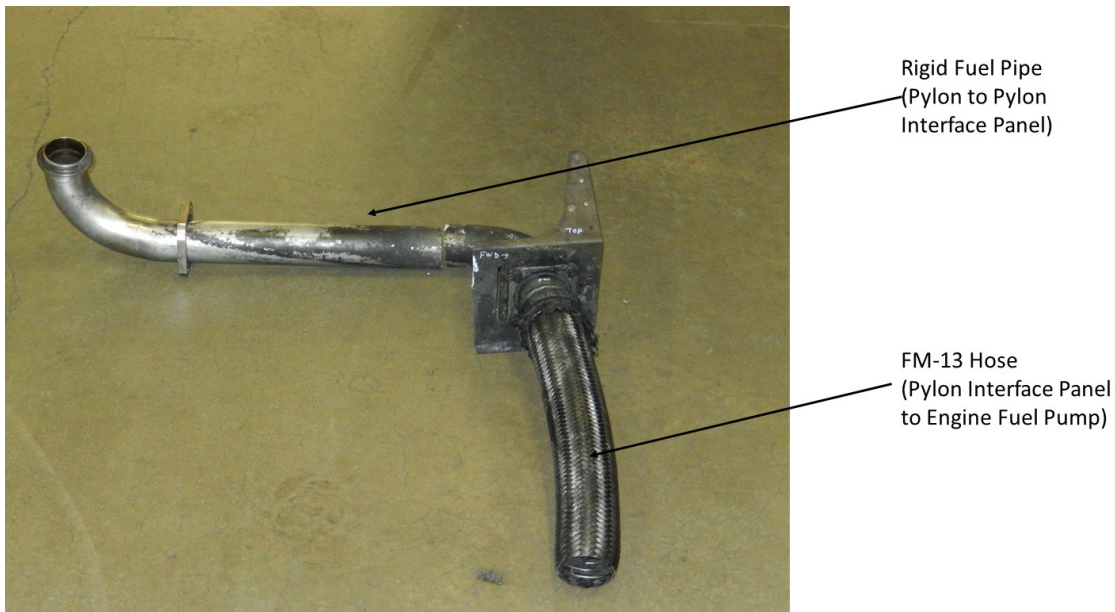
**Photo 33- Rigid fuel pipe to FM-13 hose Connection at Pylon Hydraulic Interface Panel**

The FM-13 hose to pylon hydraulic interface connection removed from the accident aircraft were left intact. Both the FM-13 hose and the rigid fuel pipe were cut with a cutting wheel to fit the hydraulic interface panel connection in the DAL TechOps x-ray machine (**Photo 33**). The x-rays did not conclusively show the condition of the interface.

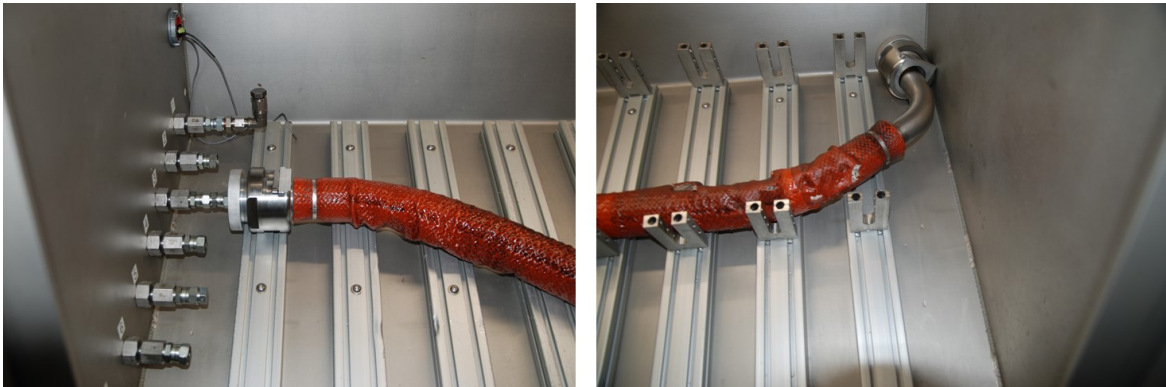
**Photo 35- AMS FM-13 Hose in Pressure Test Bench**

The AMS FM-13 hose fire sleeve had multiple tears and exhibited degradation of the silicone layer (**Photo 34**). The hose was installed in the Parker Stratoflex pressure test bench with production tooling (**Photo 35**). The test bench used water as the pressure fluid. The hose was leak tested at the pressures and time durations shown below in **Table 4**. No leaks were observed.

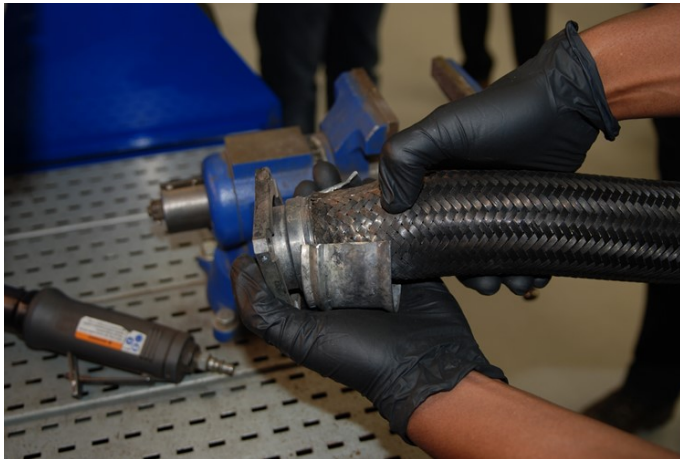
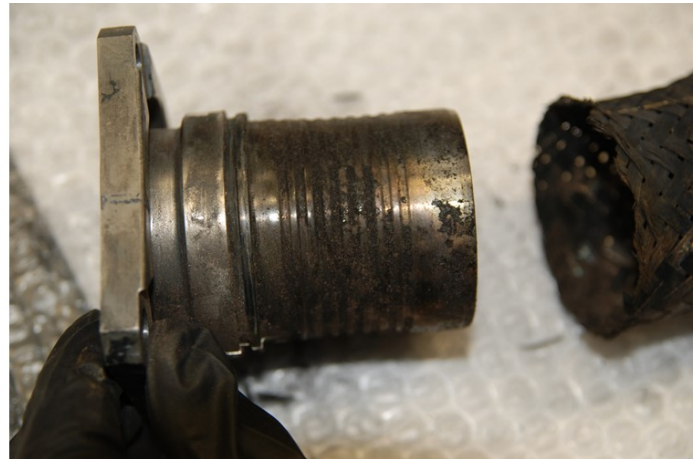
**Photo 37- Accident FM-13 Hose Upper Flange Disassembly**

The accident FM-13 hose was disassembled to separate the upper flange for pressure testing. A cutting wheel was used to separate the fire sleeve retaining band and the crimped socket was cut to separate the metal braid from the hose nipple (**Photo 37**). Parker Stratoflex stated that the nipple and socket appeared to be OEM hardware. A steel blank plate was welded onto the accident FM-13 hose nipple to create a seal. A brazed tube end (BTE) fitting was welded onto the cut end of the accident rigid fuel pipe. (**Photo 38**). A new Gask-O-Seal and new bolts were installed between the FM-13 hose and rigid pipe flanges and the assembly was plumbed into the pressure test bench (**Photo 39**). The test pressures, time duration, and bolt torque values<sup>20</sup> are listed in **Table 5**. There were no leaks observed during the tests.

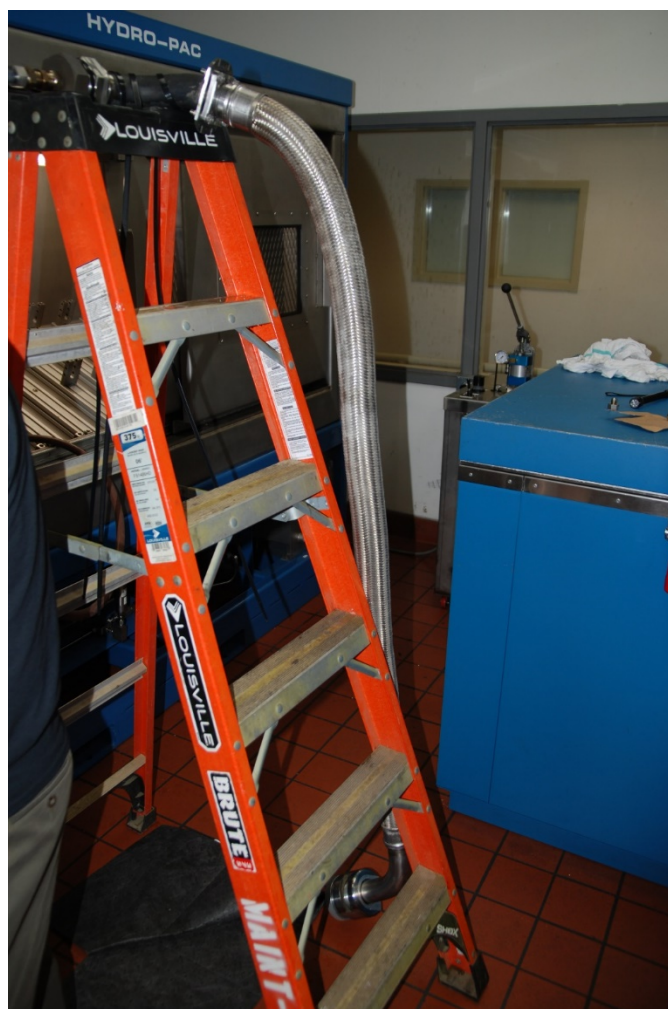
**Photo 40- AMS FM-13 hose to Accident Rigid fuel pipe Flange Test Setup**

The AMS FM-13 hose to rigid pipe flange was secured to the top of a ladder with zip ties and the hose was allowed to hang to the ground to roughly simulate the orientation of the hose when installed (**Photo 40**). A new Gask-O-Seal® was installed between the FM-13 flange fitting and the accident rigid pipe flange and the bolts were torqued to 200 in-lbs. The pressure test bench water line was plumbed into the brazed tube end fitting welded onto the rigid pipe. The test pressures and time durations are listed in **Table 6**. No leaks were observed during the test.

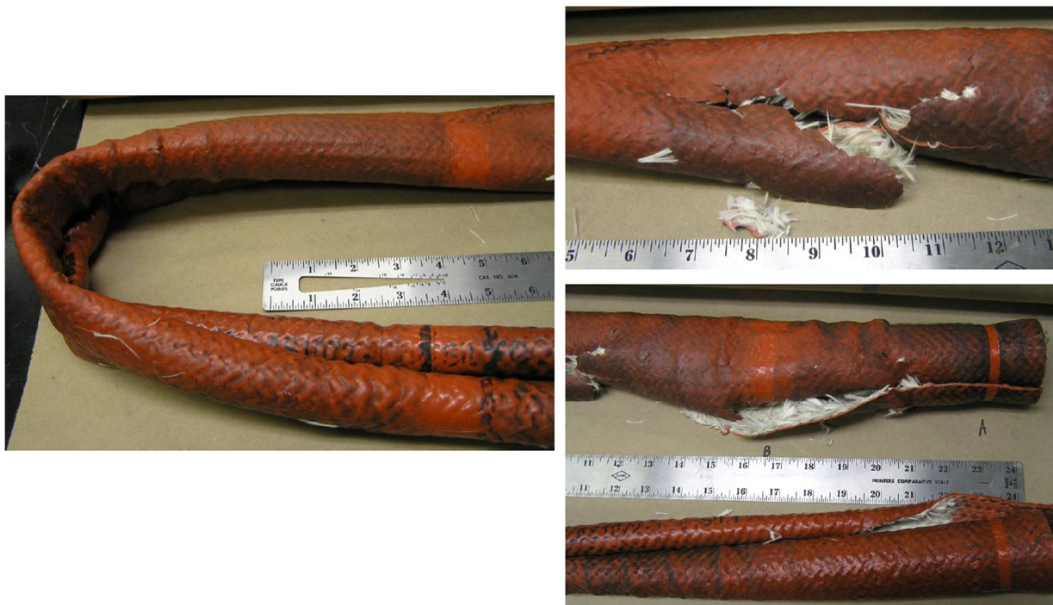
**Photo 41- AMS FM-13 Hose Fire Sleeve, As Received at Parker Aerospace (Photos Courtesy of Parker)**

The FM-13 hose fire sleeve that was removed in AMS was shipped to Parker Aerospace in Irvine, California in January 2020 to identify the chemical residue on the silicone surface (**Photo 41**). A new piece fire sleeve was also submitted for testing as a control. Samples were collected from multiple areas on the fire sleeve exterior and interior surfaces and were analyzed by Fourier-transform infrared spectroscopy (FTIR) and EDS. The samples identified markers consistent with jet fuel, but no phosphate ester type hydraulic fluid markers were detected on any of the samples. The Parker Aerospace laboratory report, “LR 253984 Analysis of the Fire Sleeve from FM-13 (A330, PW4000 Engine) Fuel Line” is available in the docket as Powerplants- Attachment 5- Parker Aerospace AMS FM-13 Fuel Line Fire Sleeve Chemical Analysis Report.

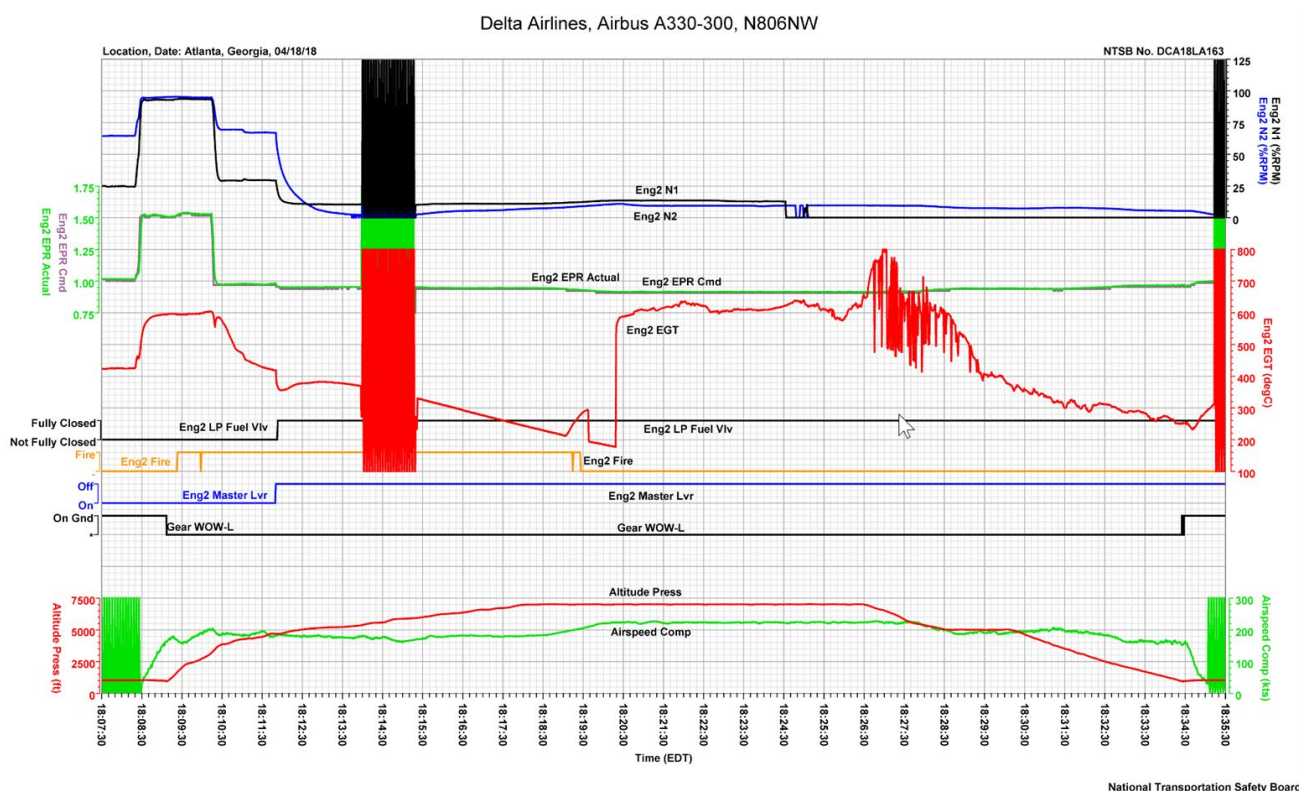
Figure 12- Select DFDR Parameters, Full Accident Flight

The No. 2 engine parameters were plotted, and all engine related parameters appeared nominal leading up to the time of the engine fire (**Figures 13 and 14**). According to P&W engineering the repeated data spikes (appear to be color blocks on Figure 14) beginning at approximately timestamp 18:14:00 are consistent with data drop out due to thermal damage and the NTSB agrees with this assessment.

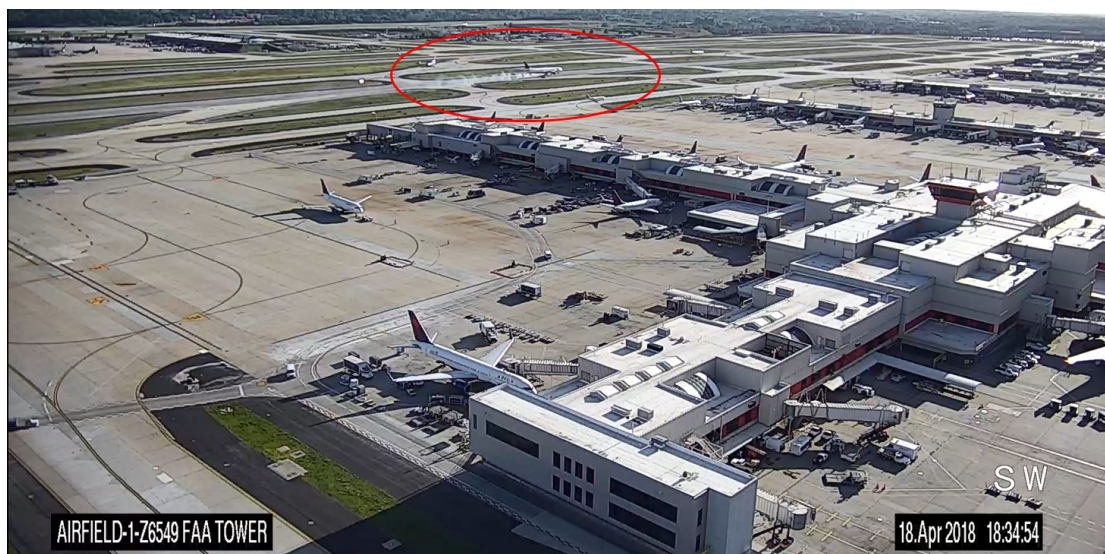
**Photo 42- FAA Tower Video**

ATL airport operations provided video files from the FAA Air Traffic Control Tower. DAL Flight 30 enters the video frame shortly after landing at 18:34:34 according to the video timestamp. A faint smoke trail is visible from the No. 2 engine as it enters the video frame, and the smoke continues to intensify as the airplane decelerates (**Photo 42**). ARFF crews arrive at 18:35:56 and begin spraying fire retardant into the No. 2 engine.

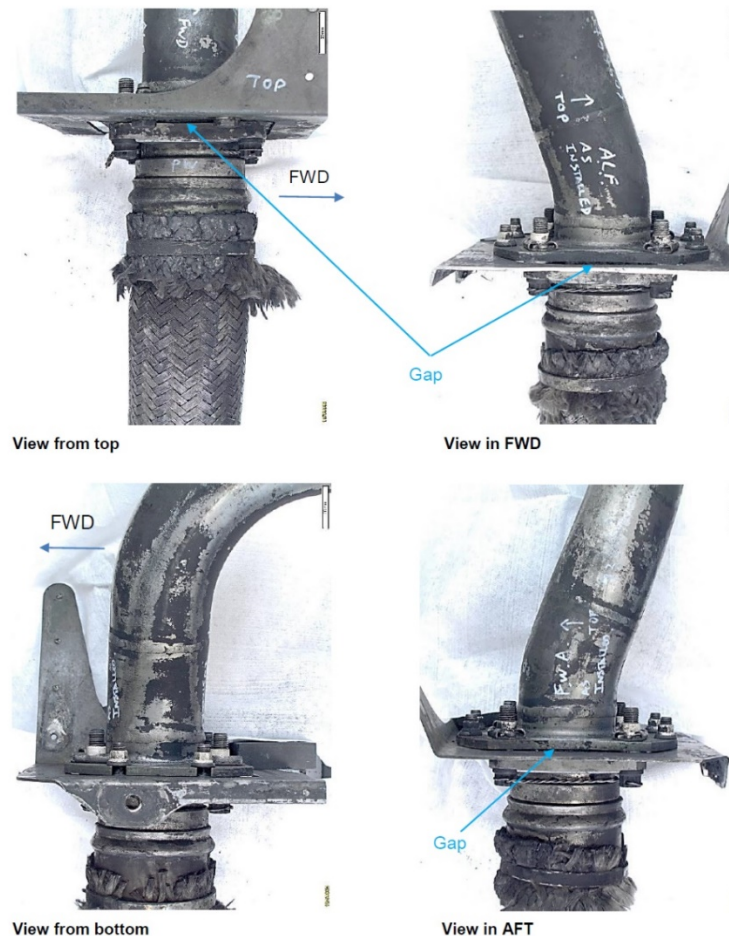
Prior to the group examination, Airbus Bremen was given permission to open the box containing the accident parts and CT and blue light three-dimensional (3D) laser scan the assembly. In the as received photos of the assembly, a gap was visible between the main fuel supply rigid pipe flange and the FM-13 flange (**Photo 46**).

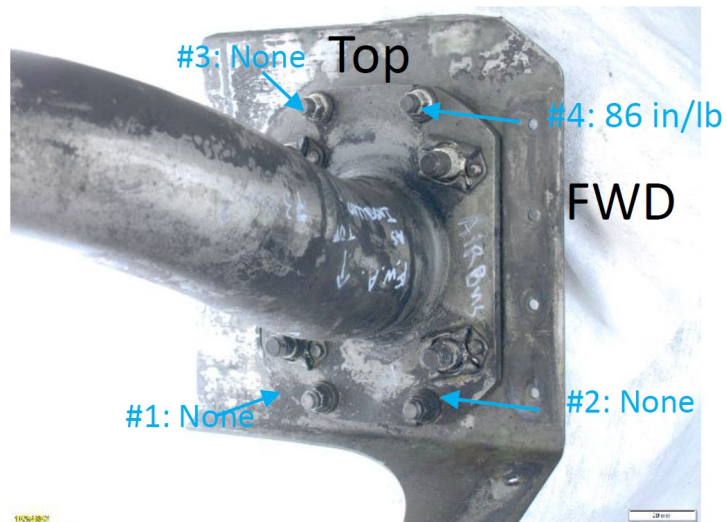
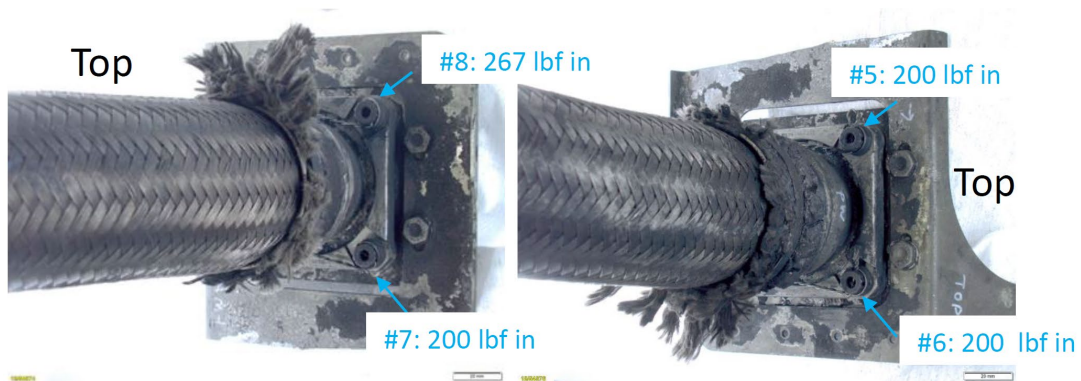
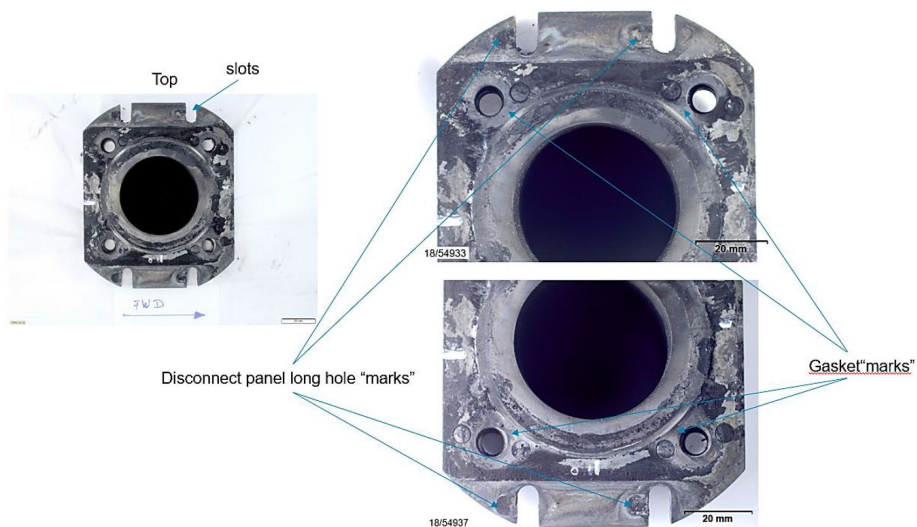
Breakaway torques were measured on the four bolts connecting the rigid pipe to the pylon hydraulic interface panel and the four bolts connecting the FM-13 flange and the rigid pipe flange. The torque value of each of the four bolts connecting the rigid fuel pipe and FM-13 hose were 200 in-lbs. or greater. Three of the four bolts connecting the rigid pipe flange to the pylon hydraulic interface panel had no breakaway torque and the fourth bolt torque was 86 in-lbs. The torque values for each of the eight connections are identified in **Photos 47 and 48**. When the flange faces were separated, gasket residue was visible on both the FM-13 hose flange and rigid pipe flange sealing surfaces, consistent with proper Gask-O-Seal installation and elastomer contact (**Photo 49**).

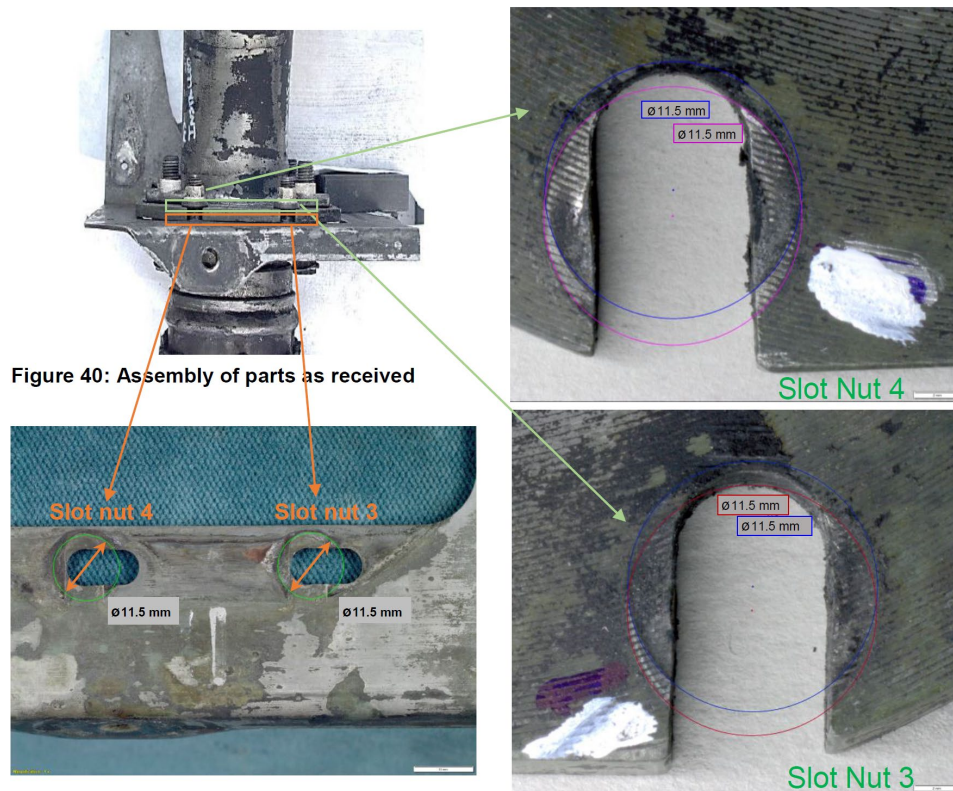
Figure 40: Assembly of parts as received

A visual inspection of the lower rigid fuel pipe flange was performed to check for evidence of imprints created by the attaching nuts in the flange nut slots. Two imprints were identified on the engine side (inboard) flange face consistent with installation in the as received installation. One imprint was identified on the pylon (outboard) flange face consistent with installation in accordance with Airbus drawings at an unknown point in the airplane service history (**Photo 50**).

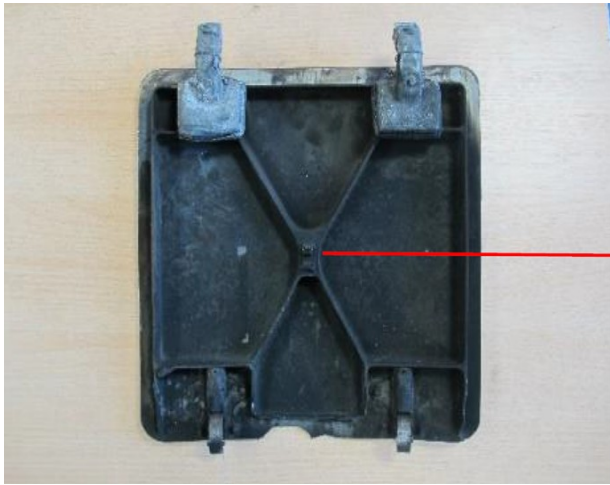
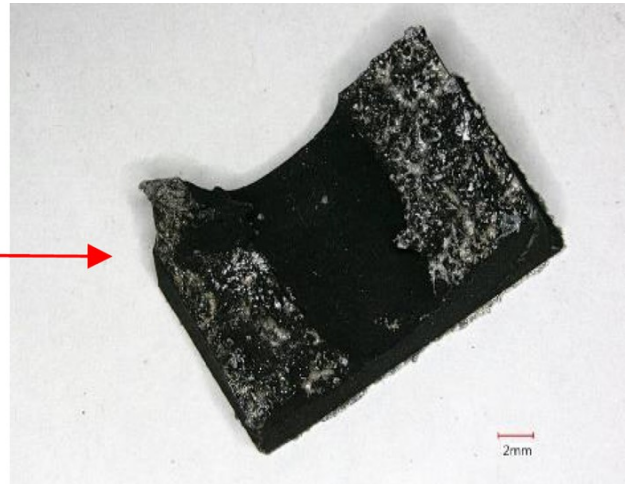
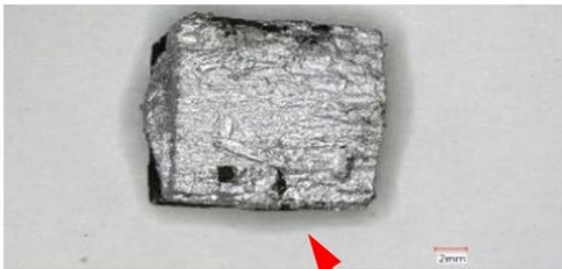
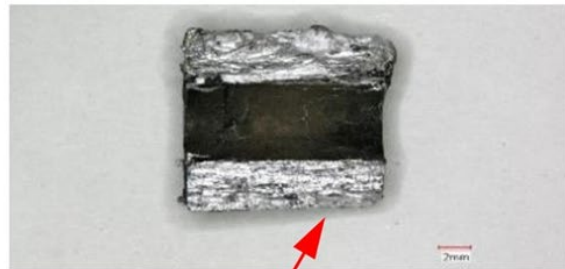
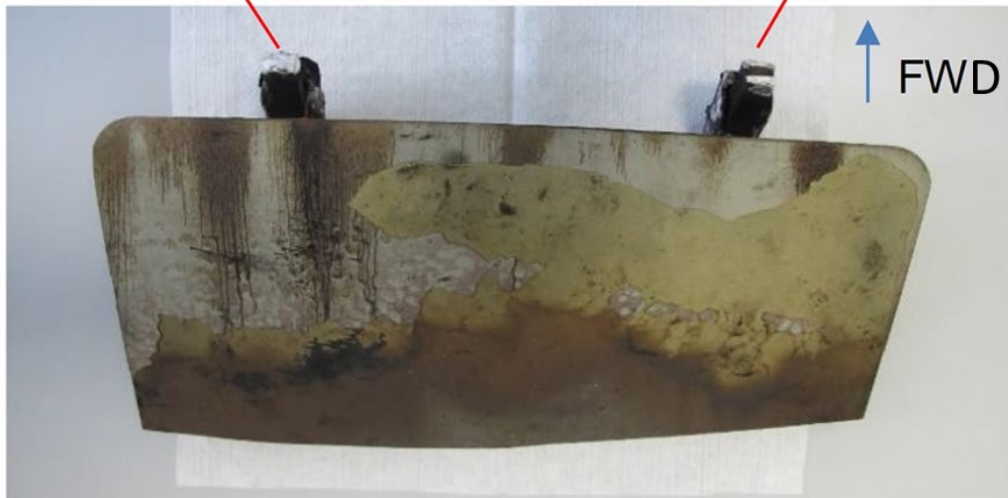
The separated right thrust reverser upper PRD that was dropped from the airplane during the accident flight was sent to Airbus Bremen Materials Laboratory for examination of the ratchet lug and hinge fracture surfaces (**Photos 51 and 52**). The ratchet lug surface was covered in residue and exhibited significant thermal distress. The fracture surface was intensely cleaned, but laboratory staff were unable to remove all residue and consequently, a detailed fracture surface morphology was not possible. The fracture surface had visible indications of free solidified material. The fracture surfaces on the hinges appeared shiny typical of melting and free solidification.

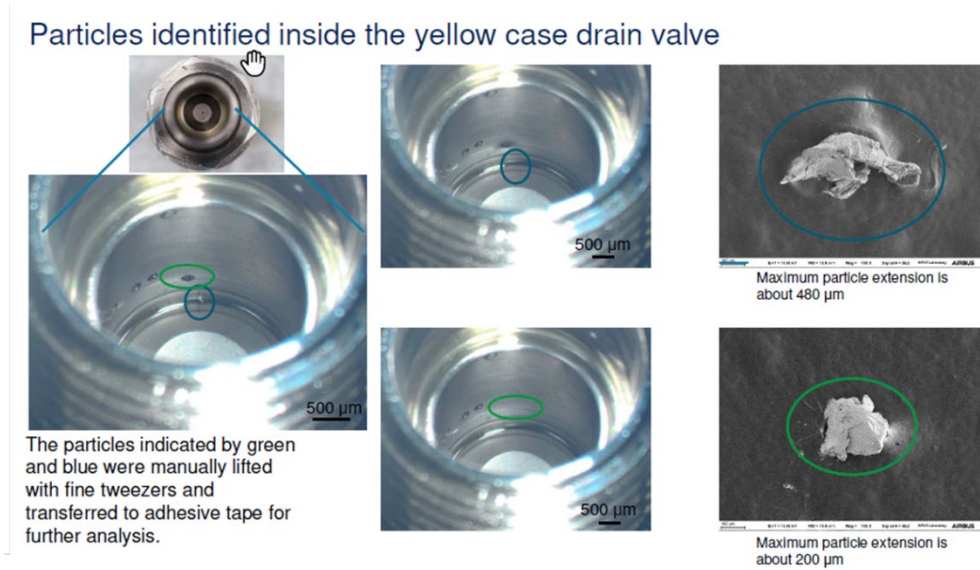
The yellow hydraulic system case drain check valve was examined at the Airbus Materials Laboratory in Bremen, Germany to look for debris/residue inside the valve<sup>23</sup>. A binocular examination was performed, and multiple small particles were found adhered to the valve wall (**Photo 53**). Two of the particles were removed with a fine tweezers and were analyzed to determine the material composition. EDS and chemical analysis revealed that the particles contained Iron (Fe), Chromium (Cr), and Nickel (Ni), this combination is consistent with stainless steel. Aluminum (Al) was also identified during the analysis.

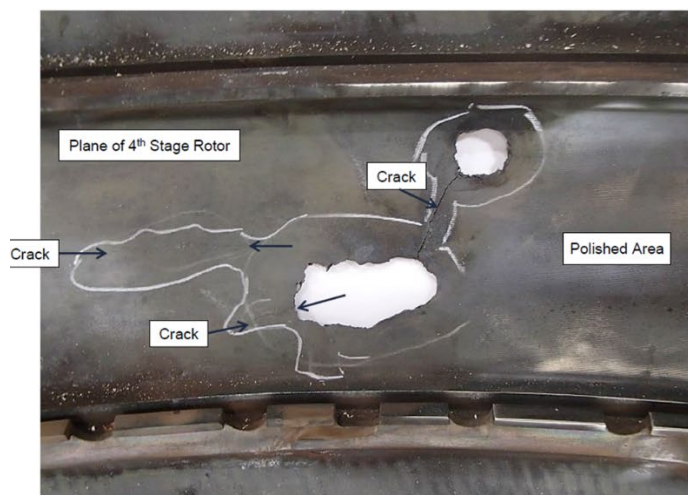
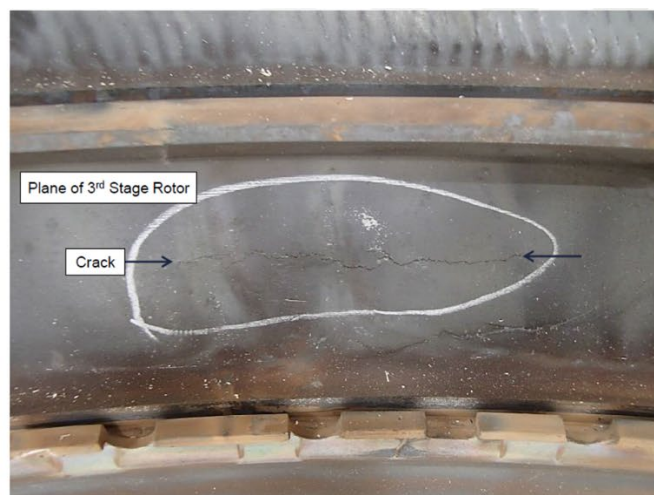
The two molten deposits were located in-line with the LPT 4<sup>th</sup> stage rotor place of rotation (**Photo 55**). The LPT case was deformed near the deposits and exhibited a dark, mottled appearance and texture from sooting and metal splatter according to the P&W lab. Cracks were observed extending from the larger hole to the smaller hole (**Photos 56 and 57**). The P&W materials lab report "PW4168 ESN 733603 Undercowl Fire LPT Case Examination" is available in the docket as Powerplants- Attachment 10- Pratt & Whitney PW4168A-1D LPT Case Materials Analysis Report.

Approximately 3 o'clock position  
Internal surface exhibited a dark discolored appearance

Approximately 9 o'clock position  
Internal surface appeared typical

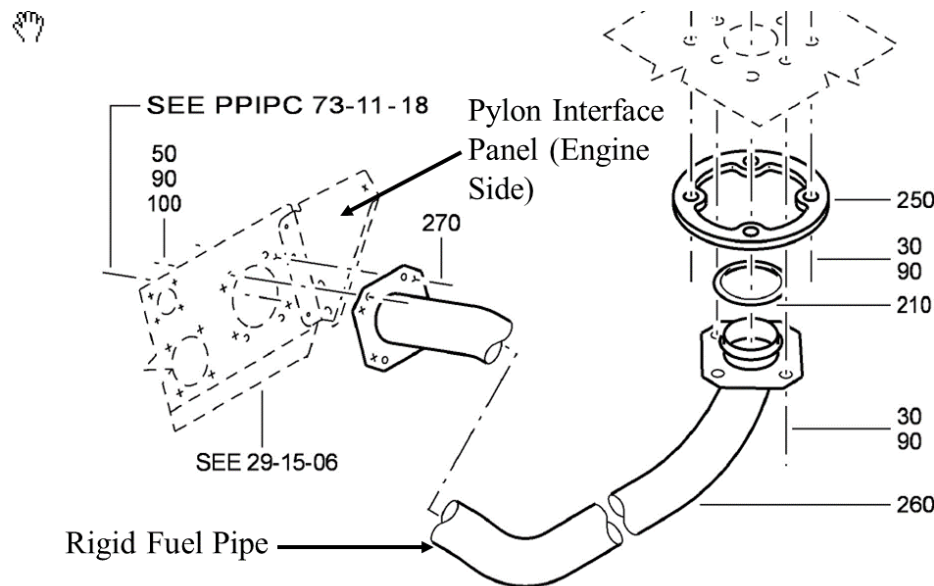
Figure 15- Original DAL A330-300/PW4168 IPC Figure

After the on-scene pylon and engine examination, DAL reviewed their A330 AMM and Aircraft Illustrated Parts Catalog (AIPC)<sup>24</sup> and determined that the rigid fuel pipe installation position on the Pylon Hydraulic Interface Panel was depicted incorrectly in several figures (**Figure 16**). The Rigid fuel pipe lower flange was shown installed on the engine side of the Hydraulic Interface Panel as was documented on the No. 2 engine, rather than the pylon side in accordance with Airbus drawings. The applicable figures were revised to show the correct installation in accordance with the Airbus drawings (**Figure 17**). DAL then voluntarily performed a fleetwide inspection of all their Pratt & Whitney PW4168 powered Airbus A330-300 airplanes to check for rigid fuel pipe installation errors. There were no additional rigid fuel pipe installation error findings in the DAL fleet, but the inspection did identify one mis-seated FM-13 upper flange (**Photo 58**). There was no evidence that the mis-seated FM-13 hose flange had resulted in a fuel leak. DAL then initiated a second fleetwide inspection campaign to verify that all FM-13 hoses were properly seated, with no additional findings.

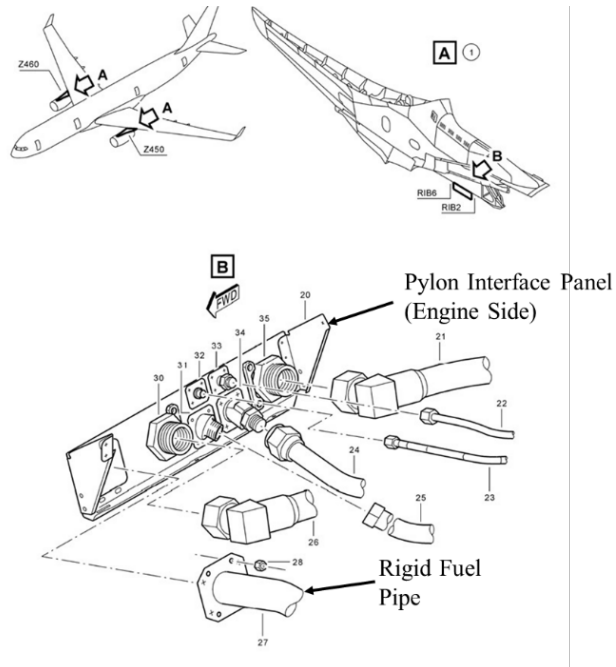
**Figure 17- Original Airbus A330-300/PW4168 AMM Figure**

Airbus reviewed the Airbus A330-300/PW4168 AMM and AIPC manuals and also identified that the rigid fuel pipe installation position on the pylon hydraulic interface panel was depicted incorrectly in several figures (**Figure 18**). The applicable figures were revised to show the correct installation in accordance with the Airbus drawings (**Figure 19**).
