DOCKET NO. SA-542

# NATIONAL TRANSPORTATION SAFETY BOARD

NTSB ID No. DCA18MA142

## TIMELINE STUDY

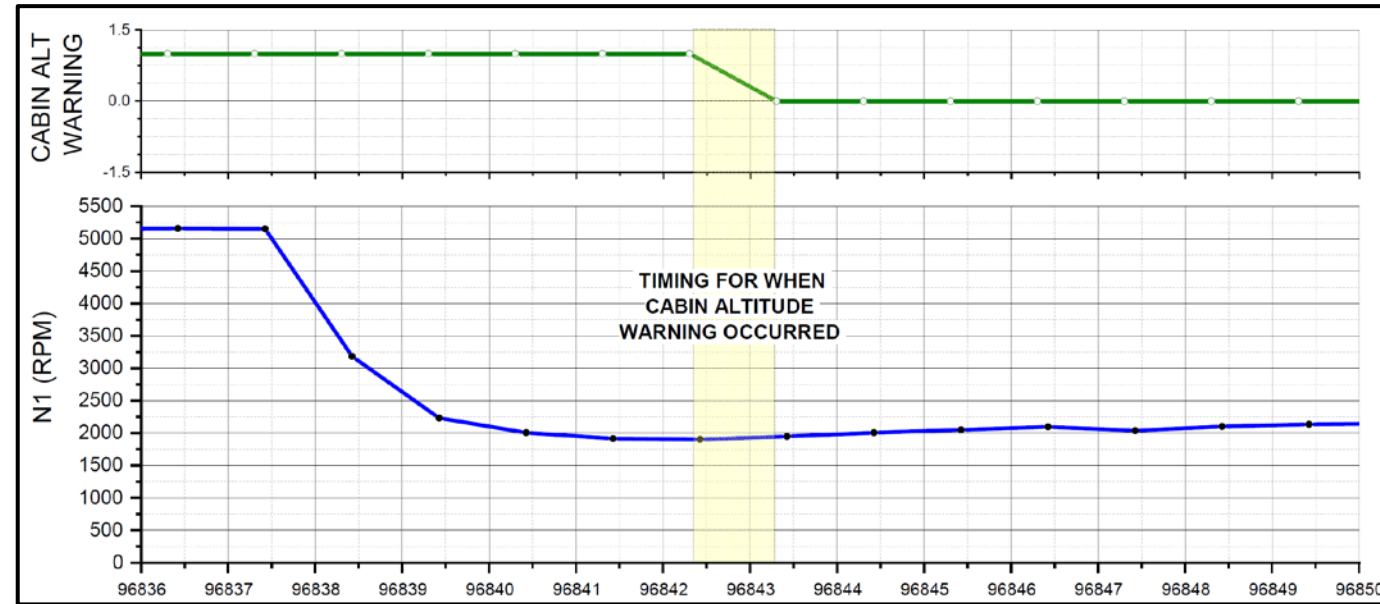
The FDR recorded the Cabin Altitude Warning discrete at a rate of one sample per second. A review of the data revealed that discrete transitioned from 1 (no warning) to 0 (warning) between the times of 96842.3 and 96843.3

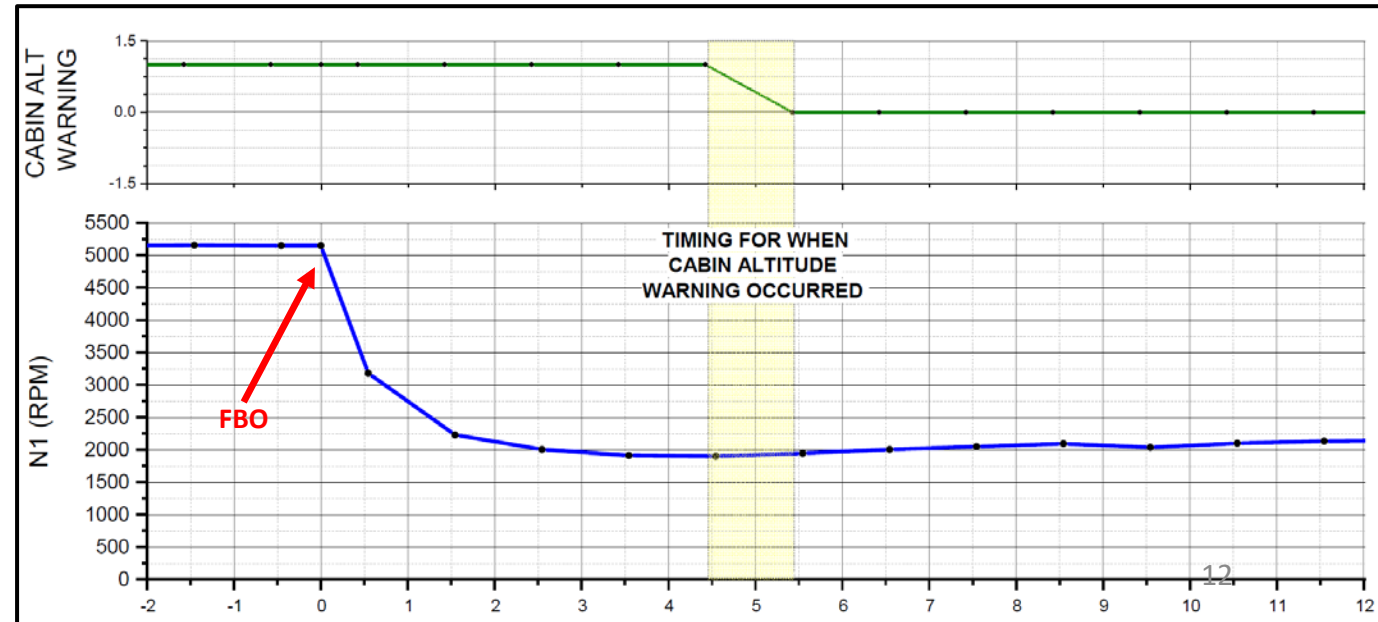
Aligning the timing of the Cabin Altitude Warning discrete with the calculated timing of the FBO indicates that the warning occurred between 4.4 and 5.4 seconds after the FBO

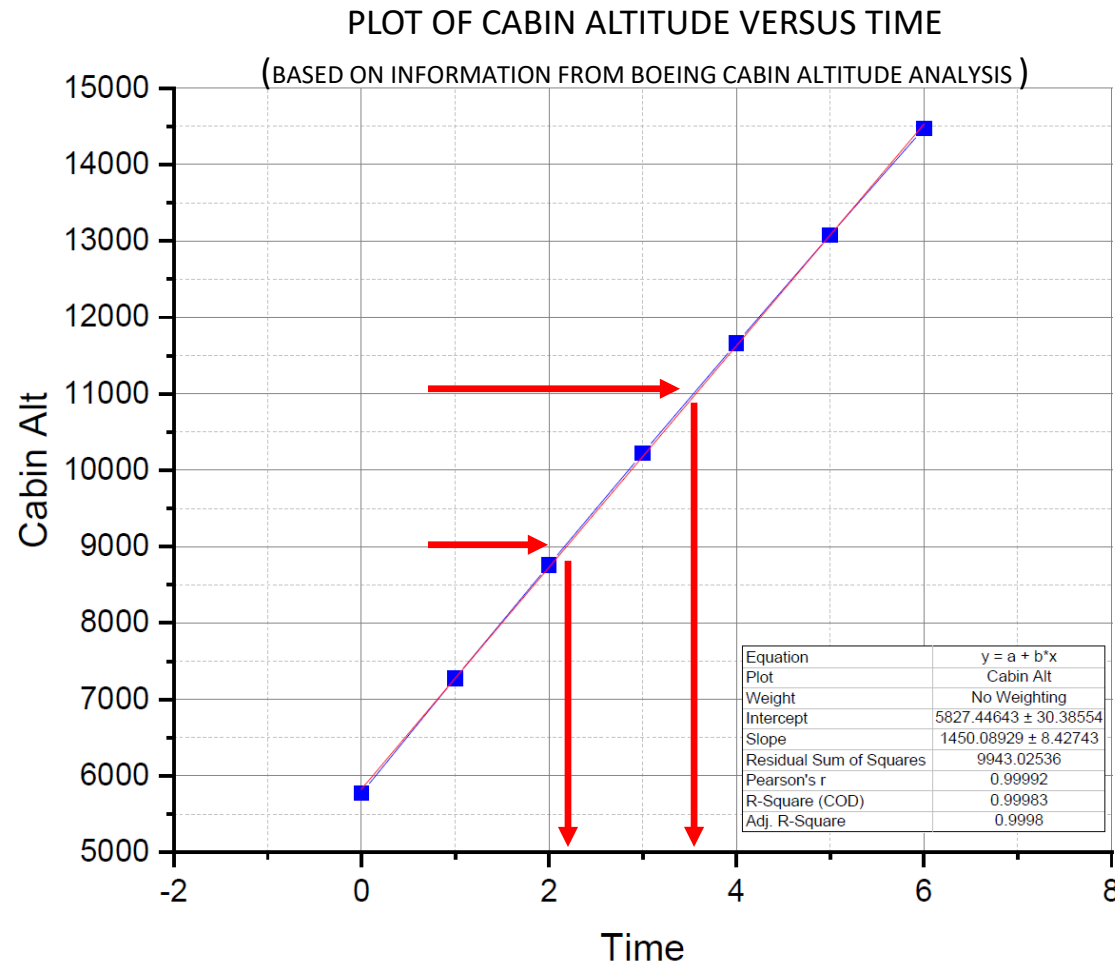
ANALYSIS USING THE SLOPE OF THE CURVE TO DETERMINE RANGE OF TIMES DUE TO A TOLERANCE BAND ON THE PRESSURE SWITCH OF +/- 1,000 FEET

FOR AN UNOBSTRUCTED WINDOW, IT COULD TAKE BETWEEN 2.23 AND 3.60 SECONDS FOR THE CABIN TO DEPRESSURIZE ENOUGH TO TRIGGER THE PRESSURE SWITCH

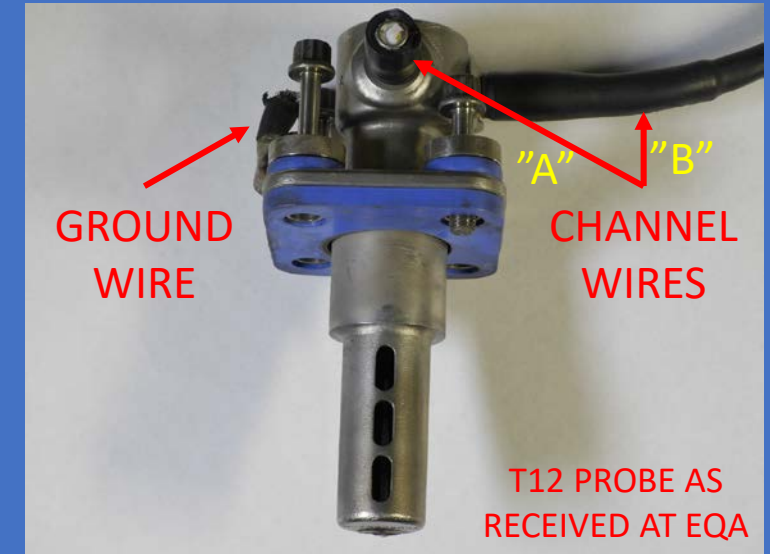
- T12 Sensor wiring examined by Boeing EQA on July 18, 2018
- Objective was to determine the mode of fracture of the wires leading to the sensor

- T12 Probe was in good condition
- All examined wire fractures are consistent with tension overload
- Observed 'pull' direction for 'A' channel wire was consistent with a 'downward' (airplane sense) direction.

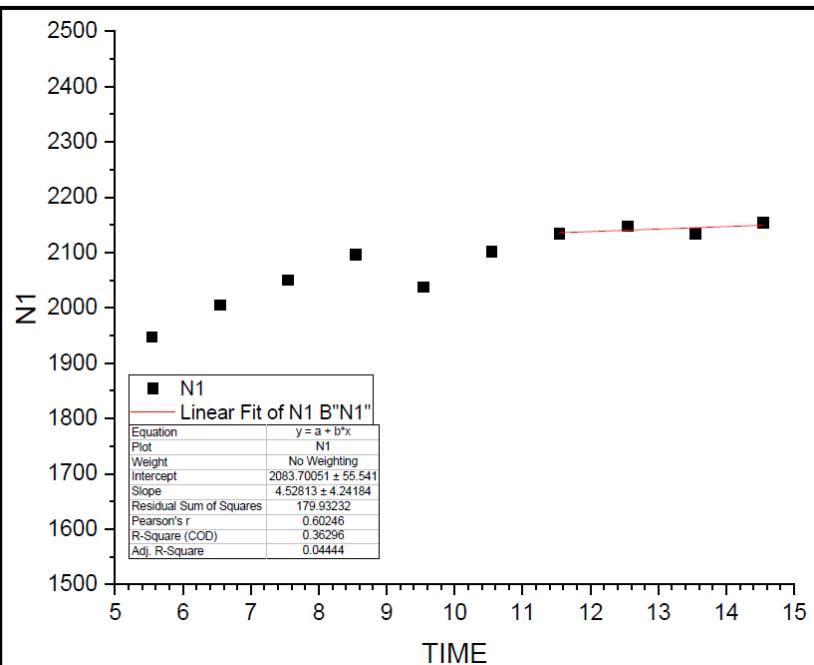
- Channel A: N1=2141.5 rpm @ 12.764 sec
- Channel B: N1 = 2167 rpm @ 18.963 sec

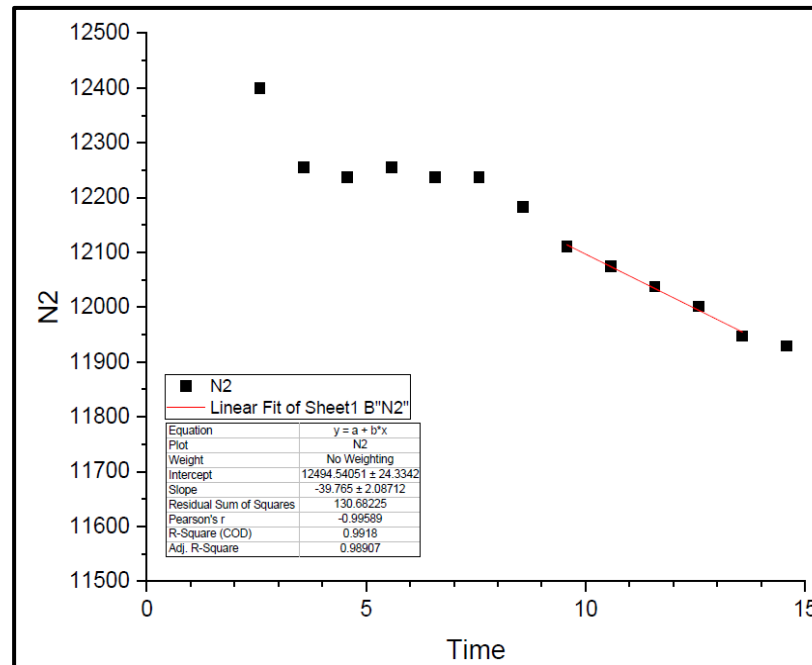
- Channel A: N2 = 12,048 rpm @ 11.229 sec
- Channel B: N2 = 11,958 rpm @ 13.49 sec

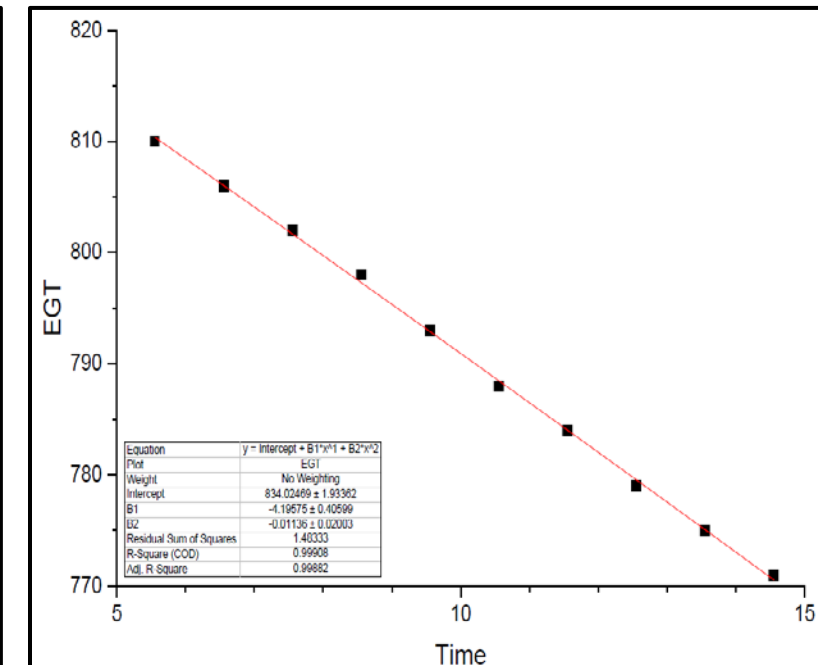
- Channel A: EGT = 782.5 C @ 12.28 sec
- Channel B: EGT = 772.5 C @ 14.69<sup>25</sup> sec

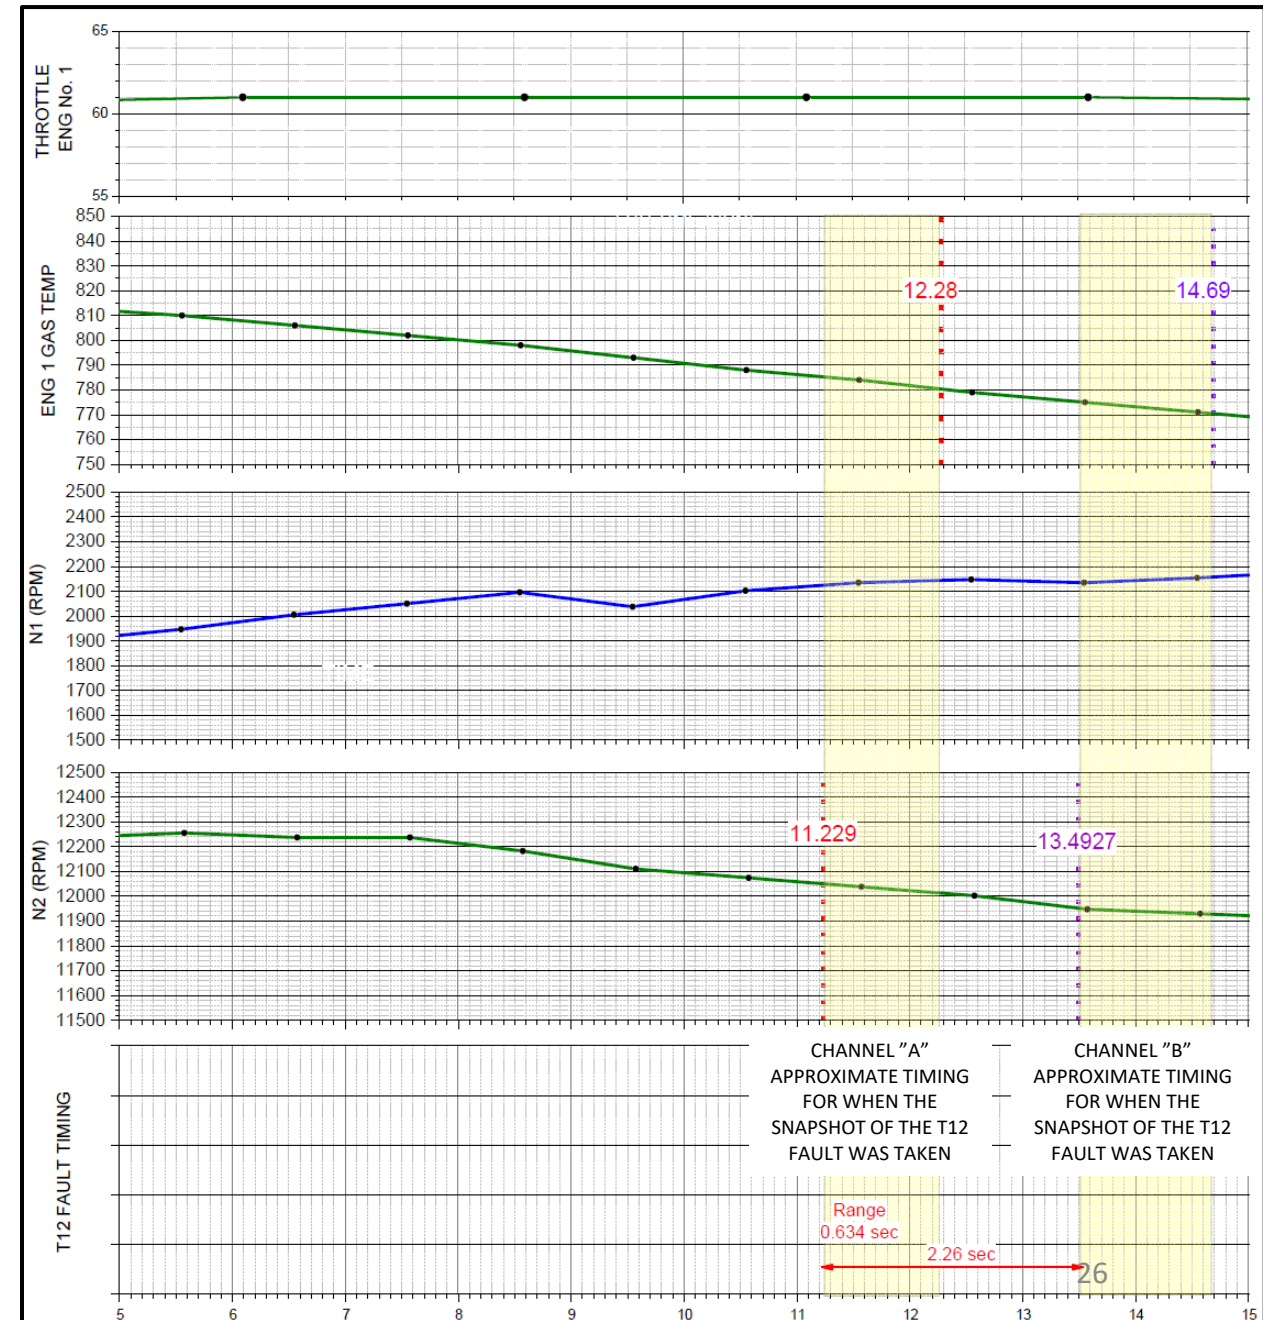
Aligning the EEC “Snapshot” data with the FDR data shows the following:

- Snapshot of engine data for the Channel “A” likely occurred between 11.23 and 12.28 sec after FBO
- Snapshot of engine data for the Channel “B” likely occurred between 13.49 and 14.69 sec after FBO

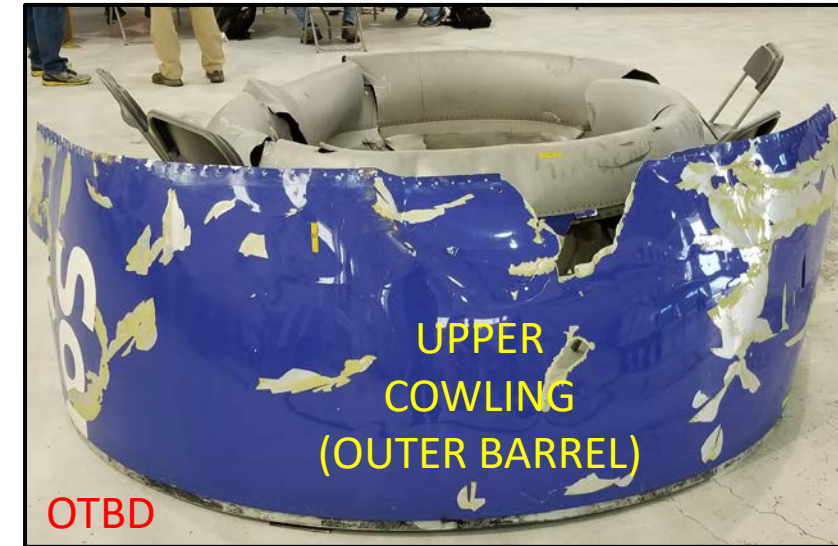
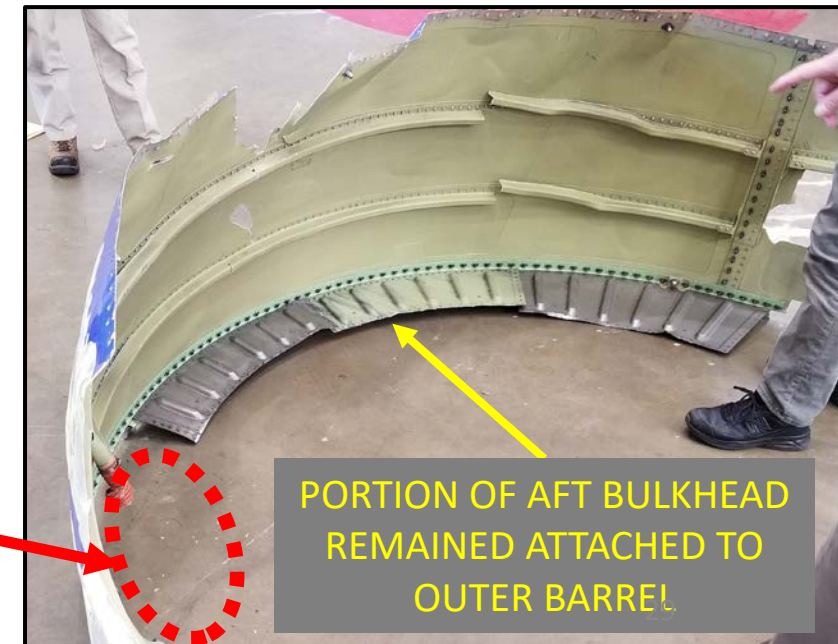
- EXACT TIMING FOR WHEN THE INLET (OR PORTIONS OF THE INLET) DEPARTED THE ENGINE IS NOT KNOWN AT THIS TIME.
- THE T12 SENSOR WIRING WAS LIKELY DAMAGED WHEN THE AFT BULKHEAD (SECTION WHERE WIRES WERE ATTACHED) MOVED SUFFICIENTLY.
- THE T12 CHANNEL "A" SENSOR WIRING WAS SEVERED BETWEEN 6.2 AND 7.15 SECONDS AFTER THE FBO

PORTION OF AFT BULKHEAD NOT FOUND
