**NATIONAL TRANSPORTATION SAFETY BOARD**

**STRUCTURES GROUP CHAIRMAN'S FACTUAL REPORT**

**NTSB No.: DCA18MA142**

NATIONAL TRANSPORTATION SAFETY BOARD  
Office of Aviation Safety  
Washington, D.C. 20594  
November 7, 2018

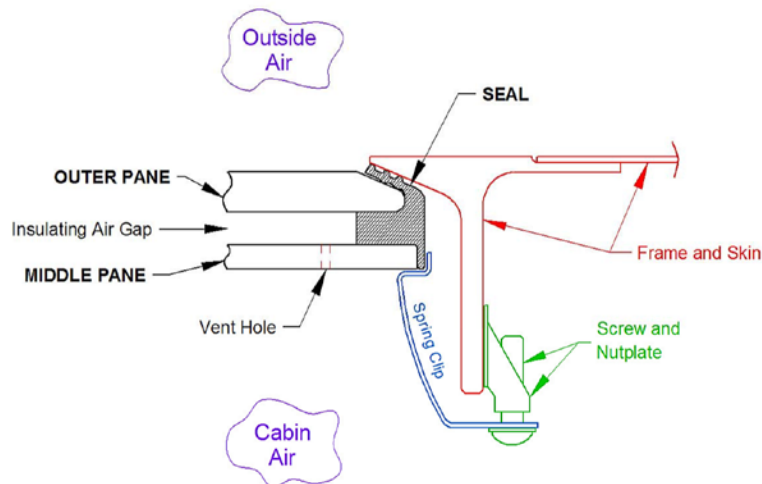
Figure 30 - Passenger window assembly

The passenger window assembly consists of an outer pane and middle pane held together by a silicon rubber seal. The outer panes are made from stretched acrylic and the middle pane is either made from cast acrylic or stretched acrylic depending on the version of the window. The 737 outer panes were qualified by test in 1967. They were designed to meet the requirements of 14 CFR 25.775(d). There are no FAA or Boeing design requirements regarding impact resistance for passenger windows. There are no directed inspections for passenger windows.

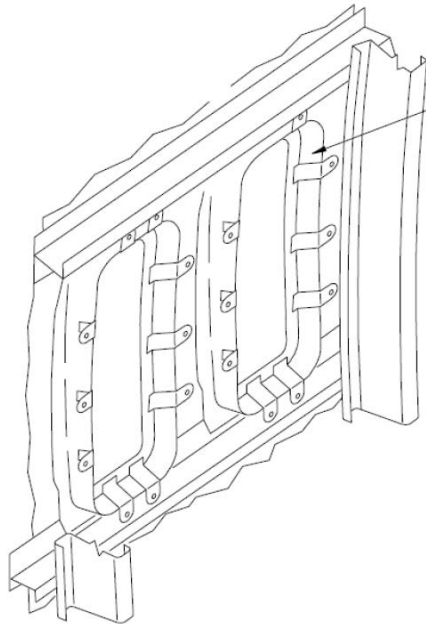
Figure 31 – Passenger window interior view schematic

None of the window inner and outer panes or the seal were recovered from inside the airplane or during the ground recovery of airplane debris. The cowling structure that impacted the fuselage caused a small puncture to the fuselage skin just below the incident passenger window.
