# BACKGROUND

On April 17th, 2018 SWA 1380 experienced a fan blade out (FBO) event at FL 320. The FBO event resulted in portions of the inlet and fan cowl departing the aircraft, specifically the inlet d-duct, inlet outer barrel, forward sections of the inlet inner barrel and large sections of the fan cowl. In support of the NTSB, Collins Aerospace (Collins) documented the condition of the inlet and fan cowl components that remained on the aircraft as well as the recovered hardware that departed the A/C. The recovered hardware and the remaining portions of the inlet and fan cowl were removed from the aircraft and were shipped to the Collins facility in Chula Vista, California.

# Fan Blade Fragment Trajectories and Inlet Damage

# COLLINS INLET FAN FRAGMENT DAMAGE ASSESSMENT

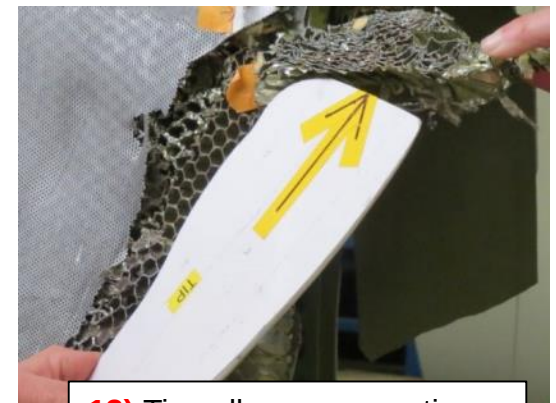
**13)** Tip collapses acoustic core and impacts 9:00 beam

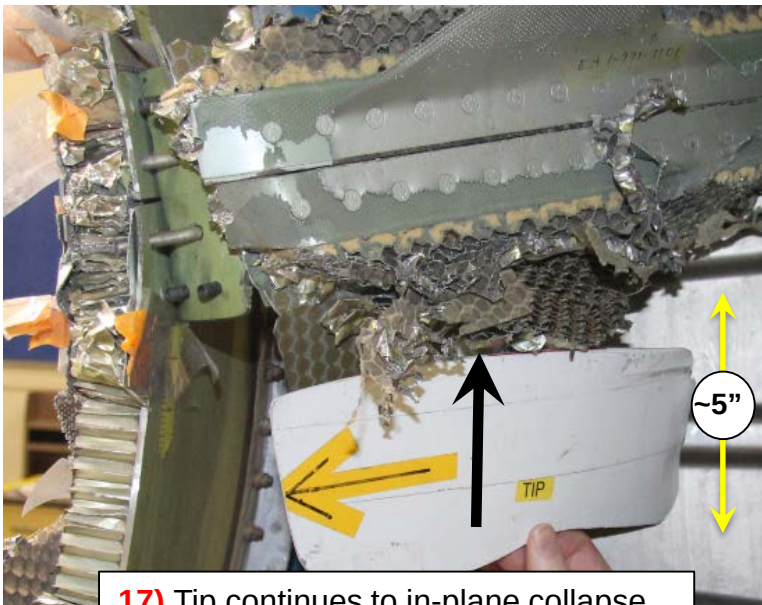
**17)** Tip continues to in-plane collapse  
~5" of acoustic core into 9:00 beam
