## **CFM presentation**

### **Fan blades fragments trajectories and Philadelphia inlet damage assessment**

The objective of this report is to document the CFM assessment of fan blade fragments trajectories and Philadelphia inlet damage presented to the investigative parties during the meeting held March 5-6, 2019 in Cincinnati, Ohio.

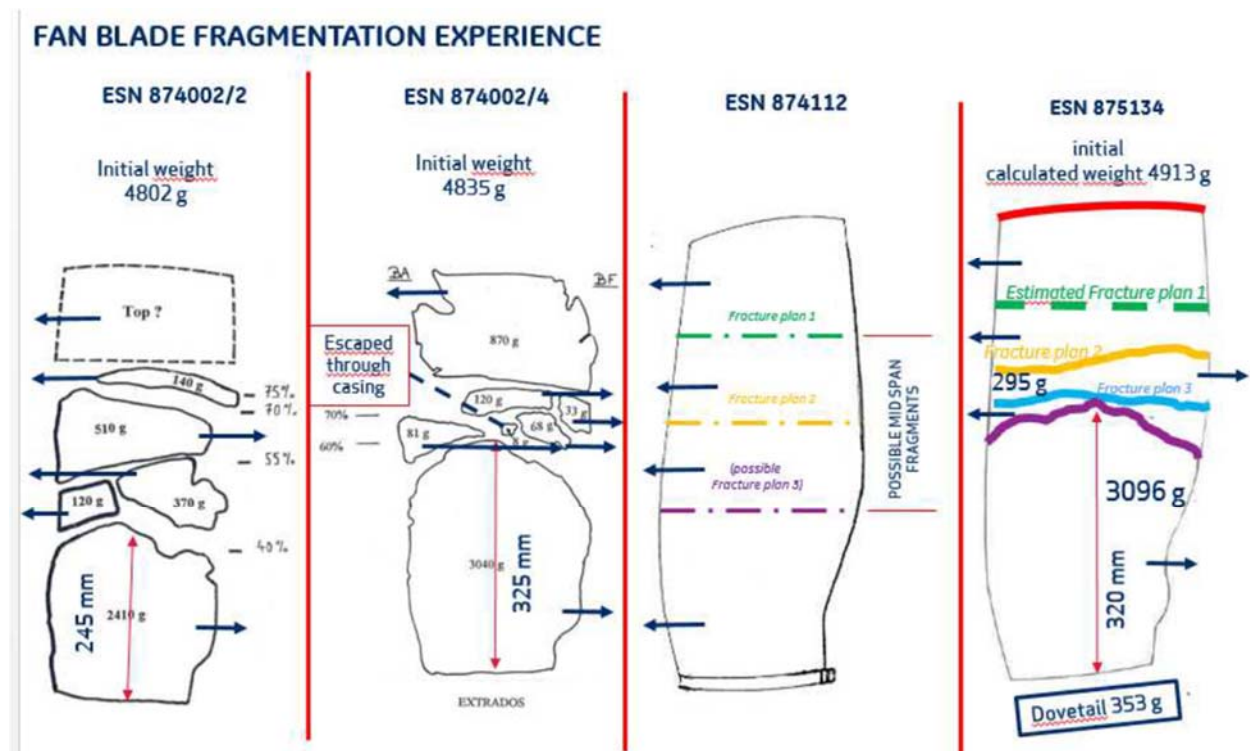
During a Fan Blade out event, after fan blade is released, the fan blade hits the fan case and is fragmented into several pieces: tip fragment, mid –span fragments and root fragment. CFM test and field experience can be summarized as follows: the Tip fragment has always gone forward. Mid span fragments have gone both forward and aft. The Root fragment has always gone aft except for Pensacola event where the root fragment went forward during the event based on witness marks.

Figure 2-1 below depicts the CFM56-7B Fan Blade fragmentation experience for the two certification tests and the Pensacola and Philadelphia events with an indication of the direction of the fragments (forward or backward). For the Pensacola event, no fragments were found inside the engine so it is assumed all fragments have gone forward. For the Philadelphia event, assumptions for Fan Blade fragmentation are detailed in the Powerplant Group Chairman's factual report (NTSB DCA18MA142). CFM has described, based on recovered fragments (one mid span fragment and the root fragment) and witness marks on Fan case, that there must have been one tip fragment and two/three mid fragments that have exited forward. This fragmentation and direction of the fragments is very similar to what was observed during FBO certification test 874002/2 performed with Boeing type design inlet.

Figure 2-1 : CFM56-7B fan blade fragmentation – Certification experience versus Pensacola and Philadelphia events

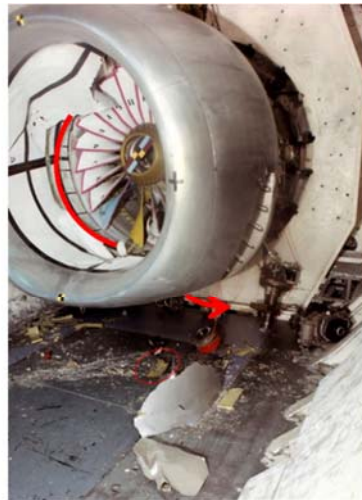
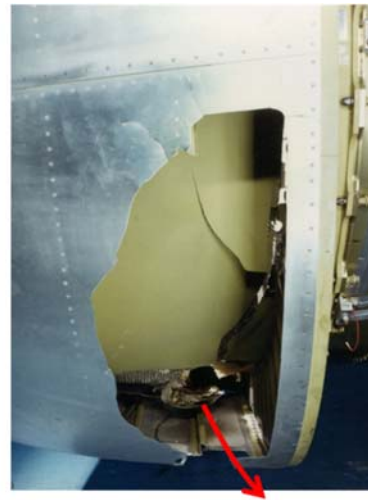
Engineering FBO test Rig 4 was performed using preliminary Boeing inlet design. During this test, tip fragment penetrated inner barrel back skin at 6 o'clock (~180° from blade release position) and exited through the inlet which had no containment doubler at that time.

Tip panel exit through the inlet.  
Inlet still in place after FBO

Tip blade fragment trajectory

**Figure 3-1 : Photographs of engine post FBO RIG test 4 – Tip blade fragment trajectory**

Review of photographs of Rig Test 4 shows continuous tip fragment trajectory aft and forward of A1 flange between 2 o'clock and 4 o'clock. Tip fragment edge crossed A1 flange with an angle of 15°. Continuous marks observed on fan case and inlet suggest that fragment center of gravity (CG) had same trajectory as tip fragment edge.

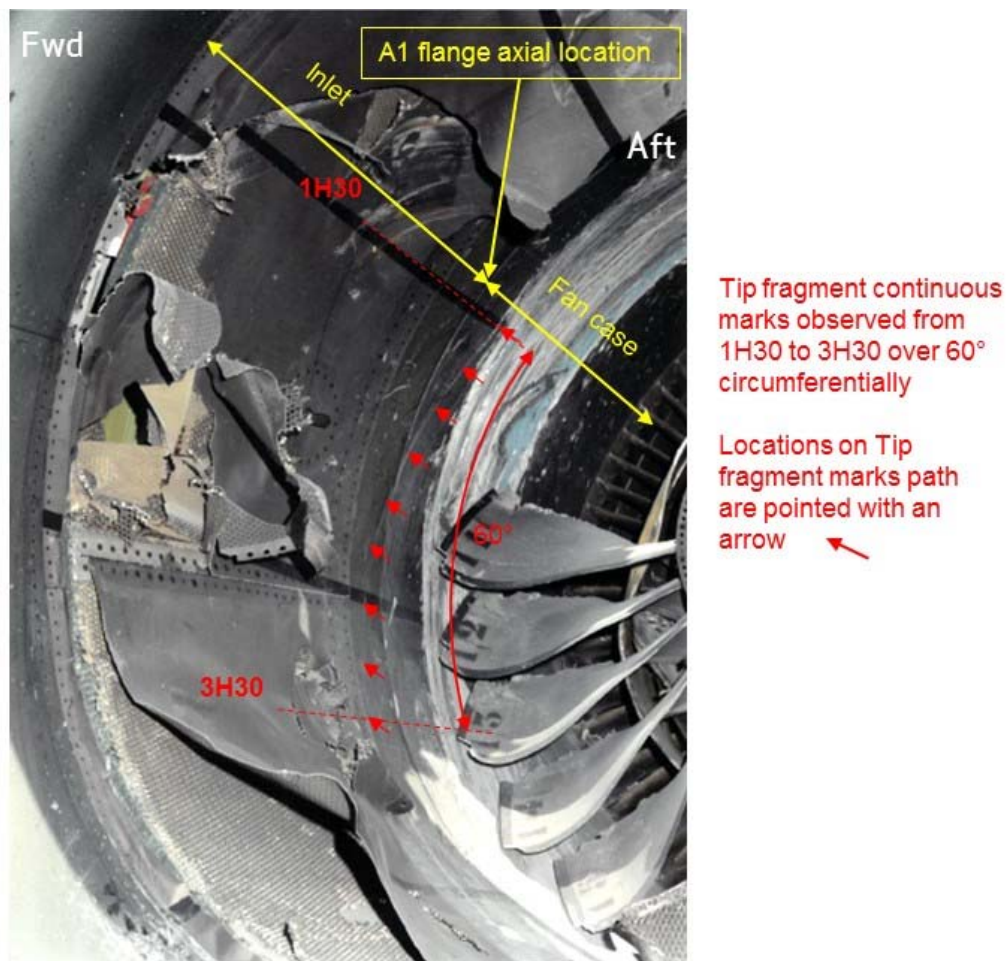
After the FBO certification engine test, the tip fragment marks on the fan case leading up to A1 flange and in the aft inner diameter of the Inlet are visible on the photograph from the test between 1H30 and 3H30 (Clockwise Aft Looking Forward comprising a 60° angle).

**Figure 3-3 : Engine 2/2 front view after FBO Certification test**

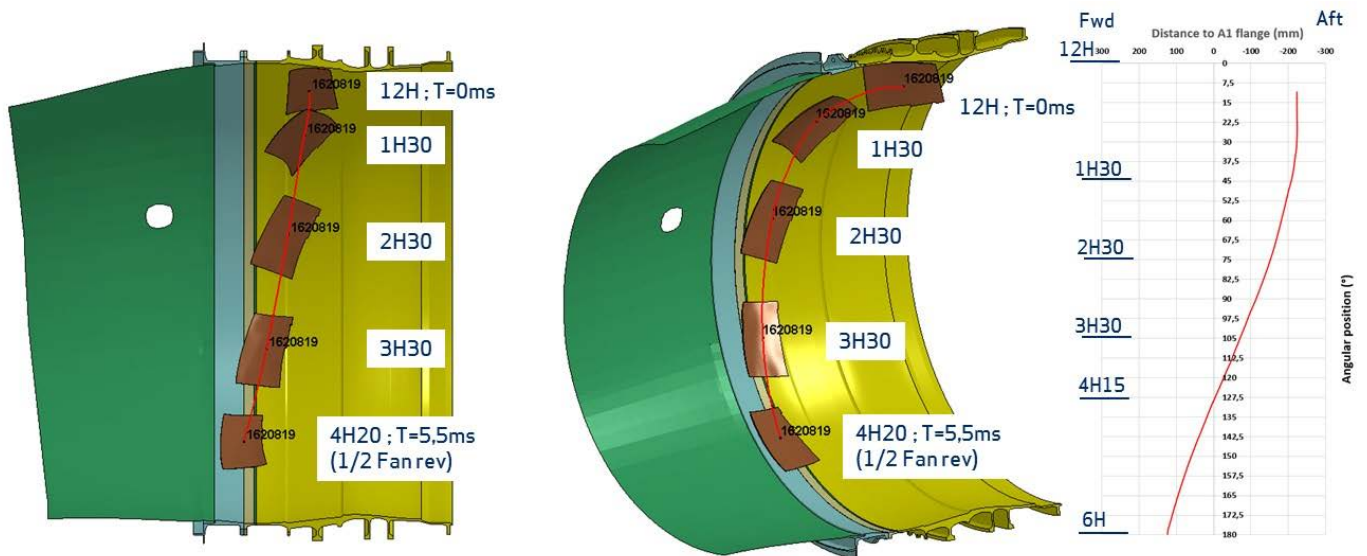
- The Tip fragment CG predicted trajectory is analyzed from the blade release angle up to half a revolution
- The Tip fragment CG crosses A1 flange at 5.3ms around 4:15 before half a revolution (5.5ms)

Figure 3-8 : LS-DYNA calculated Tip fragment CG trajectory for engine 2/2 Certification test conditions

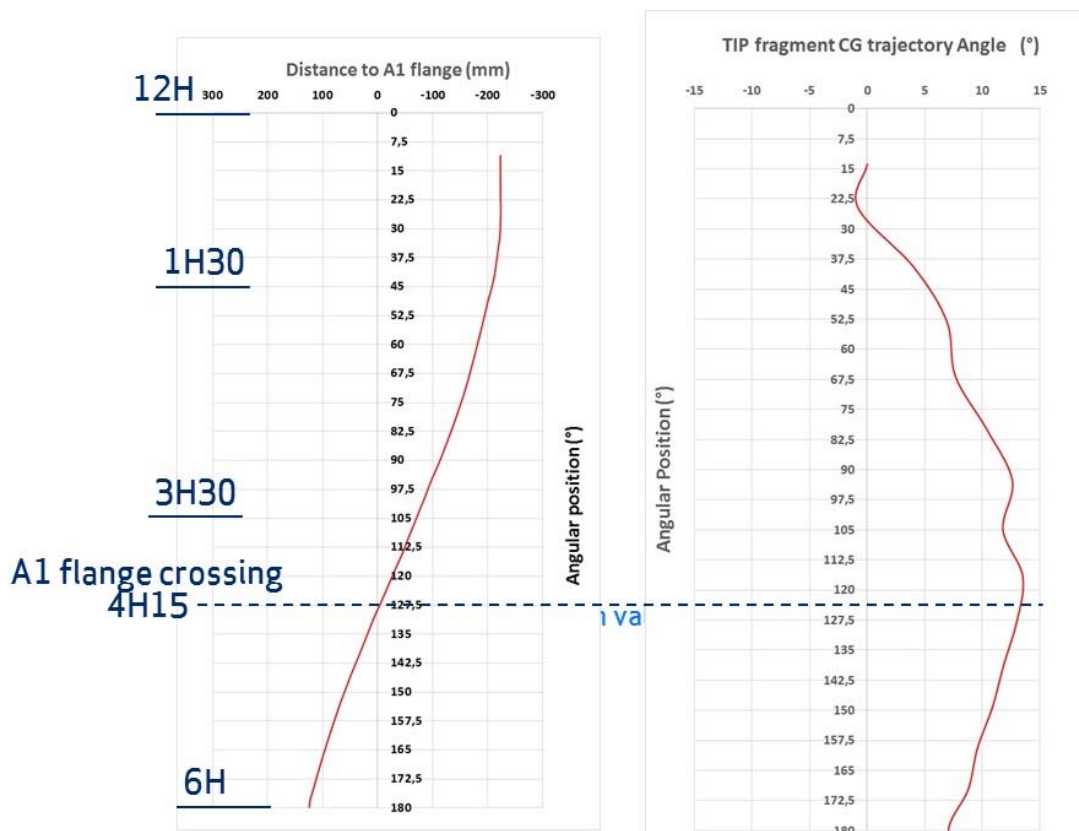
Figure 3-9 : LS-DYNA calculated Tip fragment CG trajectory for engine 2/2 Certification test conditions

The calculated Tip fragment CG trajectory angle when crossing A1 flange is 13.2°

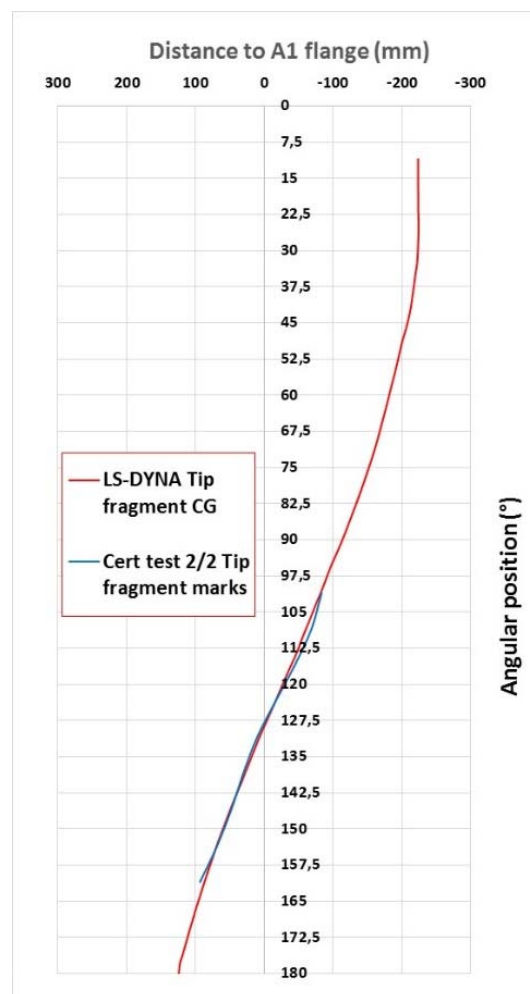
- In LS-DYNA calculation, Tip fragment CG trajectory crosses A1 flange at 4:15
- In the following figure 3-10, both Tip fragment CG trajectory assessed on engine 874-002/2 and LS-DYNA calculated CG trajectory are superimposed considering identical A1 flange crossing angular location at 4:15 to compare their trajectory angles.

**Figure 3-10 : Engine 2/2 Tip fragment marks and LS-DYNA Tip fragment CG trajectory superimposed**

This comparison indicates that the Tip fragment edge marks on engine 874-002/2 (Figure 3-5) and the Tip fragment CG trajectory calculated by LS-DYNA (Figure 3-9) when superimposed (Figure 3-10) show very similar trajectories with following angles at A1 axial plane:

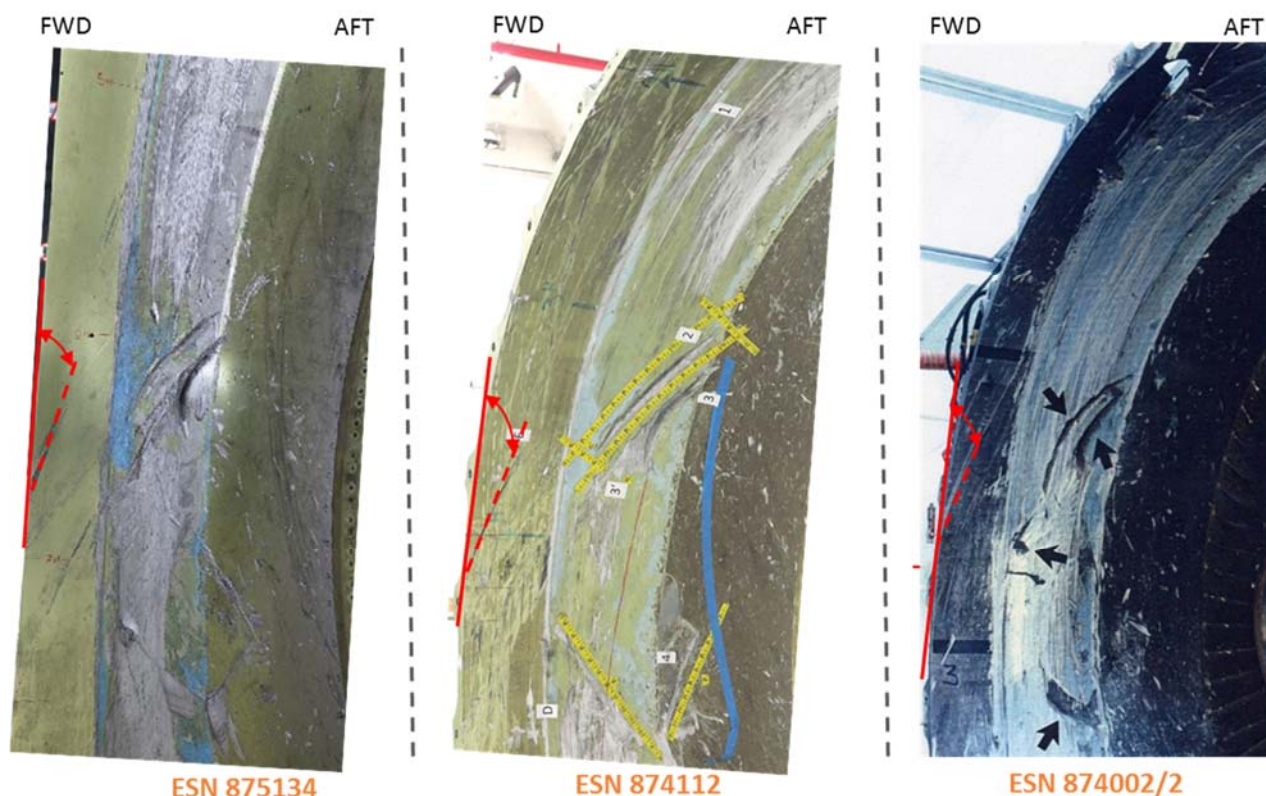
The tip fragment witness marks at A1 flange location on the Fan case show very similar angle  $\sim 15^\circ$  between Pensacola engine 874112, Philadelphia engine 875134 and FBO Certification test engine 874002/2. This is based on *physical evidence*; that is, the tip panel imprints on fan case.

Figure 4-1 : Tip fragment imprints on the Fan case angle at A1 flange

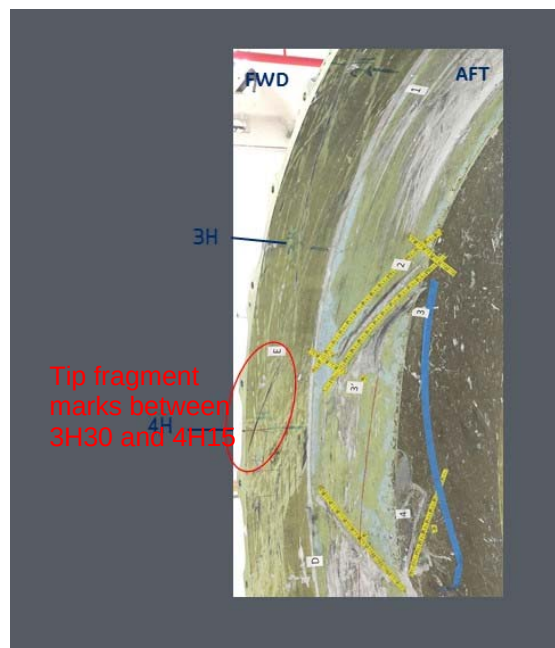
Tip fragment marks are observed between 3:00 and 4:15 on engine 874112 Fan case:

Figure 4-5 : Tip fragment marks measurement on Pensacola engine 874112 Fan case

The detailed analysis of these tip fragment marks on the Fan case shows one local Tip fragment trailing edge imprint on the Fan case, and edge marks.

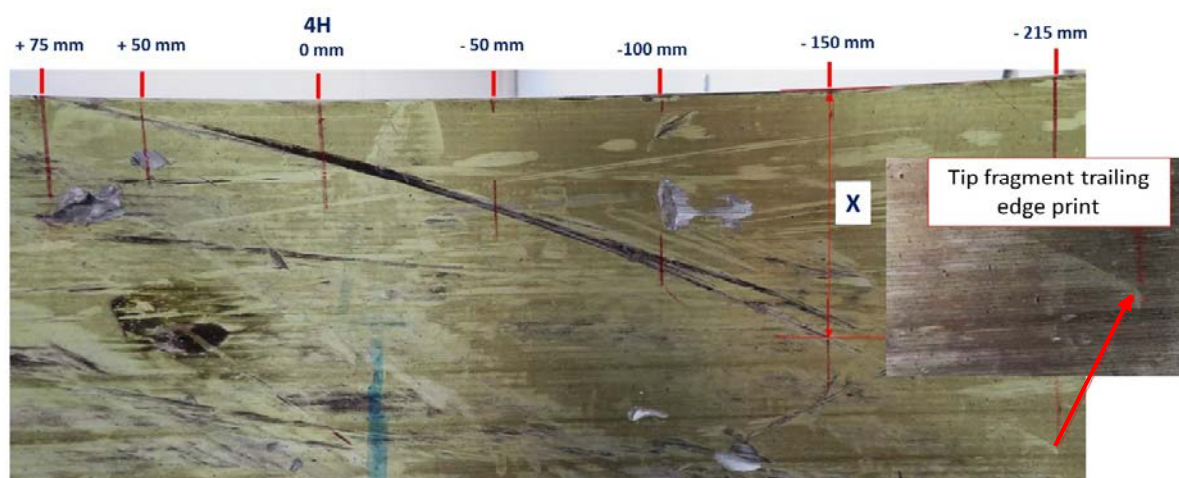
**Figure 4-6 : Tip fragment marks measurements on Pensacola engine 874112 Fan case**

As described in Figure 4-6, the distance to A1 flange of tip fragment marks has been measured at different circumferential positions. Based on those measurement, the Tip fragment witness mark calculated angle on Pensacola engine 874112 Fan case when crossing A1 flange is 13°.

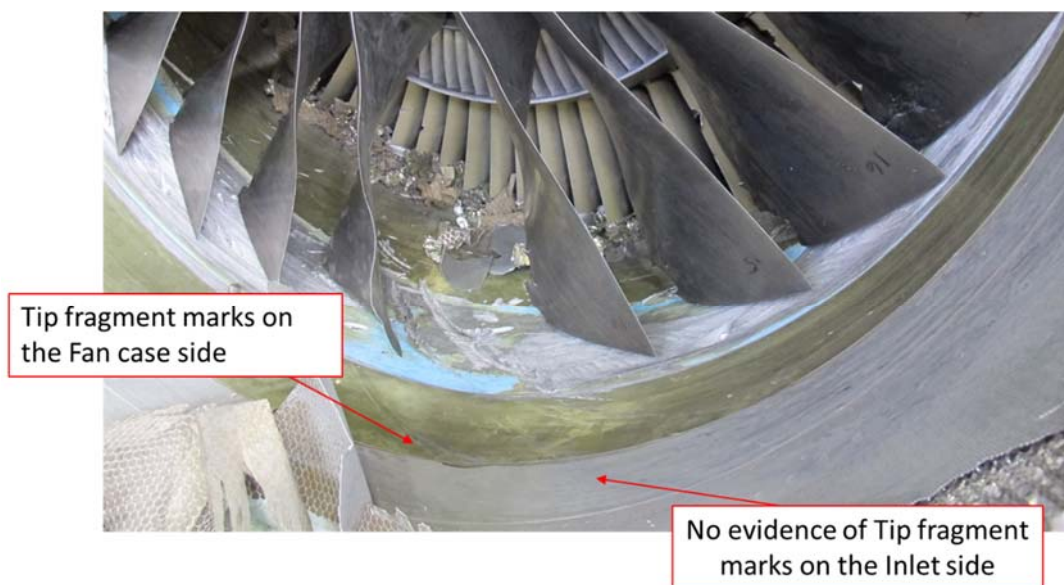
Tip fragment marks on the Fan case are the only data available to estimate the tip fragment edge trajectory up to A1 flange, as no evidence of tip fragment trajectory is observed on the Inlet inner diameter just forward of the A1 flange.

**Figure 4-7 : Tip fragment marks on Philadelphia engine 875134**

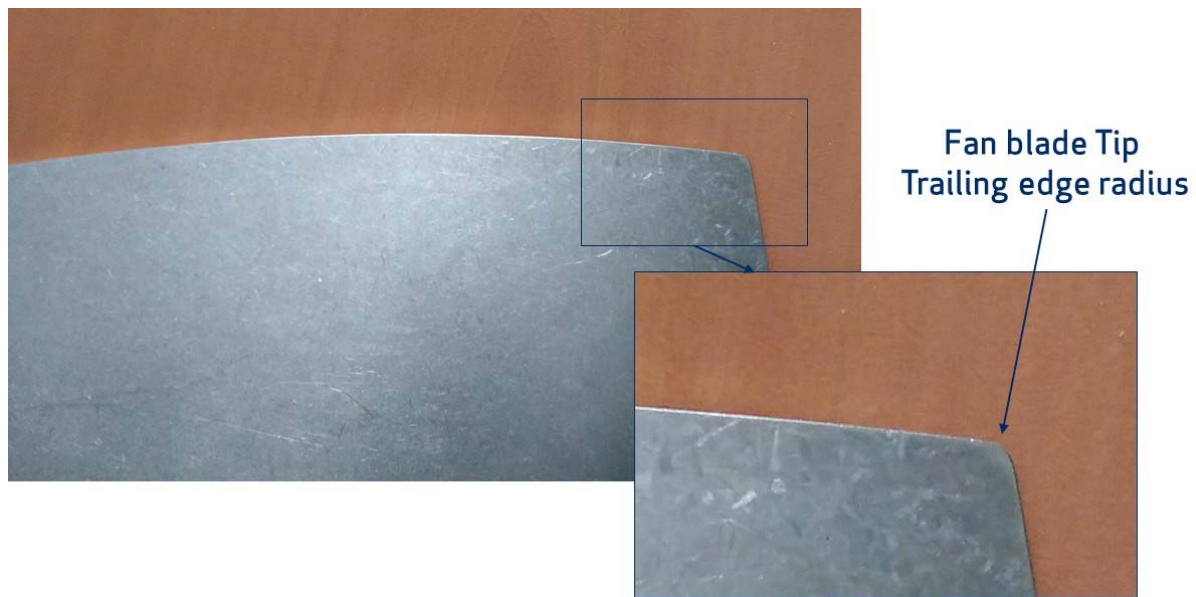
Detailed analysis of these tip fragment marks on fan case show **three** distinct Tip fragment trailing edge imprints on the Fan case. A photograph of the blade Tip trailing edge radius is shown in Figure 4-9.

**Figure 4-9 : Fan blade Tip trailing edge radius**

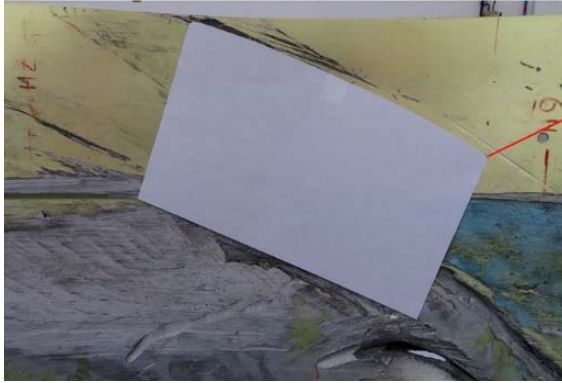
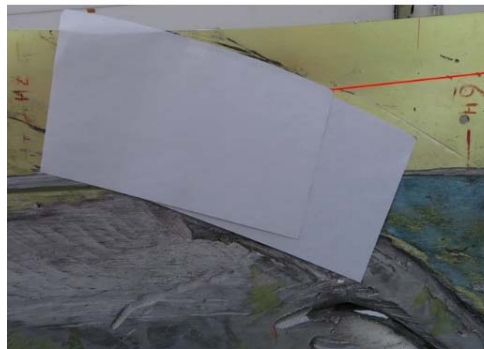
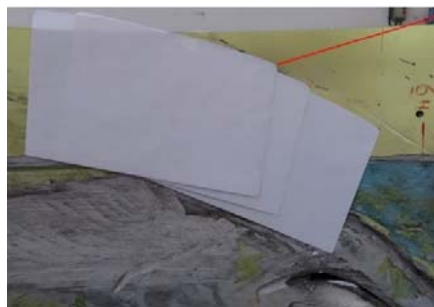
- Step#1: Each of these three imprints of the Tip fragment trailing edge radius is used to locate precisely the Tip fragment using a typical tip fragment shape. See Figure 4-10.
- Step#2: The corresponding three Tip fragment Center of Gravity locations are used to estimate the trajectory of the Center of Gravity including CG angle with A1 flange plane. See Figure 4-11 and Figure 4-12.

Tip fragment trailing edge and  
Tip fragment location n°1

Tip fragment trailing edge and  
Tip fragment location n°2

Tip fragment trailing edge and  
Tip fragment location n°3

**Figure 4-10 : Three distinct locations observed of the tip fragment trailing edge radius  
on Philadelphia engine 875134 Fan case**

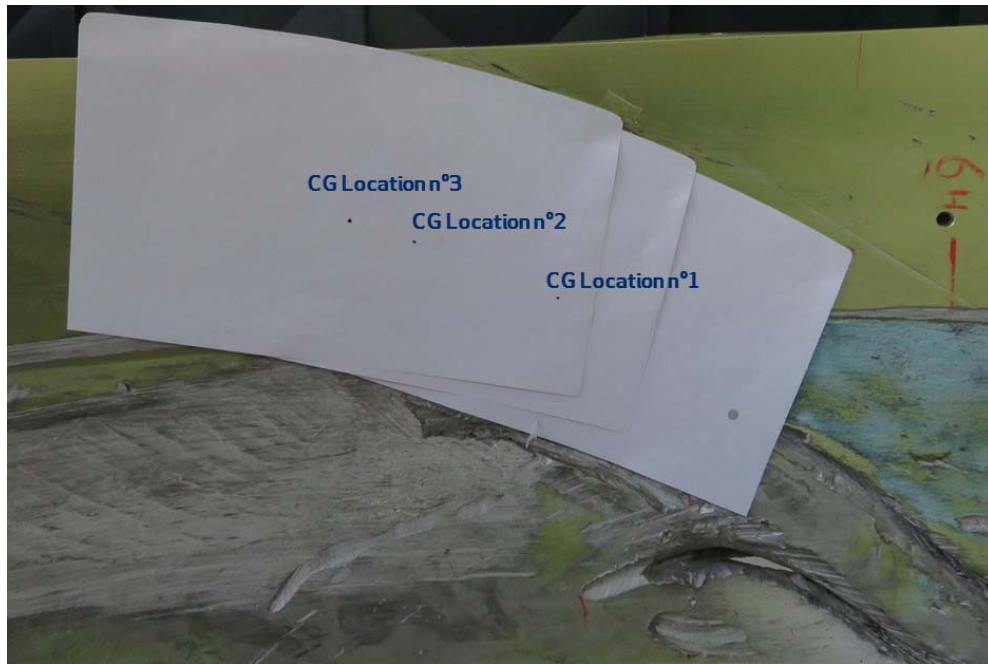
**Figure 4-11 : The three distinct locations of the Tip fragment superimposed to show Tip fragment CG trajectory**

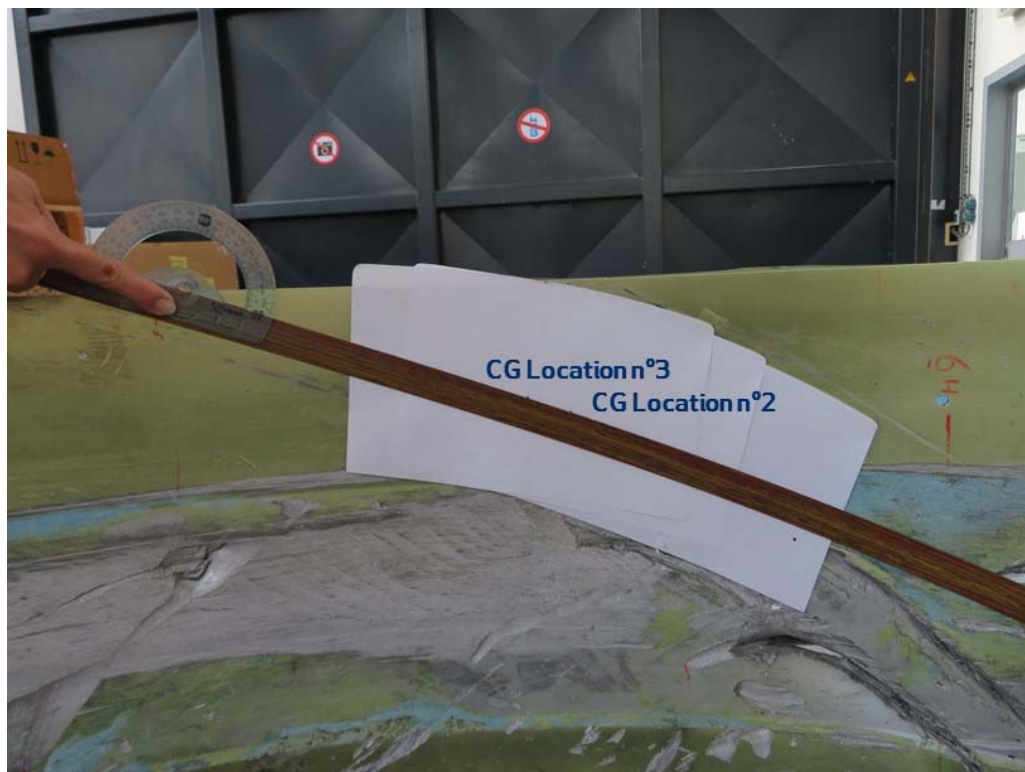
**Figure 4-12 : Tip fragment CG trajectory angle measurement**

Based on the two most forward identified locations of the Tip fragment CG on Philadelphia engine 875134 Fan case (location n°2 and location n°3), the Tip fragment CG trajectory angle crossing A1 Flange is 20°. However, note that from location n°1 to location n°3, the angle of the Tip fragment CG with A1 flange is reducing, so the CG trajectory angle when crossing A1 flange could be lower than 20°.

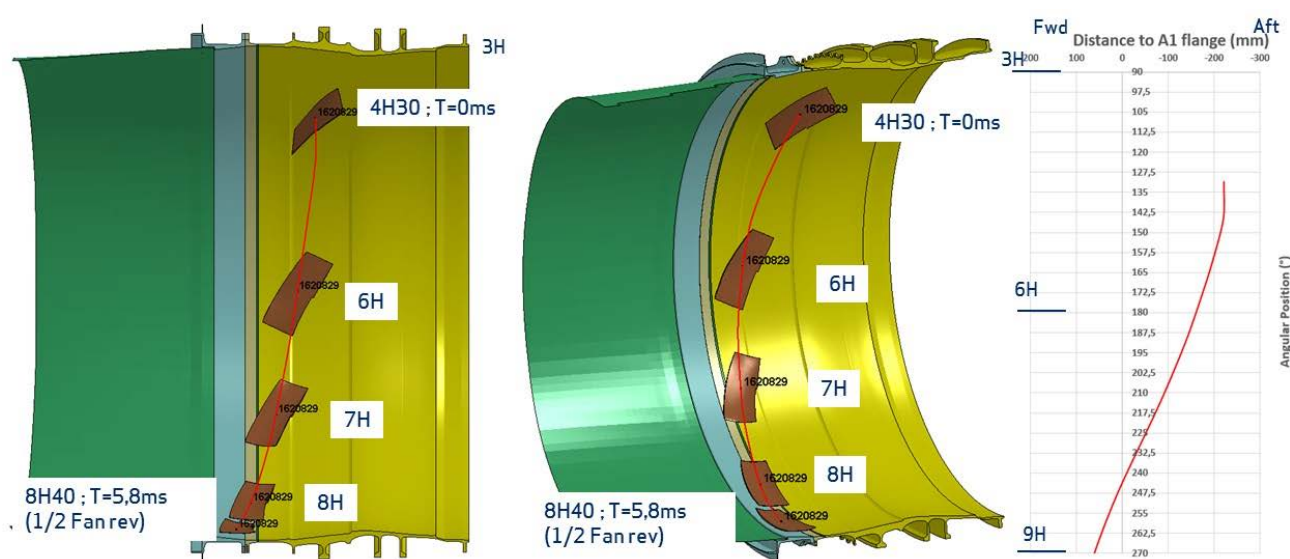
- The Tip fragment CG predicted trajectory is analyzed from the blade release angle up to half a revolution
- The calculated Tip fragment CG trajectory is described on Figure 4-14 and crosses A1 flange at 5ms around 8:10 before half a revolution (5.8ms)

Figure 4-14 : LS-DYNA calculated Tip fragment CG trajectory for Philadelphia engine 875134 conditions

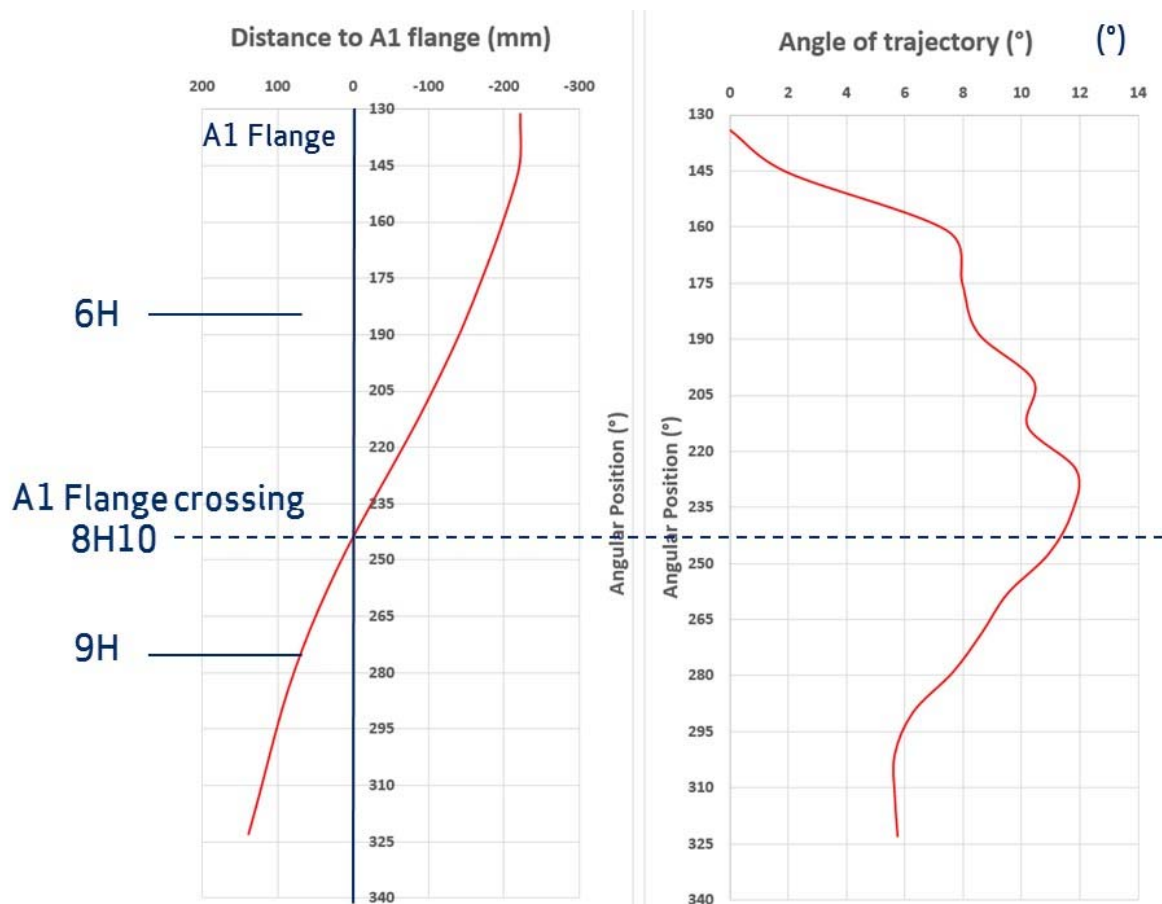
**Figure 4-15 : LS-DYNA calculated Tip fragment CG trajectory for Philadelphia conditions**

The *predicted* Tip fragment CG trajectory angle in Philadelphia conditions (11.1°) is similar to the Tip fragment CG trajectory angle *predicted* on engine 874-002/2 FBO Certification test conditions (13.2°).

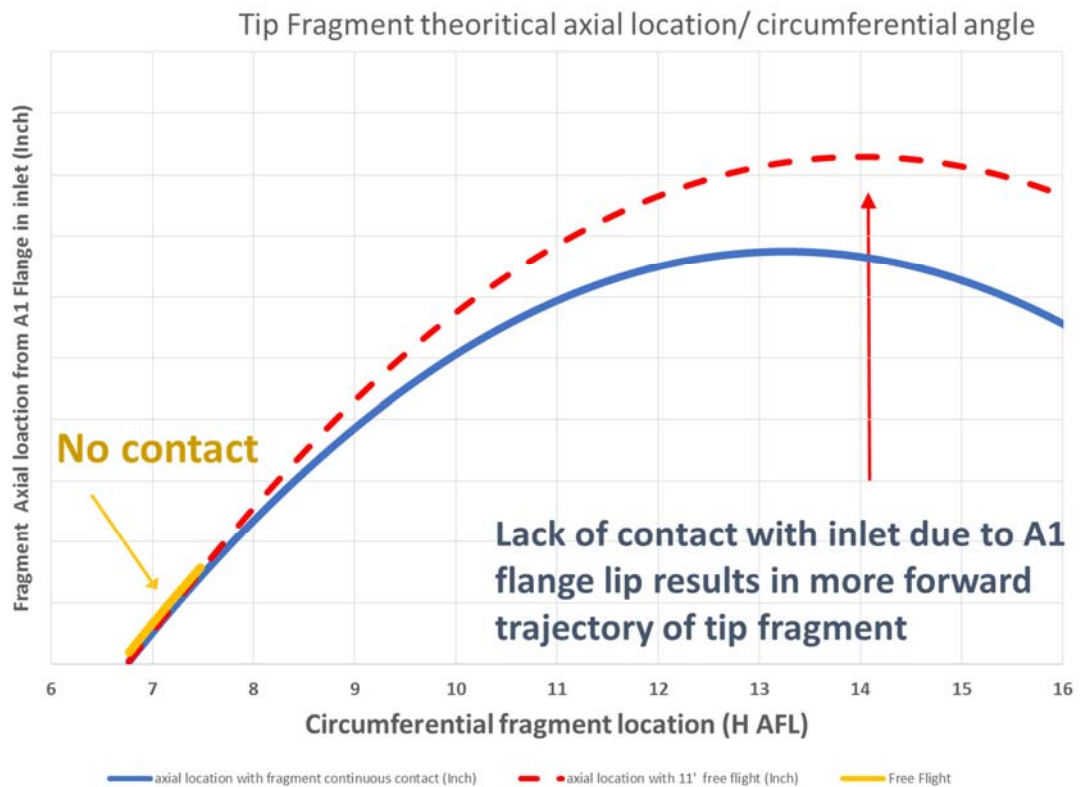
Figure 4-19 describes the tip fragment theoretical axial location based on trajectory of a ball rolling in a cone. If the fragment loses contact with inlet when crossing A1 flange, it results in more forward trajectory of tip fragment.

**Figure 4-19 : Tip fragment theoretical axial location in inlet versus circumferential angle**

Loss of contact with inlet A1 Flange lip also results in no friction between fragment and inlet. This results in higher velocity and increased energy of the fragment further forward in the inlet compared to certification test.

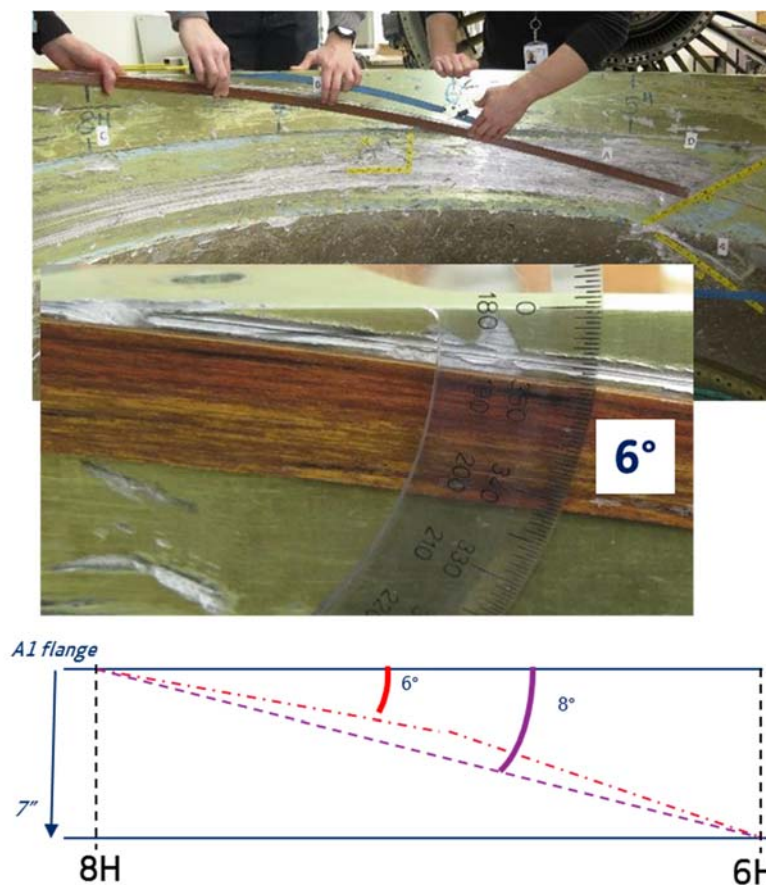
One trajectory path exits at 8 o'clock with an exit angle of 6° versus A1 flange as shown in Figure 5-1.

- ~ Local, permanent, deformation of the fan case along the mid panel trajectory is observed
- ~ Deformation causes deviation of the trajectory
- ~ Direct measurement of the exiting angle at the A1 flange location : 6°
- ~ Exiting angle with linear trajectory based on the marks between abrasable and A1 flange : 8°

**Figure 5-1 : Pensacola engine 874112 Fan case Mid fragment mark exiting at 8:00 / Measured angle at A1 flange**

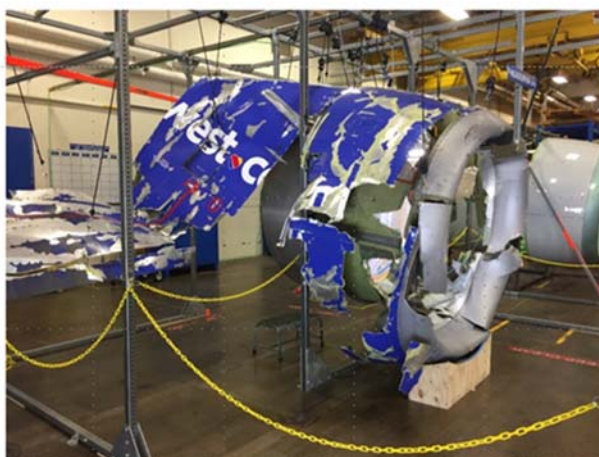
Figure 6-2 : Philadelphia Inlet in UTAS Facility

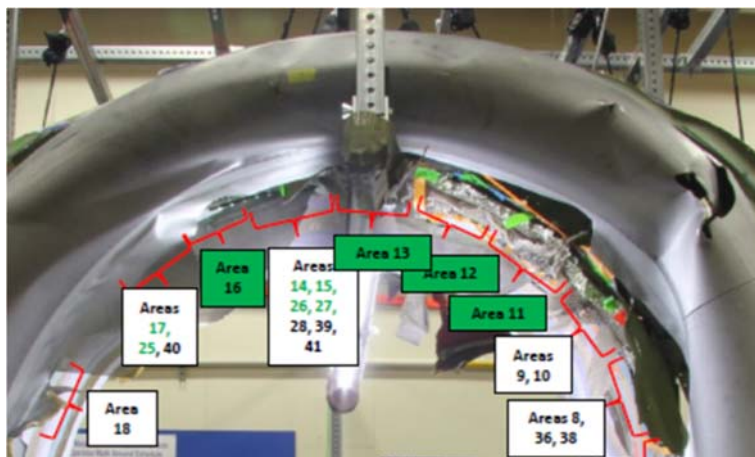
UTAS documented the inner barrel fracture surface at specific clock locations around the Phase 1 area. These locations are shown in Figure 8-1.

**Figure 8-1 : Phase 1 Metallurgical Areas**  
(Reference Oct. 2018 Structures Team Meeting)

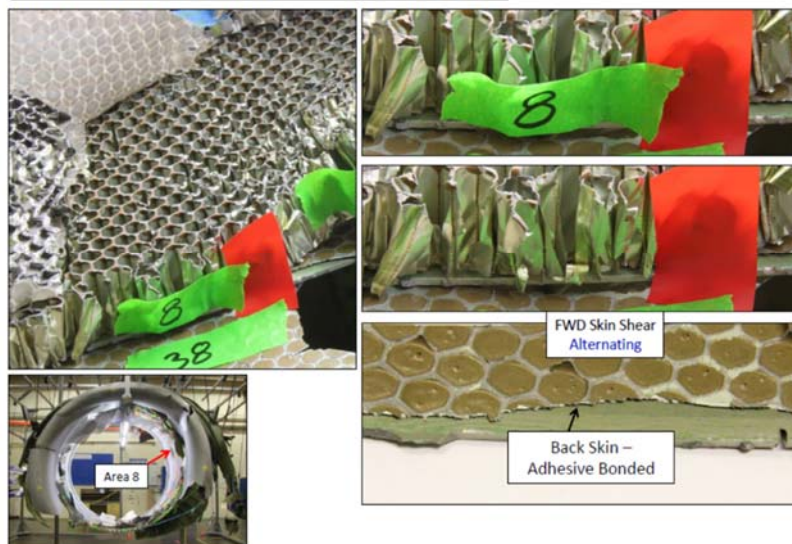
9:30 Position, Area 8. Outside of Boeing Phase 1 area. See Figure 8-2.

**Figure 8-2 : Position 9:30***(Reference Oct. 2018 Structures Team Meeting)*10:30 Position, Area 11. Start of Boeing Phase 1 area. See Figure 8-3

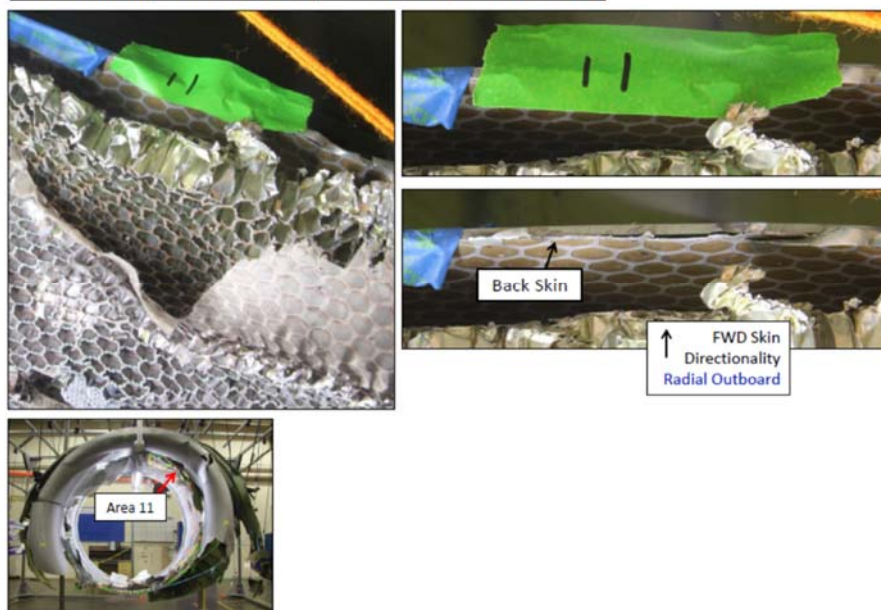
UTAS metallurgical results showed radial outboard direction of backskin fracture surface shear. Visual inspection shows backskin fracture at forward edge of containment doubler, with backskin deformed radially outward. There is technical basis to conclude that this damage is due to fragment penetration.

**Figure 8-3 : Position 10:30***(Reference Oct. 2018 Structures Team Meeting)*

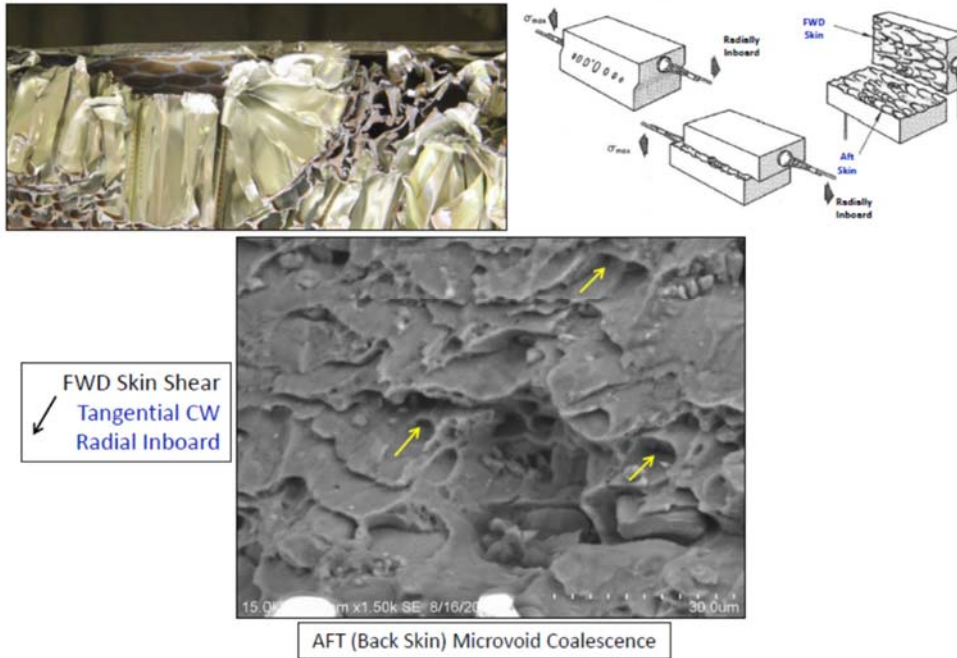
11:30 Position, Area 13. Within Boeing Phase 1 area. See Figure 8-5

**Figure 8-5 : Position 11:30**

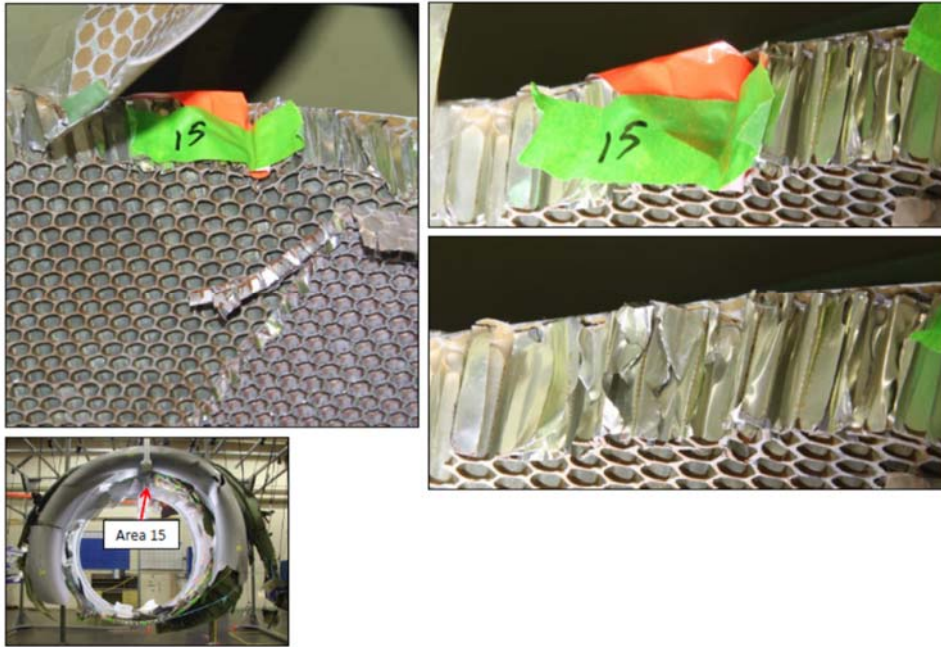
12:00 Position, Area 15. Within Boeing Phase 1 area. See Figure 8-6

**Figure 8-6 : Position 12:00**

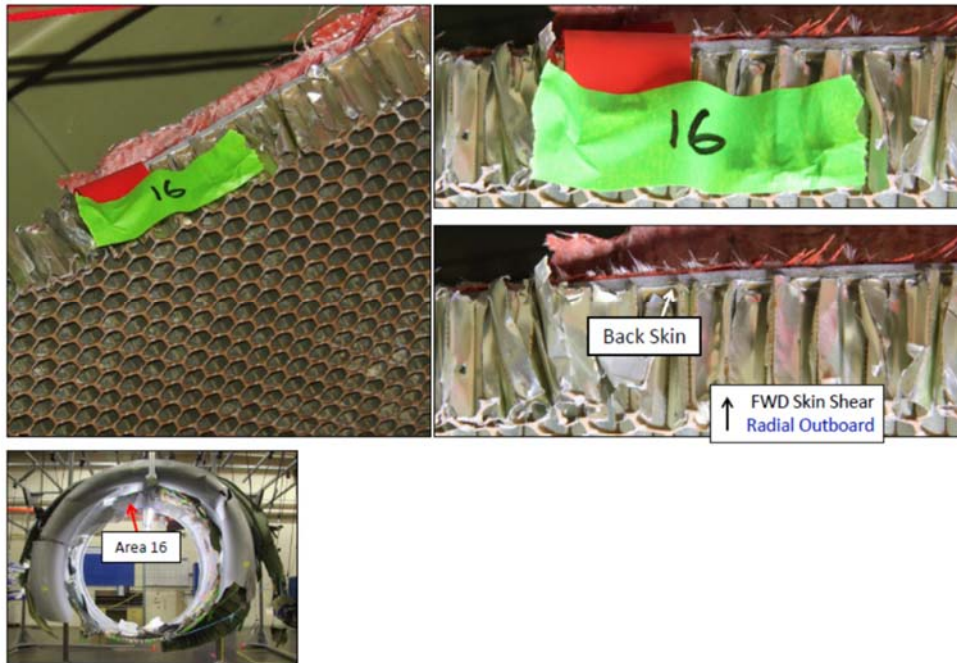
**Figure 8-7 : Position 12:30**

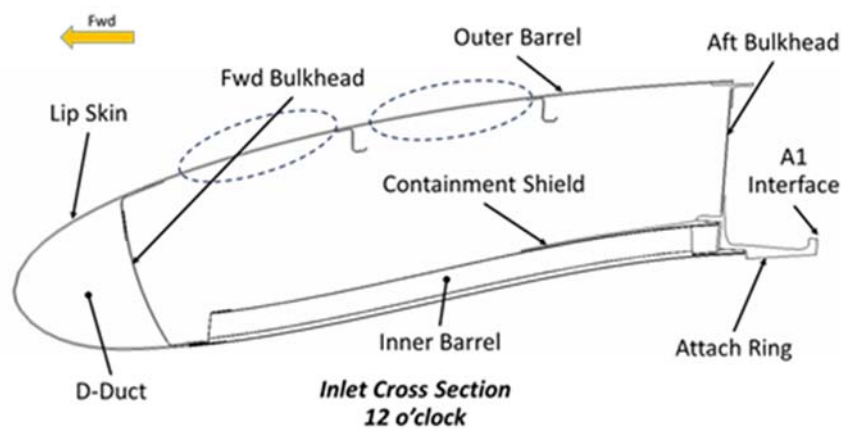
The inlet outer barrel exhibited damage at 12:00 and 12:30. Both locations contained titanium particles. These locations are consistent with fragment trajectories leaving the inner barrel between 10:30 and 11:00. See Figure 8-8. This outer barrel damage supports inner barrel fragment penetration between 10:30 and 11:00.

**Figure 8-9 Inlet cross section at 12 o'clock**  
*(Reference Oct. 2018 Structures Team Meeting)*

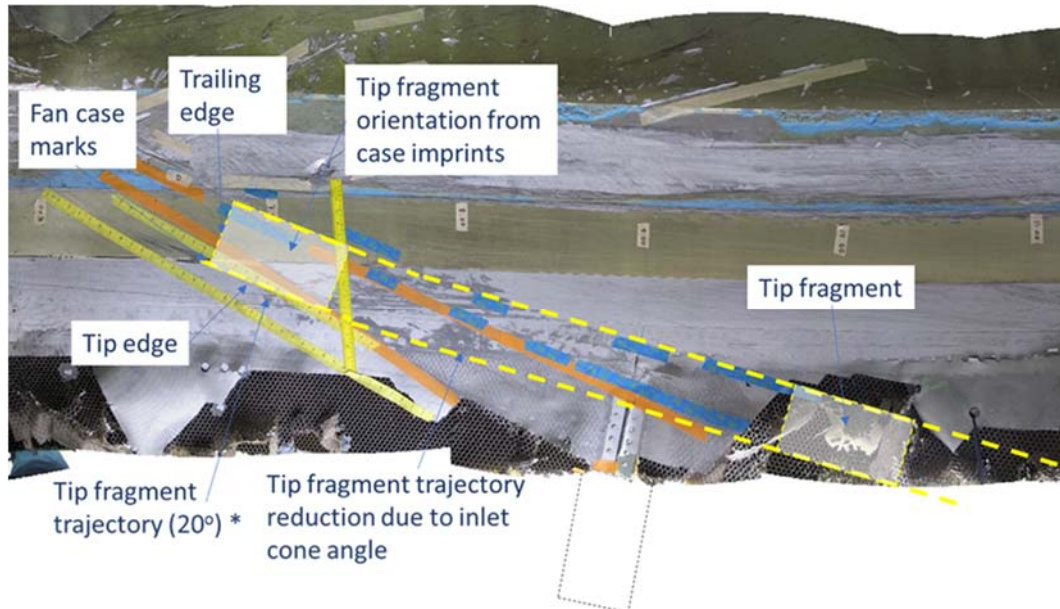
The orientation and trajectory of the tip panel was clearly determined from distinct contact marks on the fan case caused by the blade TE to tip corner radius (see Figure 4-10). The tip fragment center of gravity trajectory angle was determined from these witness marks to be maximum 20 degrees as it entered the inlet. The witness marks also showed that the tip fragment was sliding in a flatwise position, with the tip edge forward and the trailing edge to the left (forward looking aft). Therefore, the trajectory angle and orientation of the tip fragment *is known* as it enters the inlet as shown in Figure 8-11. The tip panel helix angle is assumed to reduce once inside the inlet due to the effect of the inlet cone angle on the trajectory (See figure 4-15 or figure 4-19). The resultant trajectory of the tip fragment in the inlet is consistent with damage marks on the inlet attach ring and perf skin indicating sliding contact with a fragment with significant size and radial load.

**Figure 8-11 Tip panel direction and orientation**

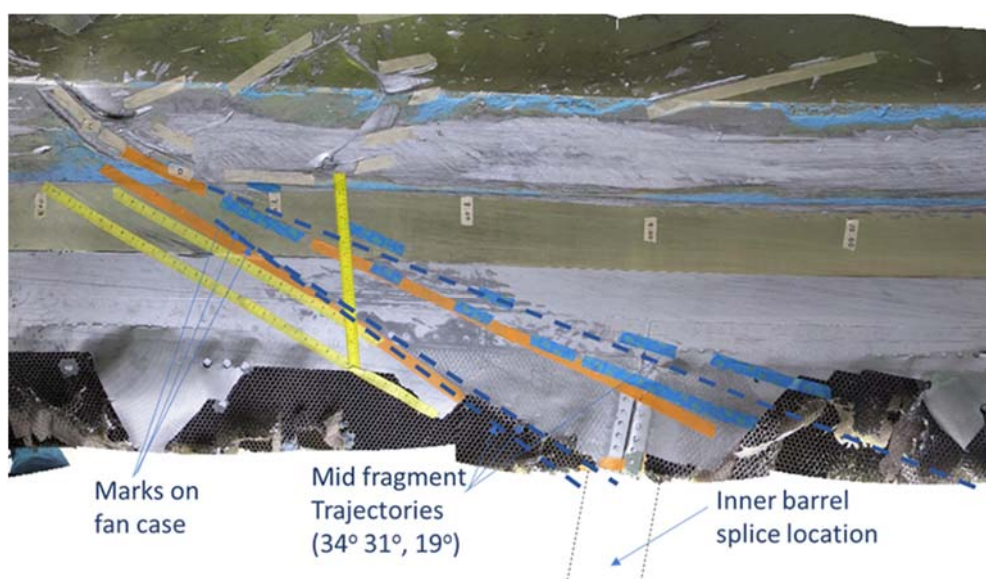
**Figure 8-12 Mid span fragment trajectories**

The 31-34degree mid span trajectories align with the edge of contact damage to the perf skin and honeycomb, as shown in figure 8-12. To the left of the fragment edge trajectory, there is no evidence of honeycomb crushing, or perf skin damage. To the right of the trajectory line there is clear perf skin damage from sliding contact and honeycomb radial crushing indicating outward radial load consistent with a sliding fragment. The mid span fragment at 31-34 degree trajectory crossed the edge of the containment doubler at the location of the 9:00 inner barrel splice plate, which was intact (although bent back by subsequent D duct contact later in event). These fragments therefore could not have penetrated the inner barrel back skin.

The 19 degree mid span fragment aligns with the right most edge of contact damage to the perf skin. It crosses the forward edge of the containment doubler at approximately 10:30.

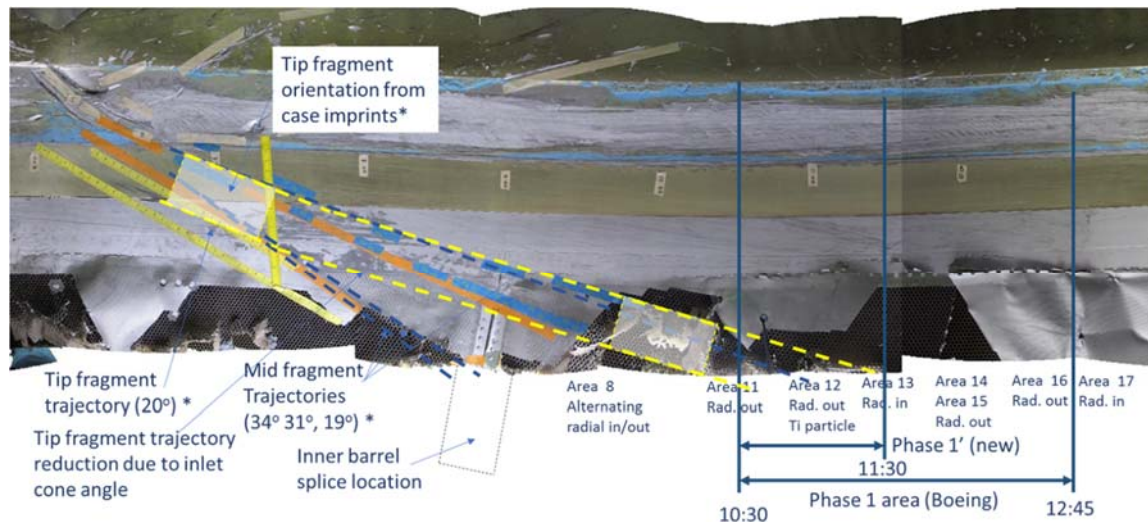
Figure 8-14 Phase 1 damage observations

The evidence from the metallurgical analysis, macro visual condition, fragment trajectory paths, and hardware observations relating to the Phase 1 damage zone extent are combined on Figure 8-14. The evidence supports that there was Phase 1 fragment penetration of the back skin from approximately 10:30 to 11:30, for a total of 30 degrees. This damage was most likely caused by the tip fragment, with one mid span fragment subsequently passing through the penetration area. This behavior is very similar to the certification and development experience, with the exception of the increased forward travel of the tip fragment. The damage from 11:30 to 12:45 is not consistent with the fragment trajectories or fragment damage. The damage from 11:30 to 12:45 is therefore most likely not due to fragment penetration.

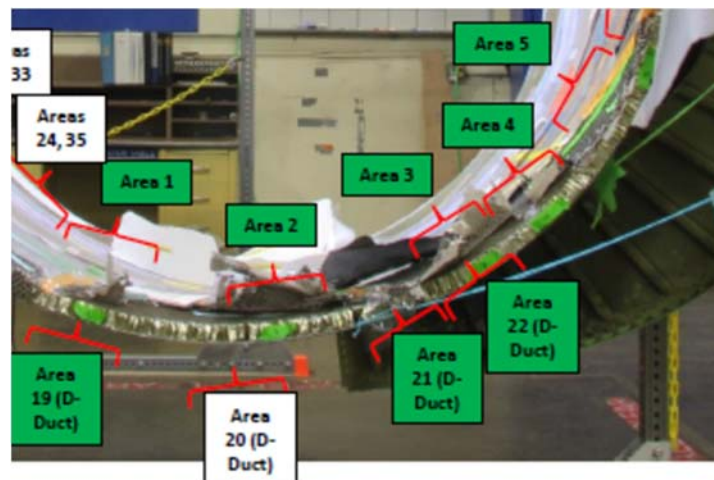
Figure 9-1 Phase 2 Metallurgical areas  
(Reference Oct 2018 Structures Team meeting)

UTAS documented the inner barrel fracture surface at specific clock locations around the Phase 2 area. These locations are shown in Figure 9-1.
