## **CFM presentation**

### **Fan blades fragments trajectories and Philadelphia inlet damage assessment**

The objective of this report is to document the CFM assessment of fan blade fragments trajectories and Philadelphia inlet damage presented to the investigative parties during the meeting held March 5-6, 2019 in Cincinnati, Ohio.

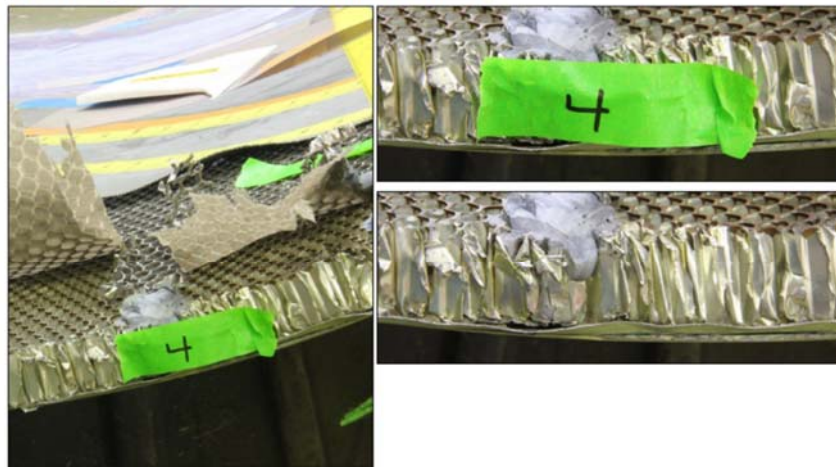
**Figure 9-2 Position 7:30**

7:30 Position, Area 4/Area 22. Beginning of Phase 2 area. See Figure 9-2

UTAS metallurgical results showed radially inward direction of backskin fracture surface shear. Macro visual inspection shows that the backskin is not deformed in radial outward direction. The honeycomb core is not deformed radially. These conditions are not consistent with fragment penetration.

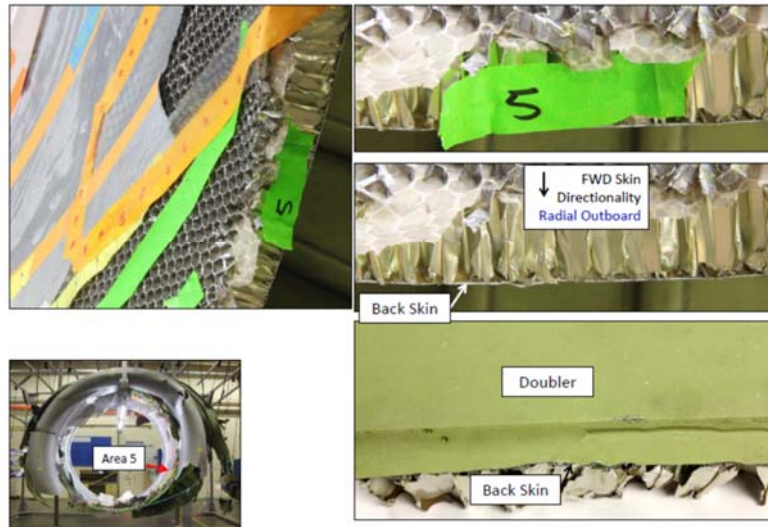
**Figure 9-3 Position 08:00**

8:00 Position, Area 5. Center of Phase 2 area. See Figure 9-3

UTAS metallurgical results showed radially outward direction of backskin fracture surface shear. Macro visual inspection shows that the backskin is not deformed in radial outward direction. The honeycomb core is not deformed radially. These conditions are not consistent with fragment penetration.

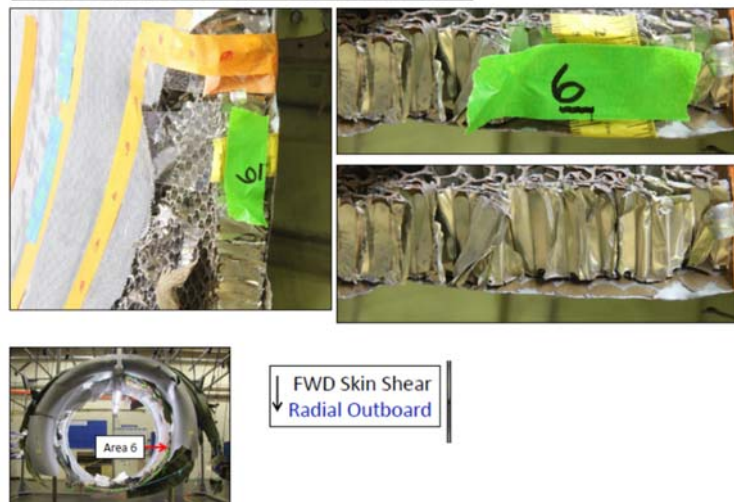
**Figure 9-4 Position 08:30**

8:30 Position, Area 5. End of Phase 2 area. See Figure 9-4

UTAS metallurgical results showed radially outward direction of backskin fracture surface shear. Macro visual inspection shows that the backskin is not deformed in radial outward direction. The honeycomb core is not deformed radially. These conditions are not consistent with fragment penetration.

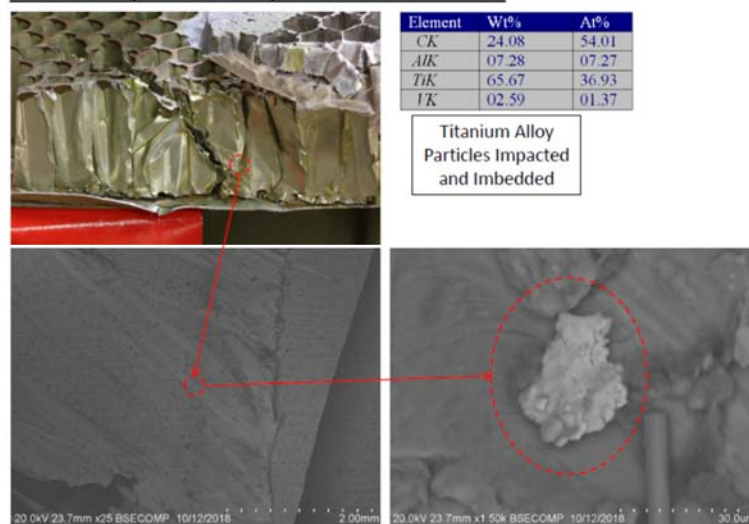
Figure 9-5 Position 07:30

A linear cut in the inner barrel honeycomb was noted at the 7:30 position near the forward edge of the containment doubler, see Figure 9-5.

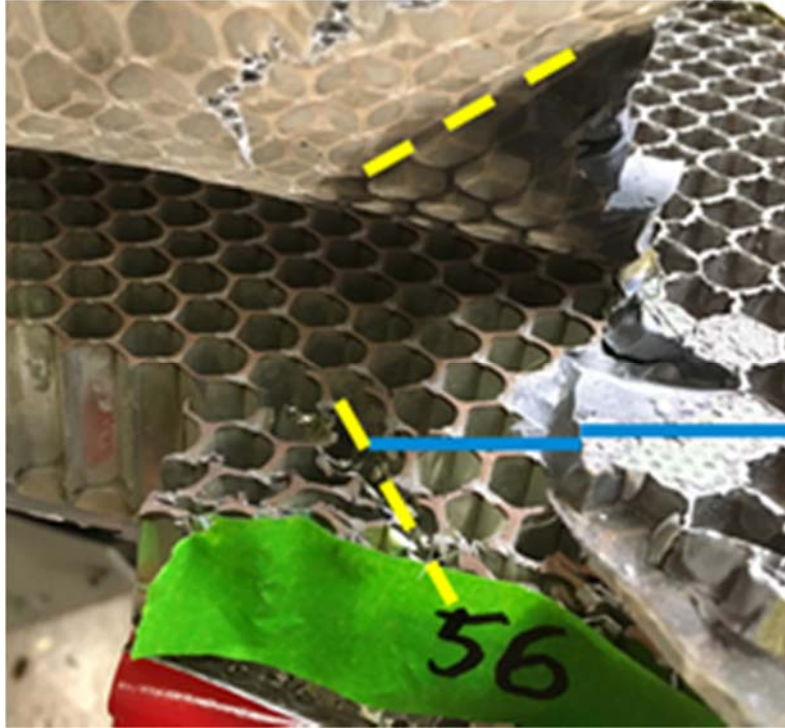
Ti 6-4 particles were found adjacent to the honeycomb cut, see Figure 9-6.

This also indicates that the Ti 6-4 material found in the honeycomb at 7:30 position must have come from a source other than a primary blade fragment. which supports that Ti 6-4 on the inner barrel can come from sources other than primary fan blade fragments.

Figure 9-6 Septum above Cut in Honeycomb  
(Reference Oct 2018 Structures Team meeting)

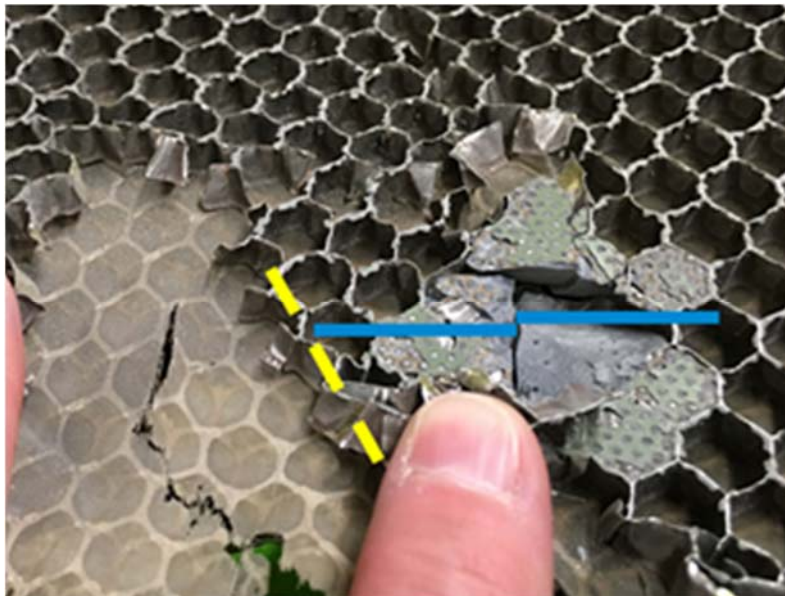
Figure 9-7 Intact Septum Over Cut in Honeycomb  
(Reference Oct 2018 Structures Team meeting)

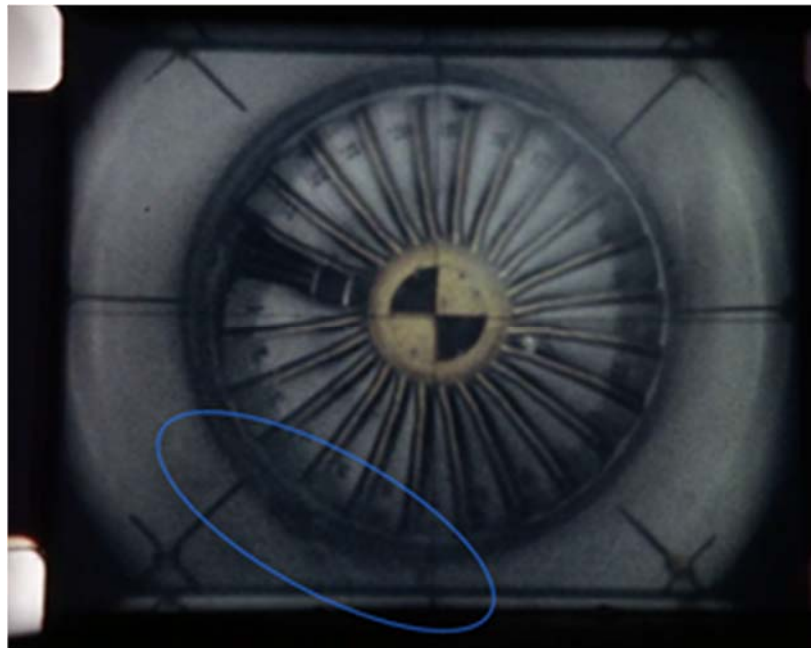
Figure 9-9 shows a view into the front of the fan approximately 0.6 seconds after blade release. The blue ellipse shows an area of small low energy fragments moving forward in the inlet. Physical evidence from the event hardware also supports the presence of multiple small fragments.

**Figure 9-9 High speed video image of engine 002/4 approximately 0.6 seconds after blade release**

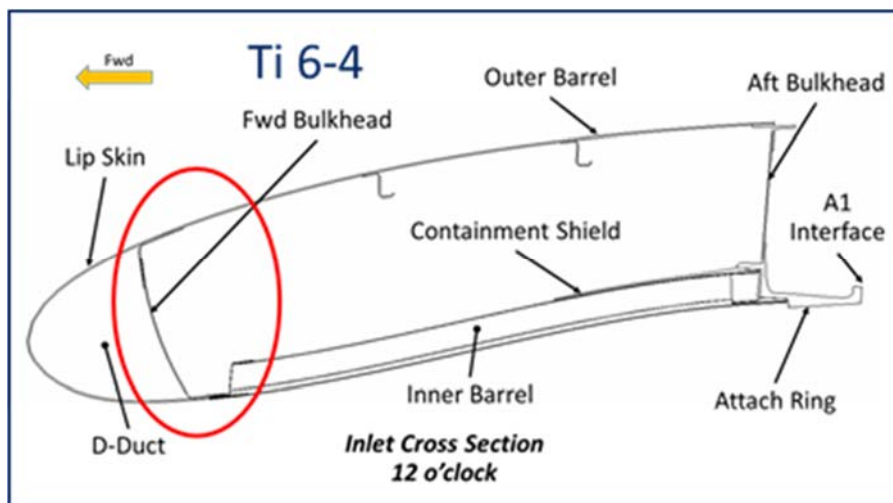
**Figure 9-11 Inlet Forward Bulkhead**

The inlet forward bulkhead is a large Ti 6-4 ring that joins the inner and outer barrel, as shown in Figure 9-11.

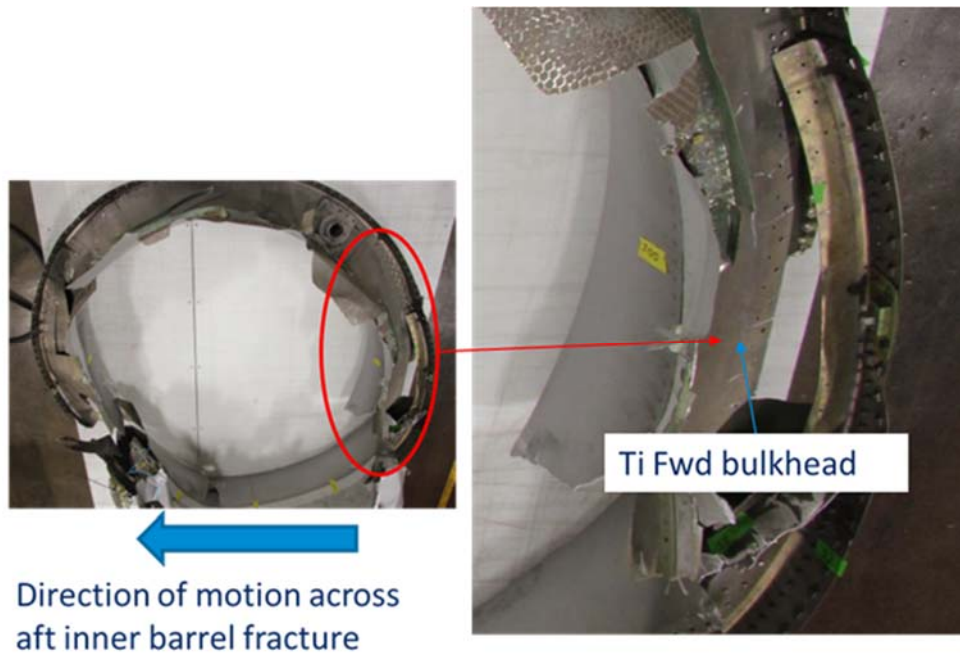
During the inlet separation, the forward bulkhead was separated from the inner and outer barrel. At the 3:00 location, the forward bulkhead became the aft most surface of the detached part of the inlet. This area of the forward bulkhead was significantly damaged. Physical evidence noted during the party meeting in October, 2018 indicated the forward part of the inlet moved right to left (aft looking forward) across the aft inner barrel fracture surface as it departed. This creates the potential for contact of the exposed Ti 6-4 forward bulkhead with areas of the inner barrel fracture surface, and the presence of additional titanium particles.

**Figure 9-12 Exposure of forward bulkhead and motion across inner barrel**

The splice plate at 9:00 is bent back around the outside of the inner barrel. This is believed to be a result of the impact of the separated forward part of the inlet departing in an outward direction (See Figure 9-12). Significant loads were imparted to the splice plate to deform this structural element.

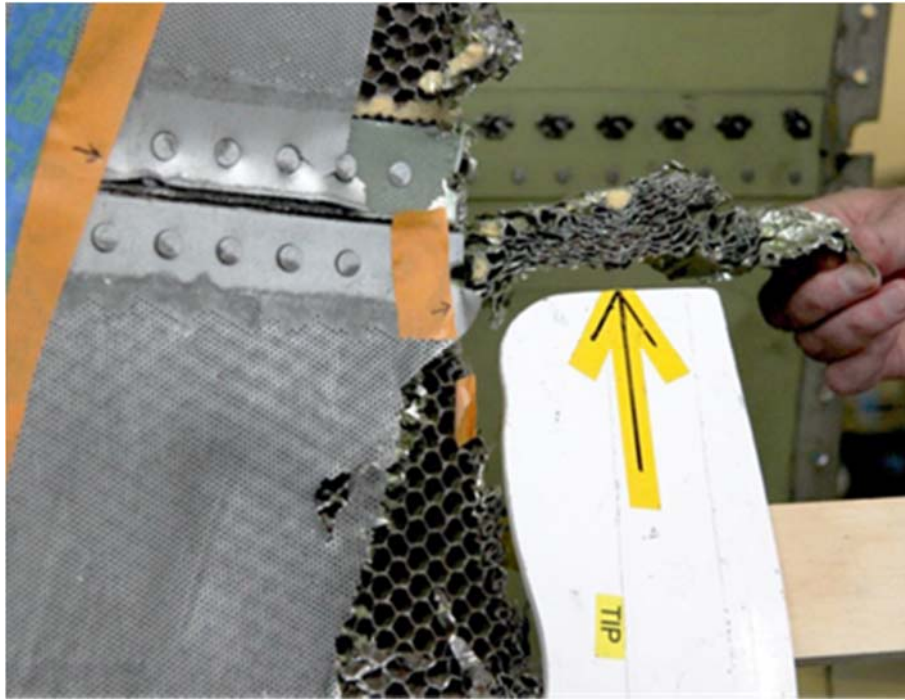
This area is of interest because initial Party assessments suggested that the tip fragment contacted this area and crushed the honeycomb in a circumferential direction as shown in Figure 9-15.

crushed uniformly the entire axial length of the splice plate. This crushed axial width is wider than the expected width of a fragment as shown in Figure 9-15, also indicating this is not consistent with fragment impact.

**Figure 9-15 Recovered Honeycomb showing Direction of Crushing**

It was also noted that the attached and recovered crushed honeycomb from this area as shown in Figures 9-15, 9-16, and 9-17 consisted of a significant number of honeycomb cells that were crushed to much less than their original thickness. The crushed honeycomb that remained attached to the splice plate included approximately 15 crushed cells. The crushed honeycomb that was separated from the splice plate and recovered as shown in Figure 9-15 includes approximately 12 cells. The original expanded width of these crushed portions of honeycomb can be calculated assuming an uncrushed cell width of 0.375 inch. The attached 15 cells of honeycomb had an original width of 5.6 inches, the separated 12 cells had an original width of 4.5 inches.

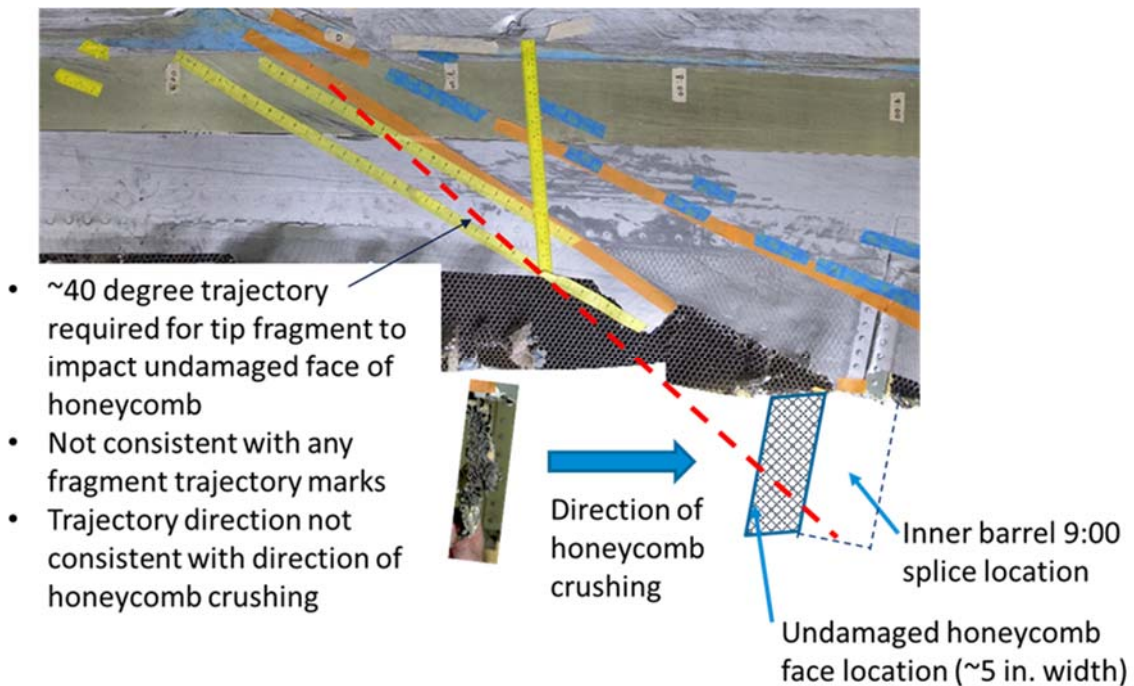
This original location of the honeycomb face was then laid out with the inlet and fan case geometry (see Figure 9-18). A red dashed line was constructed from the location at the inlet A1 flange where the tip fragment entered the inlet to the center of the undamaged honeycomb location. This would be the required trajectory for the tip fragment to impact the honeycomb adjacent to the 9:00 splice plate. The angle of the required trajectory would be 40 degrees from circumferential. This is much greater than any physical evidence of the tip trajectory angle. CFM has determined the tip fragment trajectory angle to be 20 degrees per section 4.3). A

trajectory angle of 40 degrees would result in the honeycomb being crushed in a direction 40 degrees from circumferential, which is not consistent with the circumferential direction of crushing observed.

These results all indicate that the honeycomb damage adjacent to the 9:00 splice plate was not due to impact from the tip fragment, and do not support a tip fragment trajectory in this Phase 2 area.

**Figure 9-18 Location of Original Undamaged Honeycomb Face and Trajectory Required to Impact It**

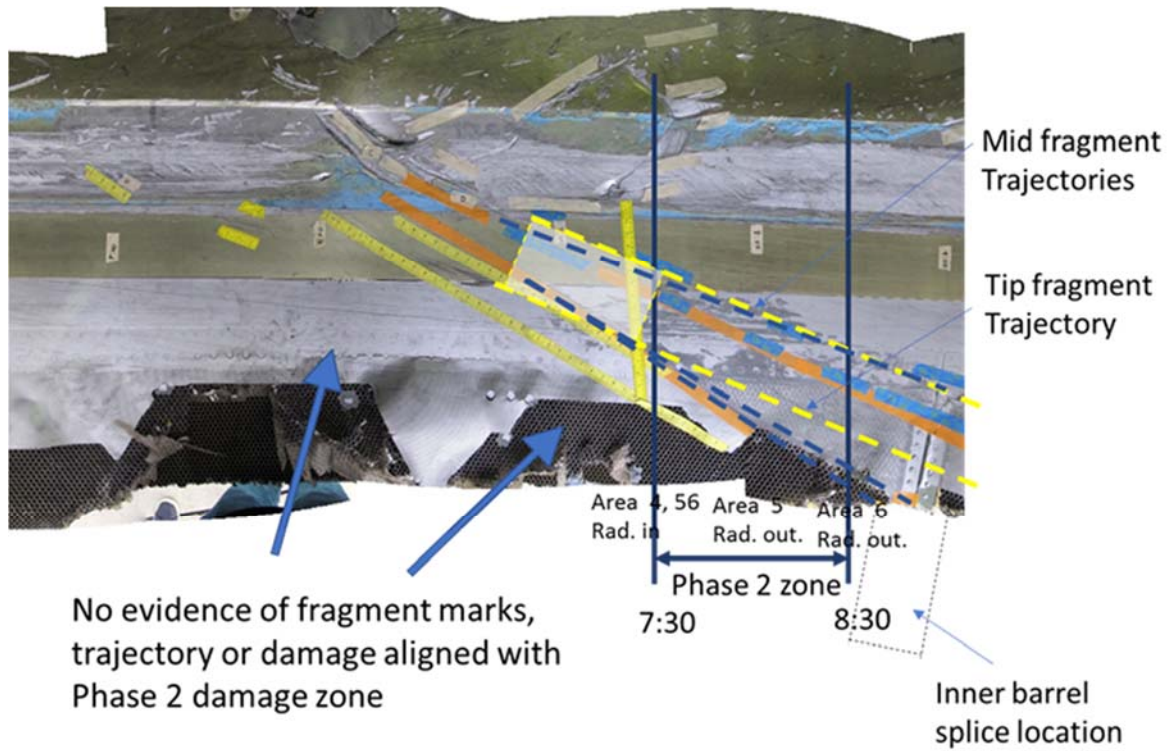
Figure 9-19 Phase 2 Damage assessment

The evidence from the metallurgical analysis, macro visual condition, fragment trajectory paths, and hardware observations relating to the Phase 2 damage zone extent are combined on Figure 9-19.

There is no evidence of primary fragment marks or trajectories aligned with the Phase 2 damage zone on the perf skin on either the attach ring or D duct side of the inner barrel separation. There is also no evidence of honeycomb crushing from fragment radial loading aligned with the Phase 2 damage. Titanium particles found at 7:30 in the Phase 2 zone cannot be from primary fan blade fragments, and other sources of titanium have been identified. Fragment trajectories observed in the fan case and inlet are not consistent with the Phase 2 damage zone. Therefore, the evidence supports that the Phase 2 back skin damage is not from fan blade fragments.
