22 October 2018  
66-ZB-H200-ASI-19067

Subject: Boeing EQA Report on T12 Sensor - Southwest Airlines 737-700 N772SW  
Engine failure and decompression Philadelphia, 17 Apr 2018

## Equipment Quality Analysis Report

**SUBJECT:** *Examination of T12 Sensor from Southwest Airlines (SWA) Aircraft YA070*

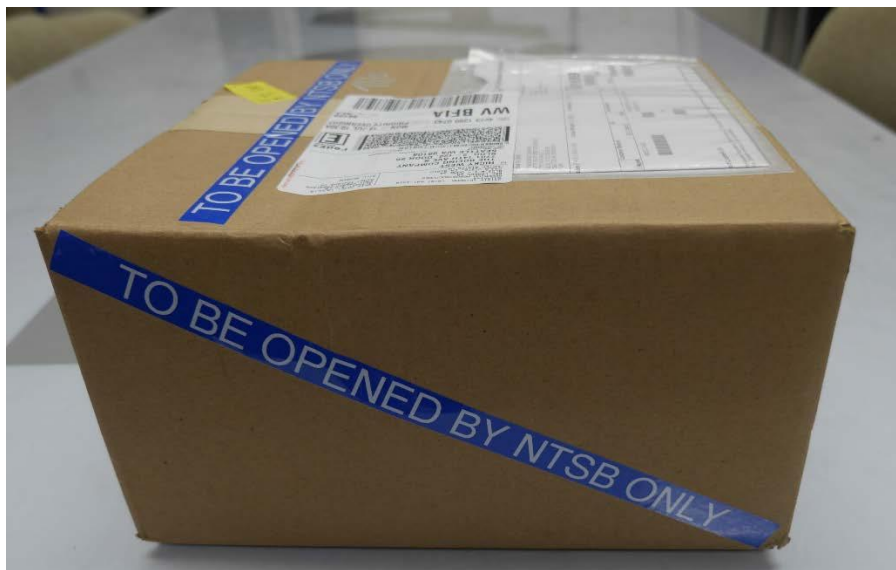
**Figure 1:** Overview of the T12 sensor packaging

An overview of the packaging that contained the T12 sensor as received is shown in Figure 1.
