**PARTY SUBMISSION OF  
THE INTERNATIONAL BROTHERHOOD OF TEAMSTERS LOCAL 2750  
TO THE NATIONAL TRANSPORTATION SAFETY BOARD**

**ATLAS AIR FLIGHT 3591**

Trinity Bay  
Anahuac, TX, USA  
23 February 2019

**NTSB DCA19MA086**

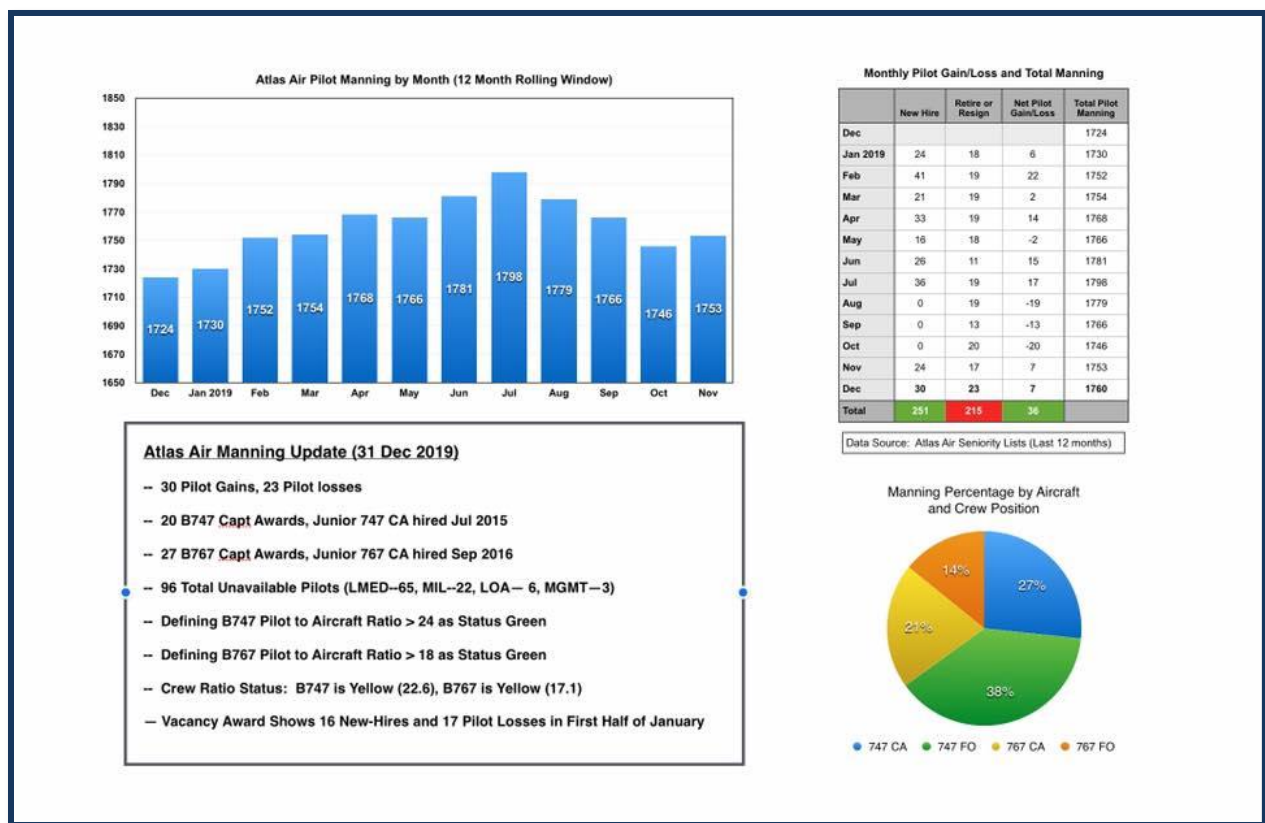
Figure 2

The figures below show the actual numbers taken from IBT's processing of the regularly issued company pilot seniority list, stated class sizes, and actual results. The charts were developed based on data the IBT obtained from Atlas. The information presented in figures 2, 3, and 4 are a compilation of the seniority lists produced by Atlas on a regularly recurring schedule and the information provided to the IBT on new-hire classes. The figures below indicate that there have been challenges in staffing the airline. Significant losses of pilots occur at an average rate of 16.7 per month. The IBT finds that these numbers echo the challenges that Atlas is facing in recruiting and retaining sufficient numbers of pilots to maintain its operations.

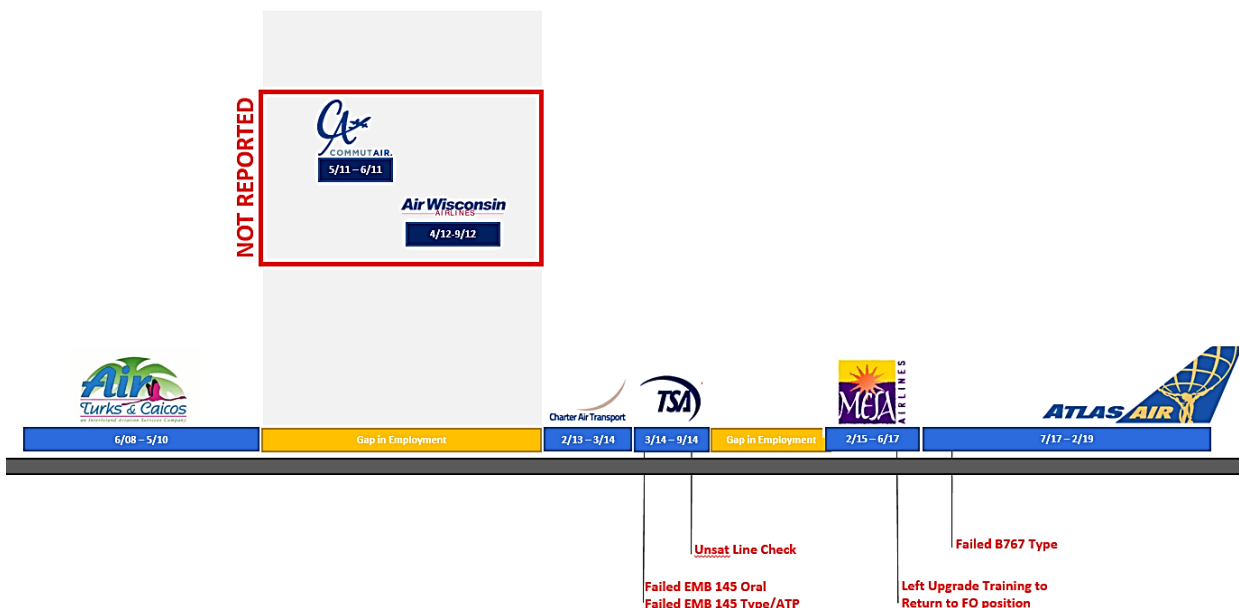
Figure 5 – First Officer Employment History

Figure 5 below depicts the First Officer's employment history based on documents provided to Atlas for his employment application as well as information collected by the NTSB Operations Group. The First Officer reported that he had been a student and/or worked as a freelance real estate agent between June 2010 and January 2013. However, the investigation revealed employment by two otherwise undisclosed airlines,<sup>45</sup> CommutAir and Air Wisconsin, during this reported gap of employment. Neither airline was listed on his employment application for Atlas nor on his PRIA requests. Another gap in employment was reported from September 2014 until February 2015 with no explanation given.

During his employment at Trans States, he received a notice of disapproval for his EMB145 oral exam on April 22, 2014, and a notice of disapproval for his EMB145 type rating on May 11, 2014. Both exams were subsequently passed on April 26, 2014 and May 12, 2014 respectively. The IBT would like to note that OE was never competed at Trans States. During his employment at Mesa, he failed to complete upgrade training on the EMB 175.<sup>46</sup>

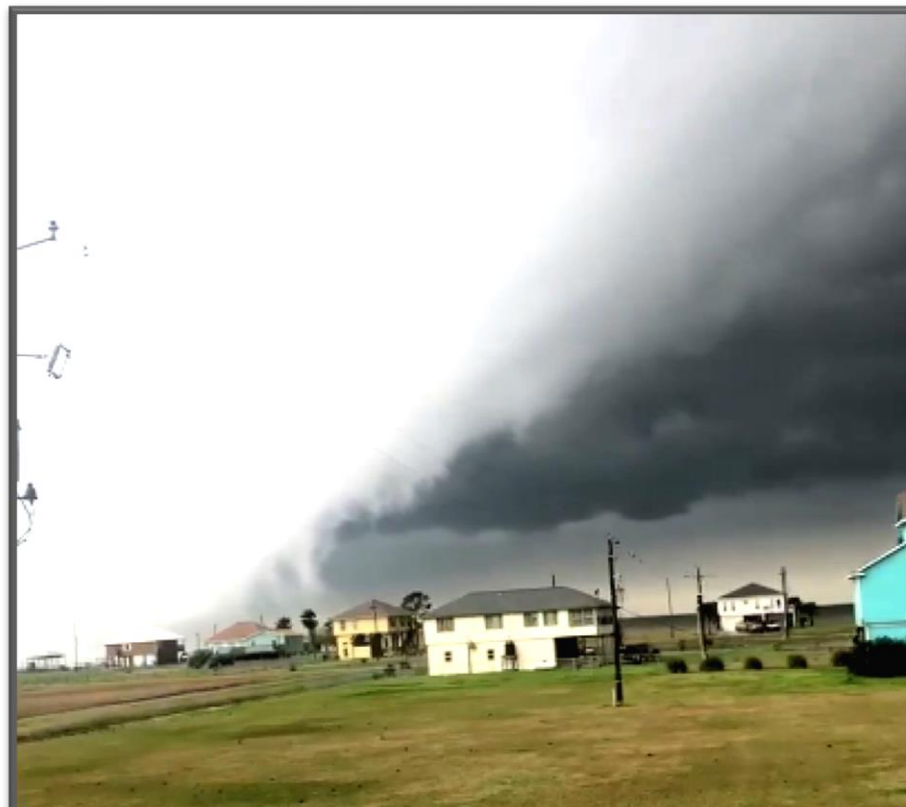
Figure 13 – A cropped screenshot of the local video." from NTSB Meteorology Factual Report
