# NATIONAL TRANSPORTATION SAFETY BOARD

## MATERIALS LABORATORY FACTUAL REPORT

Report No. 20-014

Place : Denver, Colorado  
Date : December 22, 2019  
Vehicle : Boeing 737-800, N87513  
NTSB No. : DCA20LA047  
Investigator : Dan Bower, AS-10

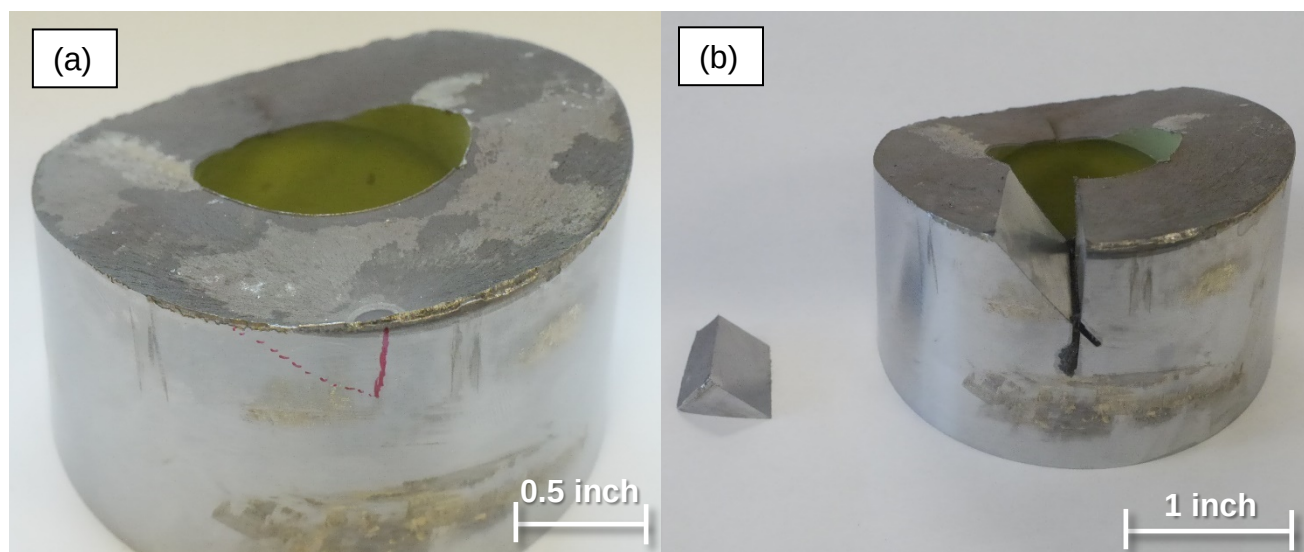
The thumbnail crack on the aft pin remnant was bisected with a small angle cut underneath to remove a wedge section (see Figure 22). The remainder of the aft pin remnant underwent a stripping process to remove the chromium electroplated layer, using an electrolytic solution of sodium hydroxide (NaOH) and sodium carbonate ( $\text{NaCO}_3$ ), held at 100 °F with 4 – 6 V. The process was interrupted in intermediate steps to examine the underlying chromium electroplated layer. This process had removed the outer smeared layer revealing microcracking of the chromium electroplated layer. The plating exhibited multiple cross-cracks, typical of hard chromium electroplated layers (see Figure 23). This microcracking was multidirectional in nature and did not exhibit cracking patterns consistent with “ladder cracking” or “chicken-wire cracking.” The remainder of the chromium electroplated layer on the aft side was then completely stripped electrochemically.

Figure 22 – A section of the aft trunnion piece, showing the location of the section removed for metallographic examination (a) as marked and (b) after sectioning.

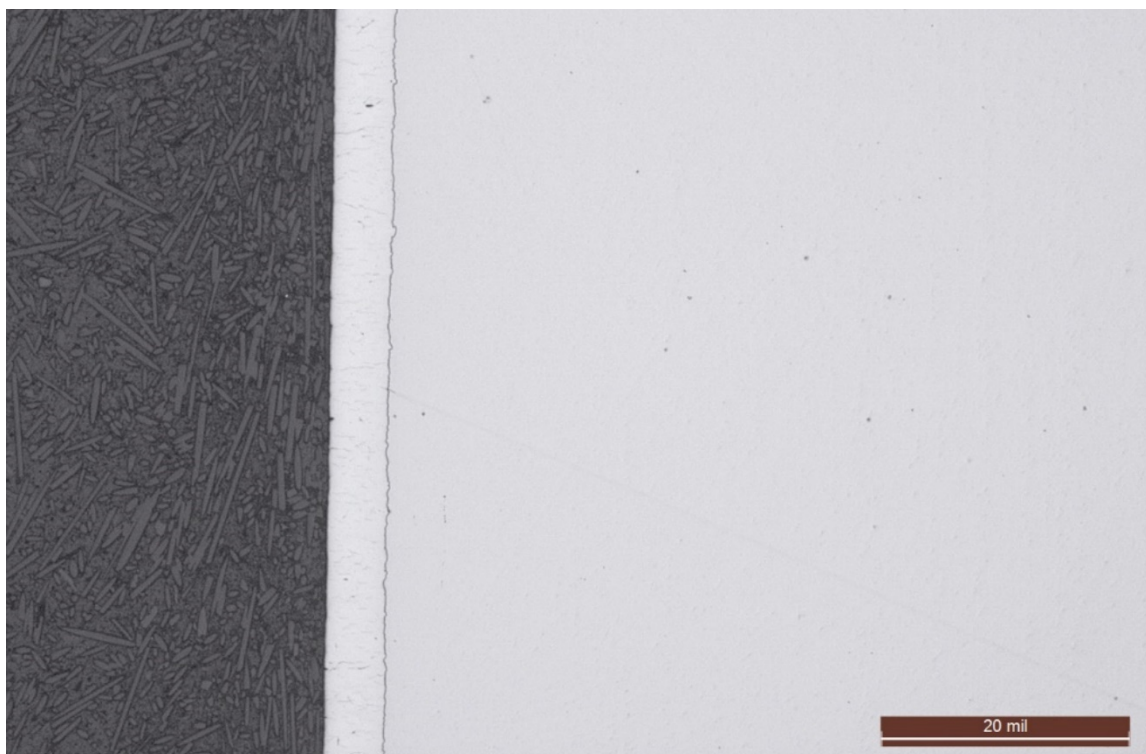
The wedge section shown in Figure 22b was mounted and polished for metallographic examination. This specimen was then etched using a 2% Nital solution to reveal the microstructure.<sup>4</sup> Examination of the cross section through the aft thumbnail crack revealed the outer chromium electroplated layer up to the damaged edge of the thumbnail crack (Figure 28 and Figure 29).

Figure 28 – Bright-field (BF) optical micrograph of an area away from the fracture surface, showing the adherent chromium electroplated layer (~50X, as-polished).

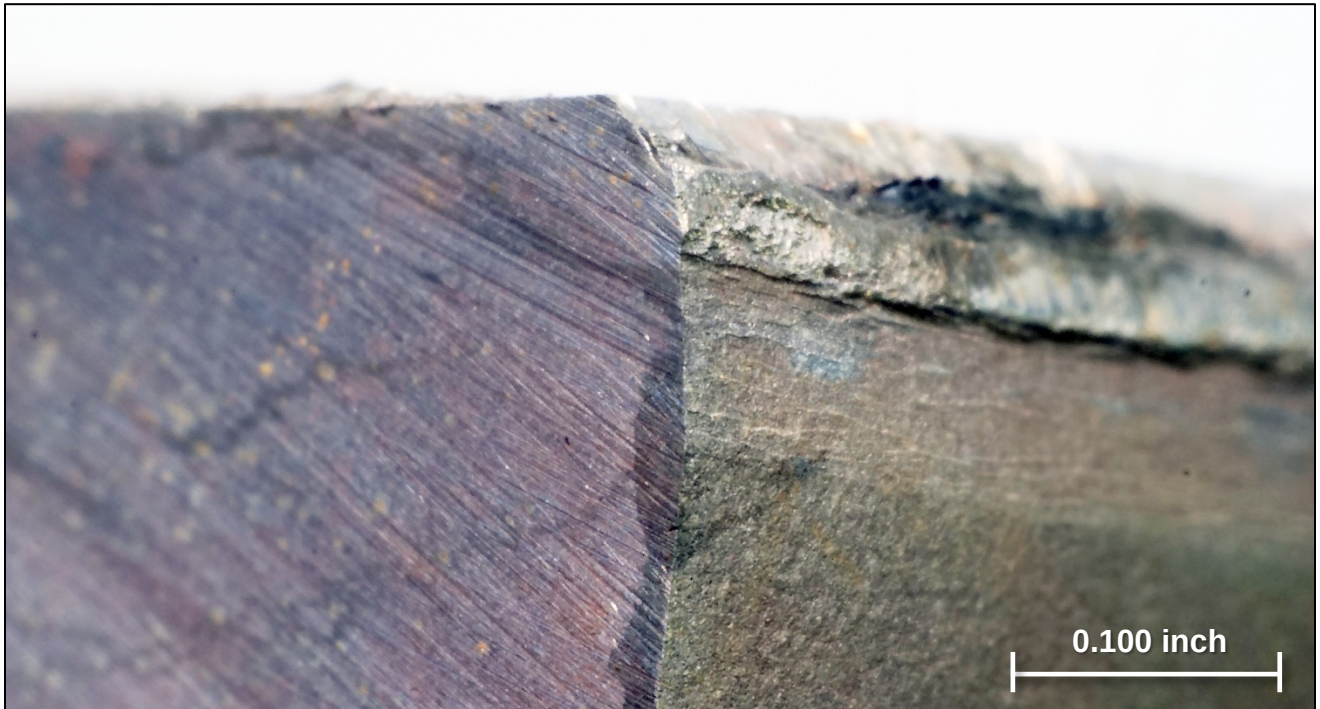
The chromium electroplated layer adjacent to the beveled edge of the thumbnail crack exhibited through cracking (Figure 30 through Figure 32). This cracking was present only in the areas consistent with post fracture impact damage. No indications of secondary cracking were found emanating from either the fracture surface or the outer diameter (plated) surface of the cross section (compare with Figure 28). The beveled area closest to the fracture surface was absent chromium electroplated layer and exhibited a localized area of a lighter-etching microstructure, consistent with untempered martensite (Figure 33). This damage mirrored that observed macroscopically on the mating aft pin remnant (shown in Figure 34 after chromium electroplated layer stripping and acid etching).

Figure 34 – The mating cross section to Figure 30, after chromium electroplated layer stripping.
