# NATIONAL TRANSPORTATION SAFETY BOARD

## MATERIALS LABORATORY FACTUAL REPORT

Report No. 20-040

Place : Victorville, California  
Date : 5/20/2020  
Vehicle : Boeing 737-8Q8 N820TJ  
NTSB No. : DCA20LA107  
Investigator : Clinton Crookshanks, AS-40

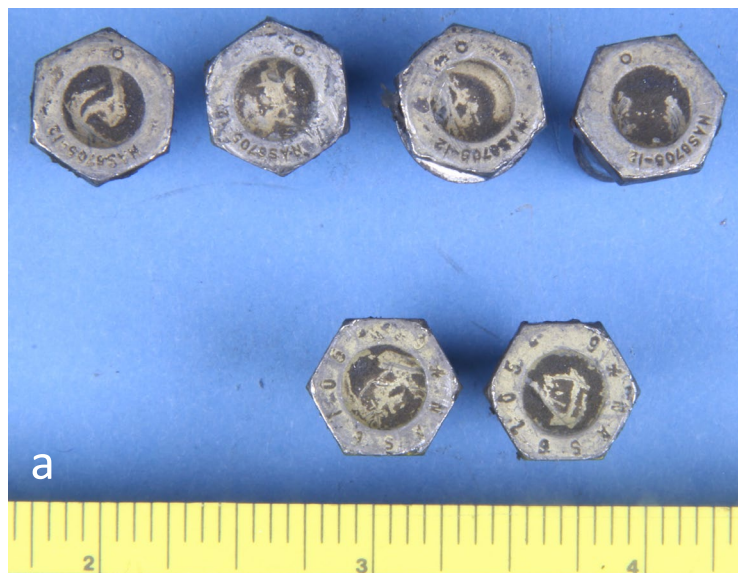
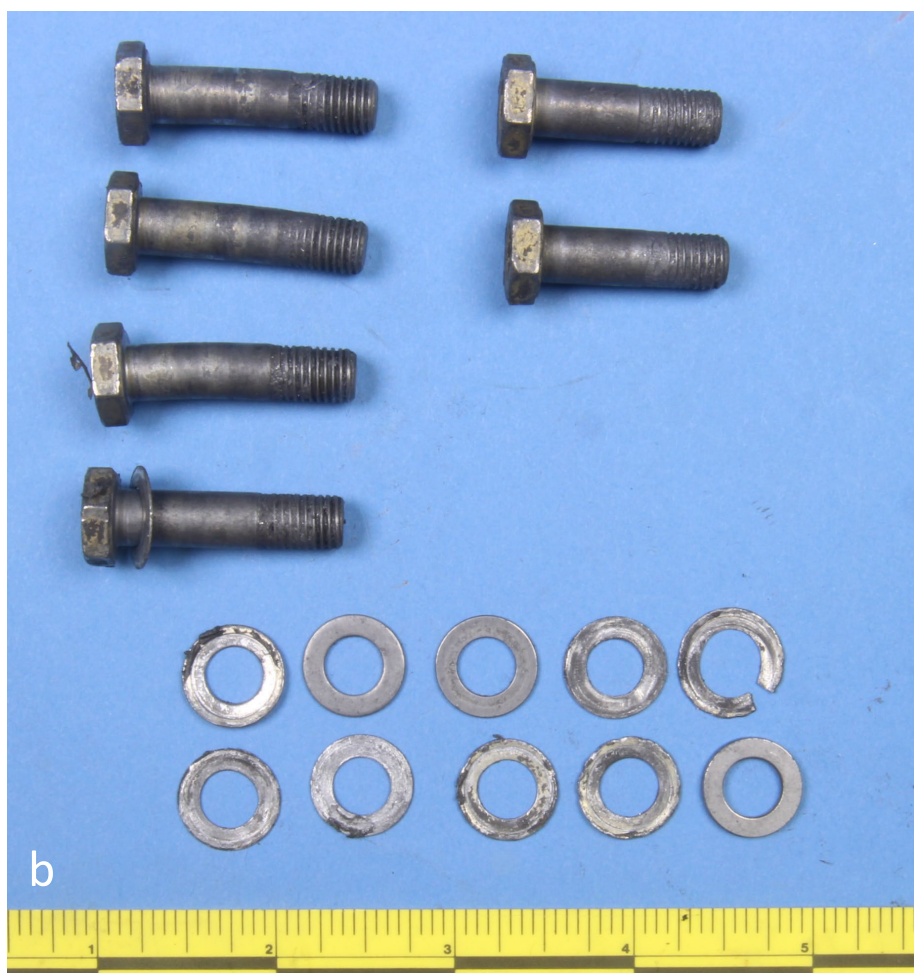
Figure 1 Image of the as-received bolts and washers. The bolts were not marked or identified relative to their installation locations.

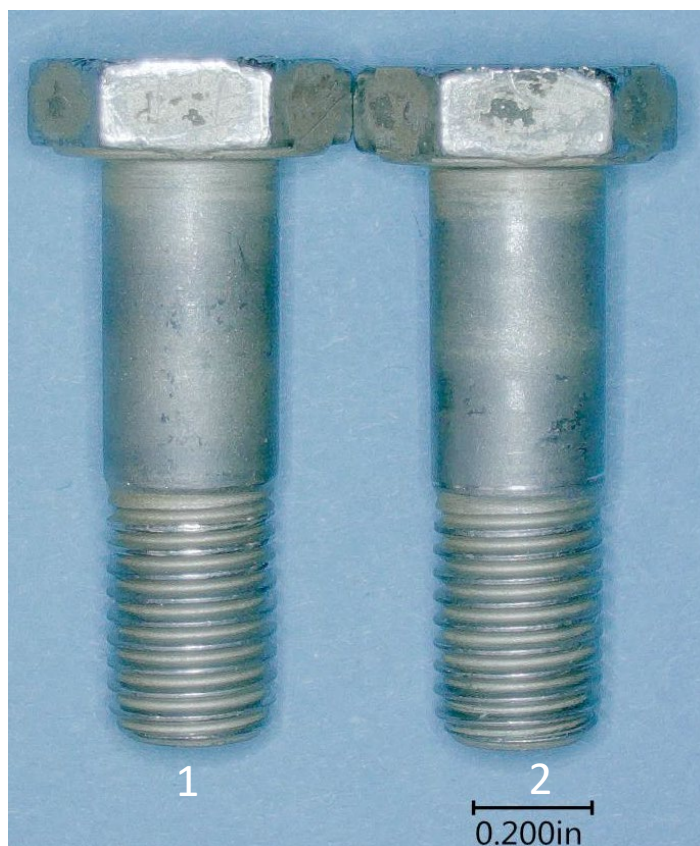
Figure 9 The NAS6705-09 bolts, after ultrasonic cleaning in acetone. Longitudinal view of the bolts.
