October 27, 2019

## Aircraft Performance Crash Site Factual

NTSB Number: DCA20MA002  
Location: Thomas Madsen Airport (DUT), Unalaska, Alaska  
Date: October 17, 2019  
Time: 1740 Alaska Daylight Time  
Aircraft: Saab 2000, N686PA  
Operator: Peninsula Aviation Services, Incorporated d.b.a. PenAir

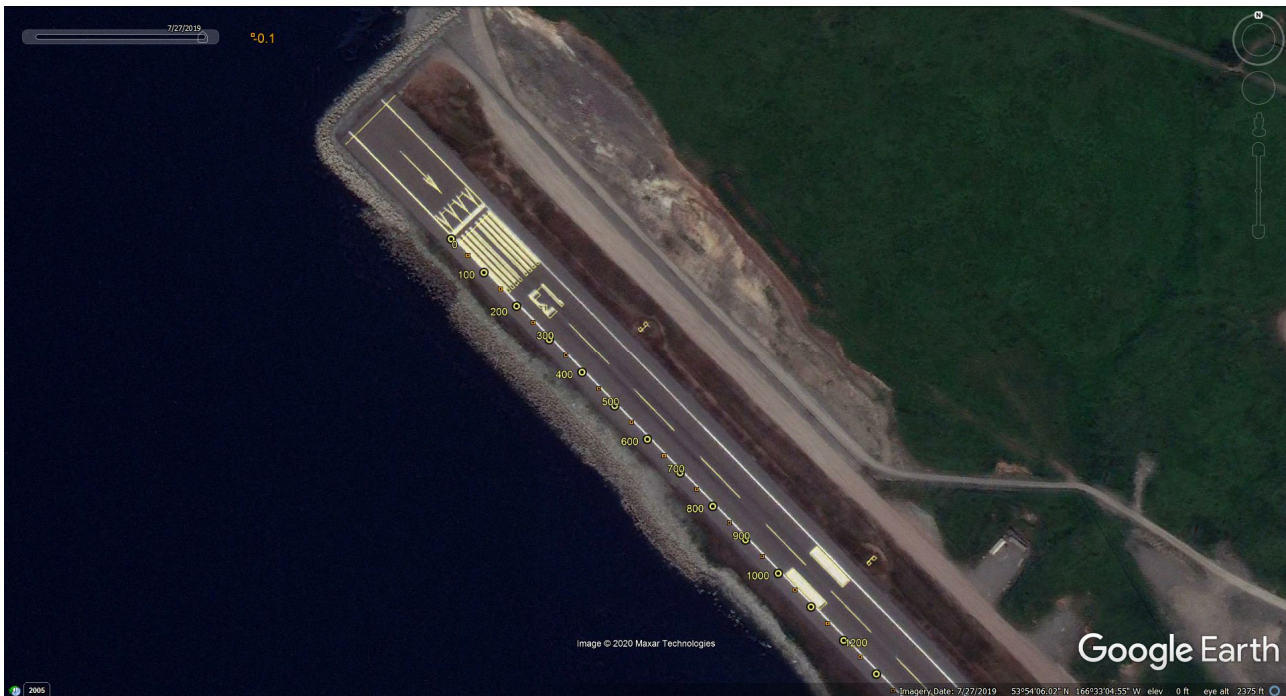
On the afternoon of October 20, one Airport Operations staff member assisted the GPS survey of runway 13 markings to compare Trimble GPS geo 7x measurements to known reference points. The solid yellow lines in Figures 11–13 compare the resulting GPS survey data to available Google Earth satellite imagery data, dated July 27, 2019. In general, there is a nearly constant, longitudinal offset of 6–8 feet between the absolute position of runway paint markings defined by the GPS survey data and the reference Google Earth imagery data.

Figure 11: Google Earth model showing GPS survey of runway 13 arrival end markings (solid yellow lines) including arrows, threshold markings, runway number, centerline markings, and the touchdown zone target. True North is toward the top of the page.

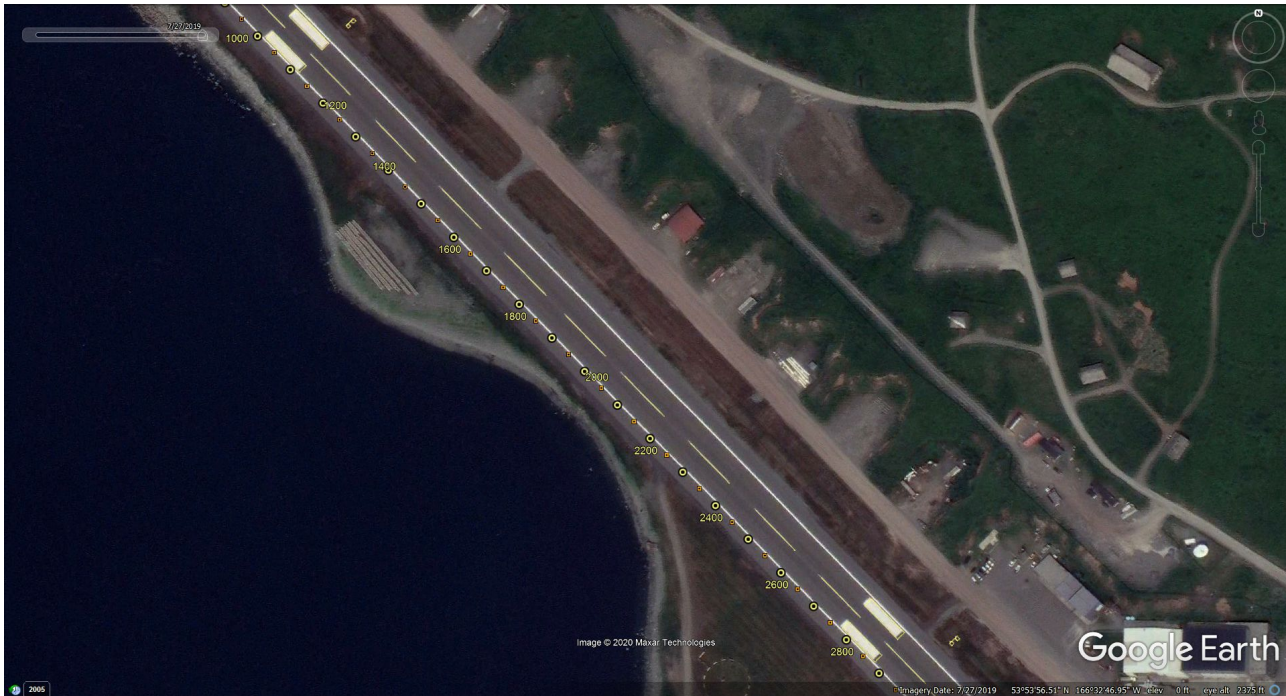
Figure 12: Google Earth model showing GPS survey of runway 13/31 midsection (solid yellow lines) including centerlines and the touchdown zone targets. True North is toward the top of the page.

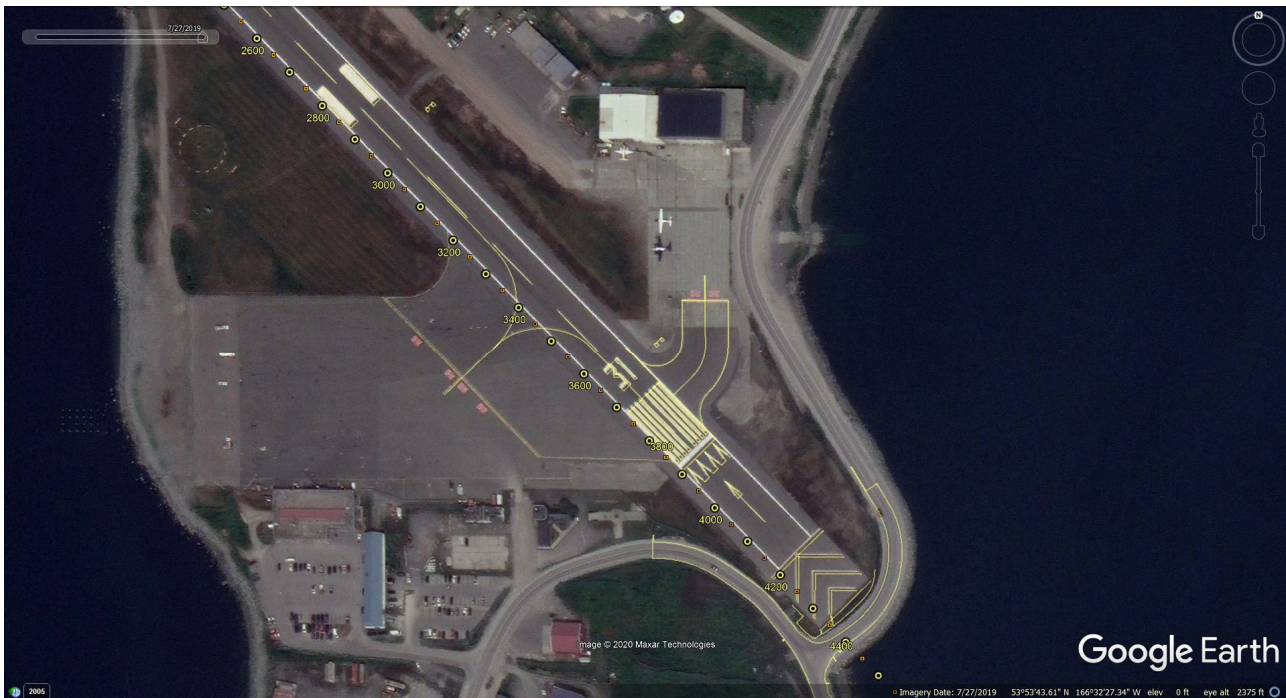
Figure 13: Google Earth model showing GPS survey of runway 13 departure end markings and public roadway edges (solid yellow lines). True North is toward the top of the page.

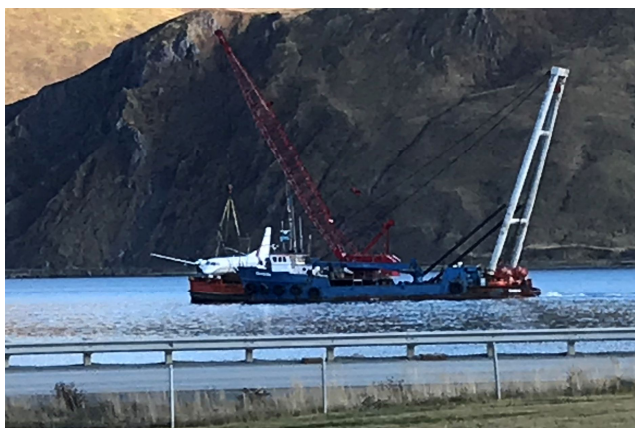
Figure 15(a): Recovered airplane voyage on salvage barge to staging area for truck transport

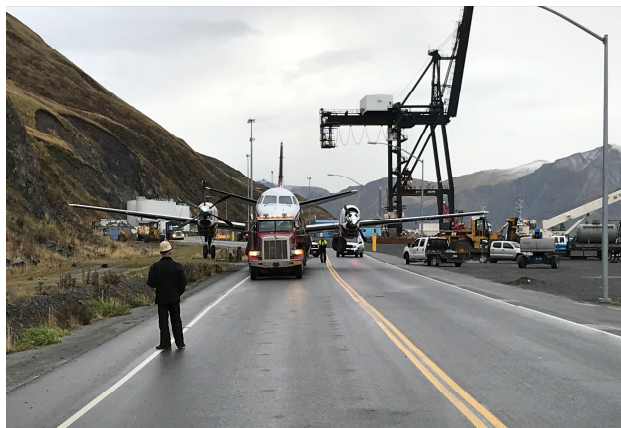
Figure 15(b): Airplane truck transport from salvage operator staging area back to airport
