# NATIONAL TRANSPORTATION SAFETY BOARD

## MATERIALS LABORATORY FACTUAL REPORT

Report No. 20-043

| Vehicle | : | Sikorsky S76 helicopter |

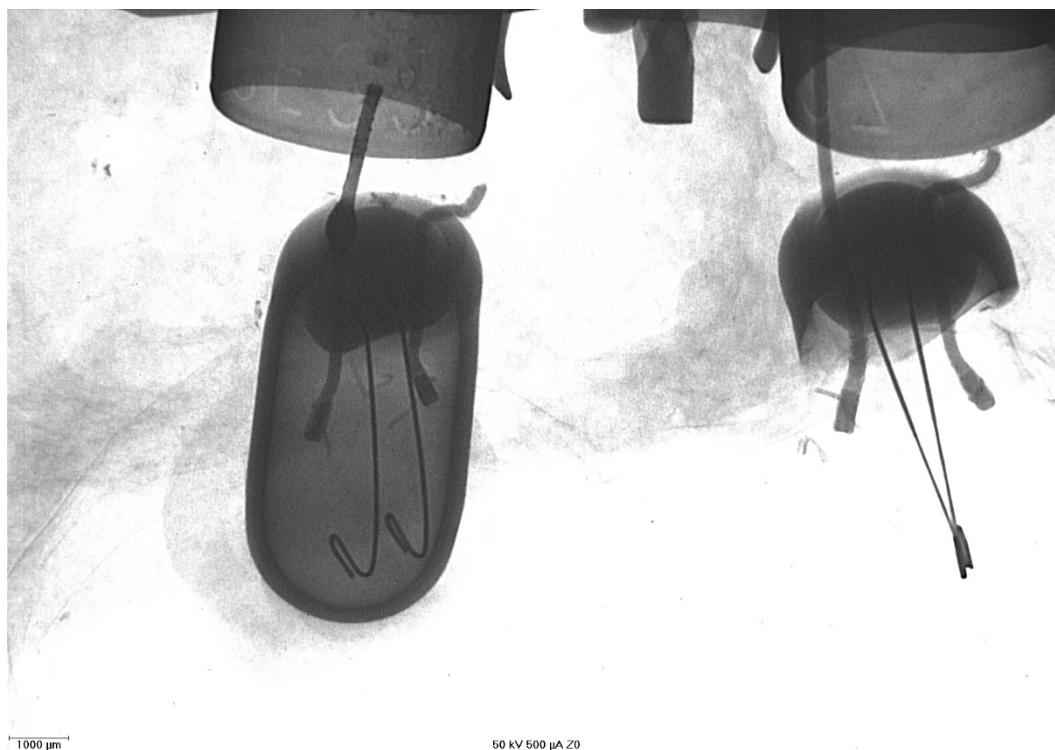
The pilot's side master warning annunciator panel sustained significant impact and fire damage as shown in Figure 10. A layout drawing of the selector panel is shown in Figure 11. The panel was x-rayed to visualize any annunciators with intact bulbs and/or filaments. The radiographs showed that only three of the annunciators had partially intact annunciators-#1 ENG MAN REV, #1 ENG FIRE and #2 ENG FIRE. However, none of the annunciators had two intact bulbs. #1 ENG MAN REV had one broken bulb with no filament and one intact bulb that had a broken, unstretched filament as shown in Figure 12. #1 ENG FIRE had had two broken bulbs and no recognizable filaments as shown in Figures 13 and 14. #2 ENG FIRE had one broken bulb with no filament and one intact bulb that had a broken, unstretched filament as shown in Figure 15.

**Figure 12. Radiograph of #1 ENG MAN REV annunciator**

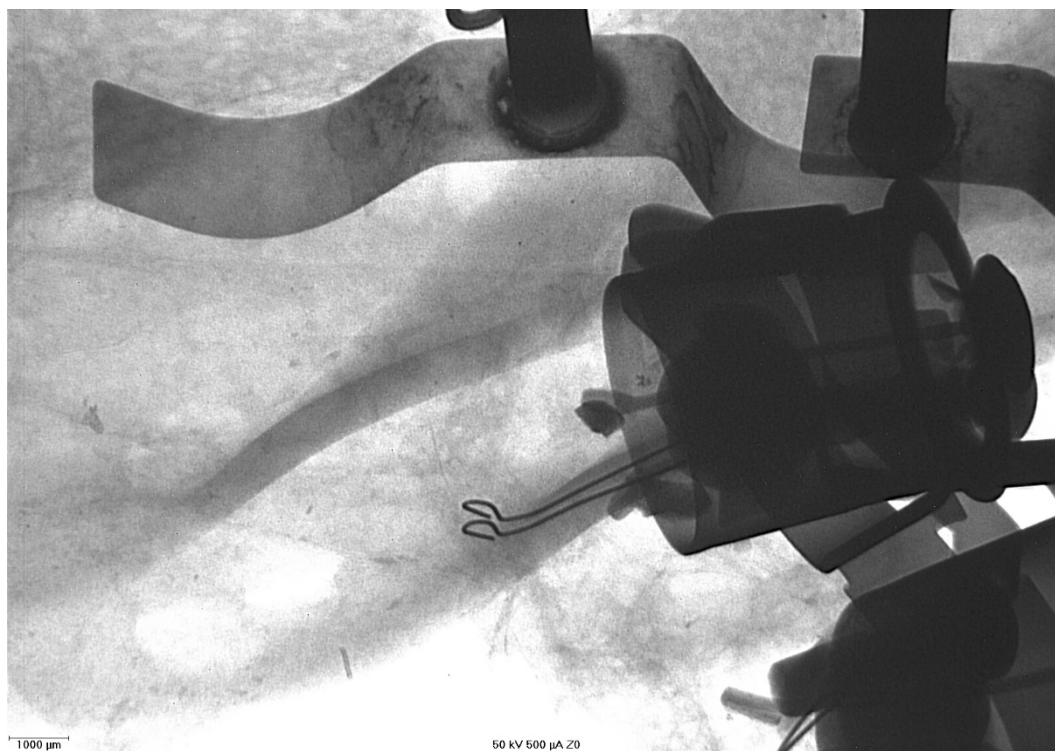
**Figure 13. Radiograph of #1 ENG FIRE bulb #1.**

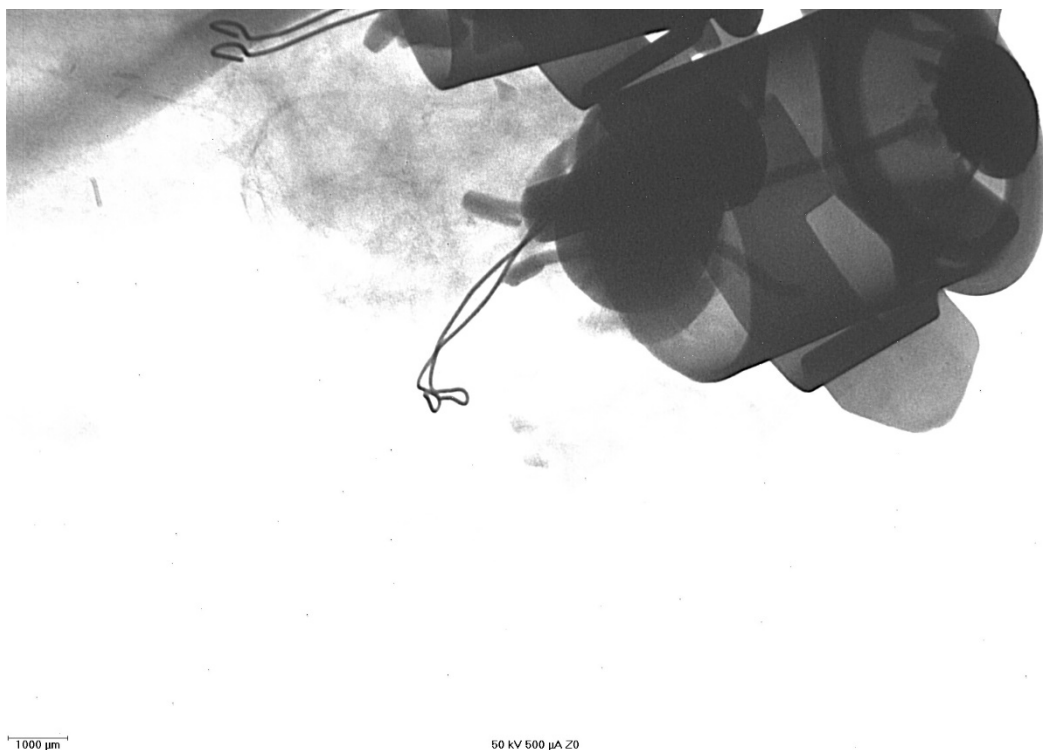
**Figure 14. Radiograph of #1 ENG FIRE bulb #2.**

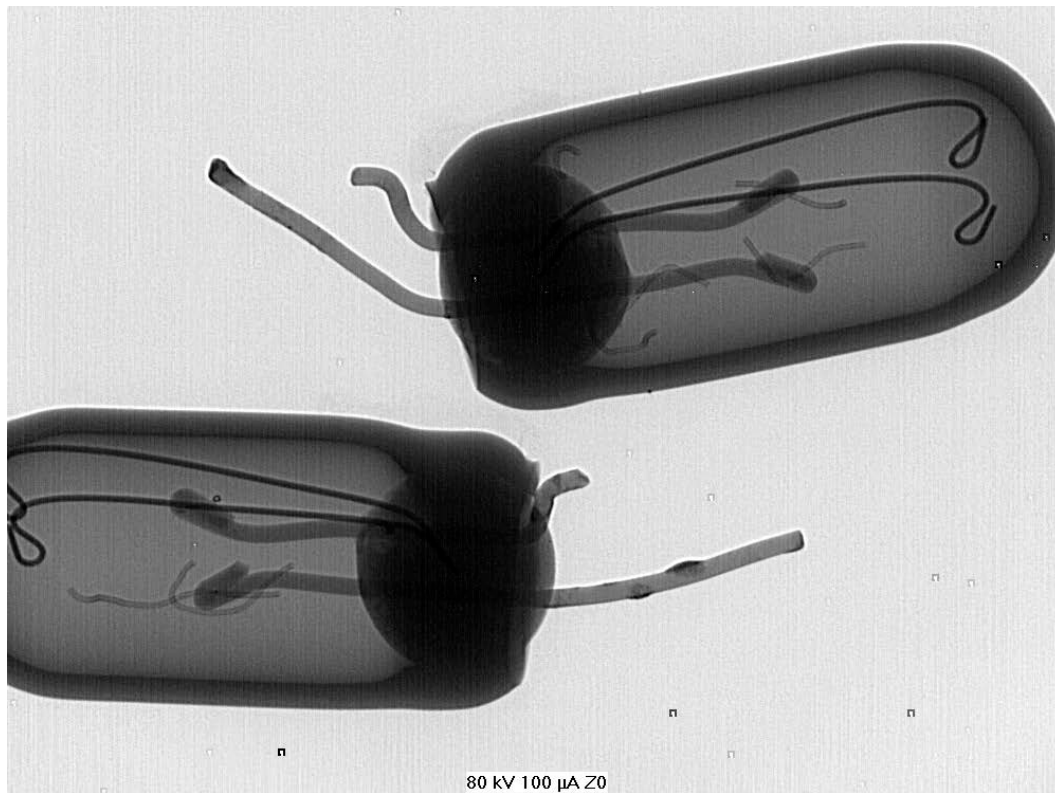
| <b>Annunciator Location<br/>(C=column; R=row)</b> | <b>Bulb #1</b> | <b>Bulb #2</b> |
|---|---|---|
| <b>C2R1</b> | Broken, not stretched | Broken, not stretched |

Figure 18. Radiograph of Column 2 Row 1 bulbs of Caution/Advisory Annunciator Panel.

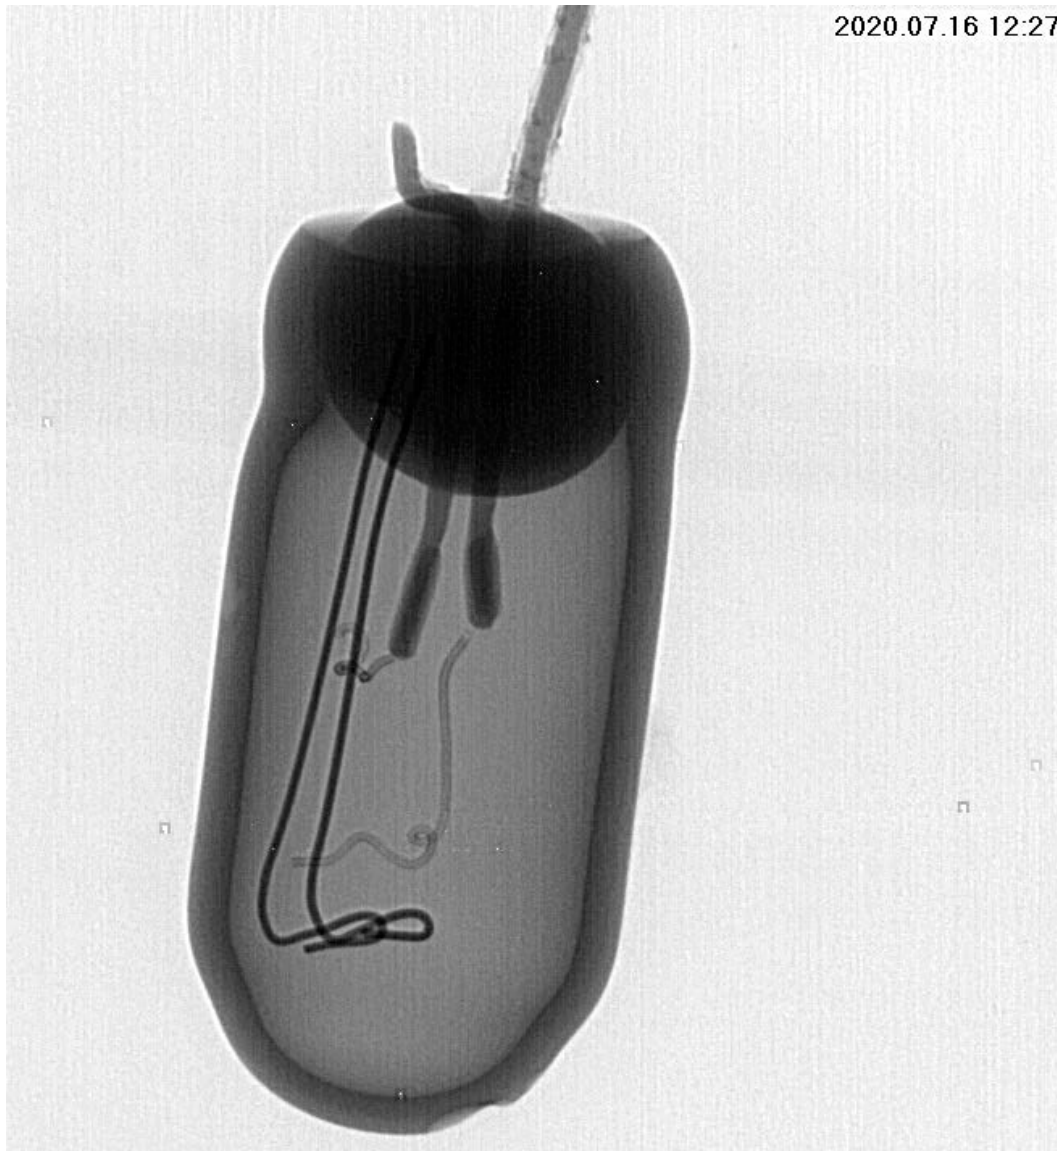
| <b>Annunciator Location<br/>(C=column; R=row)</b> | <b>Bulb #1</b> | <b>Bulb #2</b> |
|---|---|---|
| <b>C2R2</b> | Broken, not stretched | Missing |

**Figure 19. Radiograph of Column 2 Row 2 bulb #1 of Caution/Advisory Annunciator Panel.**

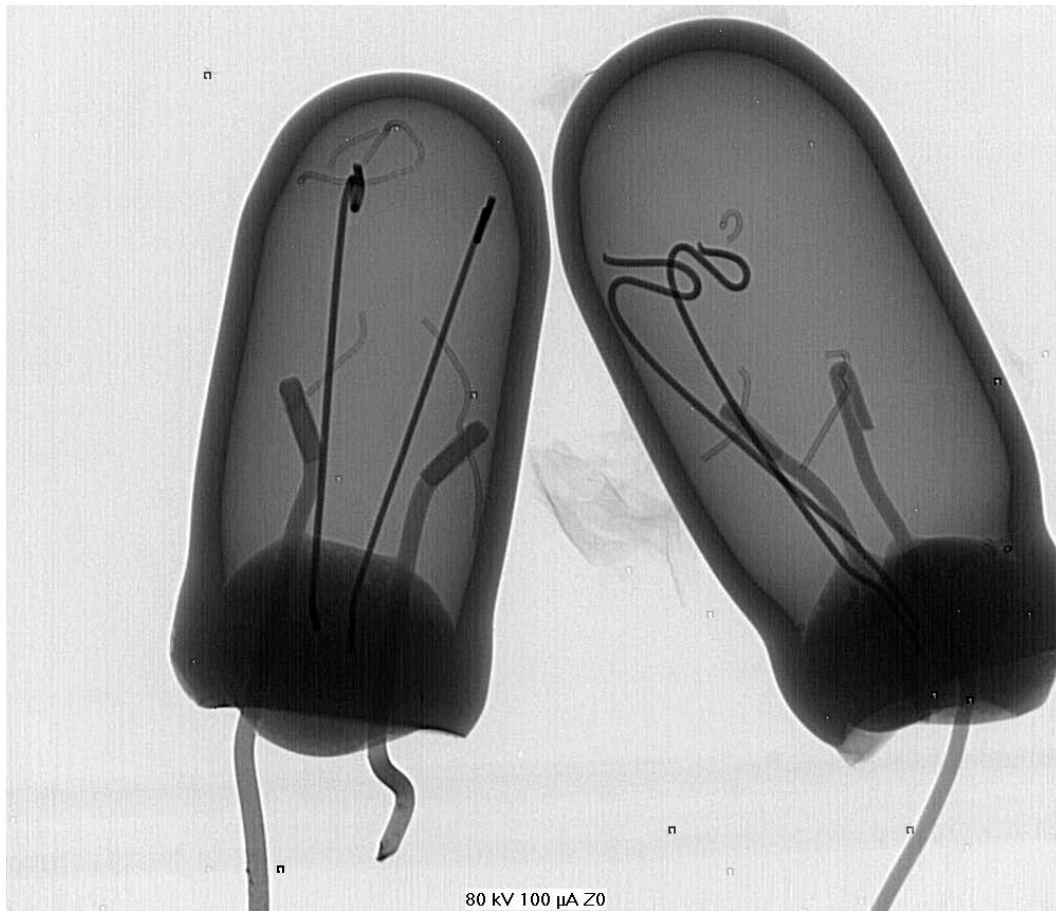
| <b>Annunciator Location<br/>(C=column; R=row)</b> | <b>Bulb #1</b> | <b>Bulb #2</b> |
|---|---|---|
| <b>C2R3</b> | Broken, not stretched | Broken, not stretched |

**Figure 20. Radiograph of Column 2 Row 3 bulbs of Caution/Advisory Annunciator Panel.**

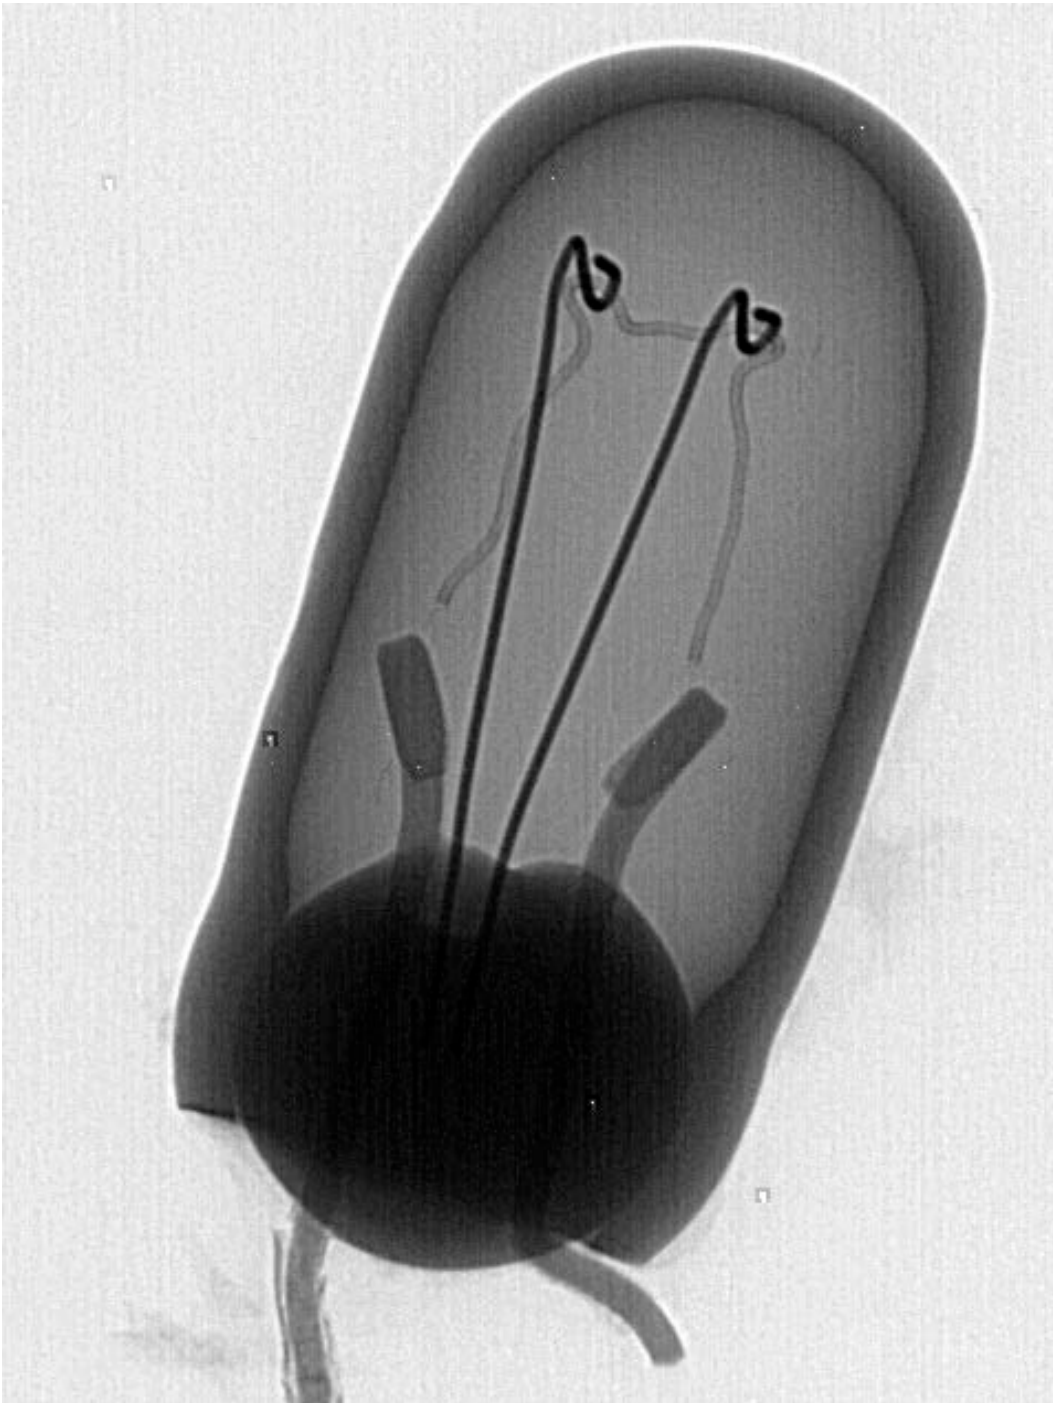
| <b>Annunciator Location<br/>(C=column; R=row)</b> | <b>Bulb #1</b> | <b>Bulb #2</b> |
|---|---|---|
| <b>C2R4</b> | Broken, not stretched | Missing |

**Figure 21. Radiograph of Column 2 Row 4 bulb #1 of Caution/Advisory Annunciator Panel.**

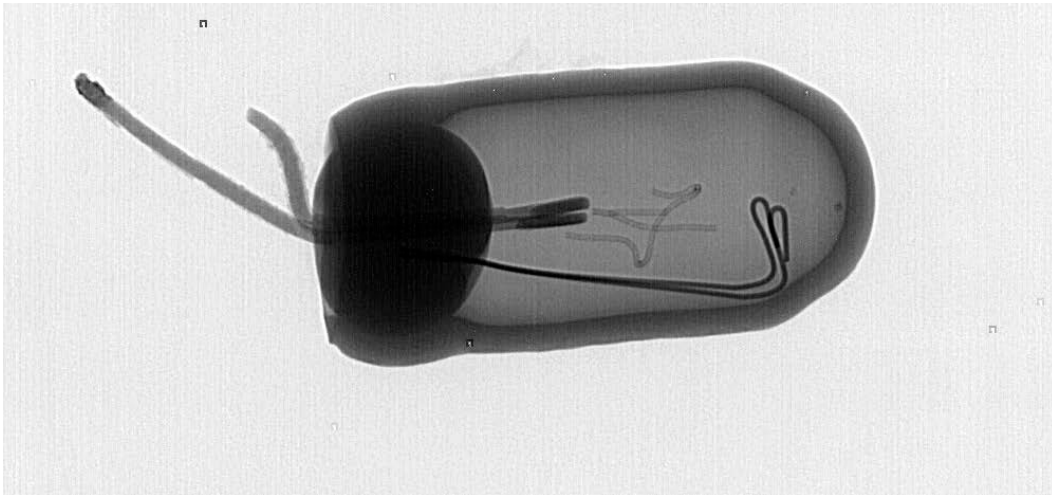
| <b>Annunciator Location<br/>(C=column; R=row)</b> | <b>Bulb #1</b> | <b>Bulb #2</b> |
|---|---|---|
| <b>C2R5</b> | Broken, not stretched | Missing |

**Figure 22. Radiograph of Column 2 Row 5 bulb #1 of Caution/Advisory Annunciator Panel.**

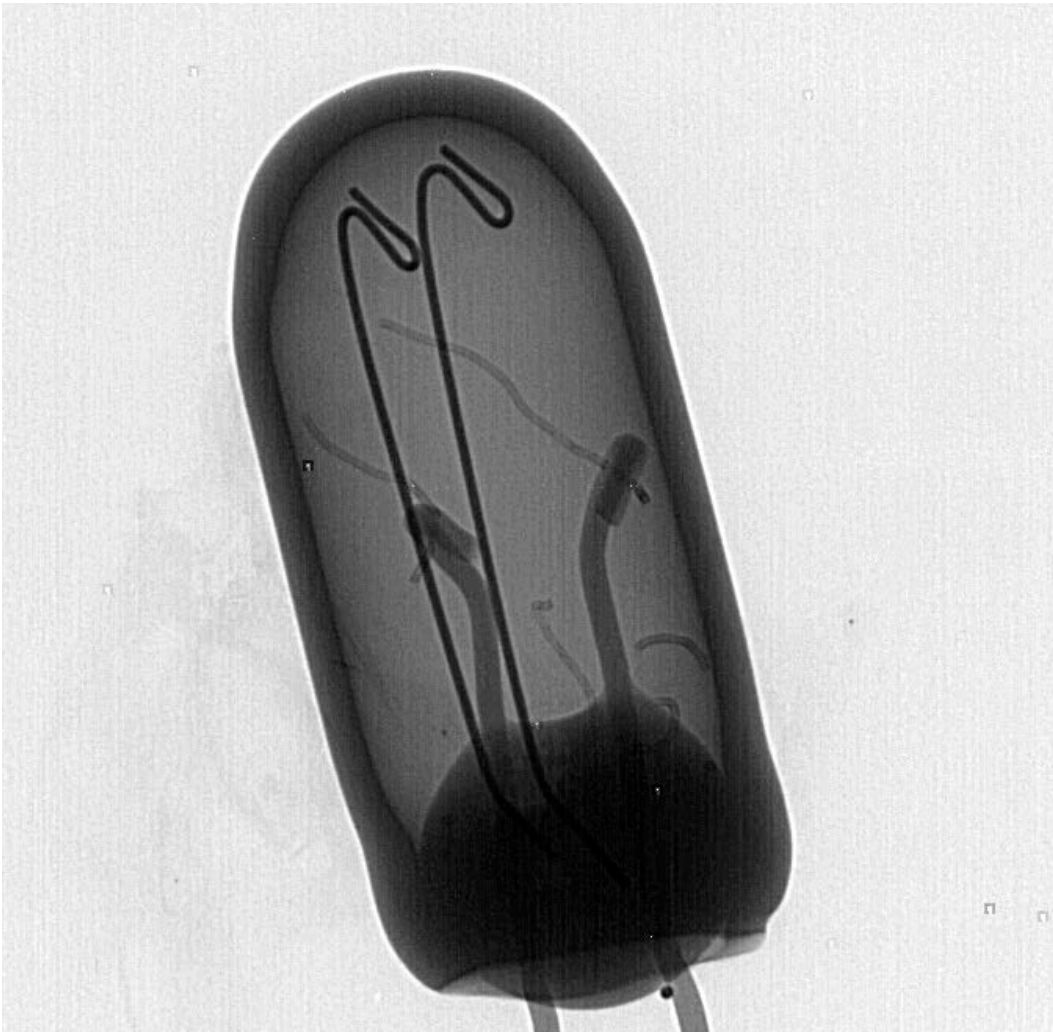
| <b>Annunciator Location<br/>(C=column; R=row)</b> | <b>Bulb #1</b> | <b>Bulb #2</b> |
|---|---|---|
| <b>C3R1</b> | Broken, not stretched | Missing |

**Figure 23. Radiograph of Column 3 Row 1 bulb #1 of Caution/Advisory Annunciator Panel.**

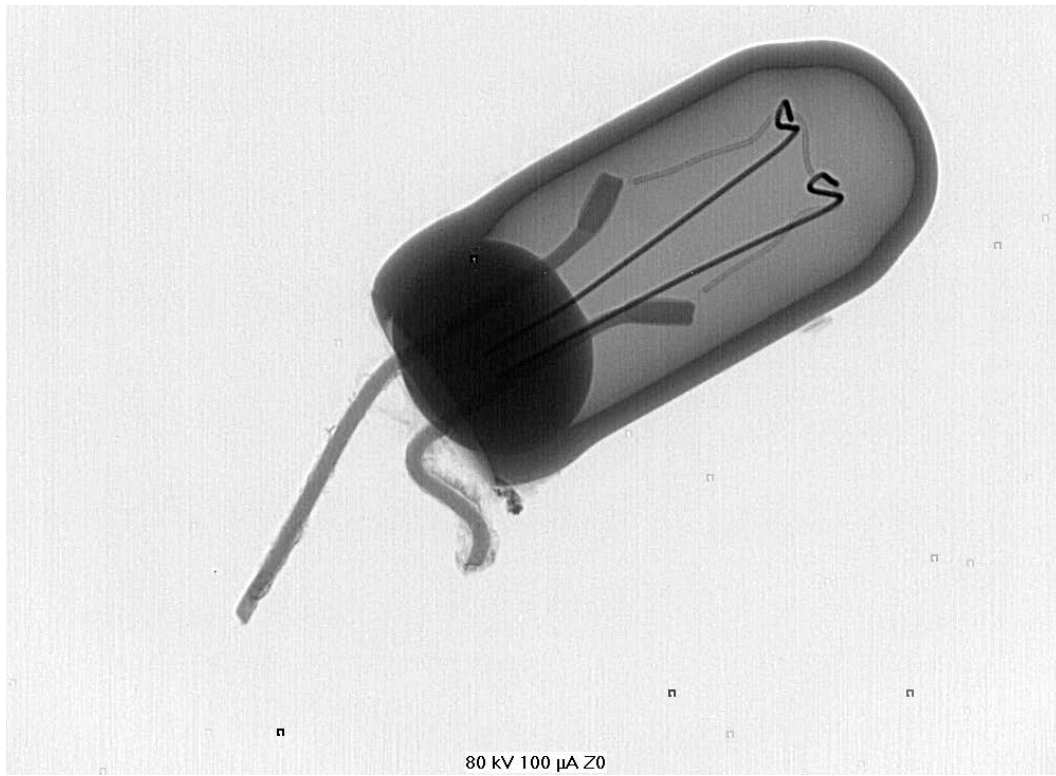
| <b>Annunciator Location<br/>(C=column; R=row)</b> | <b>Bulb #1</b> | <b>Bulb #2</b> |
|---|---|---|
| <b>C3R2</b> | Intact, not stretched | Missing |

**Figure 24. Radiograph of Column 3 Row 2 bulb #1 of Caution/Advisory Annunciator Panel.**

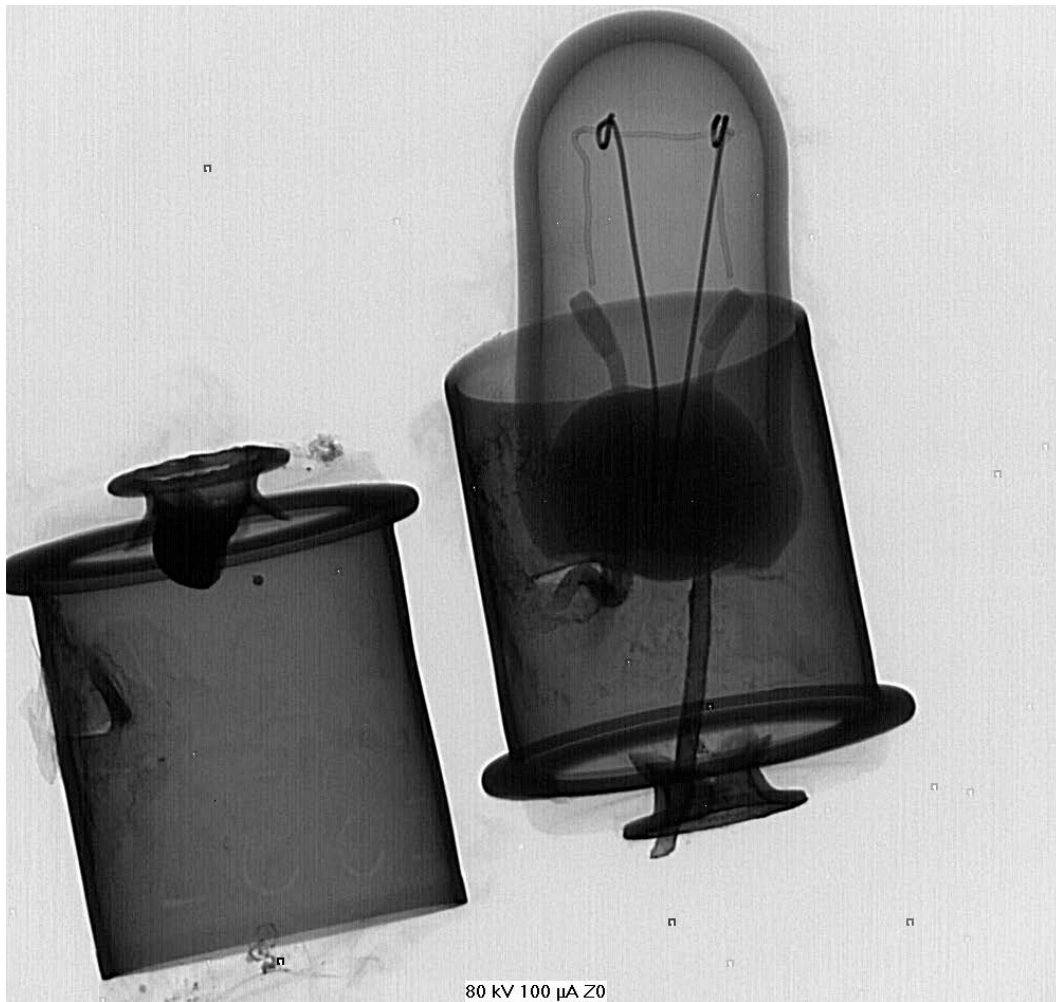
| <b>Annunciator Location<br/>(C=column; R=row)</b> | <b>Bulb #1</b> | <b>Bulb #2</b> |
|---|---|---|
| <b>C3R4</b> | Intact, not stretched | Missing |

**Figure 25. Radiograph of Column 3 Row 4 bulbs of Caution/Advisory Annunciator Panel.**

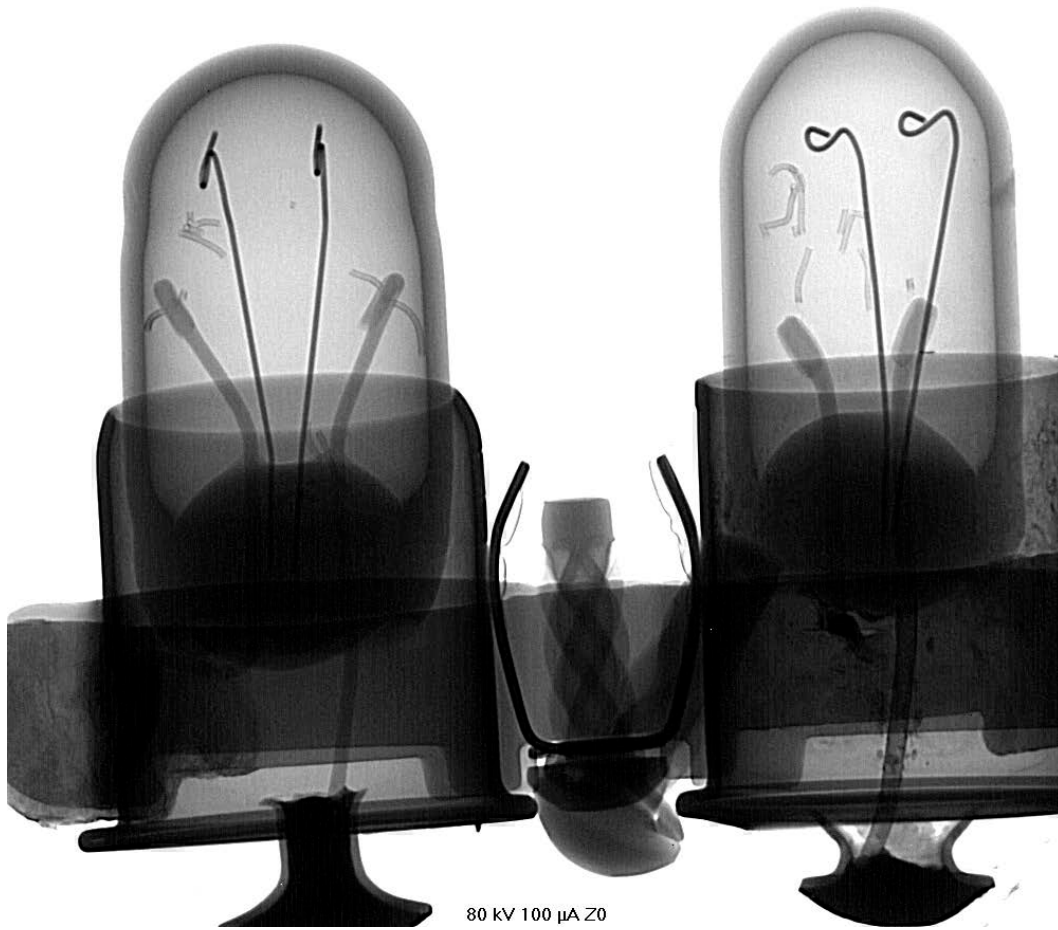
| <b>Annunciator Location<br/>(C=column; R=row)</b> | <b>Bulb #1</b> | <b>Bulb #2</b> |
|---|---|---|
| <b>C5R1</b> | Broken, not stretched | Broken, not stretched |

**Figure 26. Radiograph of Column 5 Row 1 bulbs of Caution/Advisory Annunciator Panel.**

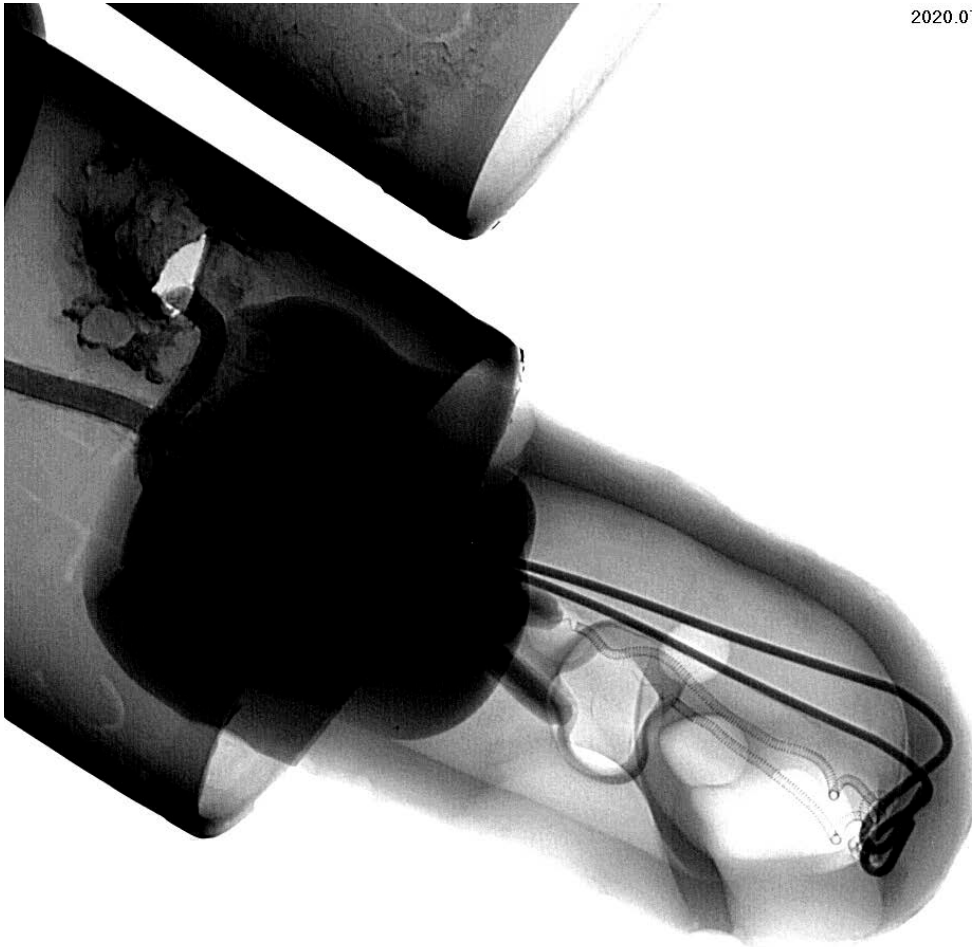
| <b>Annunciator Location<br/>(C=column; R=row)</b> | <b>Bulb #1</b> | <b>Bulb #2</b> |
|---|---|---|
| <b>C5R5</b> | Intact, not stretched | Missing |

**Figure 31. Radiograph of Column 5 Row 5 bulbs of Caution/Advisory Annunciator Panel.**

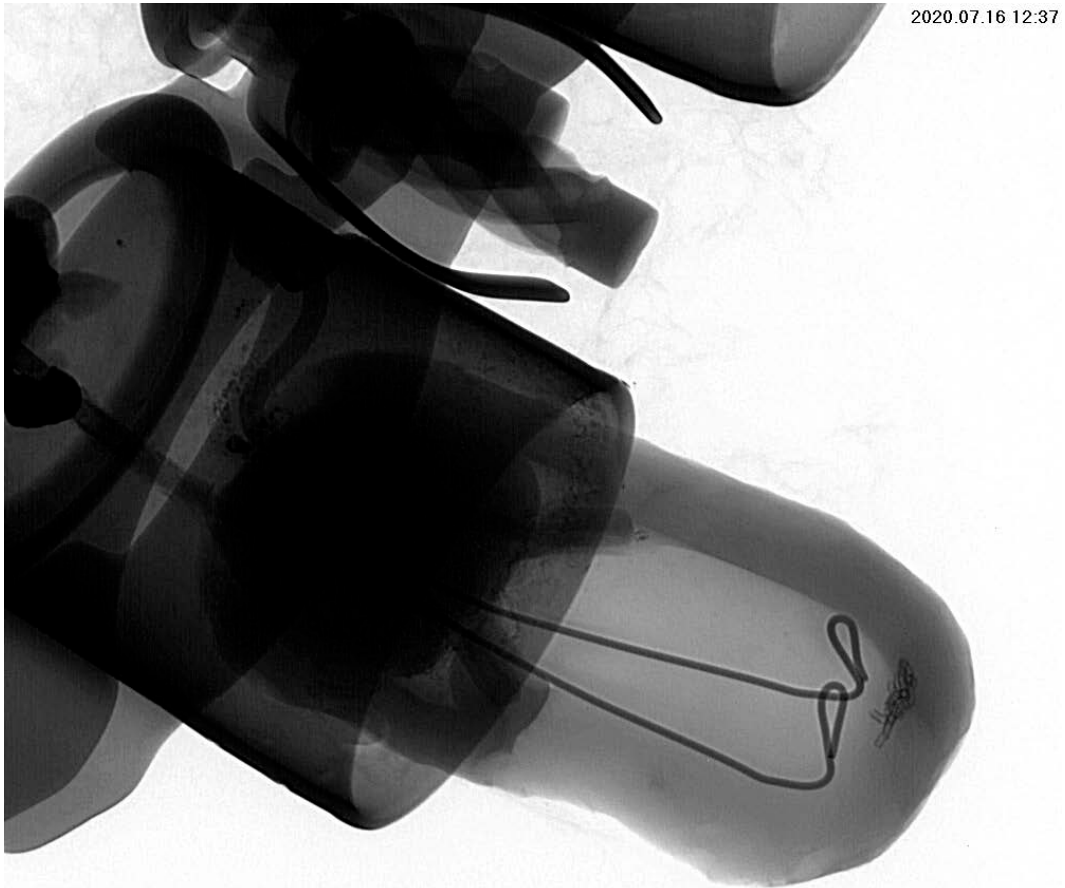
| <b>Annunciator Location<br/>(C=column; R=row)</b> | <b>Bulb #1</b> | <b>Bulb #2</b> |
|---|---|---|
| <b>C8R1</b> | Missing | Broken, not stretched |

**Figure 32. Radiograph of Column 8 Row 1 bulbs of Caution/Advisory Annunciator Panel.**

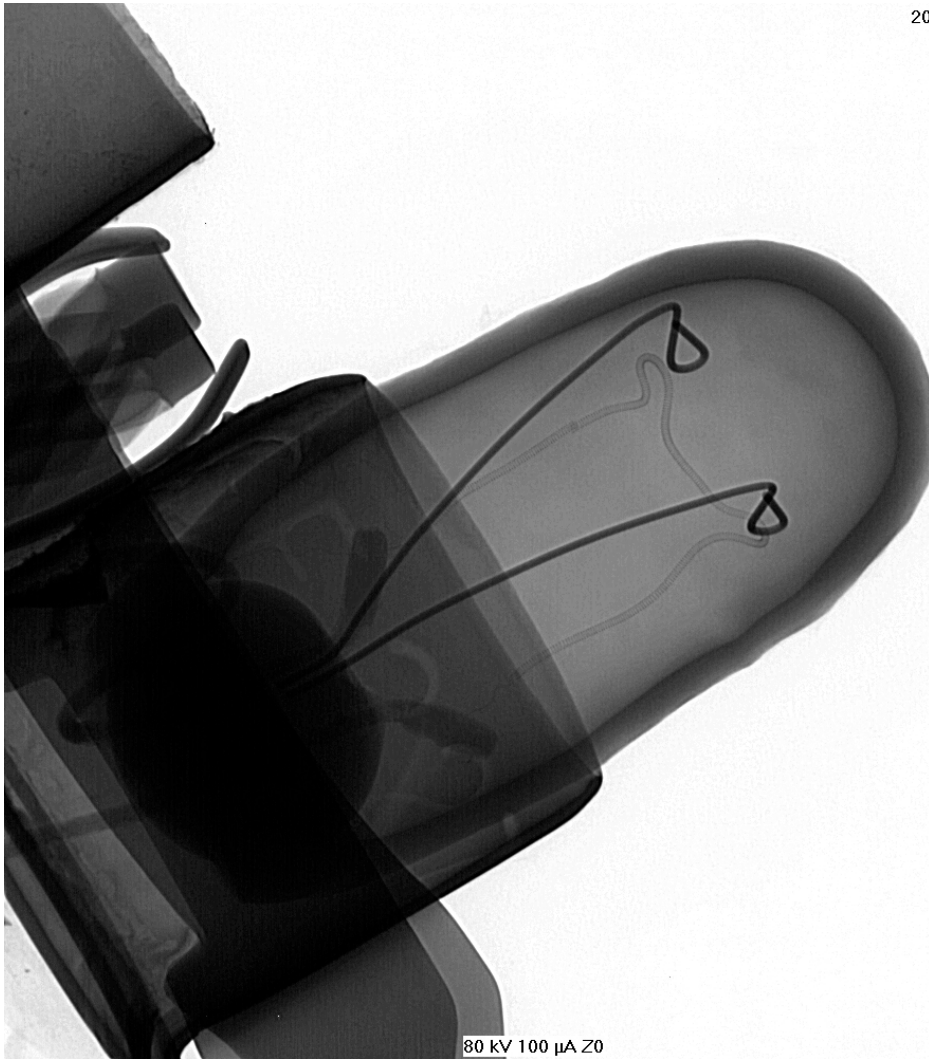
| <b>Annunciator Location<br/>(C=column; R=row)</b> | <b>Bulb #1</b> | <b>Bulb #2</b> |
|---|---|---|
| <b>C8R2</b> | Intact, not stretched | Missing |

**Figure 33. Radiograph of Column 8 Row 2 bulbs of Caution/Advisory Annunciator Panel.**

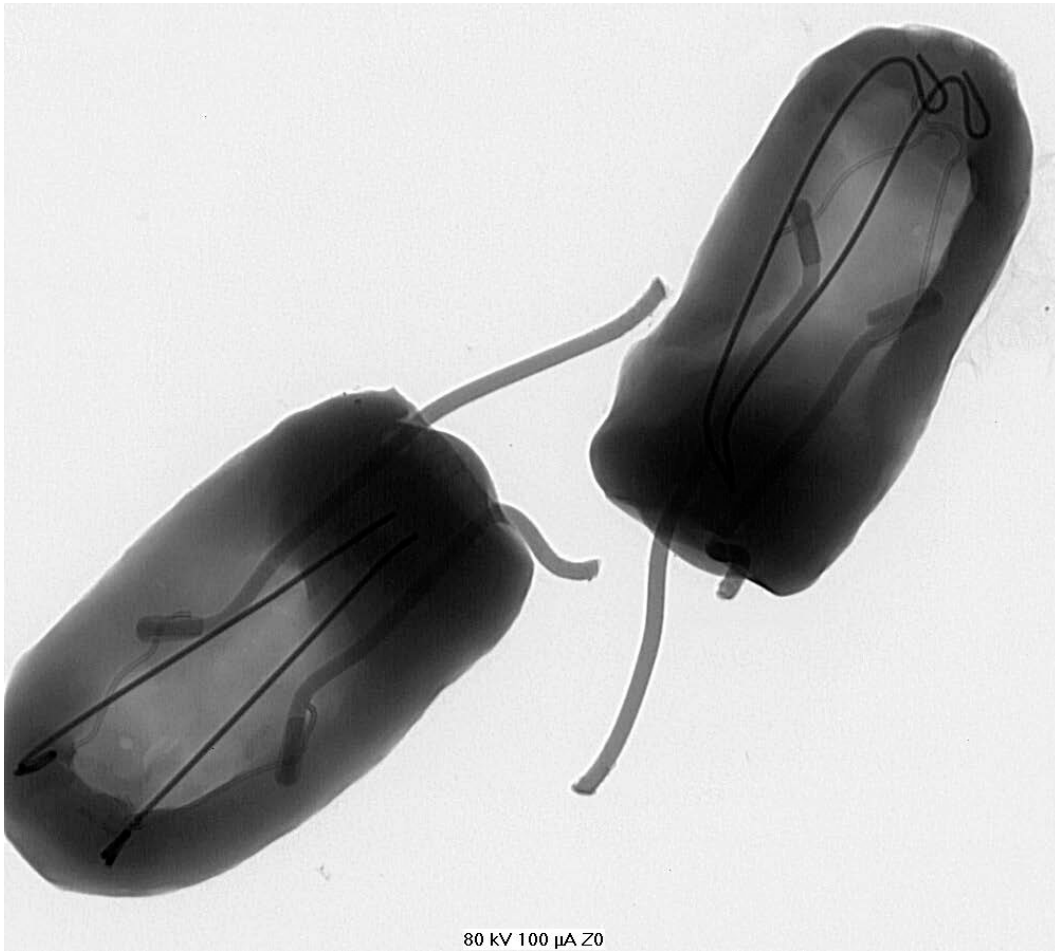
| <b>Annunciator Location<br/>(C=column; R=row)</b> | <b>Bulb #1</b> | <b>Bulb #2</b> |
|---|---|---|
| <b>C8R3</b> | Intact, not stretched | Broken, not stretched |

**Figure 34. Radiograph of Column 8 Row 3 bulbs of Caution/Advisory Annunciator Panel.**

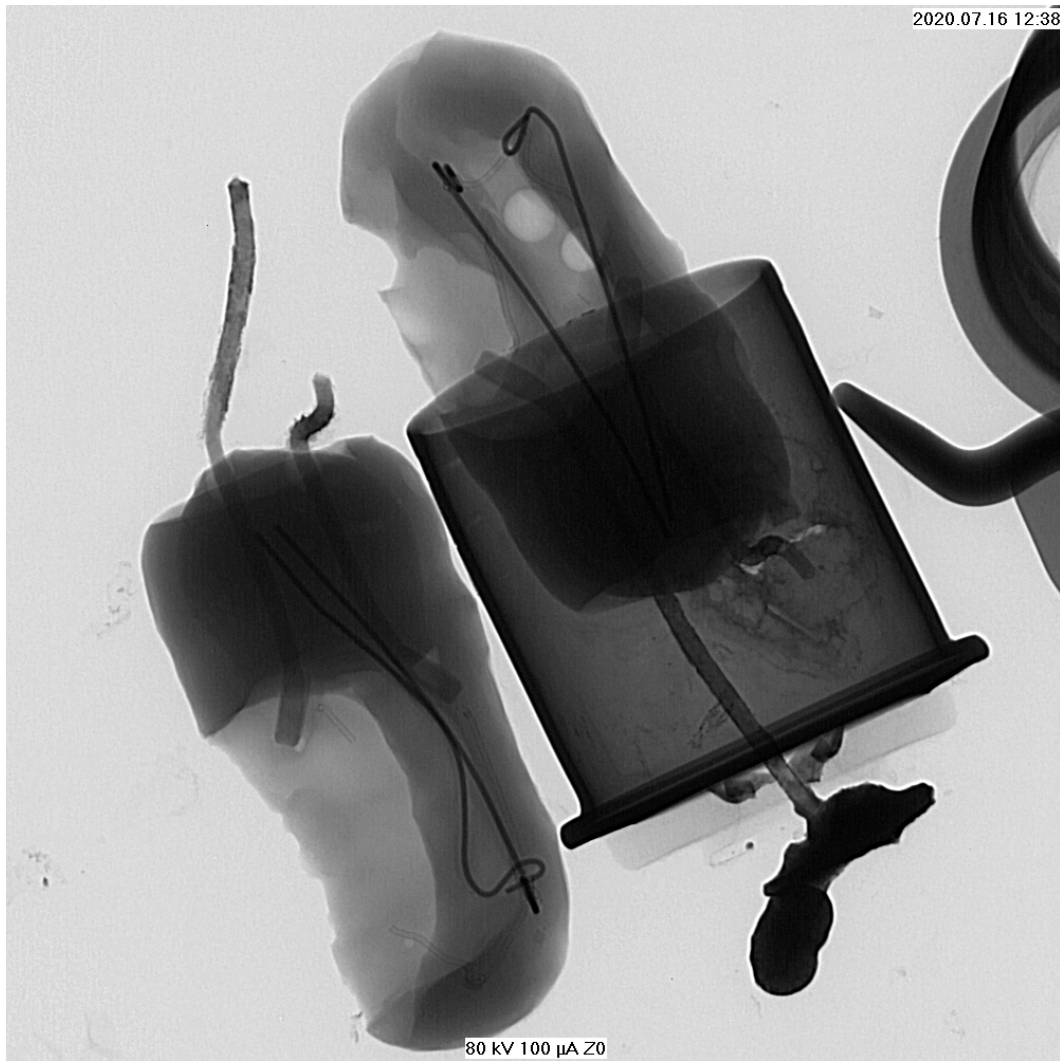
| <b>Annunciator Location<br/>(C=column; R=row)</b> | <b>Bulb #1</b> | <b>Bulb #2</b> |
|---|---|---|
| <b>C8R4</b> | Broken, not stretched | Intact, not stretched |

**Figure 35. Radiograph of Column 8 Row 4 bulbs of Caution/Advisory Annunciator Panel.**

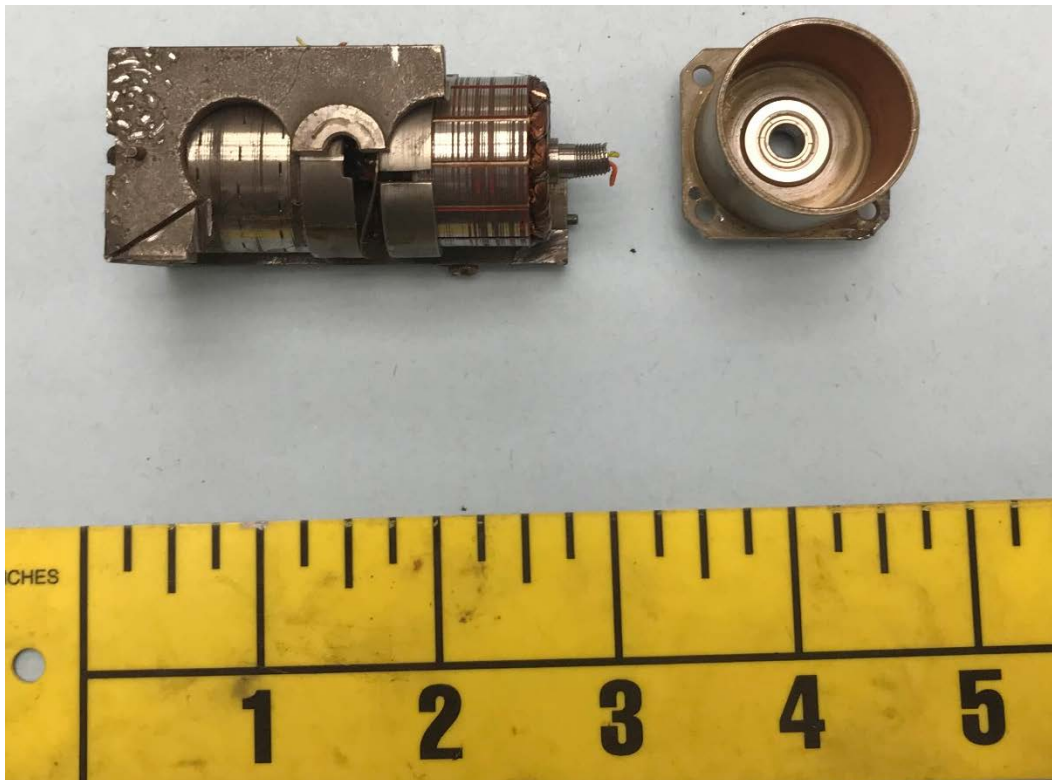
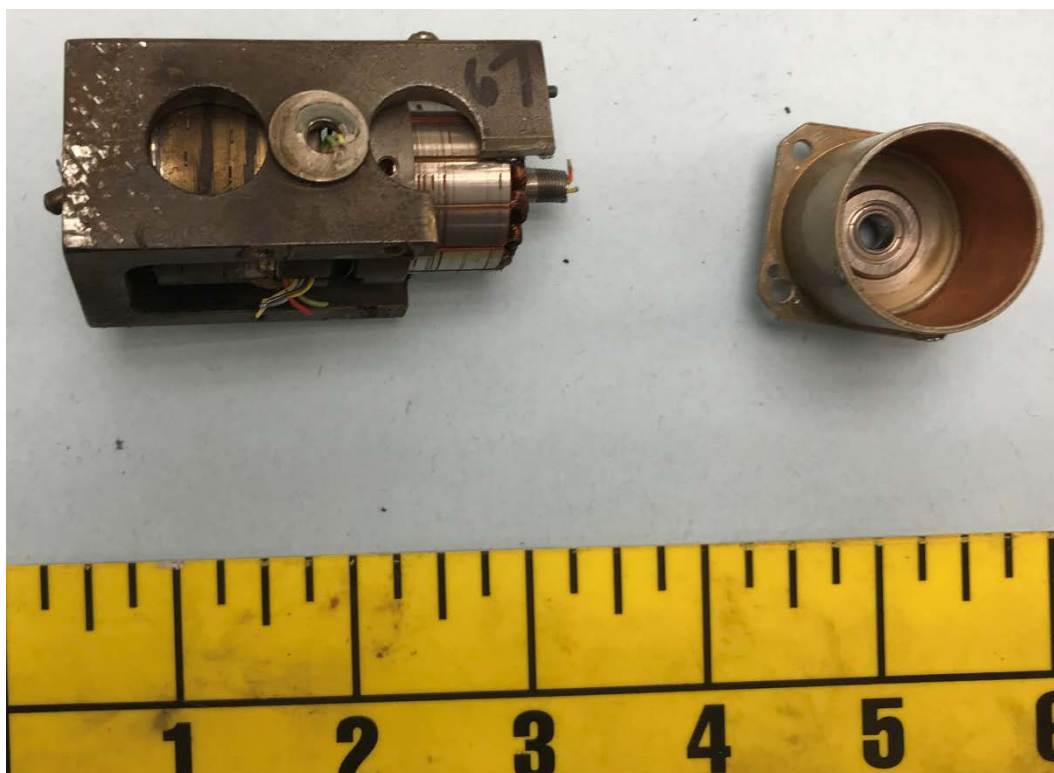
The vertical gyros sustained significant impact and fire damage as shown in Figure 40. The cases for both gyros were taken off and the individual gyros removed to assist with the examination. Both gyros appeared to freely rotate when manually turned indicating that there was no sustained contact between the masses and the structure around them. When the gyros were disassembled, light operational scoring was found on the rotational masses as shown in Figures 41 and 42. This scoring corresponded to the structure that surrounded the masses. The cases covered only the motors on the end of each gyro.

**Figure 41. Gyro #1 from Vertical Gyros.**

Figure 42. Gyro #2 from Vertical Gyros.

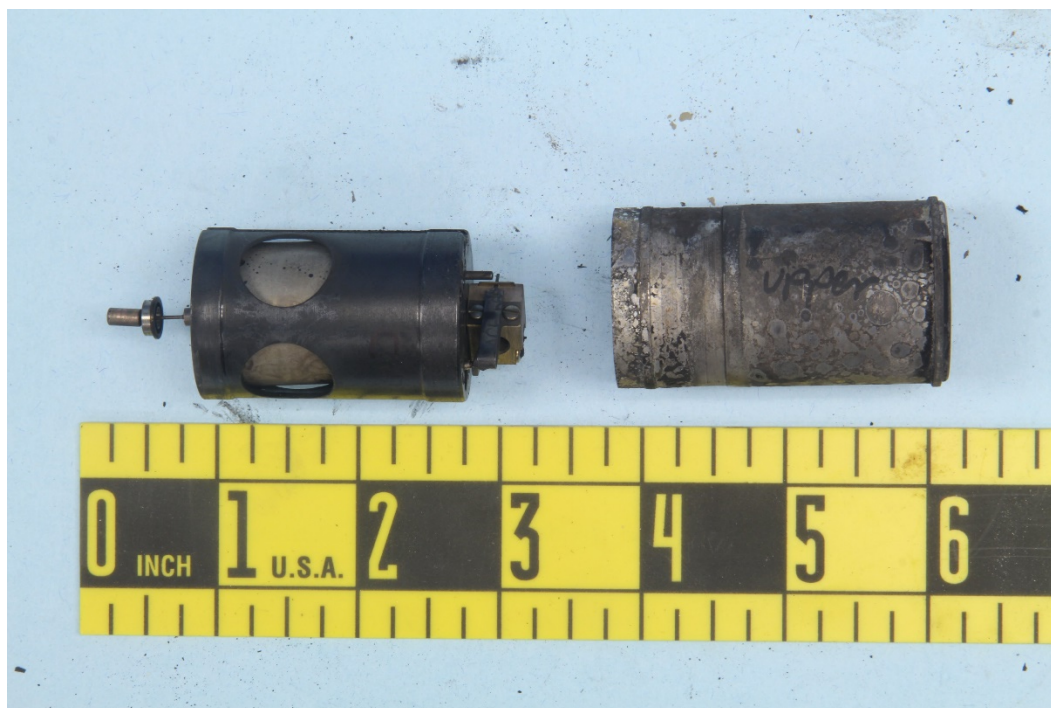
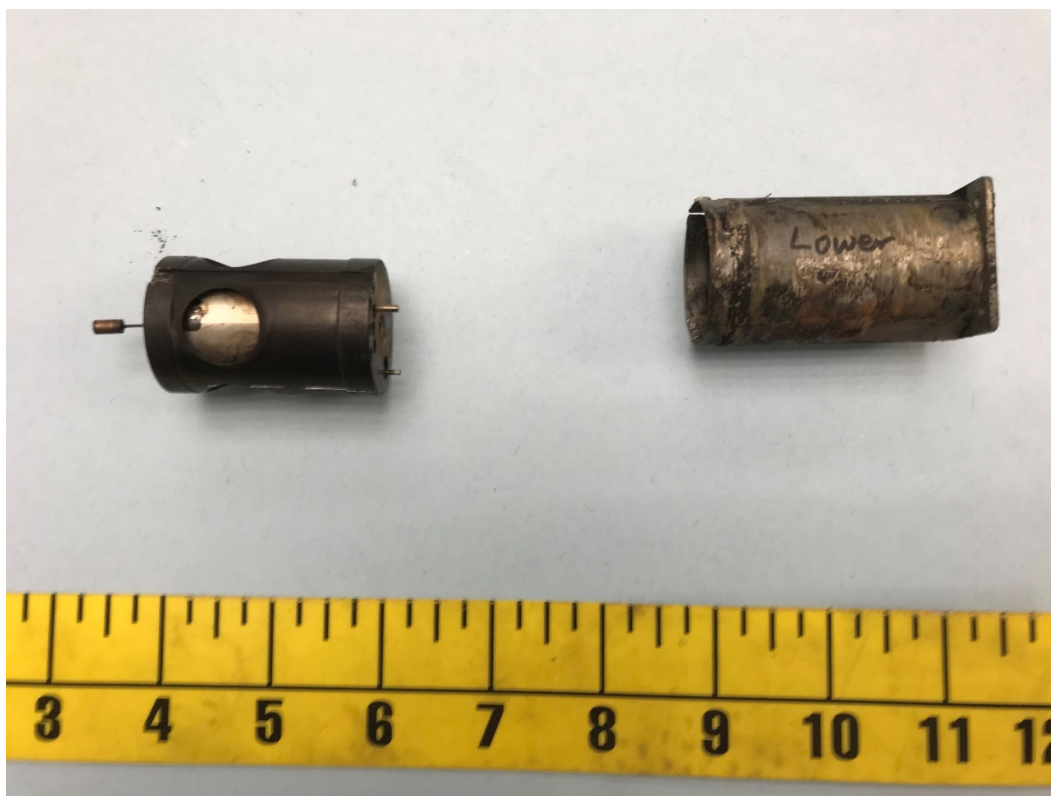
The rate gyros sustained significant impact and fire damage as shown in Figure 43. The cases for both gyros were taken off and the individual gyros removed to assist with the examination. Both gyros appeared to freely rotate when manually turned indicating that there was no sustained contact between the masses and the structure around the masses. When the cases around the gyros were removed, no operational scoring was found on the rotational masses, and the cases were unmarked. The rotational masses and exterior of the cases are shown in Figures 44 and 45.

Figure 44. Gyro #1 from Rate Gyros.

Figure 45. Gyro #2 from Rate Gyros.

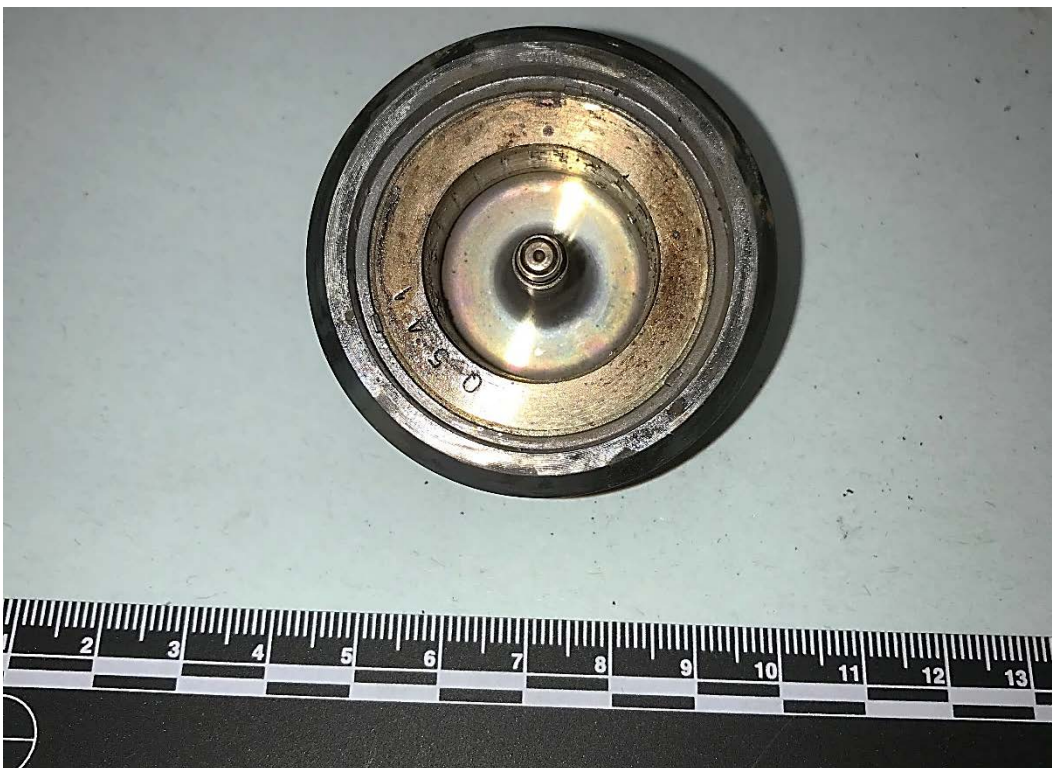
The standby attitude indicator sustained significant impact and fire damage as shown in Figure 46. The indicator faceplate sustained significant fire damage so any witness marks showing the position of the indicator could not be visualized. The case for the indicator was taken off and the gyro removed to assist with the examination. The gyro appeared to freely rotate when manually turned. When the gyro was disassembled, a small amount of operational scoring was found on the top of rotational mass as shown in Figure 47. The circumference of the mass and the top of the case had light scoring as shown in Figure 48. The scoring on the mass circumference corresponded to a machined ridge on the inside of the case.

**Figure 47. Top of gyro rotational mass from Standby Attitude Indicator**
