## **NATIONAL TRANSPORTATION SAFETY BOARD**

## **SEARCH AND RECOVERY**

DCA21FA174

## Transair Flight 810 Debris Survey

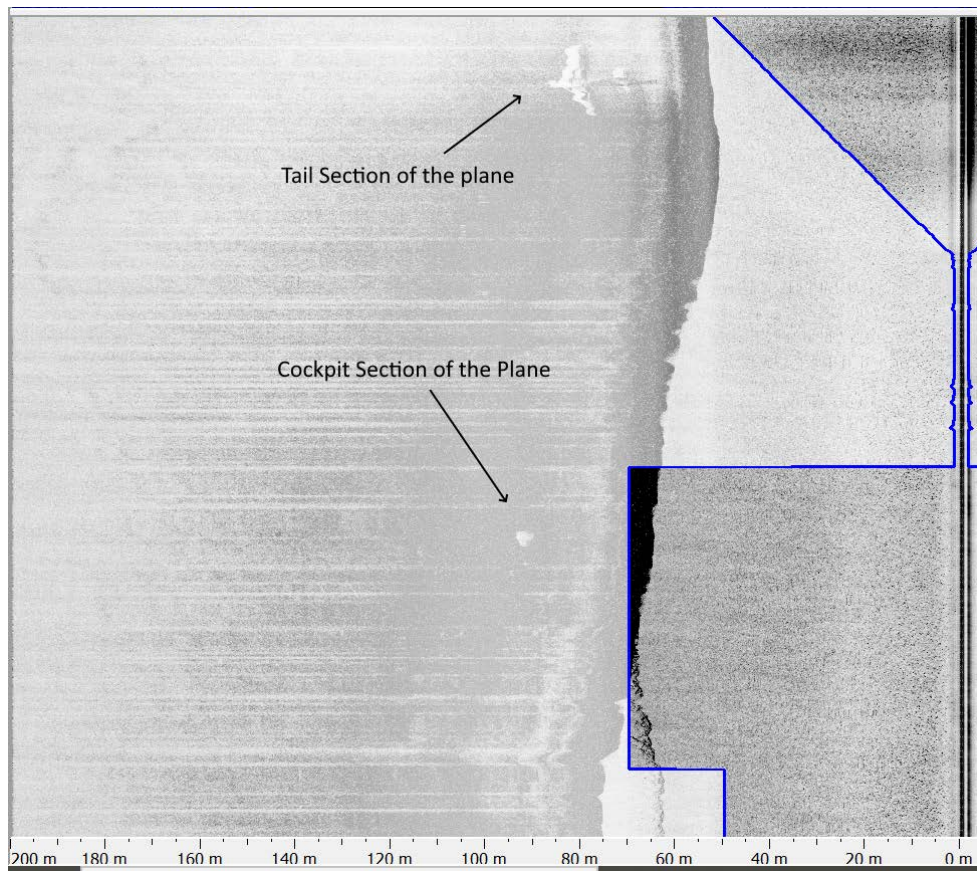
**Figure 13 Side Scan Image of Plane Tail Section and Cockpit**

The focused side scan survey lines identified a primary target of the aft section of the plane (shown Figure 13). The ROV was deployed and confirmed the aft of the plane (Figure 14). ROV inspection of the target identified that the forward fuselage and engines had detached from the aft section of the plane and a limited amount of debris surrounded the area.

The third day of surveying included ROV inspection of the remaining targets identified on day two of the survey. Beginning with the next highest priority target, the ROV located the forward fuselage and cockpit (shown in Figure 13), followed by both engines, nose landing gear, cargo containers and miscellaneous debris associated with the crash. NTSB personnel determined that all plane components had been identified over the second and third days of surveying. SEI demobilized survey equipment and the vessel on July 9<sup>th</sup>, 2021.

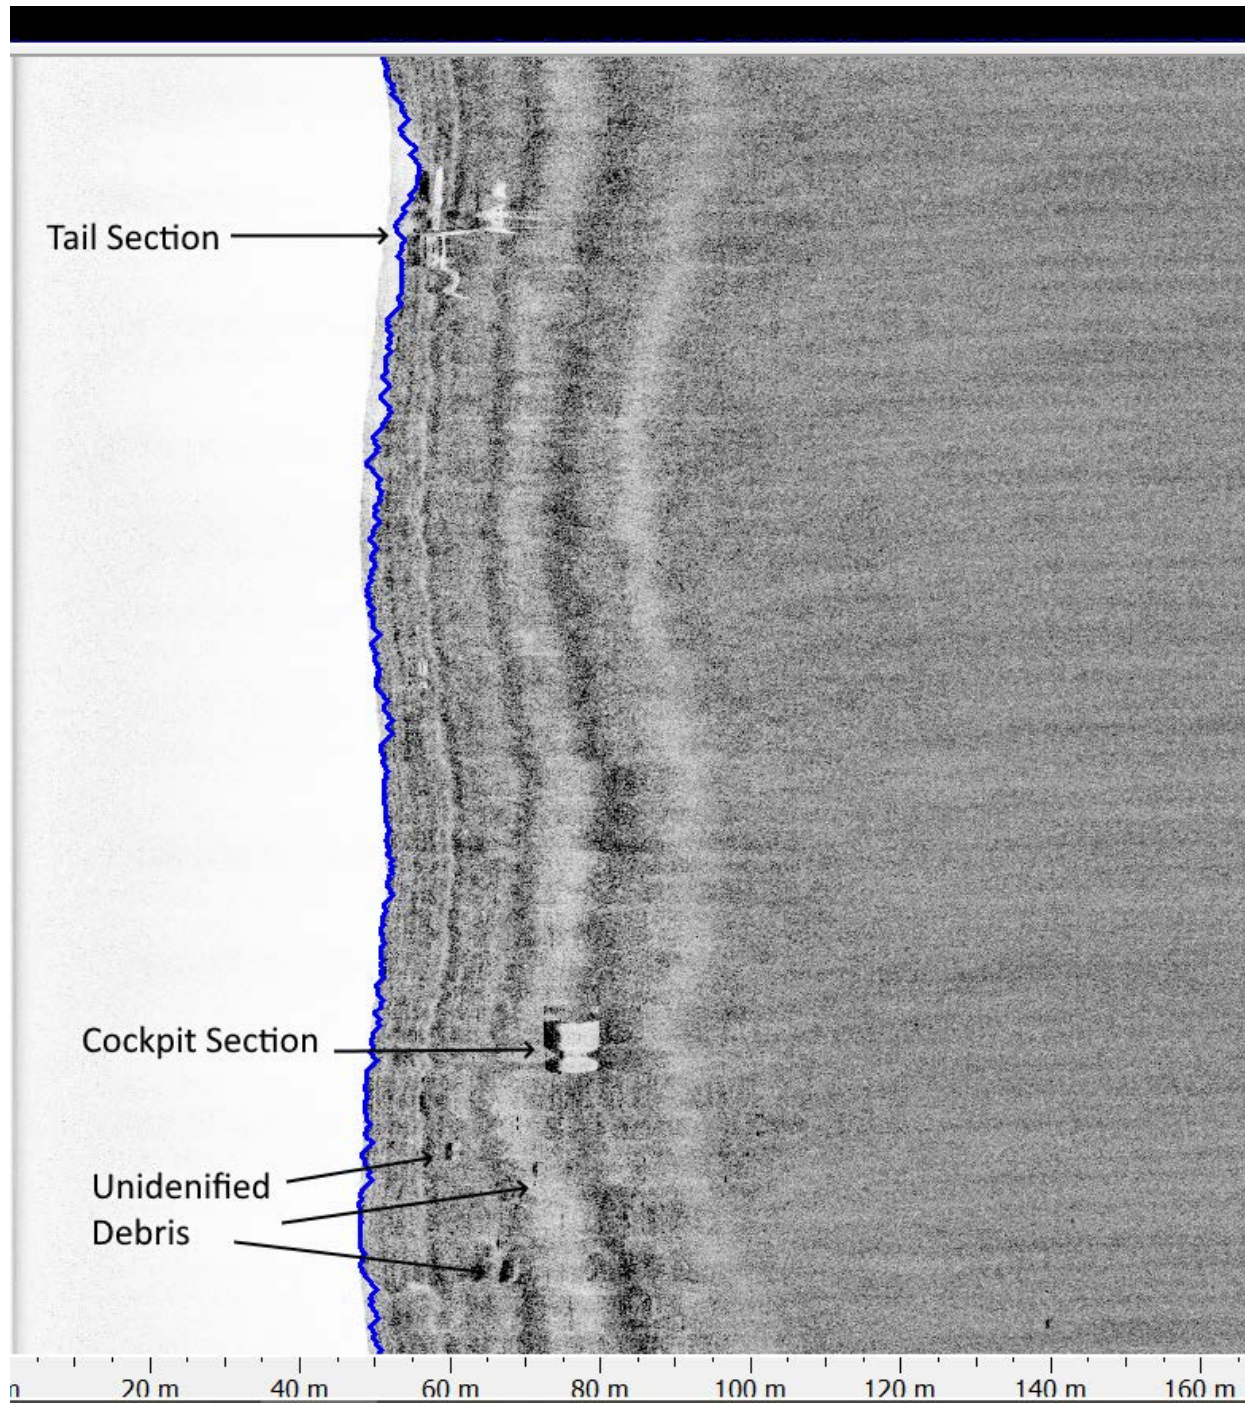
Figure 36 Side Scan Survey Image (down slope)

Initial side scan survey operations were conducted in shallower waters than the final resting place of the tail and cockpit sections. Additionally, the depths of the tail and cockpit were near the maximum survey depths for the C-MAX side scan unit. The addition of weight of the chain attached to the cable allowed the sonar to fly deeper in the water column. Images of the tail section and cockpit without the chain are not identifiable. Figure 36 and Figure 37 show the side scan images of the plane from downslope and upslope survey lines, respectively.
