## **NATIONAL TRANSPORTATION SAFETY BOARD**

DCA21FA174

Attachment 8 - EGI Final Report  
(51 pages)

TRANSAIR FLIGHT 810, BOEING 737-275C  
FAA REGISTRATION N810TA  
PROJECT FINAL REPORT

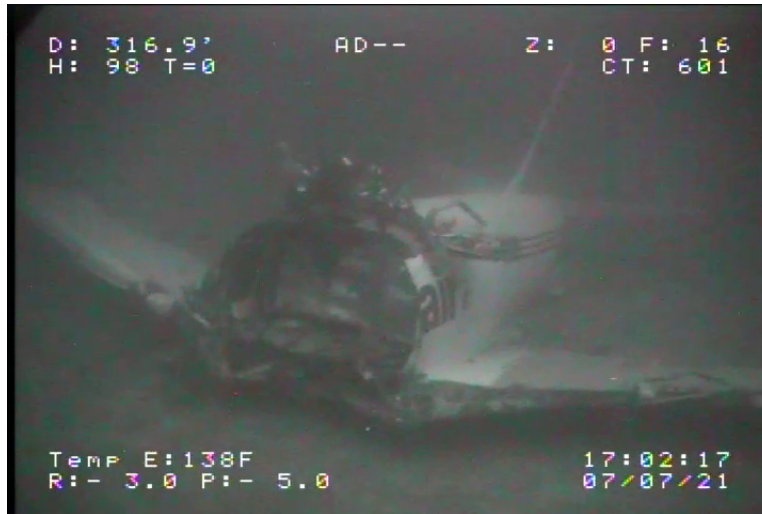
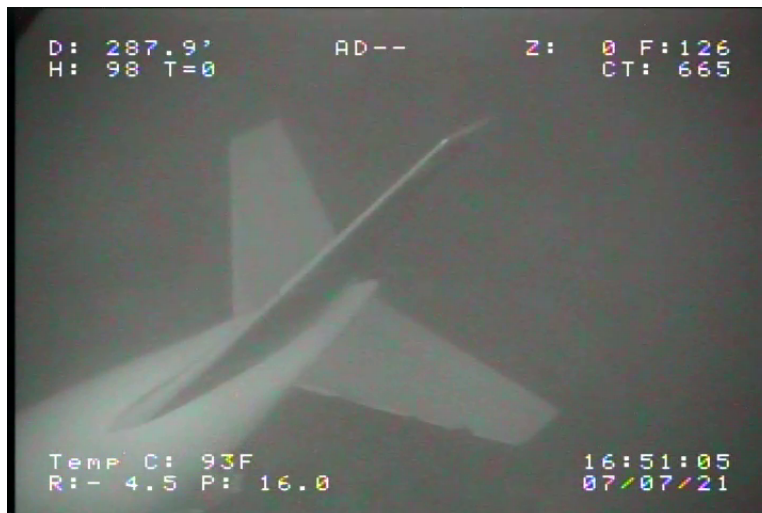
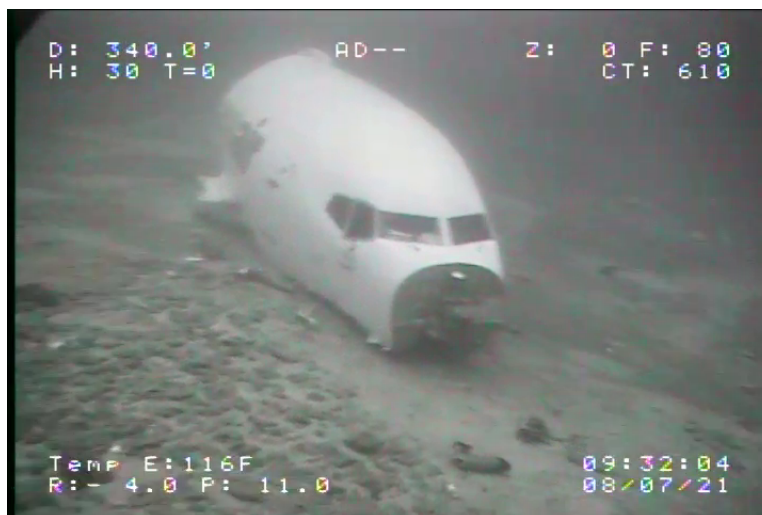
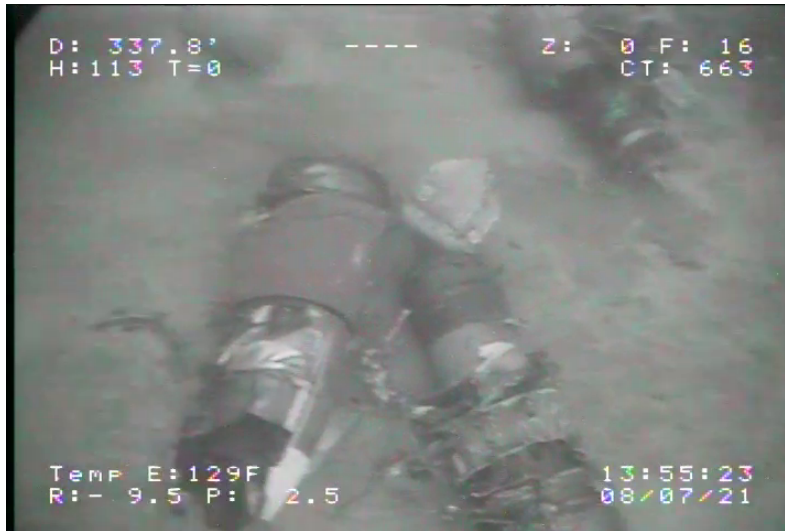
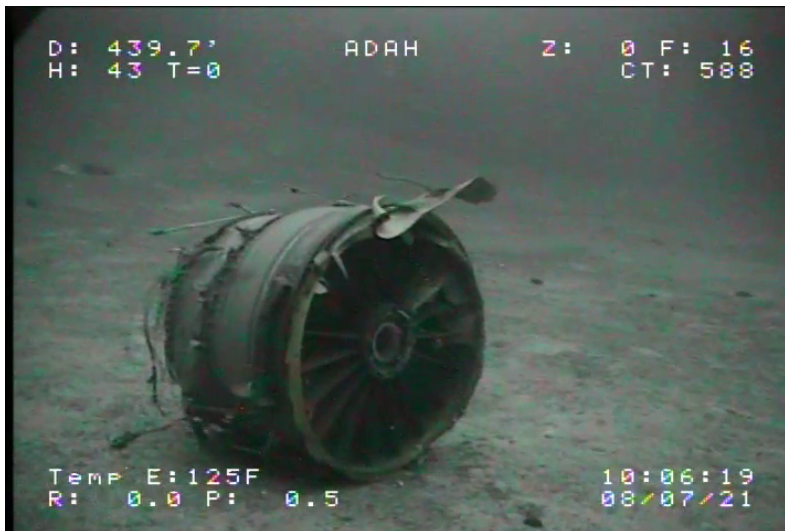
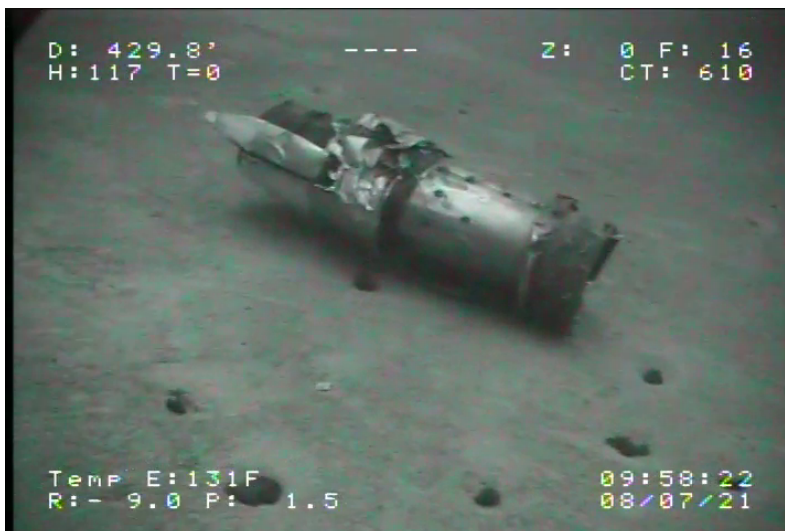
The Boeing 737 had performed a controlled, low-speed ditching onto the surface of the ocean. By design, both engines broke free from their respective wing pylons. The cockpit / forward section of the fuselage separated from the aft section at the leading edge of the wings. It was found that the forward wing spar failed during the impact. The aircraft carried one pallet and six cargo cans, four remained in place, and two were ejected from the aircraft.

- The part marked Engine Pylon was subsequently found to be the Keel Beam.
- The part marked APU was subsequently found to be an air conditioning pack
- The part marked Thrust Reverser Engine 1 is not confirmed to be from that engine.

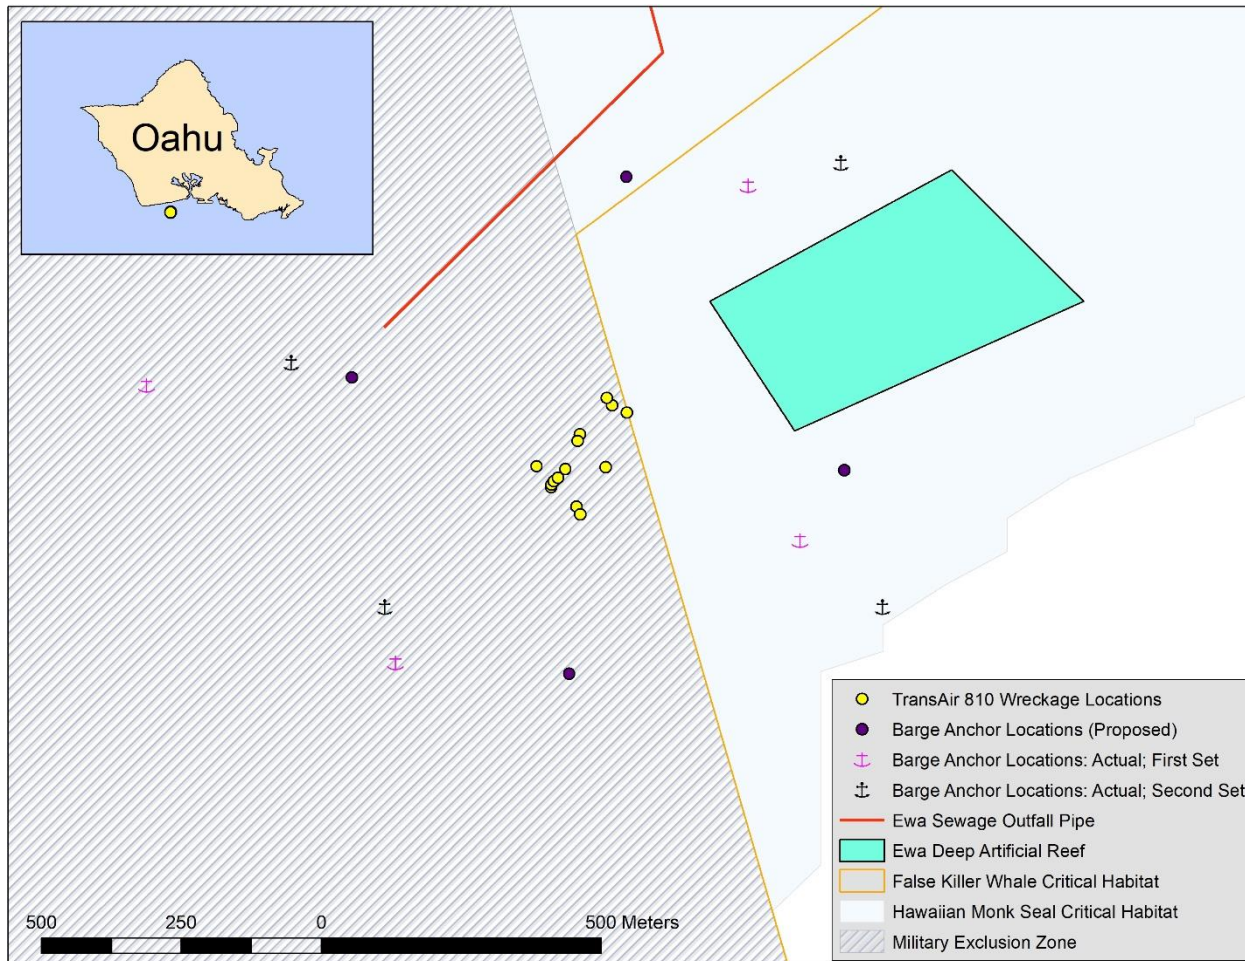
Figure 1. Barge proposed and actual anchor locations.

- A note about the barge anchorages:  
We surveyed the proposed barge anchor sites at the onset of this project to enable a visual assessment of the anchor impacts. The barge does have the ability to anchor on a particular target point, however, due to prevailing wind, wave, and currents and the reality of positioning the barge in the best orientation for these lifts, the two anchor sets have not been on the proposed/surveyed sites (Figure 1). The new plan is to survey all actual anchor locations and the surrounding areas to get a representative sample of the habitat.
