## **NATIONAL TRANSPORTATION SAFETY BOARD**

### **Group Chairman's Factual Report**

# **SURVIVAL FACTORS**

DCA21FA174

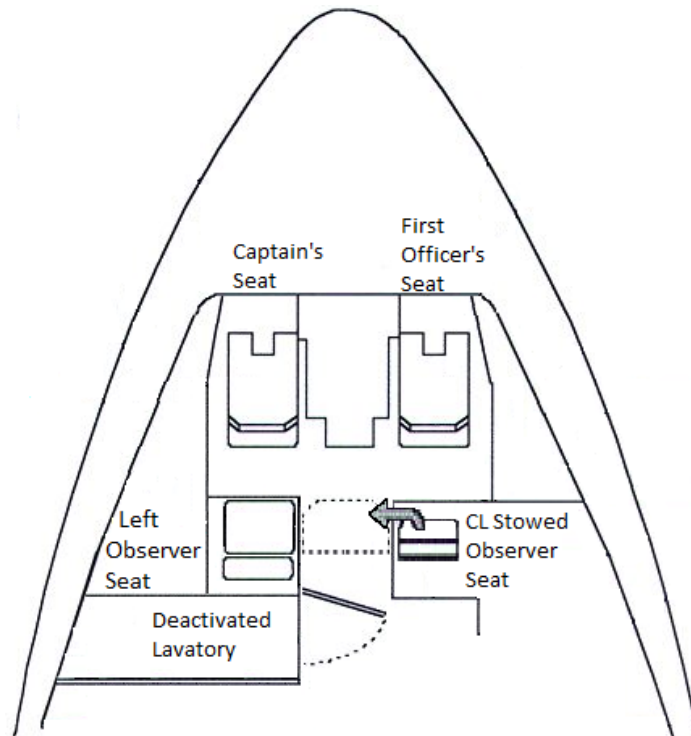
**Figure 1** Cockpit layout of N810TA.

The airplane was equipped with two pilot seats, both occupied, located in the cockpit and two observer seats, both unoccupied. The left observer seat was located directly behind the captain and the center line (CL) observer seat was stowed in the compartment just aft of the P-6 panel aft of the first officer seat.

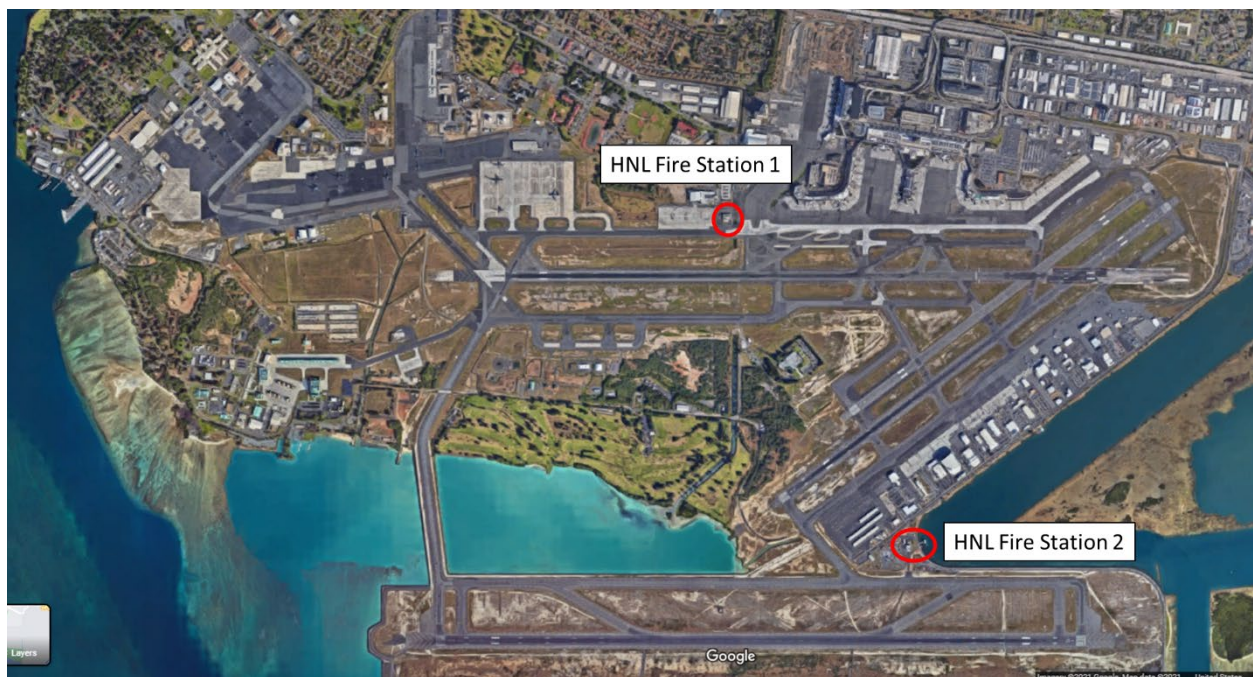
**Figure 12** Google earth view of Honolulu Airport fire station locations.

The HNL ARFF had two documents that served as guidance for personnel in the event of a water landing. The *Marine Incident Standard Operating Guideline* (SOG) dated December 7, 2012, and section 9 of HNL's Airport Emergency Plan (AEP) titled *Water Rescue Situations* dated June 13, 1997 (see attachments 1 and 2).

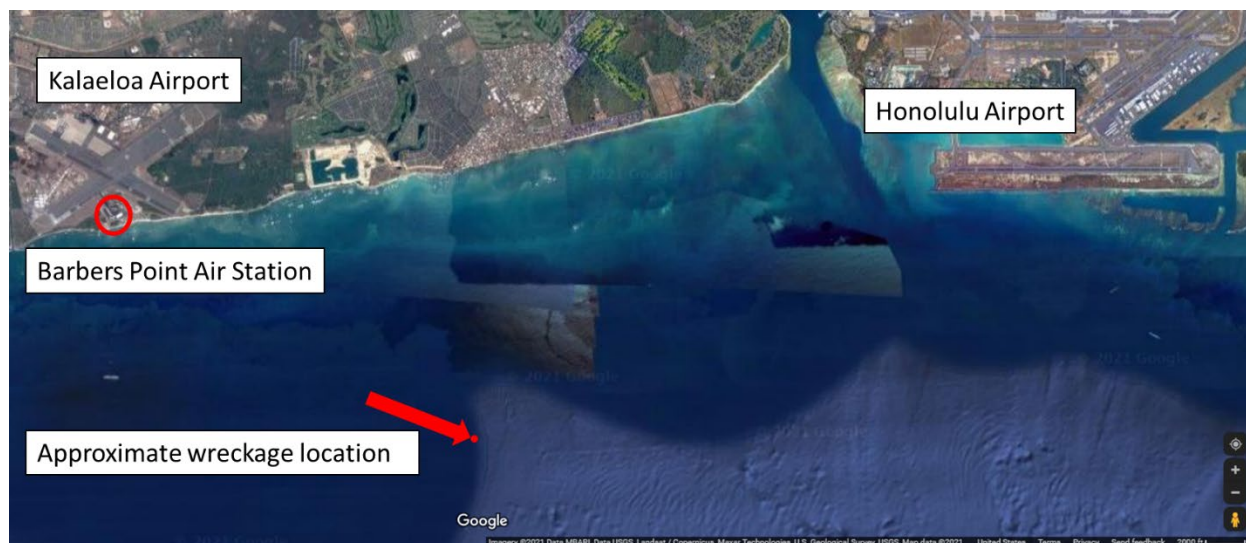
**Figure 13** Google earth view of wreckage, airports and USCG station location.

About 0147 JRCC notified HNL ARFF who estimated that it would be 20 minutes before their 32-foot rescue boat 1 could arrive on scene. About 0148 JRCC contacted USCG Air Station Barbers Point to request an MH-65 Dolphin. HNL ARFF launched the rescue boat about 0200. USCG 6544 took off about 0218 from Air Station Barbers Point. The station was approximately 2.8 miles northwest of the SARST coordinates.

About 0230 USCG 6544 located both survivors in the water floating near the ELT coordinates. About 0240 HNL ARFF rescue boat 1 arrived on scene, delayed by the high surf and low visibility. According to the SAR report, a rescue swimmer deployed from the helicopter and assisted the captain who was located on the airplane's tail. They were hoisted back to the helicopter together and then the rescue swimmer re-entered the water to assess the condition of the first officer. After evaluation the swimmer elected to swim the first officer on the floating debris to the HNL ARFF rescue boat about 0251. USCG 6544 departed the scene about 0259 and arrived at Queens Medical Center with the captain about 0305.
