## Summary

While taxiing in at KEWR aerodrome, on 31<sup>st</sup> December 2021, the A330-303 aircraft (TC-JOK, MSN: 1642) hit its winglet to the rudder of a United Airlines E170-100SE (N633RW, MSN: 54) aircraft which is being operated by Republic Airways. Flight crew weren't aware of the incident until ATC stated that they may have had an incident and advised to check the aircraft.

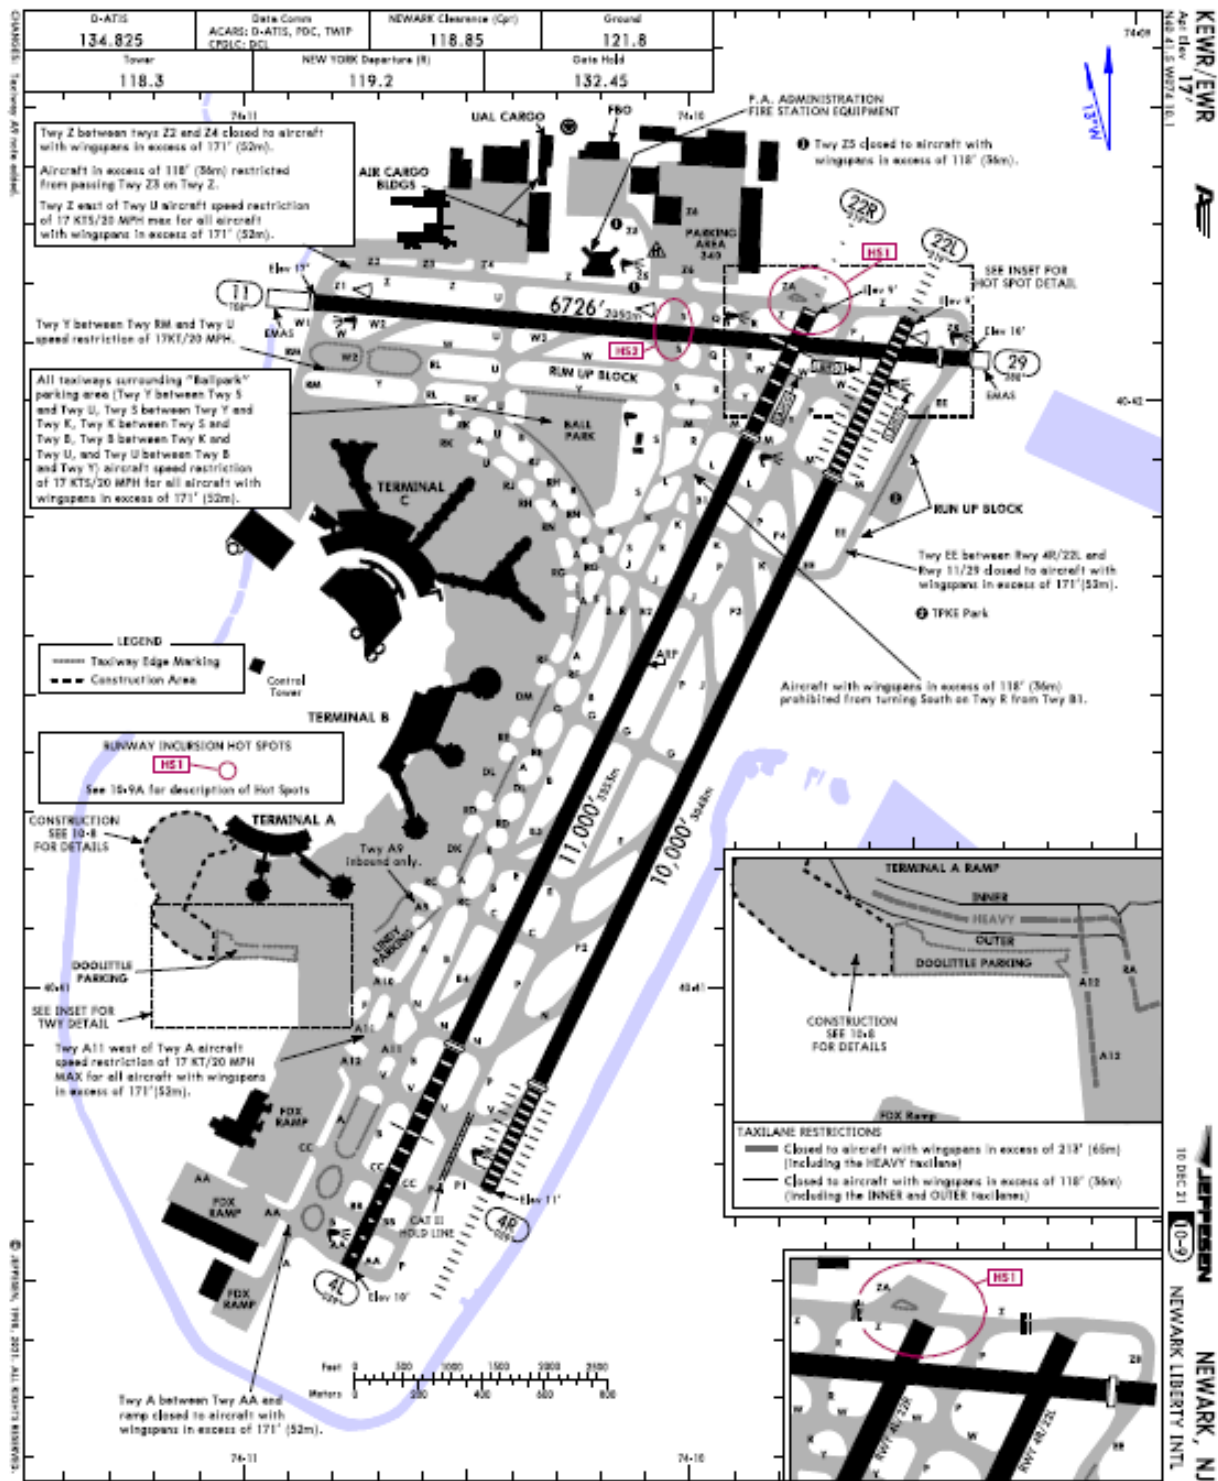
The chart below is the airport information chart which crew used for ground navigation.

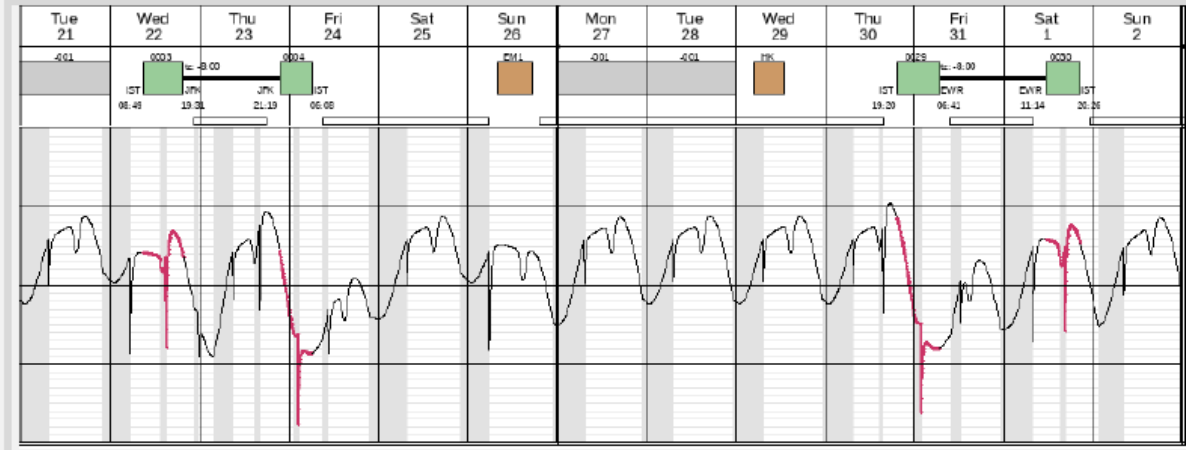
## 4. KÜMÜLATİF ZİNDELİK GRAFİĞİ / CUMULATIVE ALERTNESS GRAPH

The alertness level of the crew was analyzed by Fatigue Risk Management department. According to their evaluation any fatigue risk was not identified in terms of work load. Below are the duty details and cumulative alertness graphs of both flight crew. First graph is for CM1, second one is for CM2 and third one is for CM3. Detailed analysis forms are attached to assessment on AQD system.
