# National Transportation Safety Board

DCA22LA126

## **OPERATIONAL FACTORS/HUMAN PERFORMANCE**

Group Chairs' Factual Report

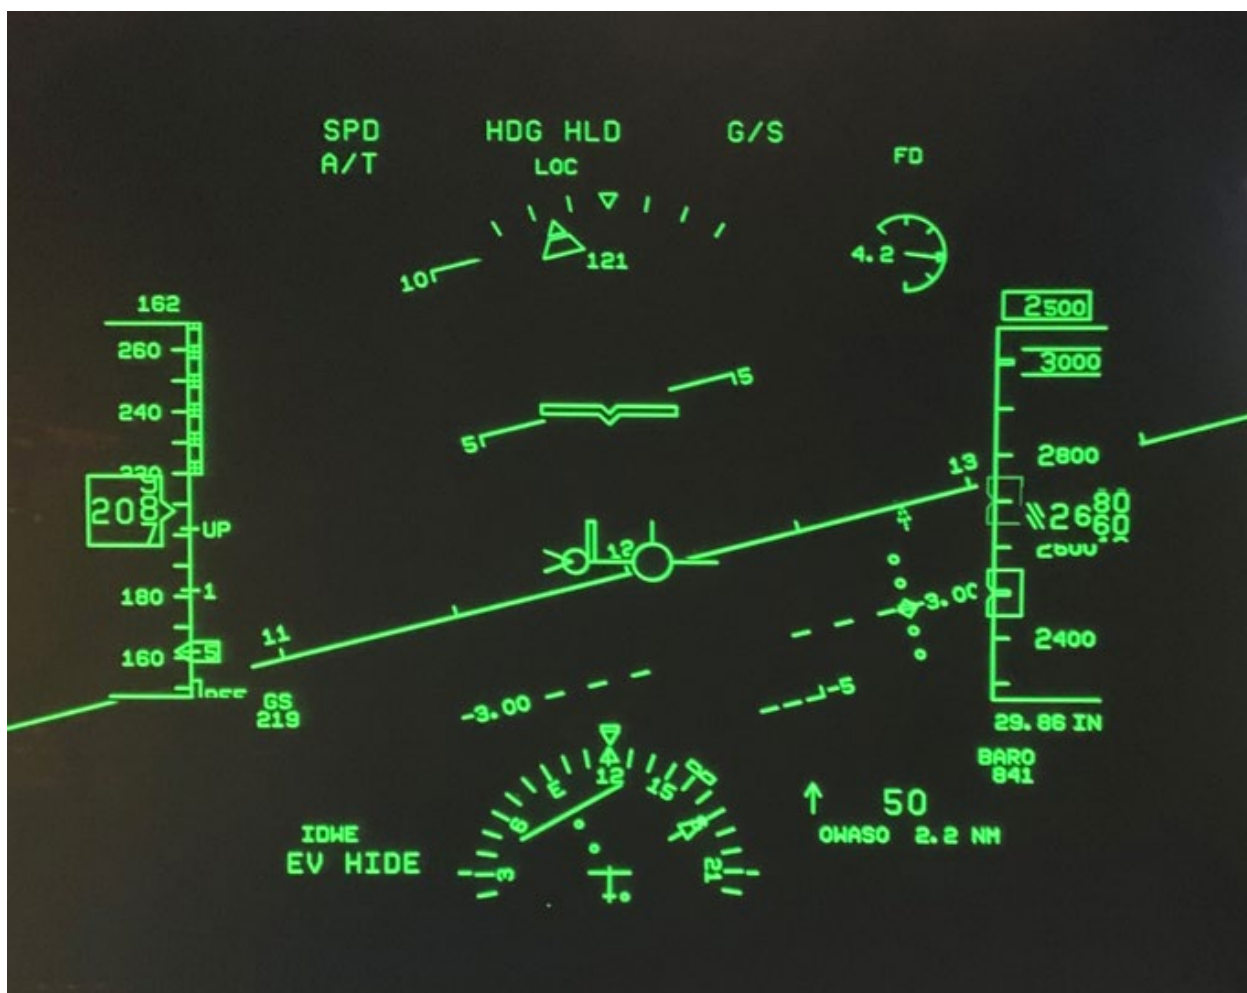
**Figure 8.** HUD display on simulator operator panel. (Source: NTSB)

Figure 8 shows the HUD display from the operator's panel in a FedEx B-757 simulator. The depiction was consistent with that shown on the captain's HUD in the simulator. The image in figure 8 was taken while the simulator was in right turn from base to final for runway 18R. The identifier IDWE located in the lower left side of the display is associated with the identifier for the runway 18L localizer. The course deviation indicator for the localizer is on the left side of the horizontal situation indicator at the bottom of the display.
