# National Transportation Safety Board

DCA23FA339

Group Chair's Factual Report

Location: Charlotte, NC  
Date: June 28, 2023  
Time: 08:52 EDT  
12:52 UTC  
Airplane: Boeing 717-200, N955AT

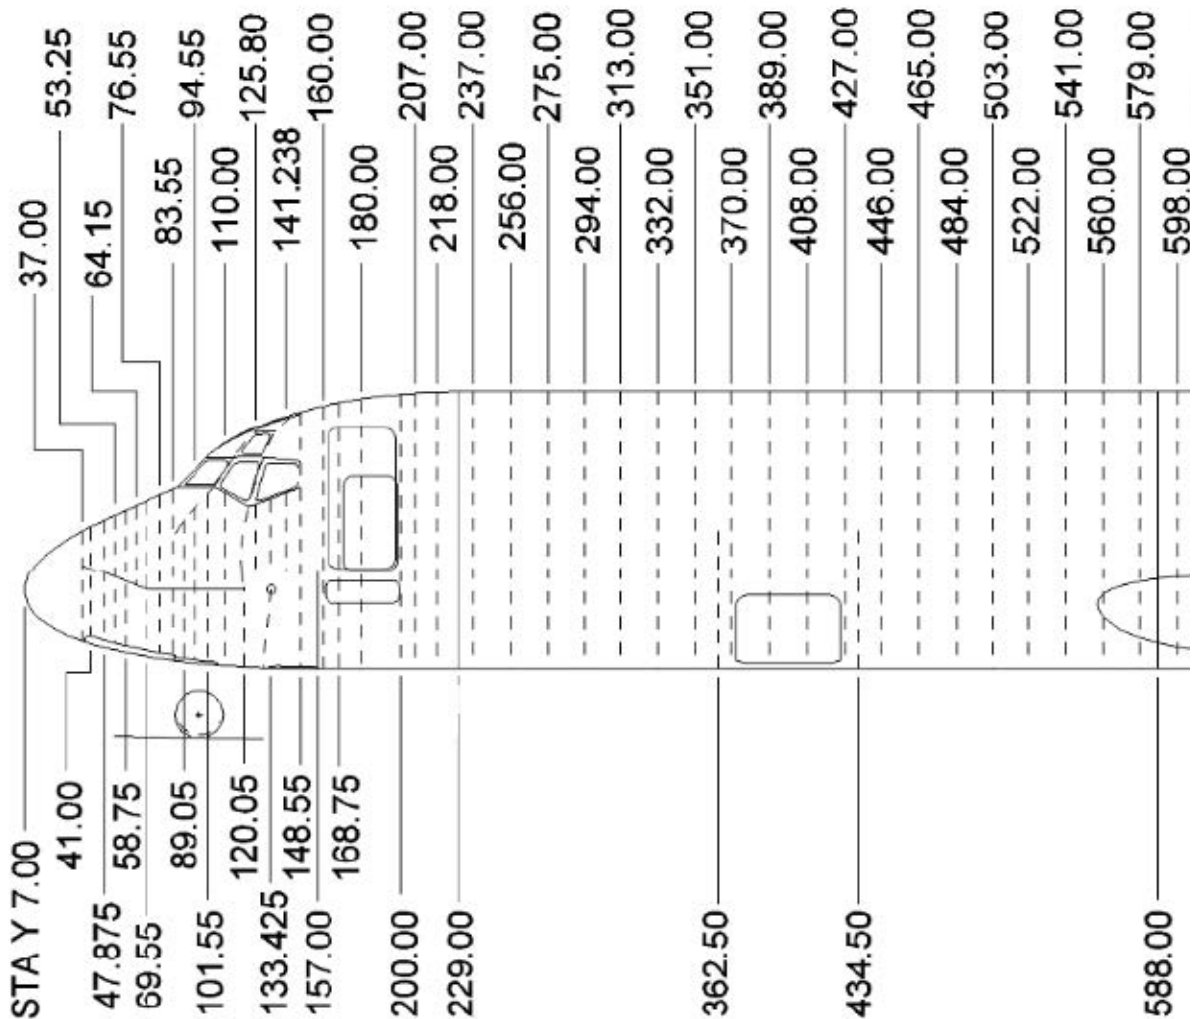
**Figure 5:** Boeing 717 fuselage station reference diagram. (Copyright Boeing. Used with permission.)

See Figure 5 for a fuselage station (FS) reference diagram to assist with the following damage description. The lower fuselage skin and lower fuselage doors from about FS 68 to FS 180 exhibited heavy abrasion damage from contact with the runway (see Figure 6). At FS 180 there was a slight buckle observed in the skin on the bottom side of the fuselage. The electronics bay door and the forward and aft nose landing gear doors were significantly damaged; however, as noted later in this report, still functioned normally. In addition, the Air Traffic Control 1 antenna located at FS 170, Marker Beacon antenna located at FS 190, drain mast located at FS 218, and Very High Frequency 1 antenna located at FS 294 all demonstrated damage consistent with the nose gear up landing.
