# National Transportation Safety Board

DCA23FA339

## **MATERIALS LABORATORY**

Factual Report 23-069

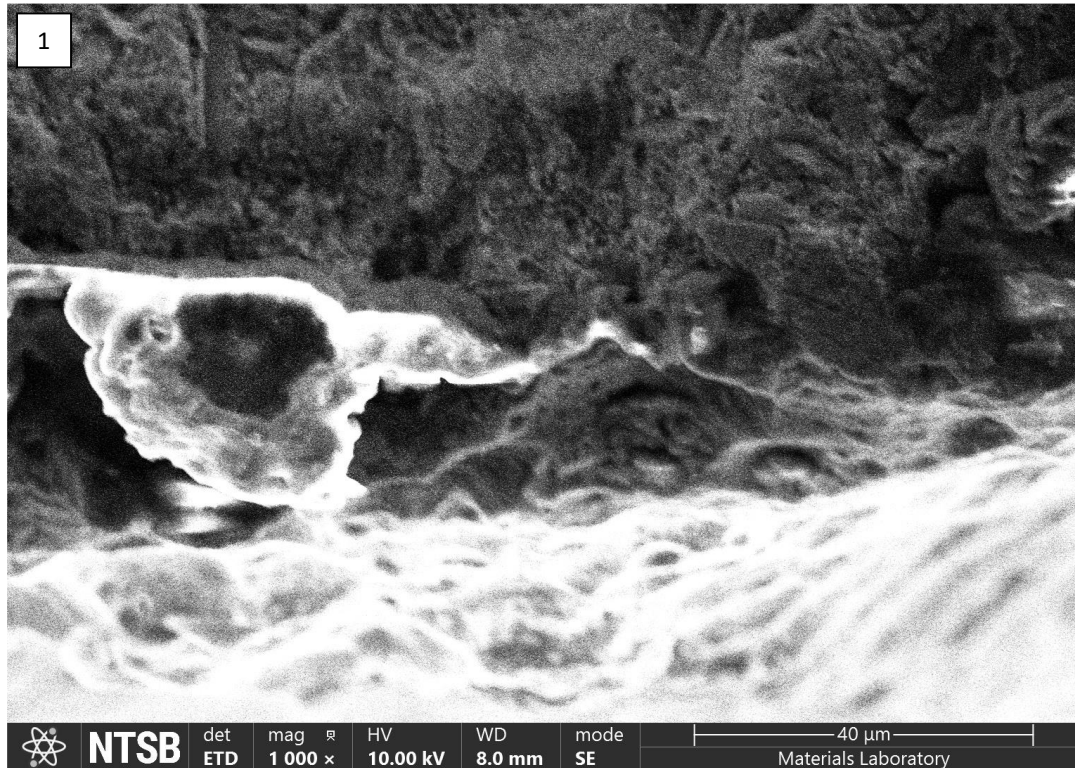
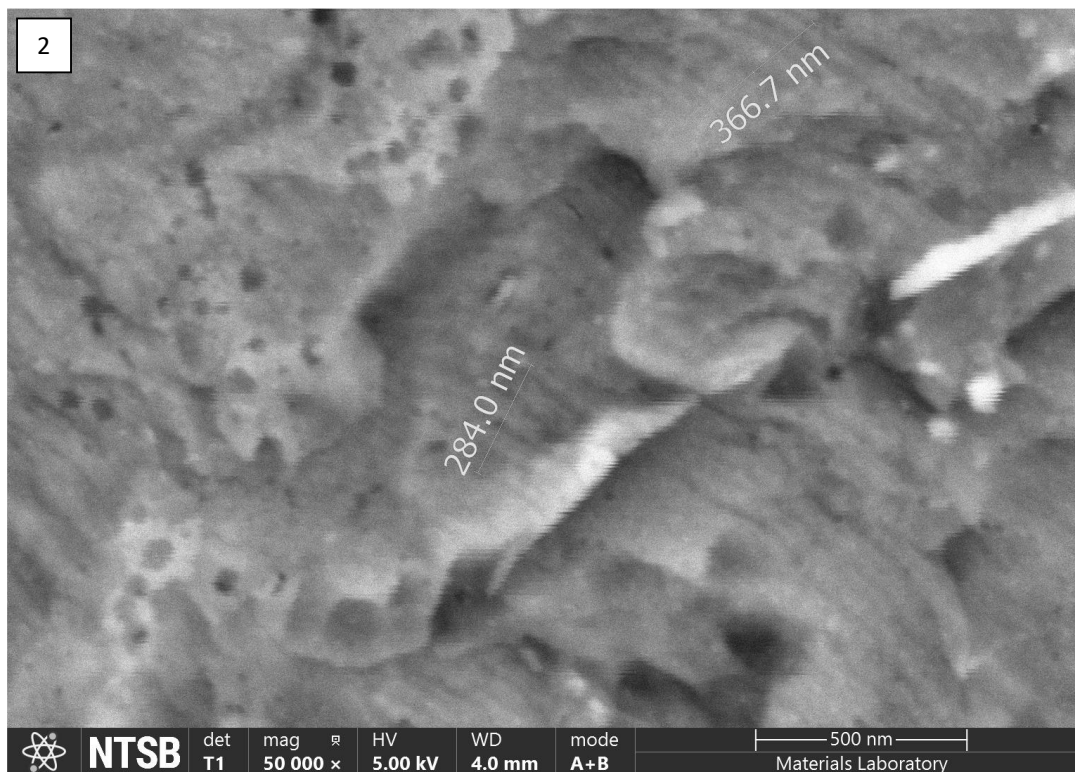
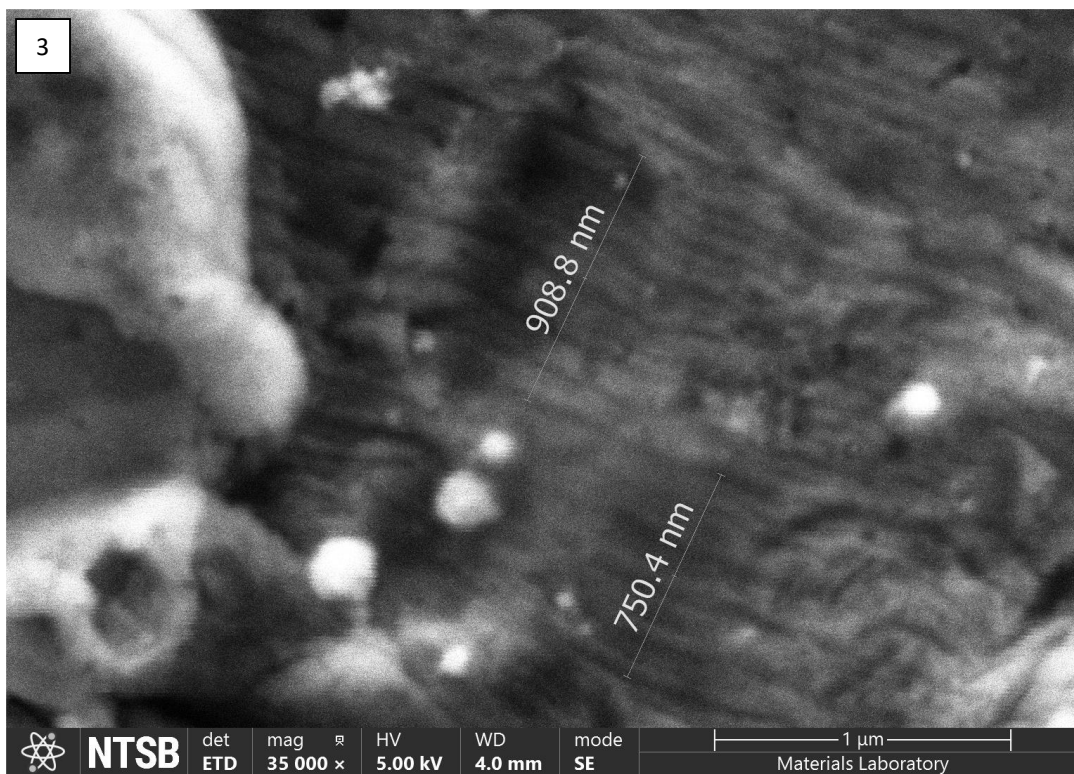
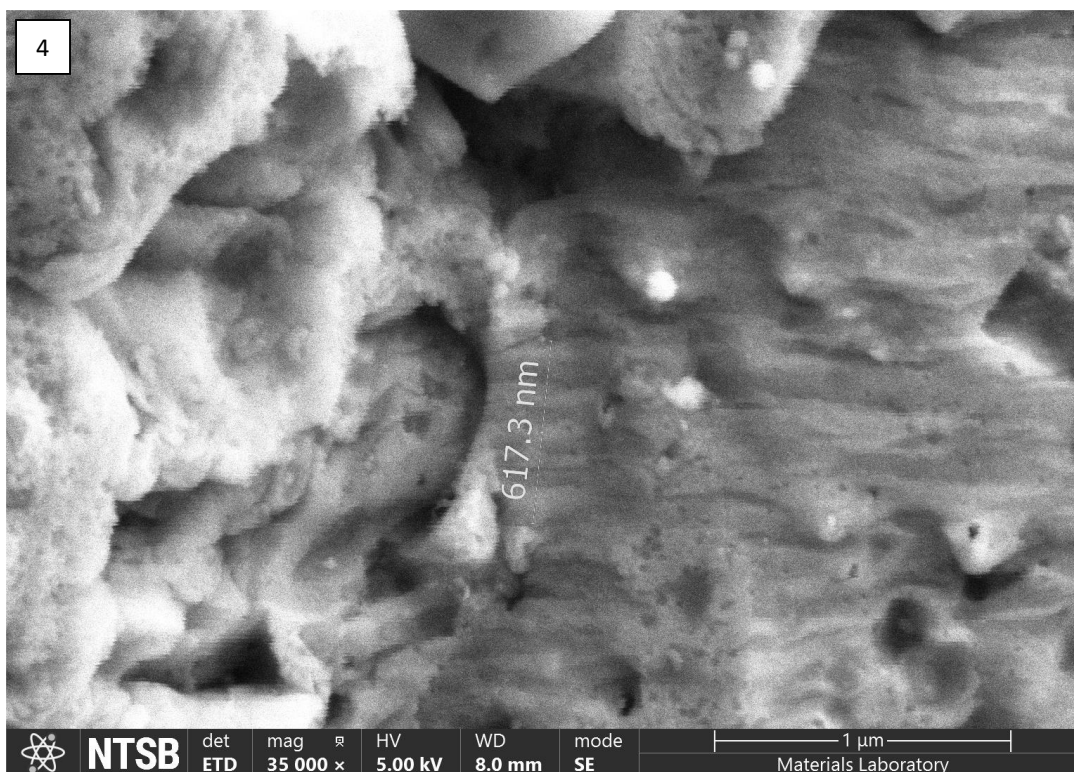
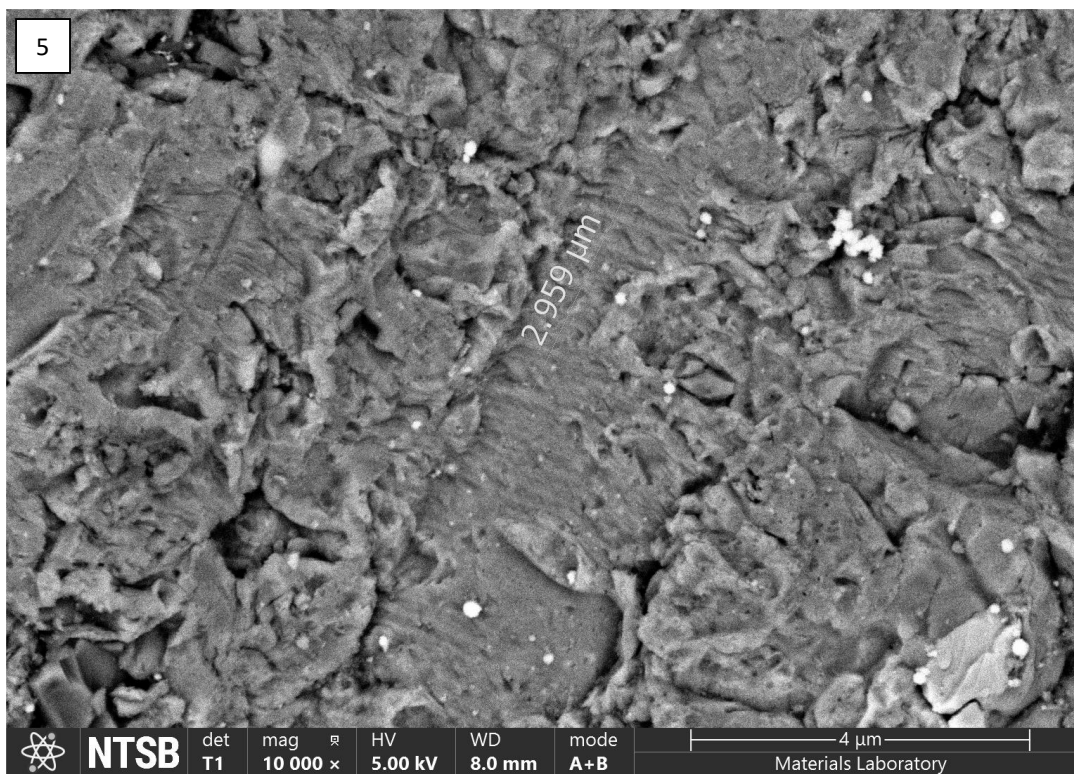
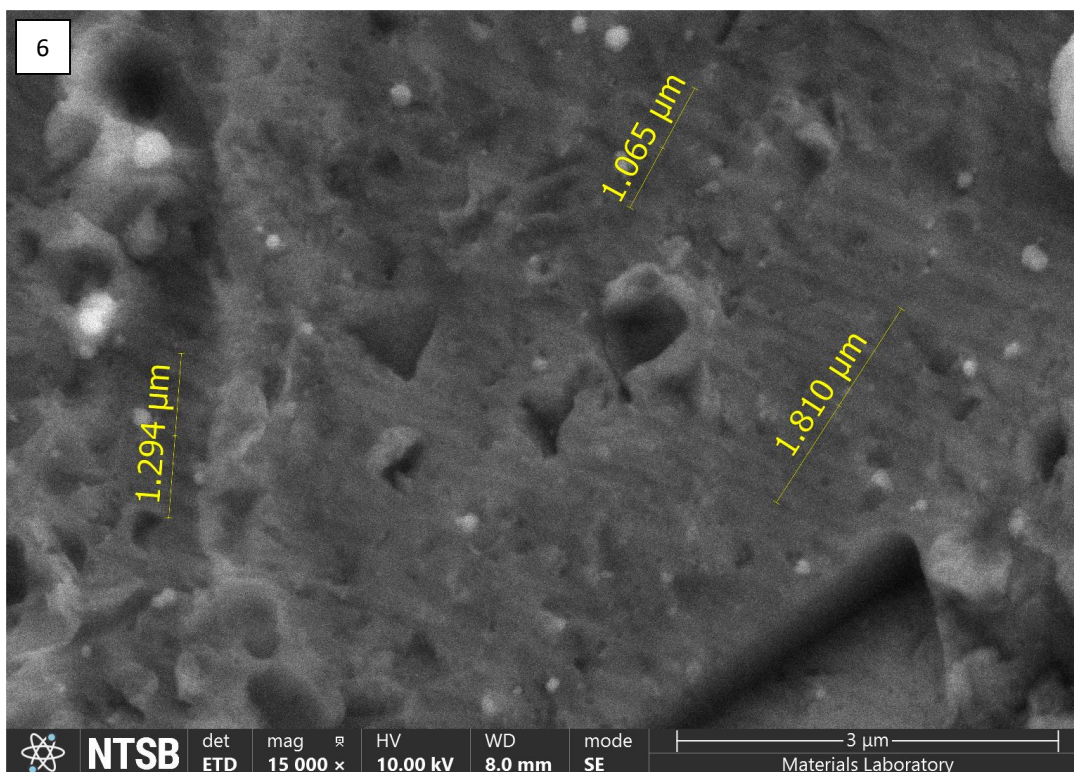
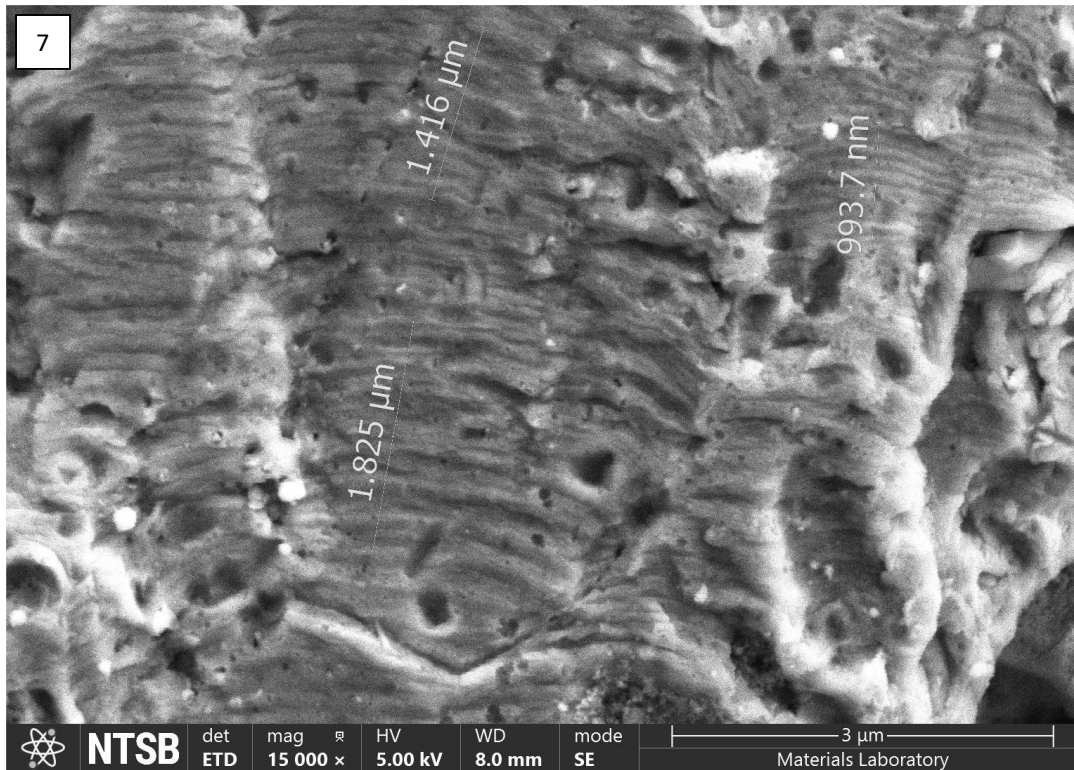
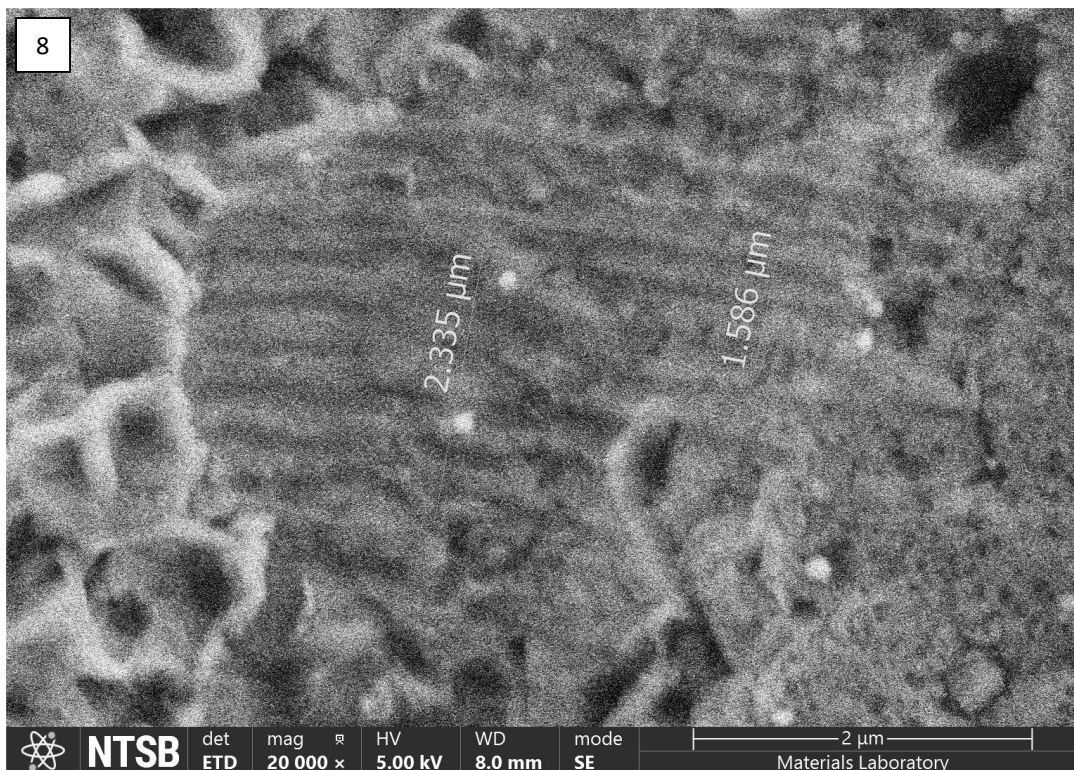
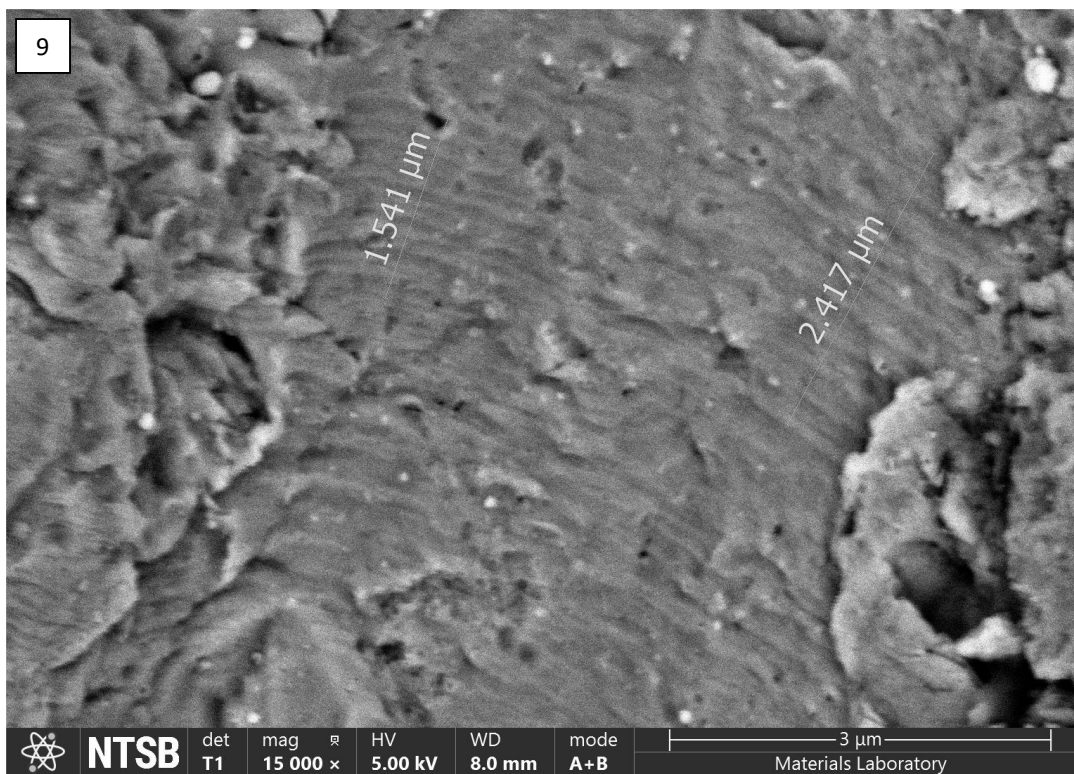
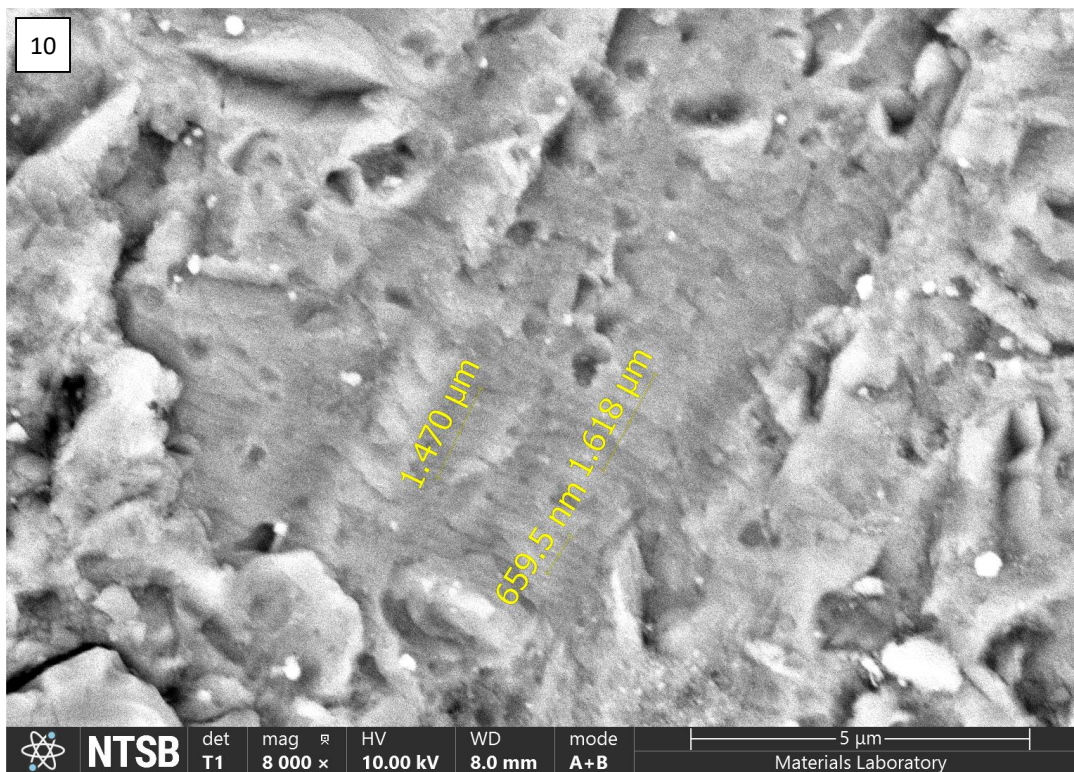
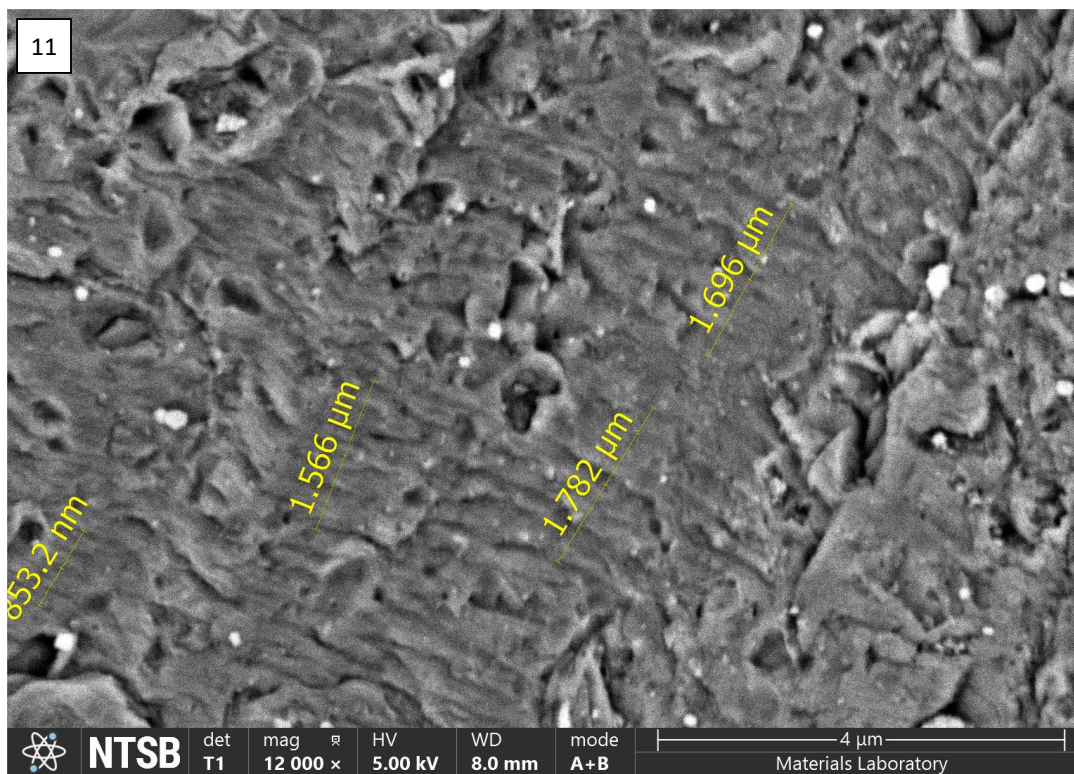
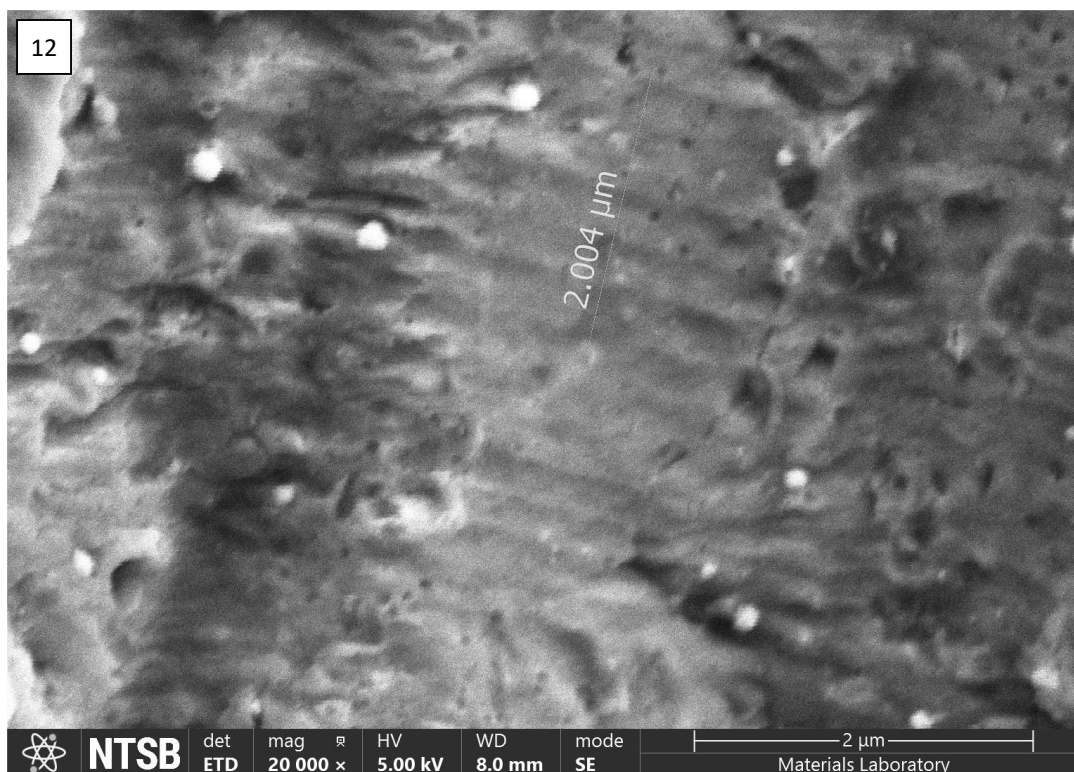
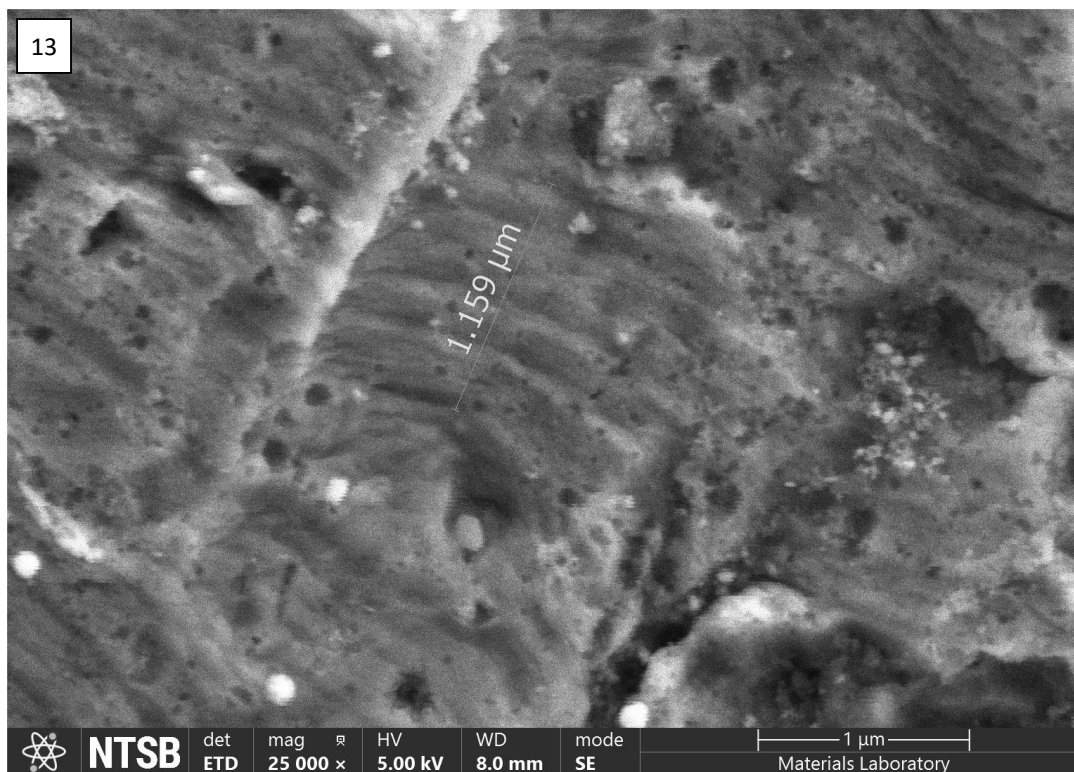
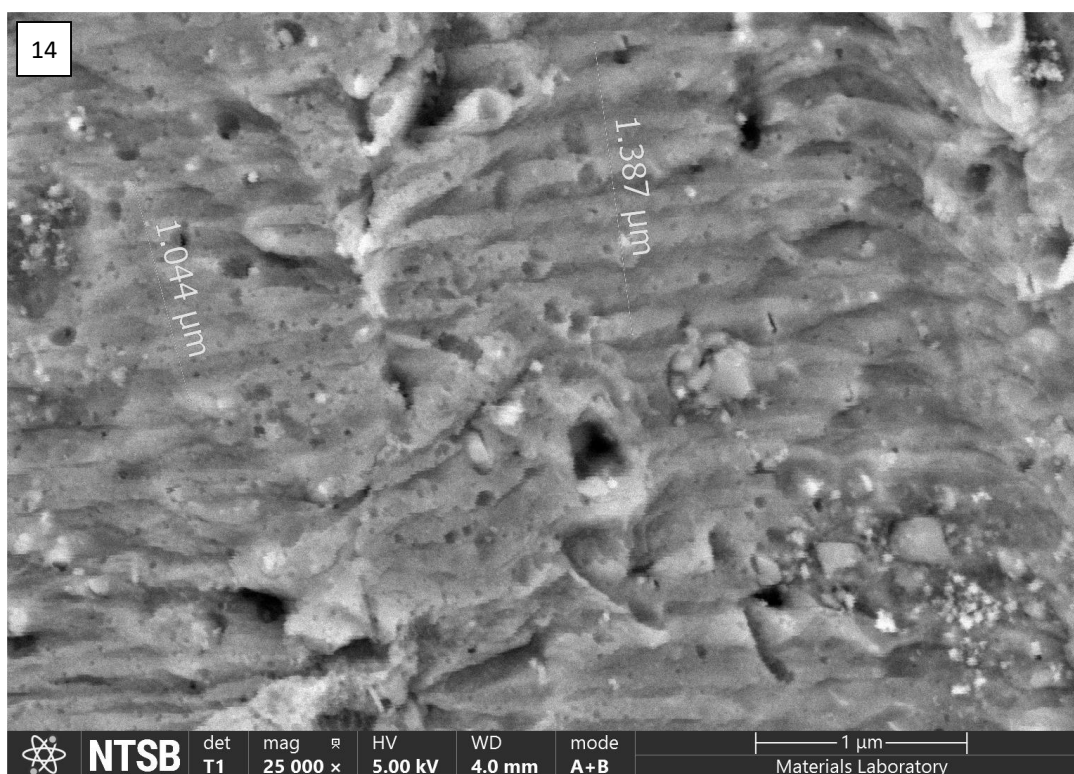
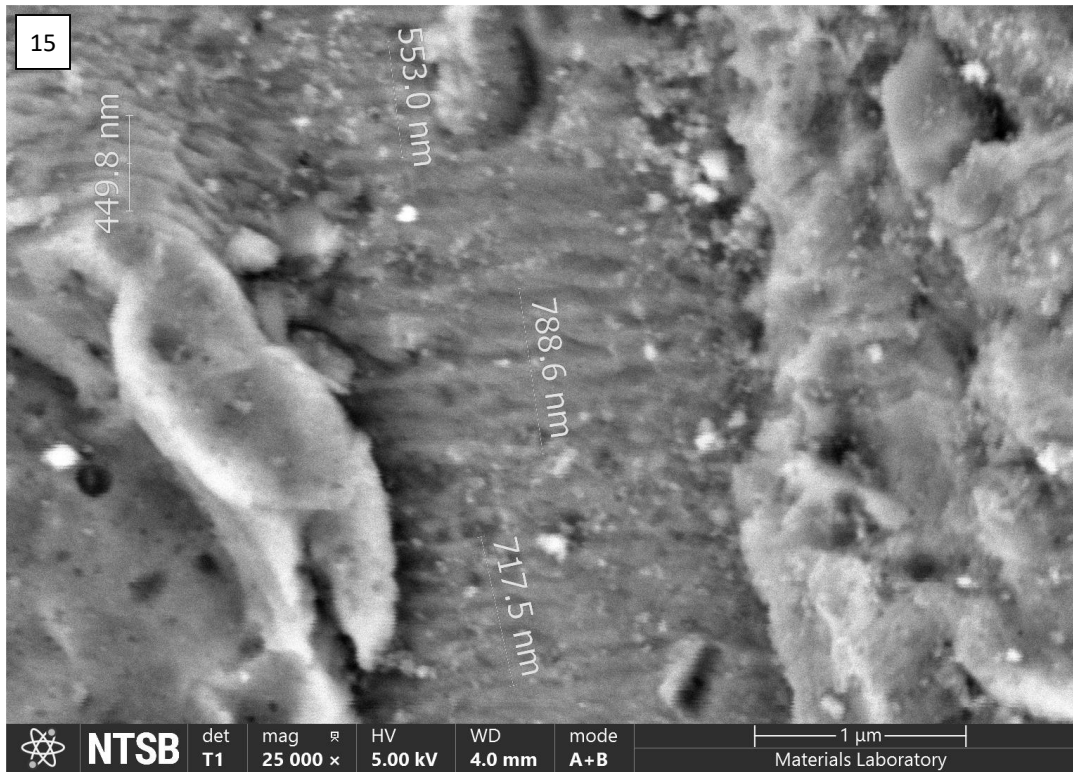
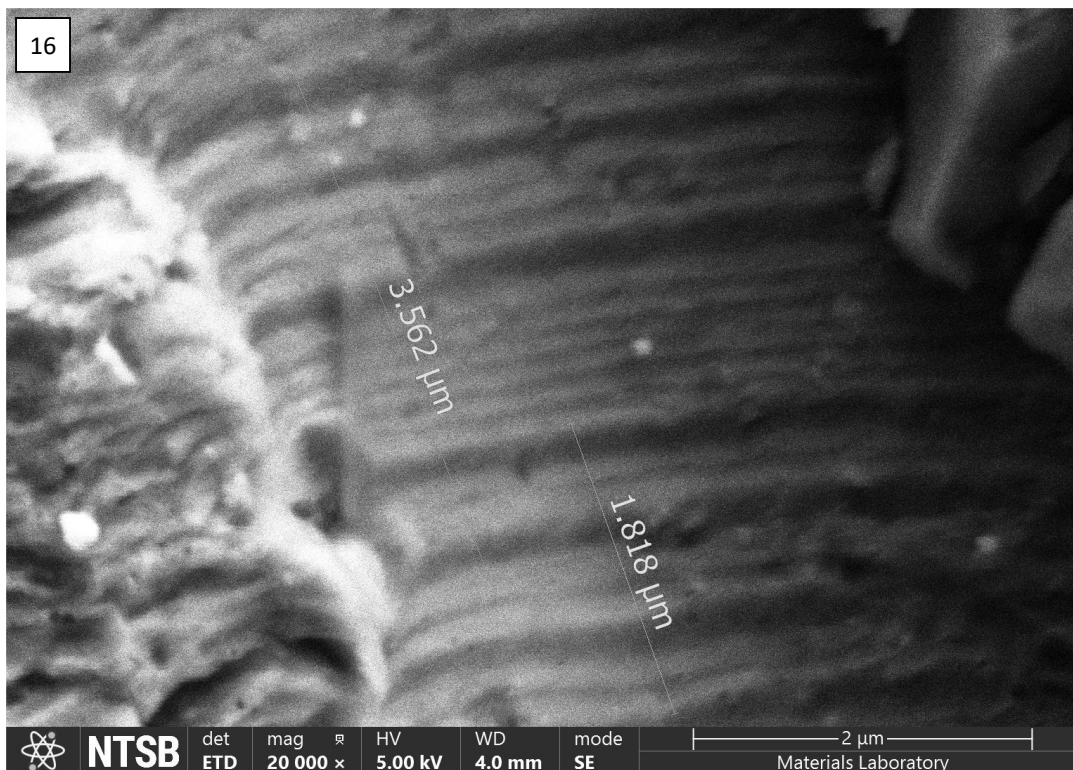
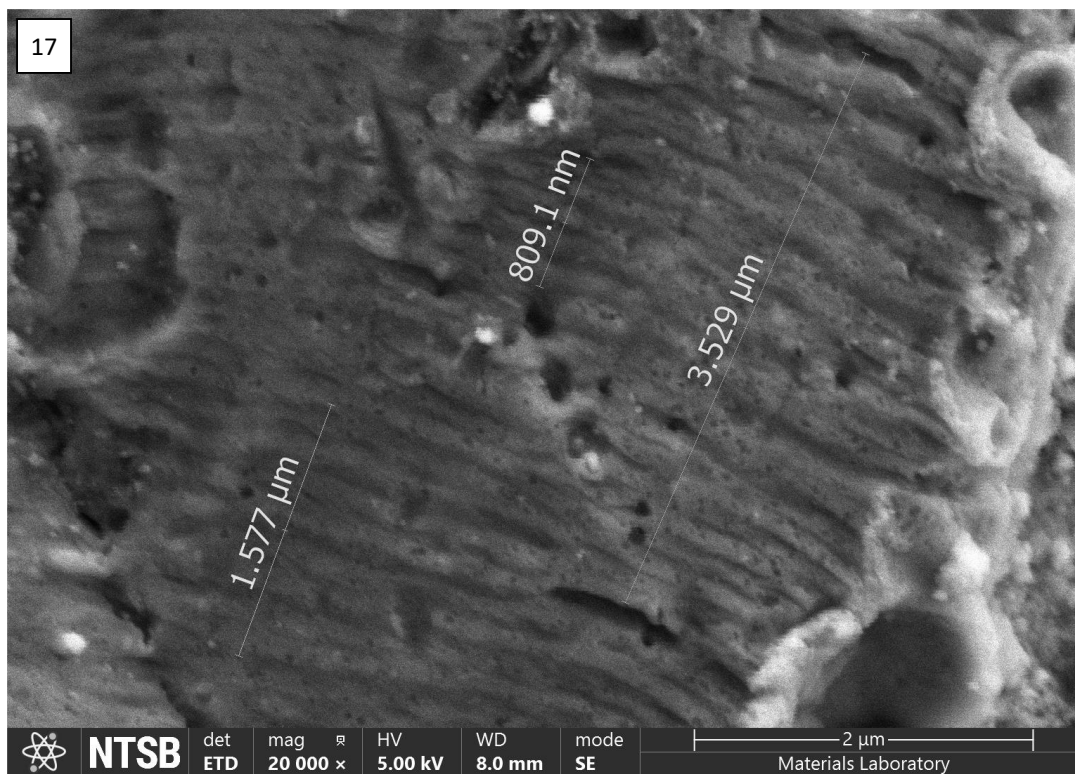
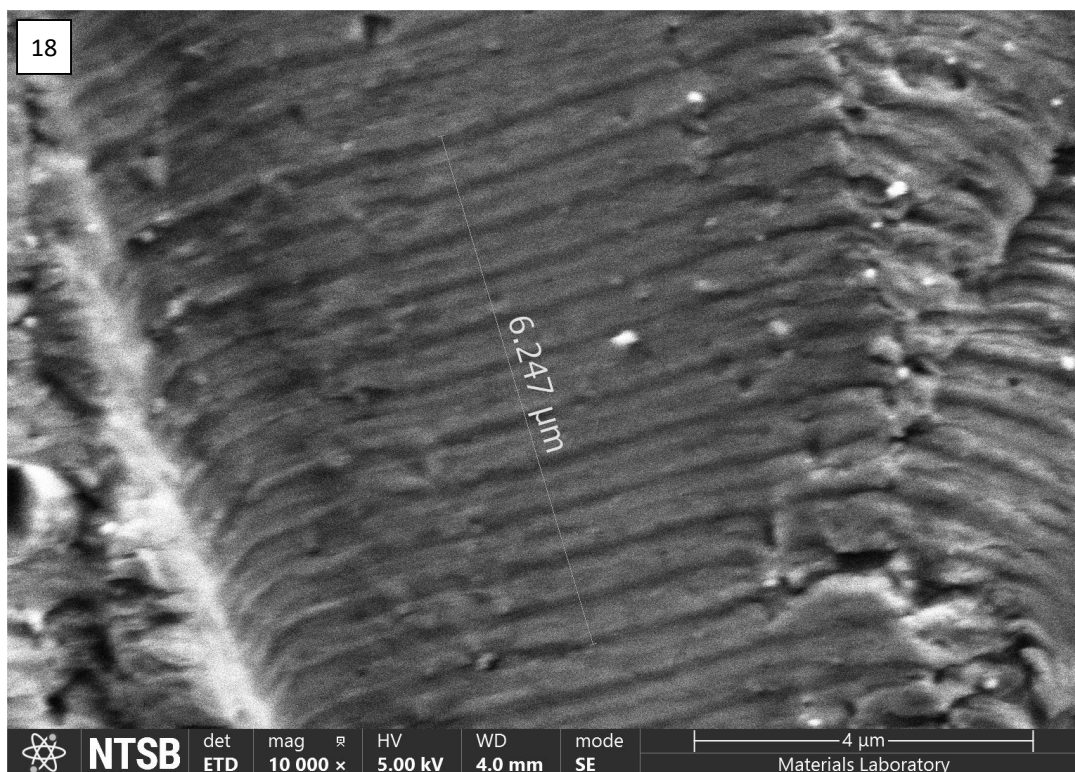
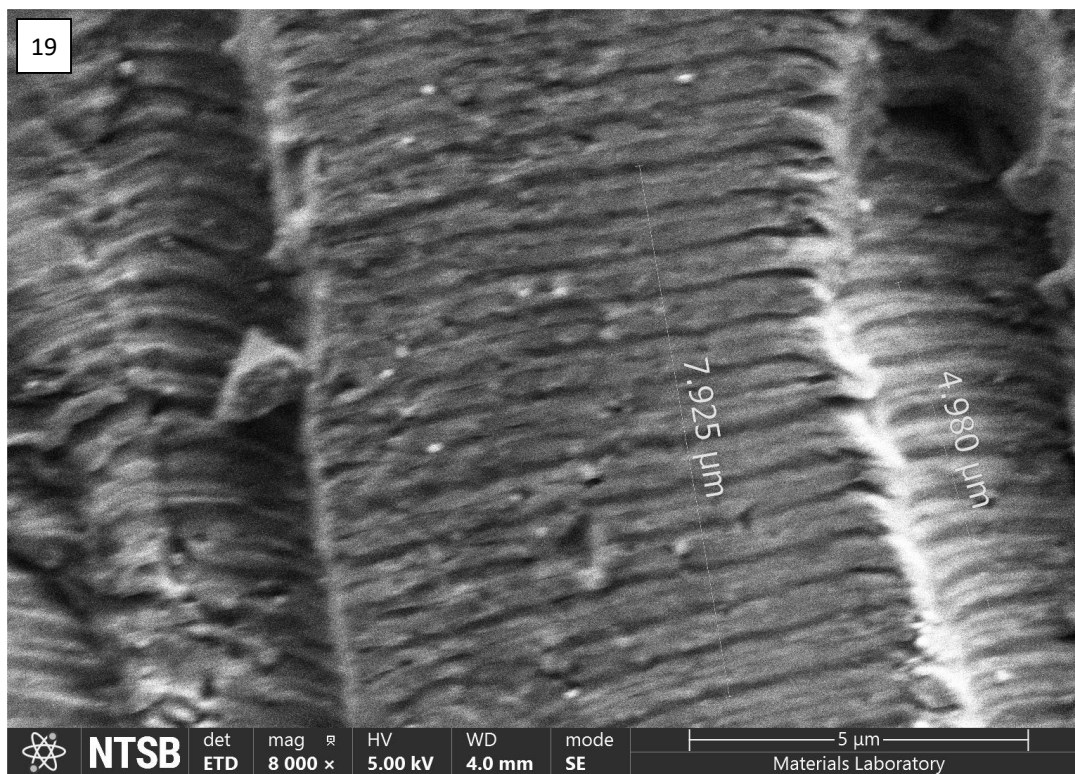
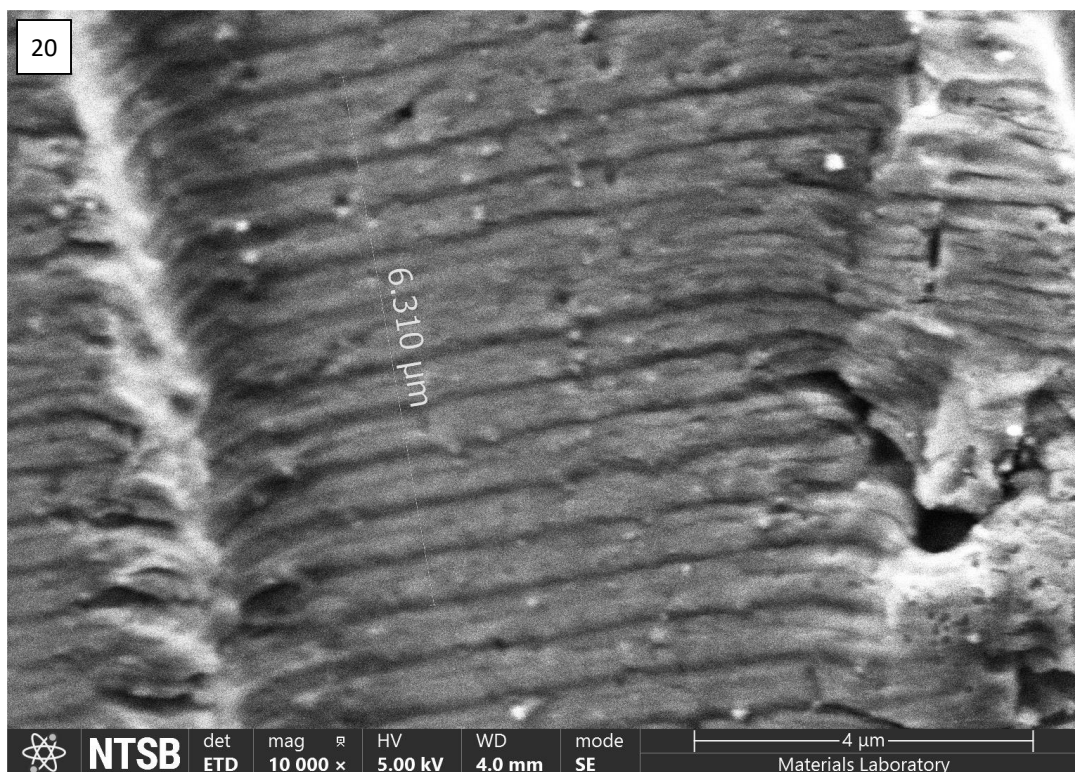
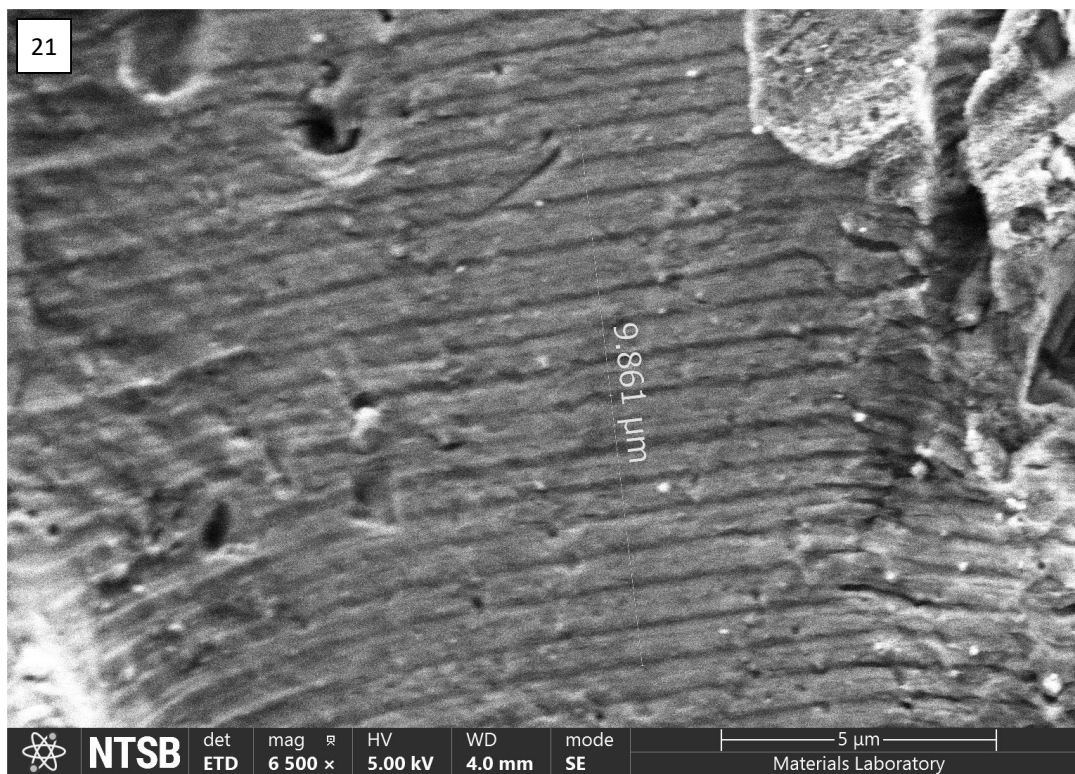
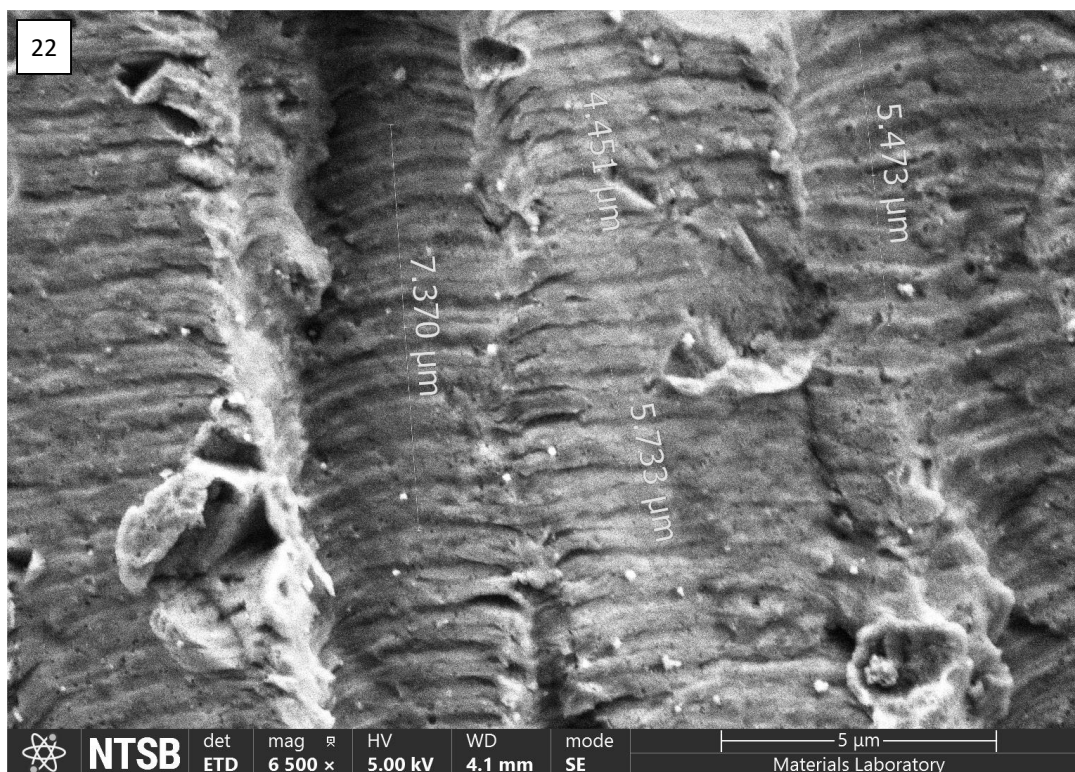
A quantitative crack growth rate analysis was performed over the fatigue crack fracture surface to estimate the number of cycles to failure. The fracture surface was cleaned progressively using a combination of solvents with ultrasonic agitation followed by a heated Chromic/Phosphoric acid solution soak. A series of 35 locations, progressing along the crack depth direction, were imaged using the SEM and stage positions were recorded to correlate crack growth rate and crack depth. Prominent fatigue striations were counted and averaged along these increments with minor striations excluded from this analysis. Fatigue striations were not resolvable within 0.043 inch of the fracture origin and the maximum fatigue crack depth was measured to be 0.417 inch. The estimated number of major fatigue striations was calculated to be 39,059. According to maintenance records, the upper lock link component had accumulated 41,257 flight cycles. Boeing engineers indicated that the lock link component experiences 2 major loads and several minor loads per flight cycle (extension and retraction of the nose landing gear), with the extension load being greater due to the gravitational force. Table I summarizes the result of the striation count exercise and representative SEM fractographs are contained in Appendix A.

Supplemental SEM fractographs for crack growth rate analysis, reference Table I.
