# National Transportation Safety Board

DCA23FA417

## **STRUCTURES**

Group Chairman's Factual Report

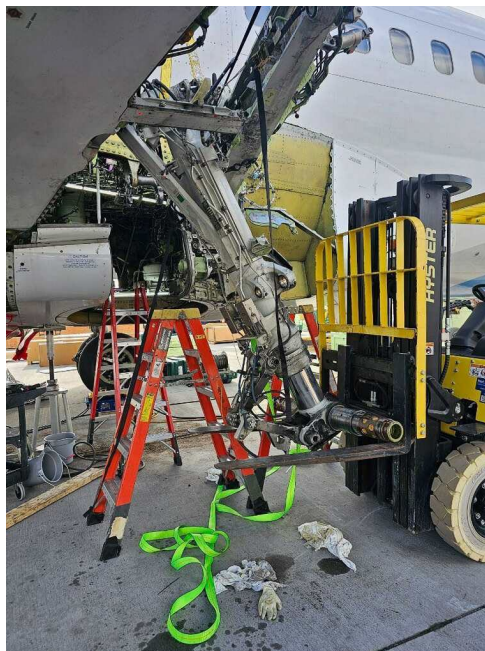
On November 29, 2023, Alaska Airlines maintenance personnel and Boeing AOG (Aircraft On Ground) personnel removed the MLG strut from the airframe (figure 12).

**Figure 12.** Removal of the left main landing gear from the airplane wing. (Source: Alaska Airlines)
