# National Transportation Safety Board

DCA23FA428

## **AIR TRAFFIC CONTROL**

Group Chair's Factual Report

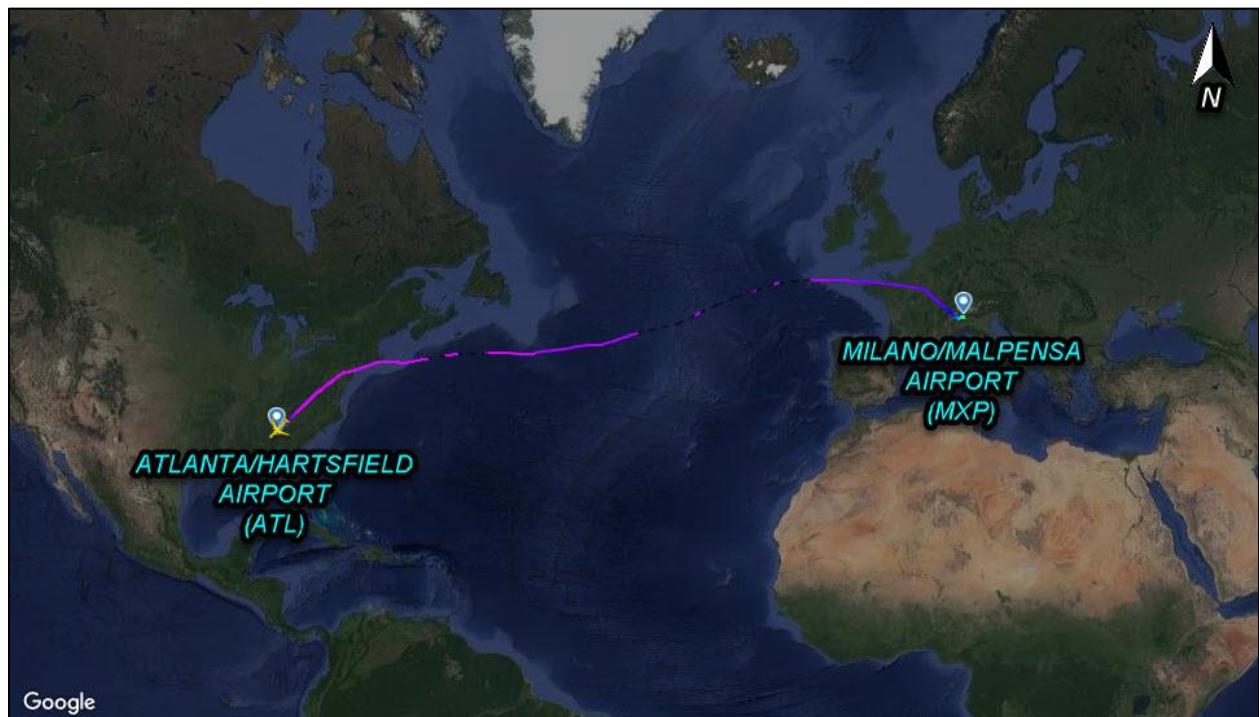
**Figure 1.** Overview of the entire accident flight track of DAL175 with point of origin and destination depicted and overlaid onto satellite imagery.

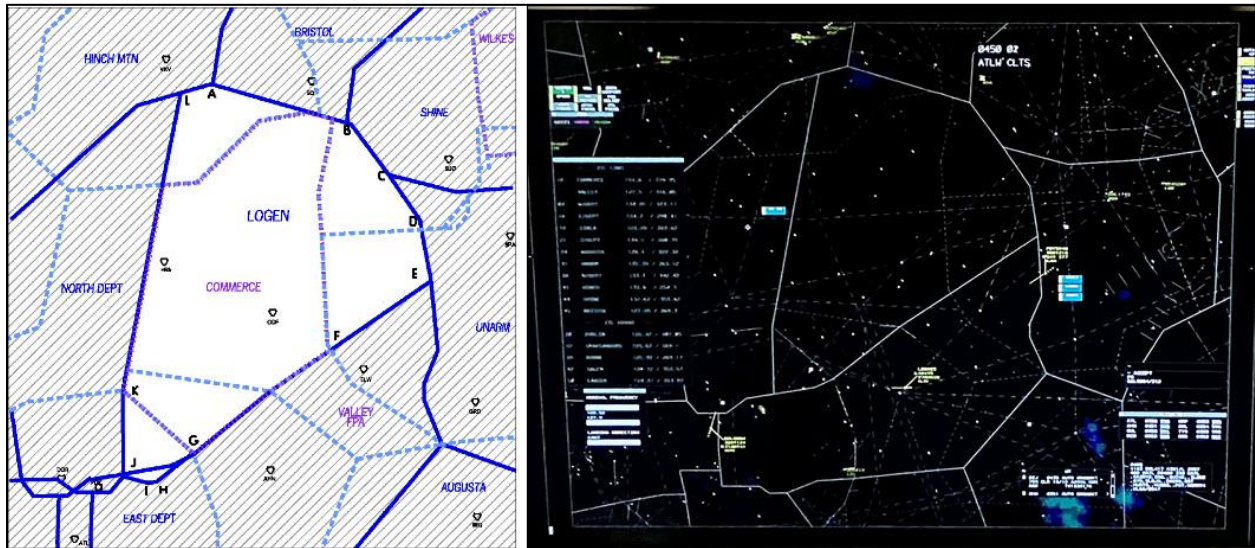
The Logen Radar (R49) sector was the involved sector which, according to ZTL Order 7230.2Q, was located within area of specialization 3. The Logen sector was a low sector with altitude limits from 15,000 feet to FL 230 for the airspace overlying A80-Atlanta sector, from 13,000 feet to FL 230 for the airspace overlying Knoxville ATCT (TYS), and 11,000 feet to FL 230 for the remaining airspace. Logen is an inbound sector for Atlanta Terminal area arrivals from the northeast and is responsible for final spacing of aircraft to A80. Figure 5 in Section F shows the Logen sector's area of responsibility as outlined in ZTL Order 7230.2Q on the left, and a photograph of the corresponding R49 controller workstation on the right.

**Figure 5.** Side-by-side view of the Logen sector area diagram (left) and corresponding photograph of the Logen sector controller's radar display (right).
