# National Transportation Safety Board

DCA24LA034

## **OPERATIONAL FACTORS/HUMAN PERFORMANCE**

Night Ground Handling Observation at Kahului Airport

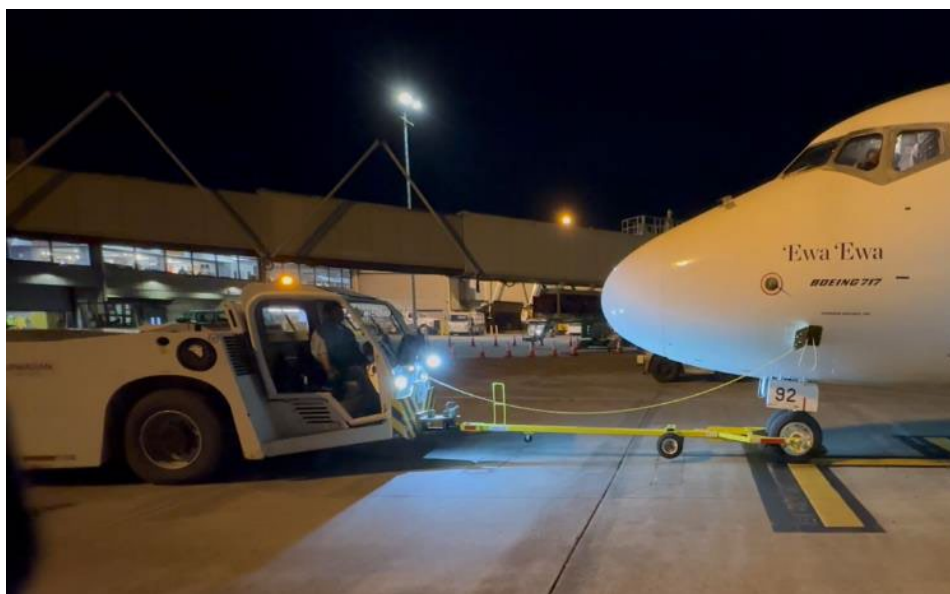
**Figure 4: Tug connected to airplane by towbar and communications cable.**

A ramp agent connected a towbar between the front of the tug and the nose gear of the airplane. The ramp agent connected opposite ends of a communication cable between the tug and a panel on the left lower left side of the airplane's nose. A dome light inside the cockpit of the airplane was selected ON.

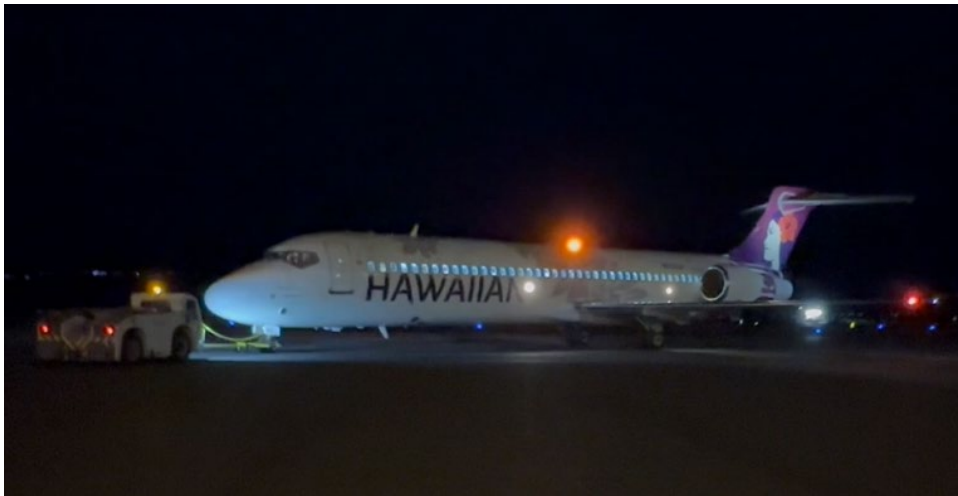
**Figure 5: Exemplar B717 exterior lighting during pushback.**

Red and green navigation lights were illuminated on the airplane's left and right wingtips, respectively. Amber anticollision beacons were flashing on the top and

bottom of its fuselage. Logo lights illuminated the airline logo on the sides of the tail of the airplane. Lights on top of each wing illuminated the sides of the fuselage.

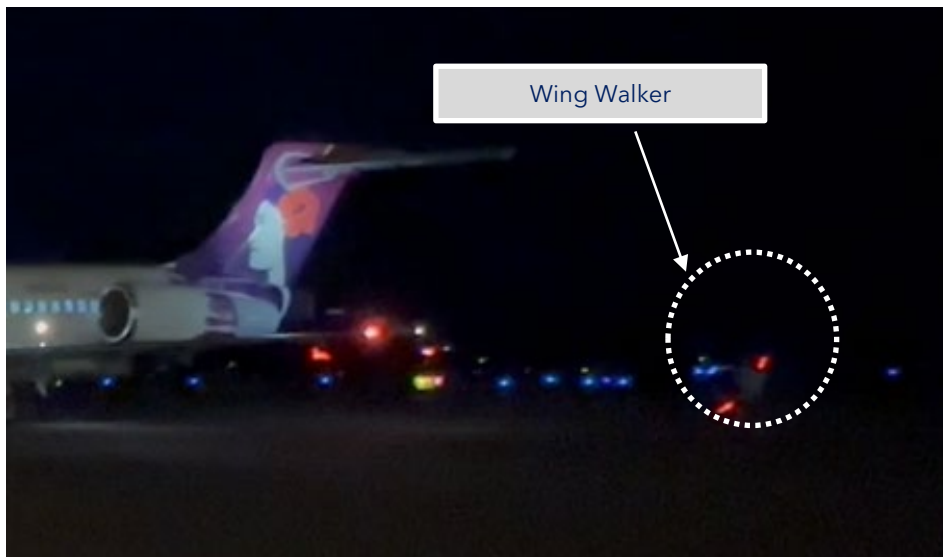
**Figure 6: Wing walker using lighted wands.**

A ramp agent positioned himself near each wingtip to serve as a “wing walkers.” Each carried a pair of lighted wands.

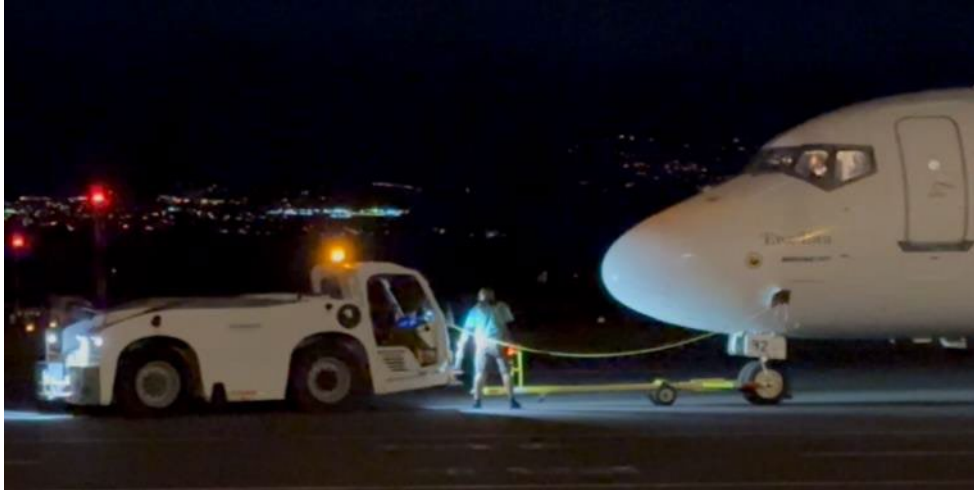
**Figure 7: Escort disconnecting towbar from tug.**

When the tug driver finished pushing the airplane back, the wing walker on the airplane’s left side (captain’s side) walked toward the nose of the airplane, transitioned to the role of “escort”, and disconnected the towbar from the tug while the wing walker on the right side walked to the nose of the airplane, around the front of the tug, and then walked back to the gate area.

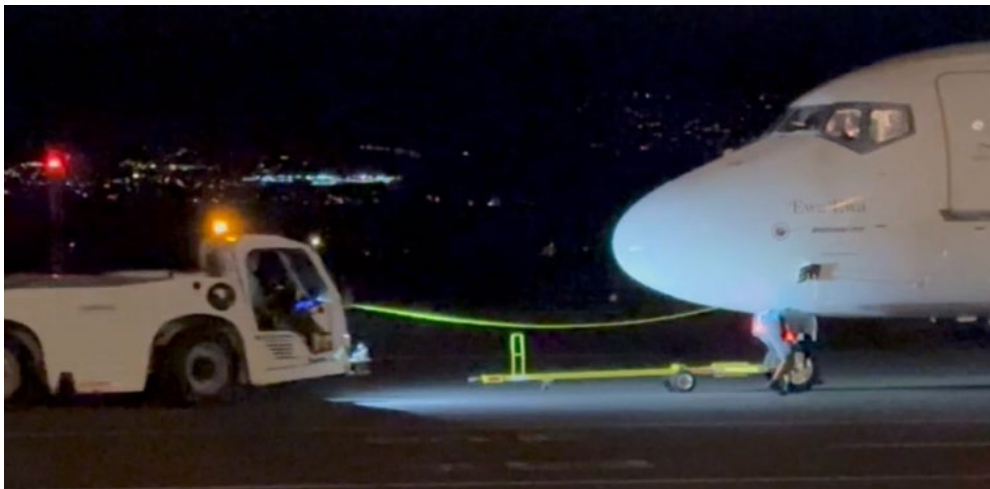
**Figure 8: Escort disconnecting towbar from airplane.**

The tug driver backed the tug up about 3-5 ft while the escort disconnected the towbar from the nose gear of the airplane.

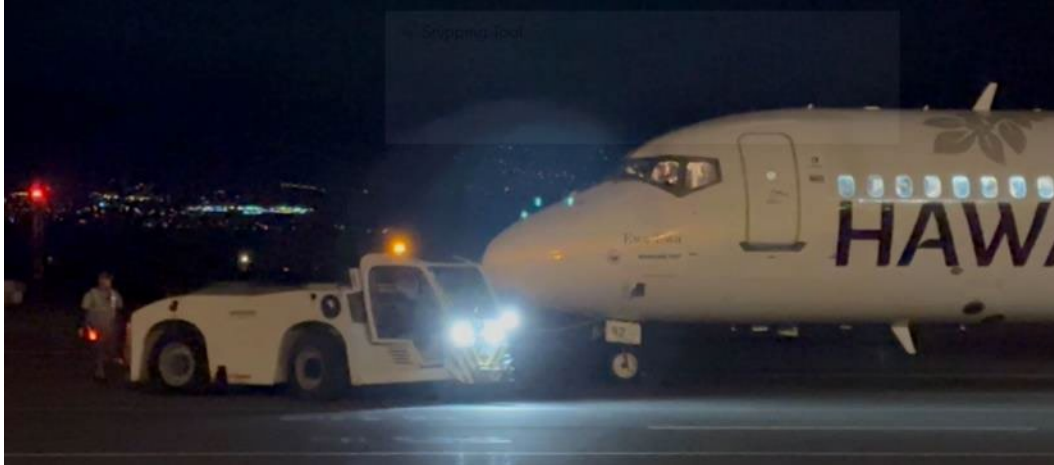
**Figure 9: Tug repositioned on the left side of the cockpit.**

The tug driver then backed up a few more ft before driving the tug forward and to the right, positioning it near the captain's side of the airplane, close to the nose of the airplane. The escort connected the towbar to the rear of the tug. The rotating amber beacon on the roof of the tug continued flashing.

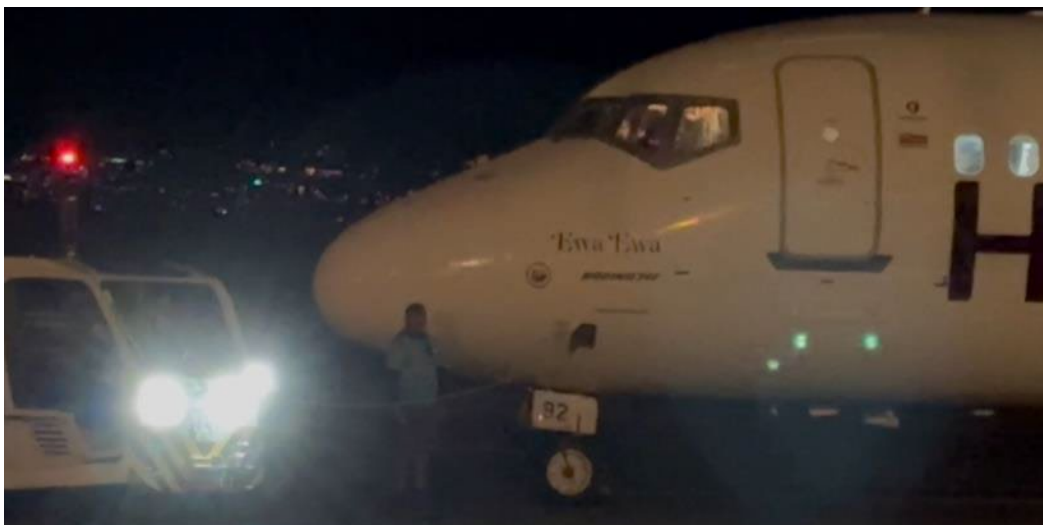
**Figure 10: Escort awaiting signal from flight crew via tug driver.**

The escort positioned himself below the cockpit in front of the nose gear and monitored the tug driver.

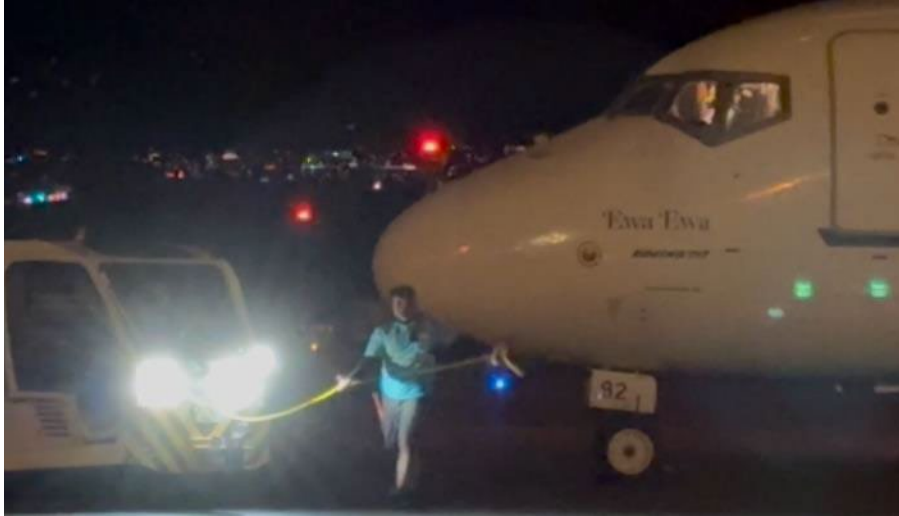
**Figure 11: Escort disconnecting communication cable.**

The ramp agent appeared to acknowledge the tug driver with his hand, then removed the nosewheel bypass pin from the nose gear and the communication cable from the side of the fuselage. The escort coiled the cable in his hands and placed it in the tug cab on the passenger side.

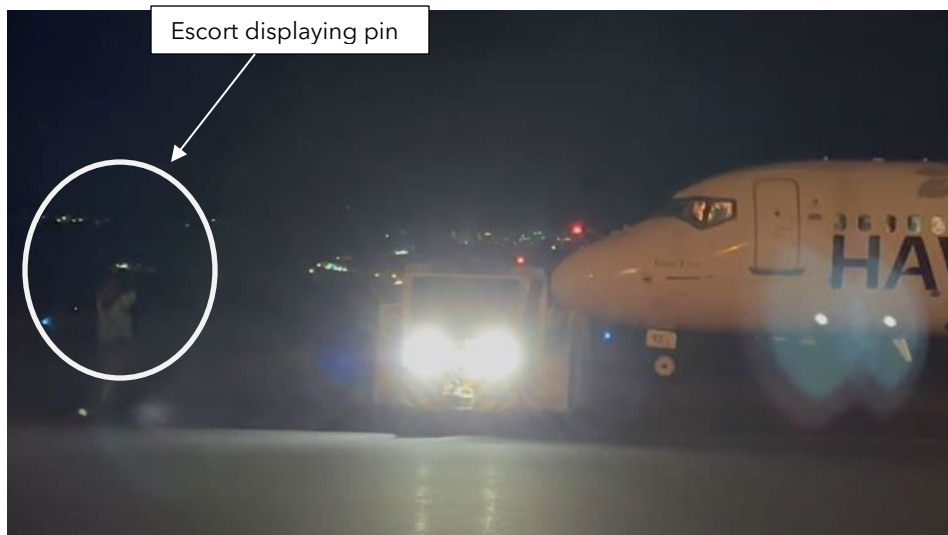
**Figure 12: Escort displaying pin to flight crew as tug departs the area.**

The tug driver drove back to the ramp area as the tug's amber beacon continued to flash. The ramp agent walked about 40 ft from the cockpit and 45 degrees left of center from the captain's point of view, and turned the wand he was holding to flashlight mode. He then faced the cockpit with his arms held straight overhead with the nose pin ribbon and flashlight in his hands and the flashlight illuminating the ribbon. A cockpit crewmember was seen moving his hands around inside the cockpit (illuminated by the dome light).

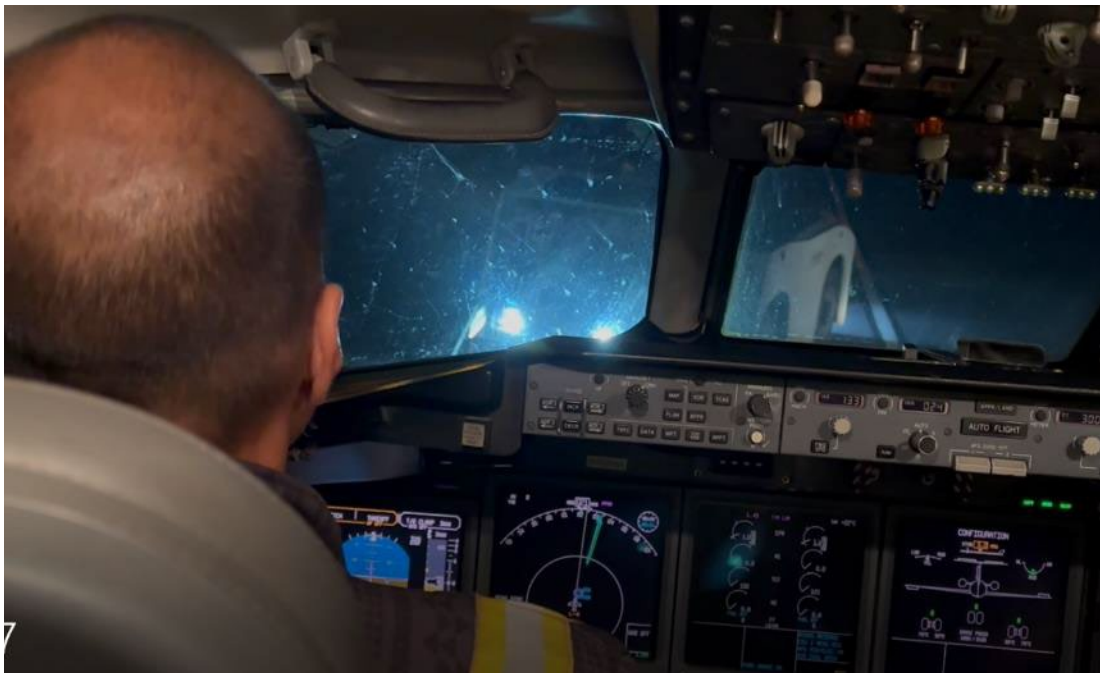
**Figure 14: Tug after backing up during towbar removal. (Headlights of tug in photo.)**

The tug backed up during the towbar removal process, at which time its headlights were visible and bright.

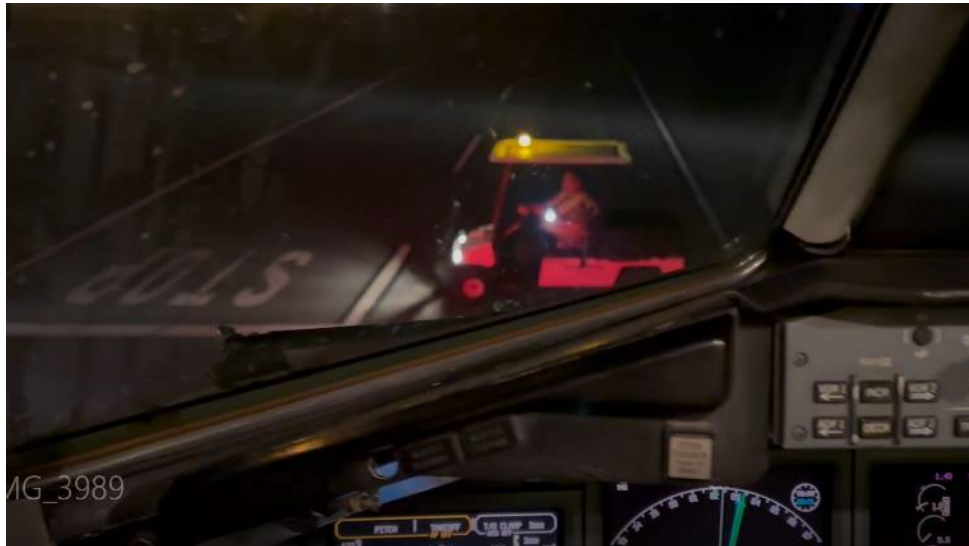
**Figure 15: Eye reference point for human performance specialist seated in captain's seat (vehicle shown is a golf cart).**

The HP investigator, who was 6'4" tall, sat in the captain's seat and adjusted the seat height so his eye reference point was parallel with the top of the glareshield and

he adjust the seat's fore-aft position so the yoke and rudder pedals were in a comfortable position.

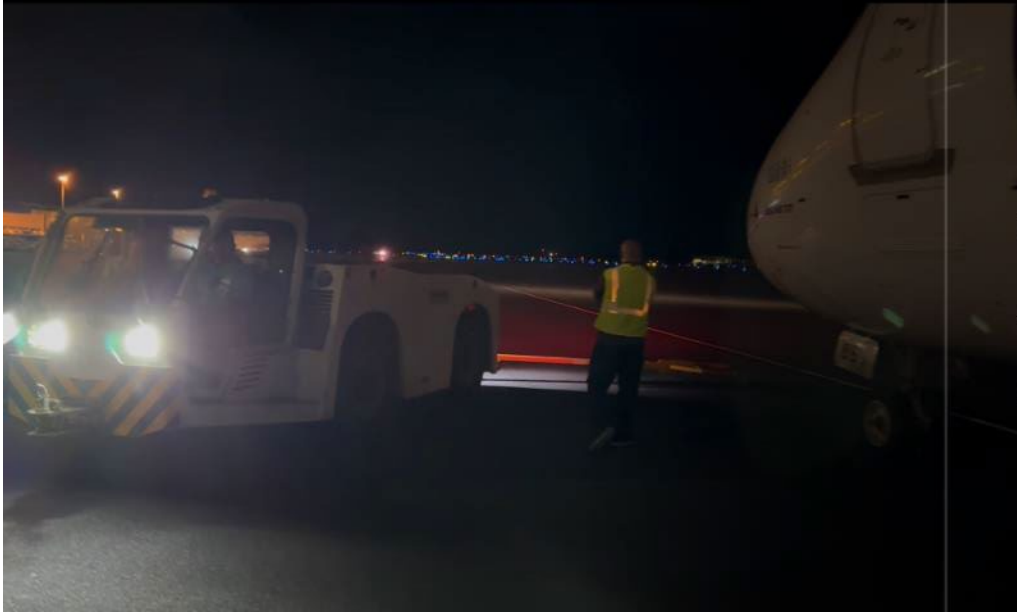
**Figure 22: Tug positioned 13 ft from the airplane.**

Next, group 1 observed a pushback from the ground. Figure 22 shows the tug positioned 13 ft from the airplane.

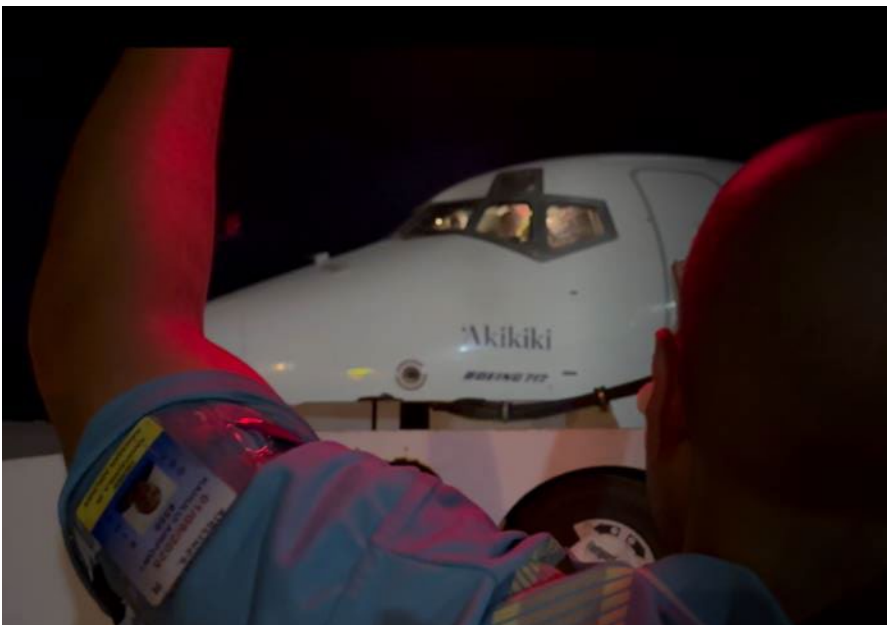
**Figure 23: View of cockpit from point of view of ramp agent standing and displaying pin on the opposite side of the tug.**

Group 1 observed the cockpit from the point of view of a ramp agent standing on the opposite side of the tug displaying a pin (figure 23). The cockpit was illuminated with the cockpit dome light. In the photograph an operational factors group member is seated in the left (captain) seat and leaning forward approximately 3 inches, when measured from seat back. Another operational factors investigator is standing in the cockpit in close proximity to the jumpseat location and can be seen in the 2<sup>nd</sup> cockpit window from the right.

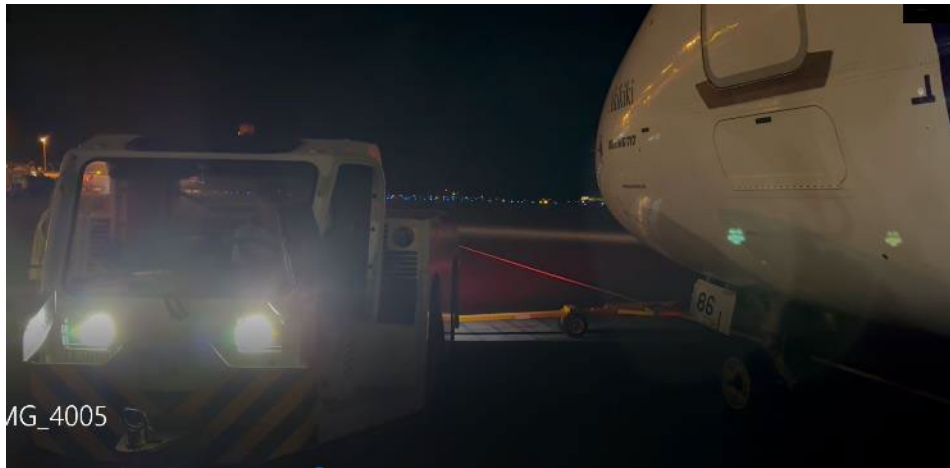
**Figure 24: Tug positioned 5 ft from the side of the airplane.**

Next, the tug was repositioned 5 ft from the airplane.

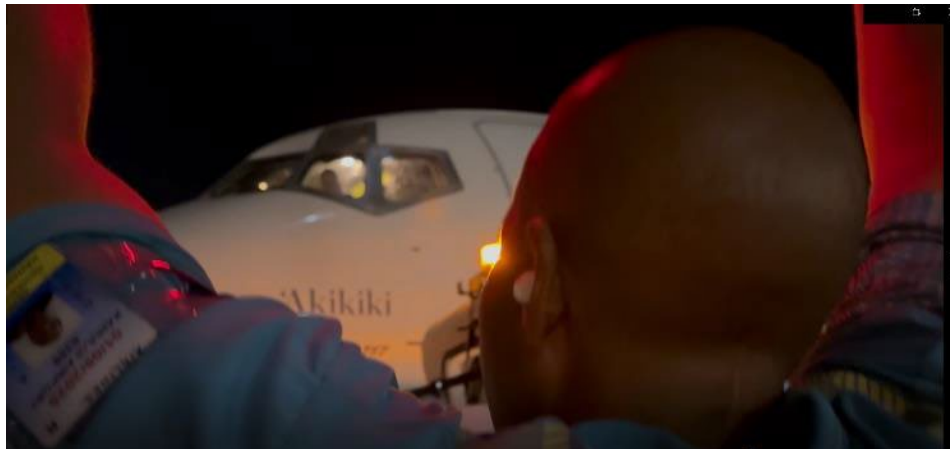
**Figure 25: View of cockpit from the perspective of ramp agent displaying pin while standing on the opposite side of the tug. Tug remained 5 ft from the airplane.**

Next, Group 1 observed the view of the cockpit of a ramp agent standing on the opposite side of the tug, with the tug positioned 5 ft from the airplane. In figure 25, an operational factors group member seated in the left (captain's) seat was leaning forward approximately 14 inches as measured from the seat back.

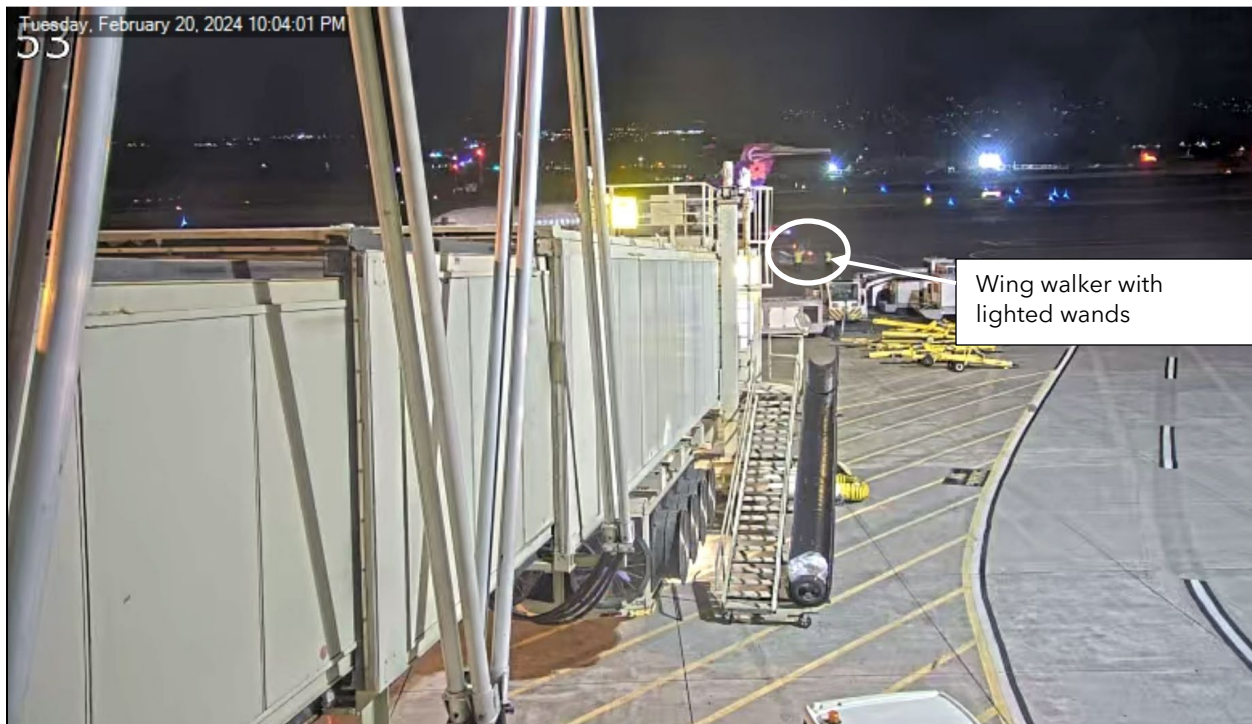
**Figure 27: Screen shot during pushback on February 20, 2024. Wing walker with lighted wands visible.**

Figure 27 was a recording of the night observation conducted on February 20, 2024. In that screenshot you can see the wing walker on the left side of the airplane with lighted wands (in white circle) with the right illuminated wand held in a nearly horizontal position and the left illuminated wand held in the a near vertical position.
