## Equipment Quality Analysis Report

**EQA NUMBER:** AS13825  
**DATE:** October 30, 2024  
**MODEL NUMBER:** 767-300ERSF  
**AIRPLANE NUMBER:** VN967

**SUBJECT:** *Auxiliary Power Unit (APU) Access Doors Departed During Flight*

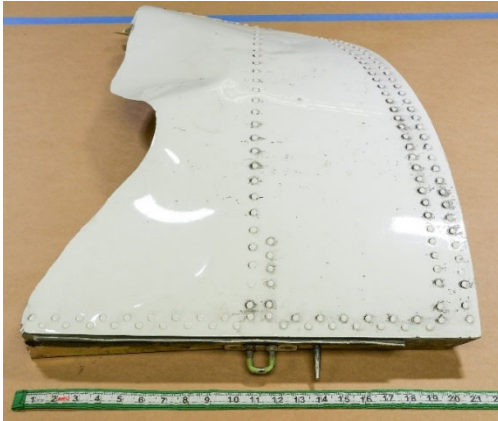
**Figure 7:** Aft section of LH APU door, outboard surface

The first part removed was wrapped in multiple layers of bubble wrap. The part was removed from the bubble wrap and was identified as the aft section of the [REDACTED] LH APU door assembly. This section of the LH APU door measured approximately 21 inches along the latch edge and 27 inches along the torn forward edge; see Figure 7 through Figure 10.

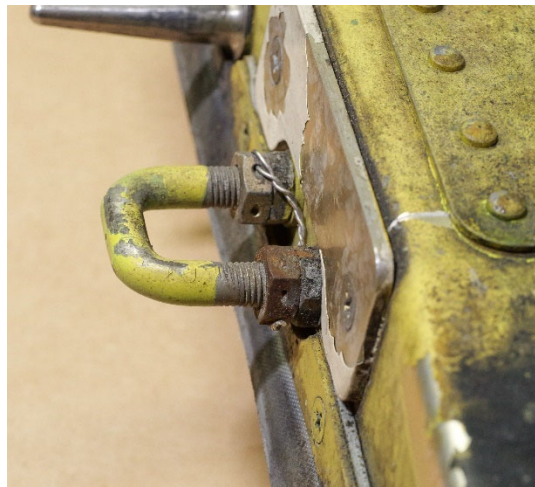
**Figure 19:** U-bolt on the aft LH APU door section

The U-bolt, part of the latching mechanism, on the aft LH APU door section was visually examined. The U-bolt lock wire was intact. The appearance of the U-bolt was unremarkable and typical of an in-service aircraft. An image of the U-bolt from the aft LH APU door section is shown in Figure 19.

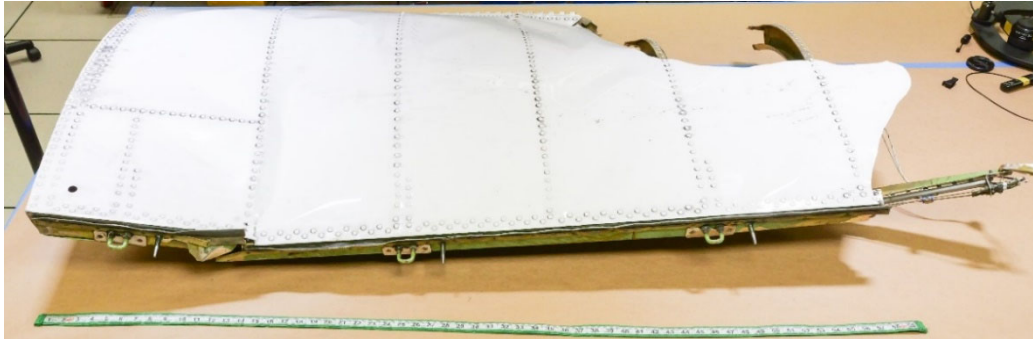
The second part removed from the crate was wrapped in multiple layers of bubble wrap. The part was removed from the bubble wrap and identified as the larger, forward section of the [REDACTED] LH APU door assembly; see Figure 20 and Figure 21. This door section measured approximately 38 inches along the forward edge, and 70 inches along the latch edge.

**Figure 20:** Latch edge of the forward LH APU door section, outboard side

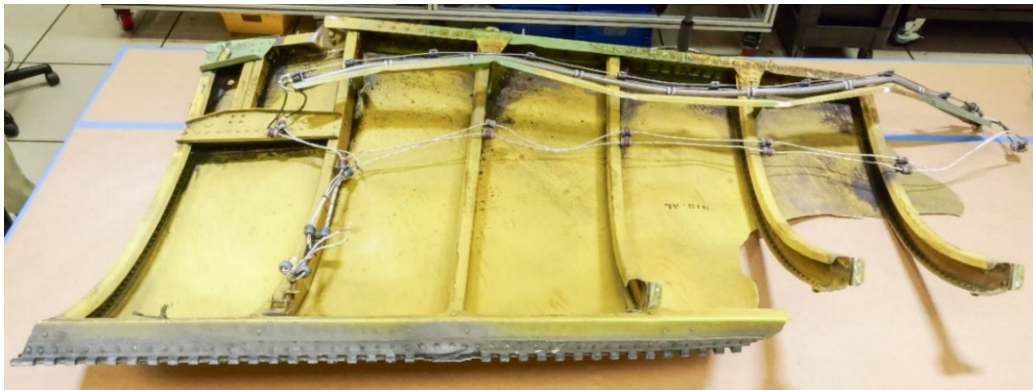
**Figure 21:** Hinge edge of the forward LH APU door section, inboard side

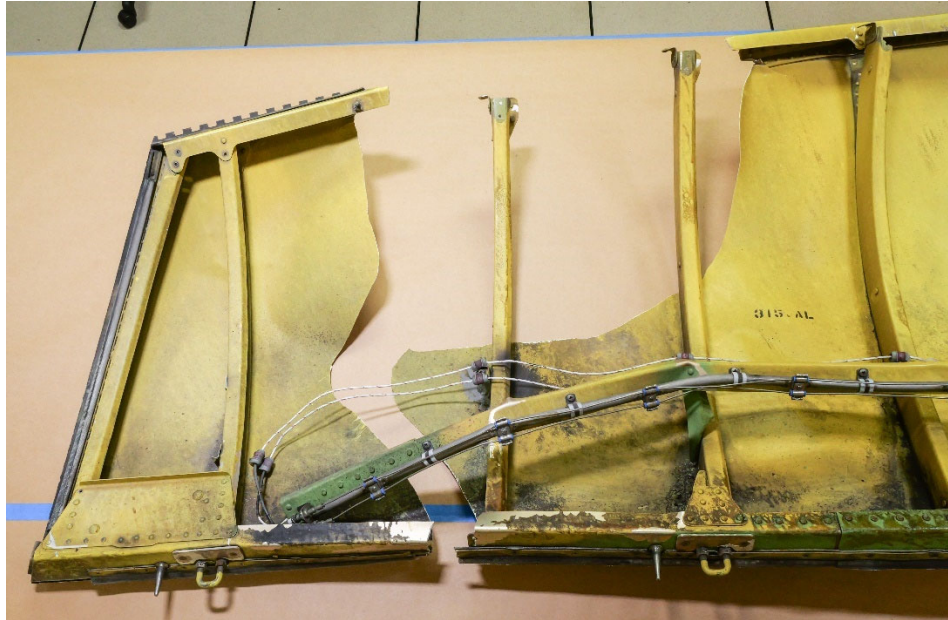
The forward and aft LH APU door sections were placed alongside each other in their approximate originating positions. These two sections did not complete the entire LH APU door assembly. These two sections of the LH APU door were aligned along the latch edge; see Figure 32.

**Figure 32:** Forward and aft LH APU door sections placed alongside each other

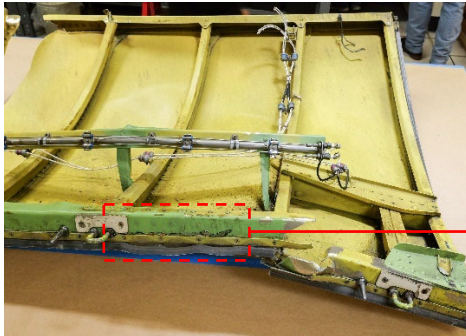
**Figure 34:** Forward LH APU door section, latch side

Approximately seven inches of honeycomb material was trapped between the door seal and the door frame between the second and third support ribs on the latch edge of the forward LH APU door section; see Figure 34 and Figure 35.

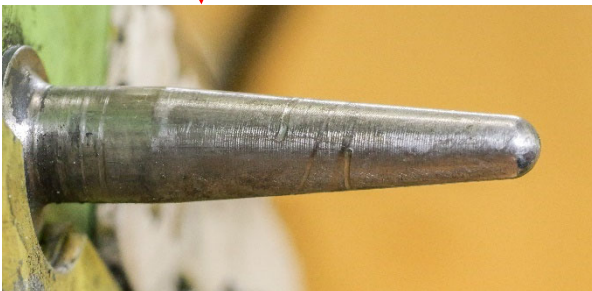
**Figure 37:** Middle alignment pin, aft looking forward

The three alignment pins on the forward LH APU door section were visually examined. There were no remarkable observations on the forward and aft alignment pins. The middle alignment pin displayed circumferential witness marks in a spiral pattern between approximately 1.0 to 1.2 inch section away from the base of the pin; see Figure 36 through Figure 38.

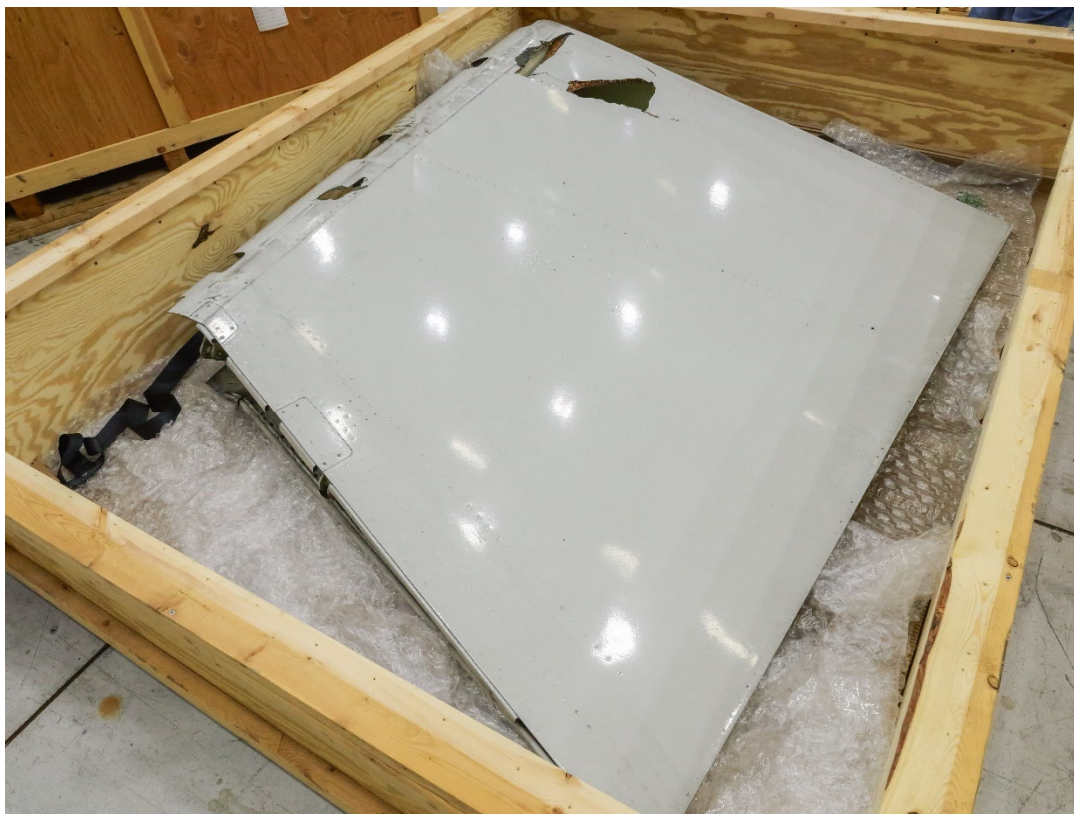
**Figure 42:** Overview image of damaged RH elevator assembly

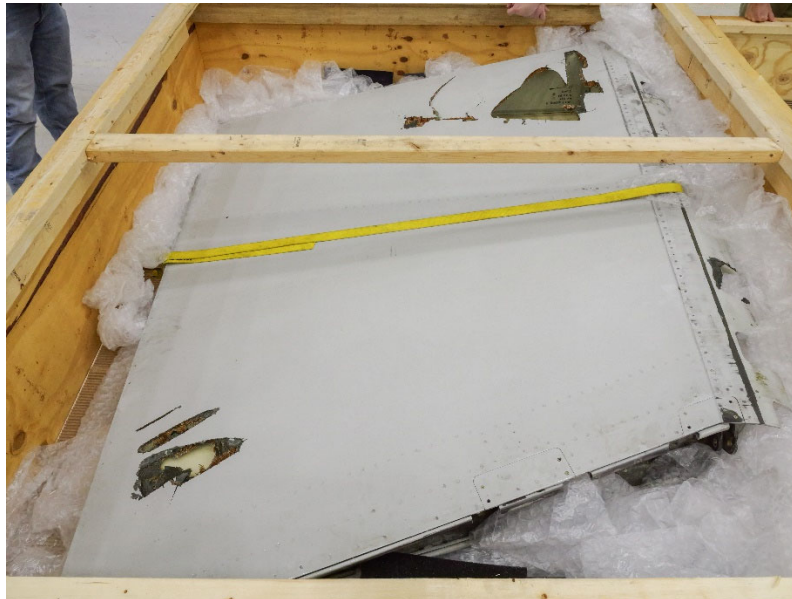
**Figure 53:** Damaged LH elevator assembly

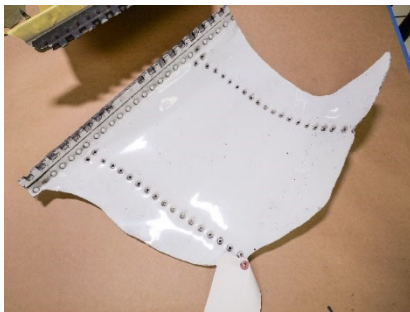
**Figure 63:** Remaining LH APU door section, outboard side

The first part was removed from its protective bubble wrap and confirmed to be a section of the [REDACTED] LH APU door assembly. This LH APU door section remained attached to the aircraft after landing and was removed while the aircraft was on ground. The skin panel was deformed and set with a curvature in the outward direction. The rivets that attached the skin panel to the support ribs were no longer present. Overview images of the LH APU door section were captured; see Figure 63 and Figure 64.

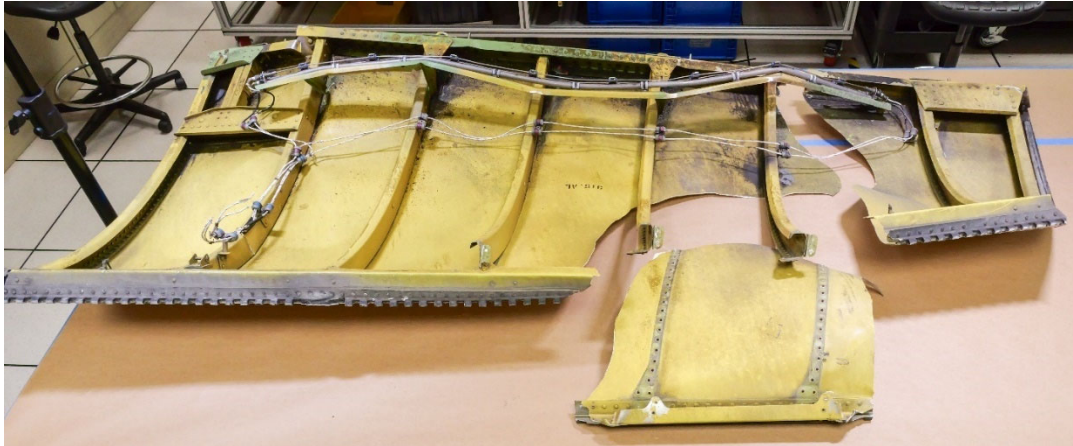
The LH APU door section was placed in its approximate originating location alongside the forward and aft sections of the LH APU door. An image of the LH APU door sections was captured; see Figure 65. Figure 66 shows an end view image of the remaining LH APU door section with the curvature in the outward direction.

**Figure 65:** LH APU door sections placed in their approximate originating locations

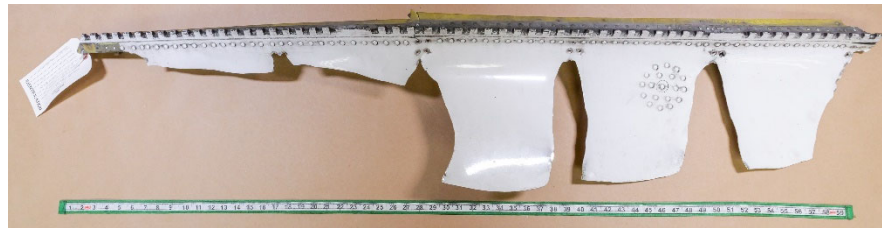
**Figure 67:** RH APU door section, outboard side

The second part was removed from its protective bubble wrap and confirmed to be a hinged section of the [REDACTED] RH APU door assembly. This RH APU door section remained attached to the aircraft after landing and was removed while the aircraft was on ground. The RH APU door section measured approximately 60 inches in length. Support ribs were not received with this part. The rivets that attached the skin panel to the support ribs were no longer present. Overview images of the RH APU door section were captured; see Figure 67 through Figure 69.

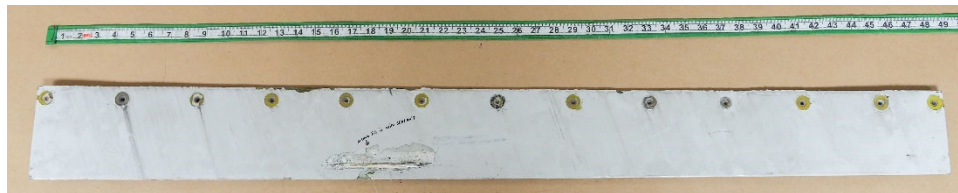
**Figure 84:** Outer surface of panel seal

The sixth part was removed from its protective bubble wrapping revealing a horizontal stabilizer panel seal. This panel seal resides on the lower surface of the horizontal stabilizer and contacts the leading edge of the elevator. The part marking on the inner surface was illegible and faint. Boeing Engineering determined that the part number for this panel seal was either a [REDACTED] or [REDACTED], depending on which side of the aircraft the part was removed from. The original position of the subject panel seal was not identified during this examination. Overview images of the panel seal are shown in Figure 84 and Figure 85.

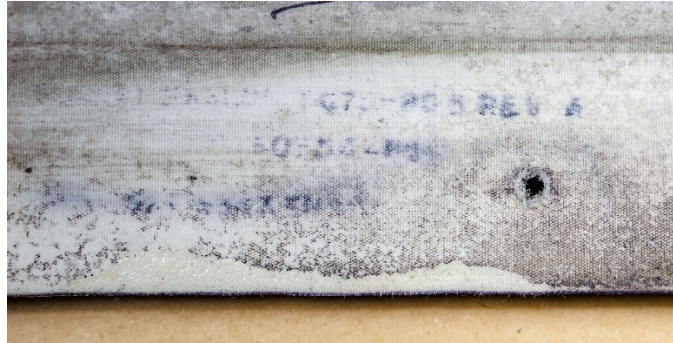
**Figure 86:** Remaining part marking on panel seal

The part number was illegible and faint. The remaining part marking was photographed; see Figure 86.
