# National Transportation Safety Board

DCA24LA330

## POWERPLANT

Specialist's Factual Report

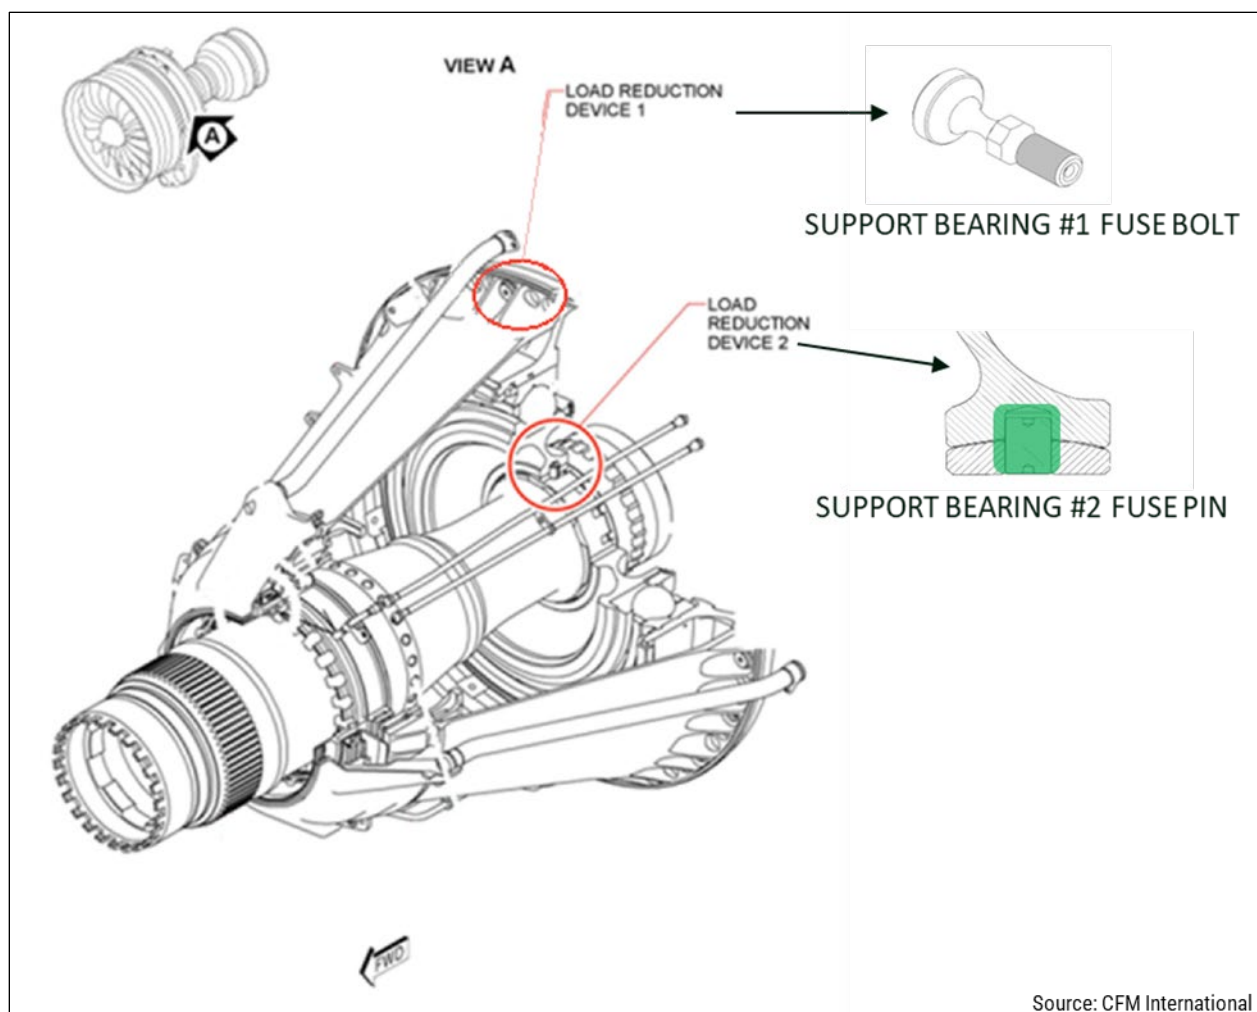
LRDs are a common feature of engines with wide-chord fan blades. While specifics vary according to engine design, the intent is the same. When the fan is significantly damaged, the LRD reduces stiffness of the fan rotor support, thus reducing the severity of the vibration transmitted to the engine and into the airframe. LRDs are design features that activate only in the event of significant imbalance and do not require any pilot intervention.

The No. 2 bearing housing bolts directly to the fan hub frame. The No. 1 bearing housing is bolted through holes in the No. 2 bearing housing to the fan hub frame by 23 shear bolts. The intent of the shear bolts is to decouple the No. 1 bearing from the engine structure during high fan imbalance events, allowing the No. 1 bearing support to move freely relative to fan frame and the No. 2 bearing housing support which remains attached to the fan frame. This enables safe continued flight during the post-event windmilling phase as the damaged fan slows or stops (Figure 4).

Fracture of the No. 1 bearing shear bolts prevents the No. 1 roller bearing from providing radial support for the fan rotor. Shear pins in the No. 2 bearing spherical joint shear, preventing overturning moment from transferring into the No. 1 bearing support while still allowing transfer of radial and axial load.

Fan case-to-fan blade tip gap is increased to avoid "hard" radial rubbing normally encountered during significant fan imbalance. Larger tip gap is achieved by using abradable material to increase the distance between the fan case base material and the blade tips. Disconnecting the No. 1 bearing radial load path and the No. 2 bearing moment load path and reducing the rub load into the fan case allows the fan to spin nearly about its new center of gravity, thereby reducing loads transmitted to the rest of the engine and airframe.
