**PARTY SUBMISSION OF  
SOUTHWEST AIRLINES PILOTS ASSOCIATION  
TO THE NATIONAL TRANSPORTATION SAFETY BOARD**

**SOUTHWEST FLIGHT 554  
KMSY – KENNER, LA  
DECEMBER 20, 2023**

**DCA24LA330**

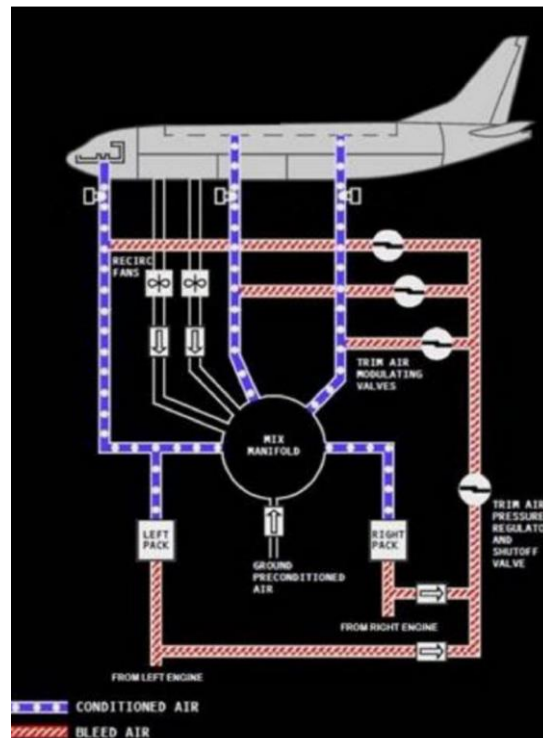
Figure 6: Air Distribution System. (Courtesy of Boeing)

Because the left pack supplies the flight deck, contaminated bleed air from the No. 1 engine resulted in the immediate introduction of smoke into the flight deck, producing rapid visibility degradation and contributing to sensory overload during an already high-workload phase of flight. Although the PRSOV closed automatically when N2 decreased below 62 percent, the smoke had already entered the flight deck prior to valve closure.

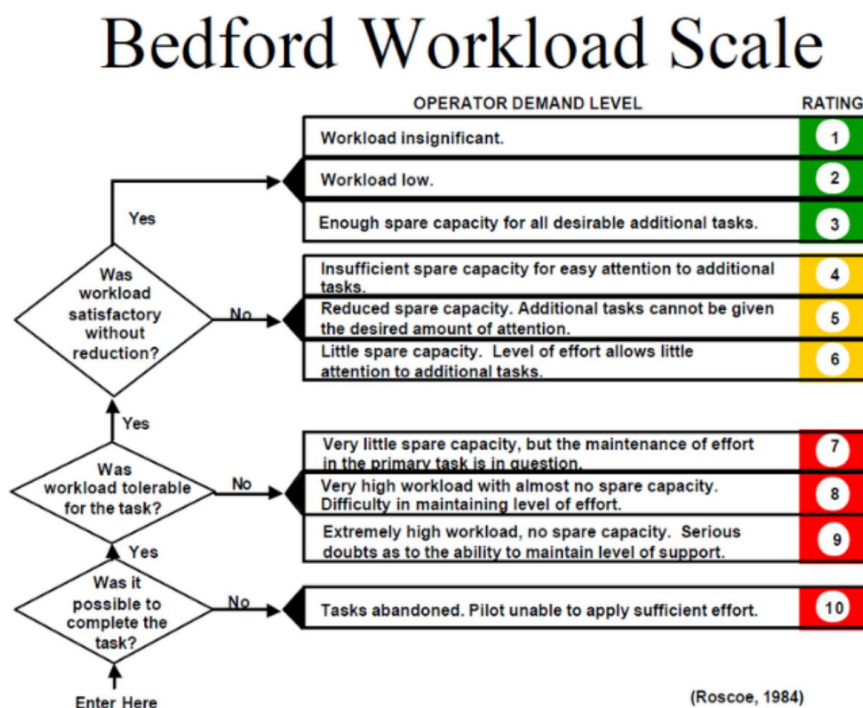
The June 16, 2025 Smoke Simulation Evaluation conducted at Southwest Airlines Headquarters, WINGS Building, Simulator 18, demonstrated that even the use of “light” smoke lenses severely degraded flight deck visibility, with pilots reporting workload ratings of 9–10 on the Bedford Workload Scale. Checklist readability was significantly impaired, reaction times were greatly reduced, and HUD usability varied depending on smoke density. These findings underscore the need for enhanced smoke-event training that realistically simulates rapid smoke onset, degraded visibility, mask-on checklist execution, and high-vibration environments.
