**Association of Flight Attendants (AFA)  
Party Submission  
Alaska Airlines Flight 1282 Accident January 5, 2024**

Seth Heiple - AFA Party Coordinator, Alaska Airlines Flight 1282 Investigation

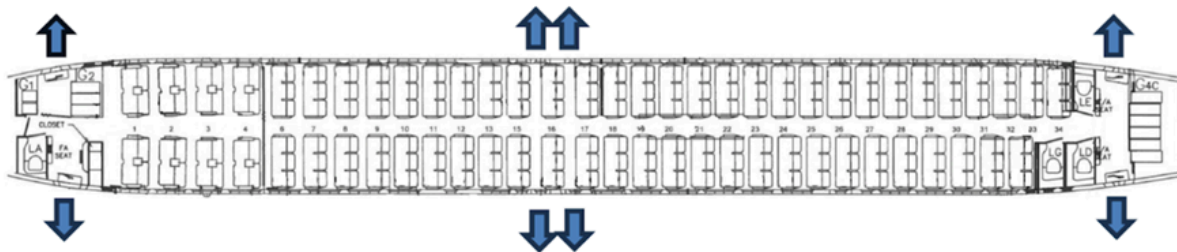
**Figure 1.** Interior configuration of N704AL. [Source: Alaska Airlines]

Alaska Airlines Flight 1282 (Alaska 1282) suffered a low altitude depressurization, yet individual sidewall panels located above the ventilation panels show displacement into the cabin. For example, the sidewall panels at row 4 left moved 1 cm to 4 cm from their mounted positions, and the sidewall panels at rows 30-32 right separated up to 2 cm from their mounted positions. There were a few other sidewall panels at row 10 right that also showed movement.

The FAA should review and revise the certification of the 737 MAX series to ensure that rapid decompressions will not result in damage to critical flight control systems that transit the area beneath the cabin floor.

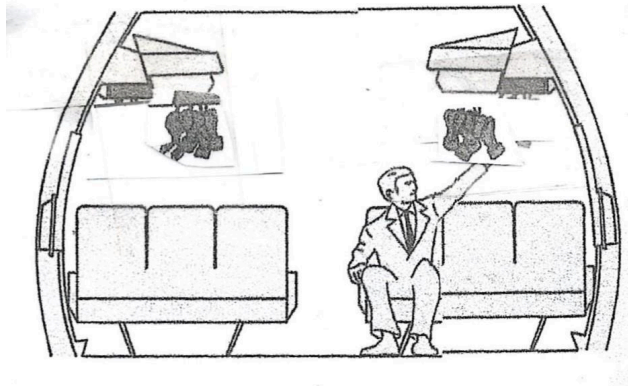
**Figure 4.** Oxygen mask location on single-aisle aircraft with shelf-style bins

The regulation was apparently intended to supply oxygen masks for persons seated in the row and not those who were standing in the aisle, such as crew or passengers waiting to use the lavatories. Airlines modified the intent into procedures and training for Flight Attendants to use spare masks to meet the requirement for oxygen to be available to all occupants. The design allowed someone in the aisle to reach over the aisle seat and grab a mask from the center seat location. When manufacturers replaced hat racks with shelf-style bins, the oxygen system remained on the lower face of the shelf and centered over the middle seat. On the 737 NG with

shelf-style bins the distance from the aisle armrest to the center of the oxygen compartment is 34 inches in the main cabin.

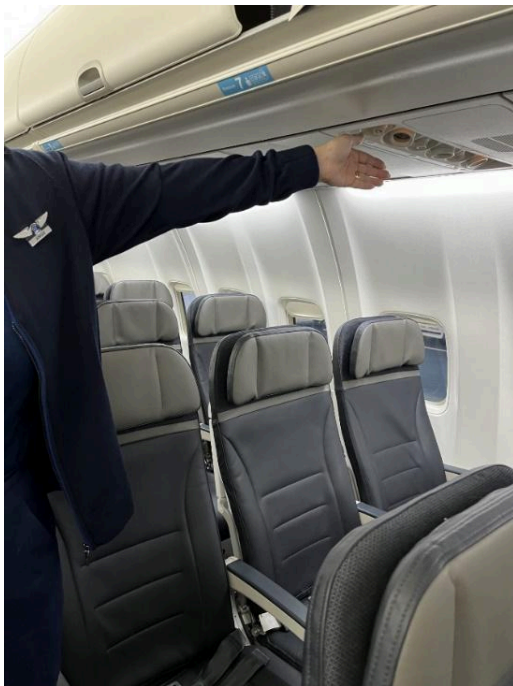
A sample of Flight Attendants' reach measured by AFA staff, from the center of the palm to the armpit, yielded an average of 22". This sample included all seniorities and two Flight Attendant qualified managers. It is assumed that the majority of passengers in the aisle would similarly be unable to reach the oxygen masks on the aircraft with push-up bins.

**Figure 6.** Reach from the aisle in premium class located in the main cabin of a 737 with shelf-style bins. Distance from the aisle armrest to the center of the oxygen mask compartment in the main cabin is 34", and the average measured Flight Attendant reach is 22".

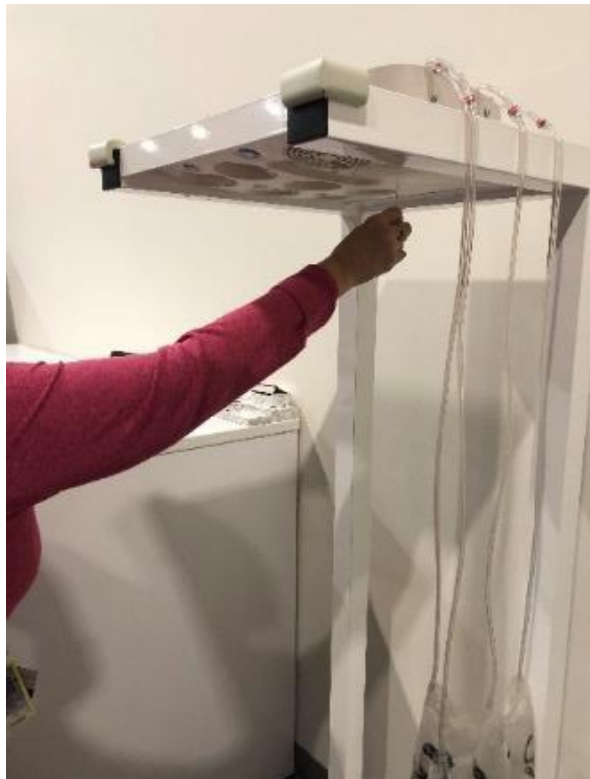
In many detailed ways, training devices significantly differ from the “real” aircraft environment. For example, all recurrent training facilities have similar training devices to simulate the manual opening of oxygen mask compartments. Students reach up and insert the open end of a paperclip into the pinhole to open the oxygen compartment in the PSU. However, the student is significantly closer to the PSU than a Flight Attendant would be in an actual aircraft cabin.

**Figure 10.** Training device used to simulate manual opening of oxygen mask compartments.

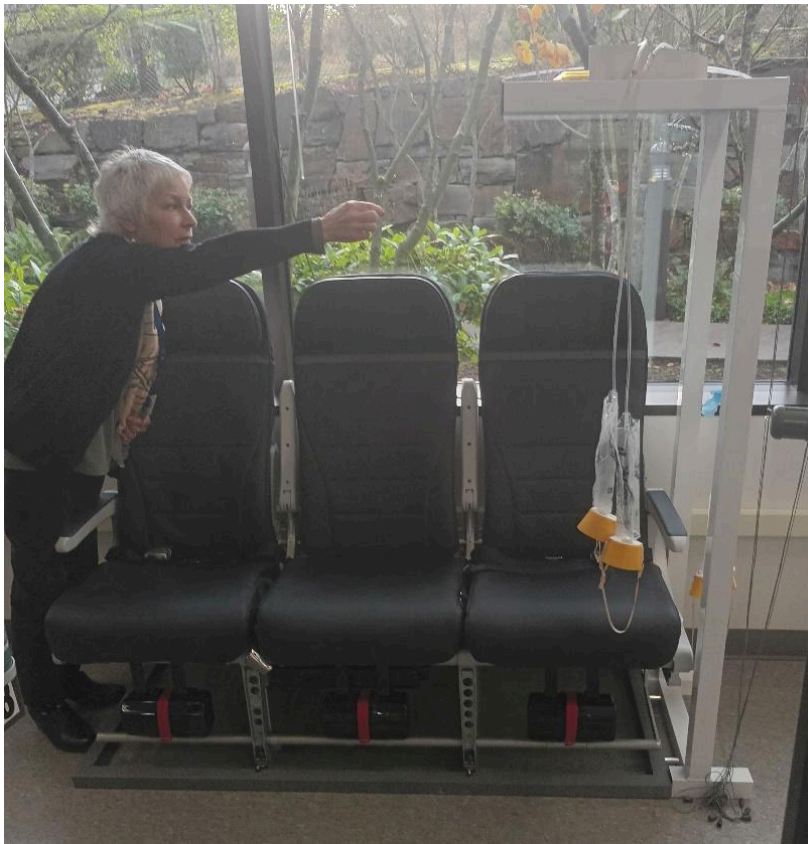
**Figure 13.** Training device with a row of seats which is more representative of the actual aircraft environment. Note that this does not demonstrate the additional restrictions caused by seat pitch or occupied seats.

The FAA should provide guidance to operators to ensure that rapid decompression emergency procedures call for Flight Attendants to remain secured in place or, if possible, be seated and wearing appropriate restraints until landing.

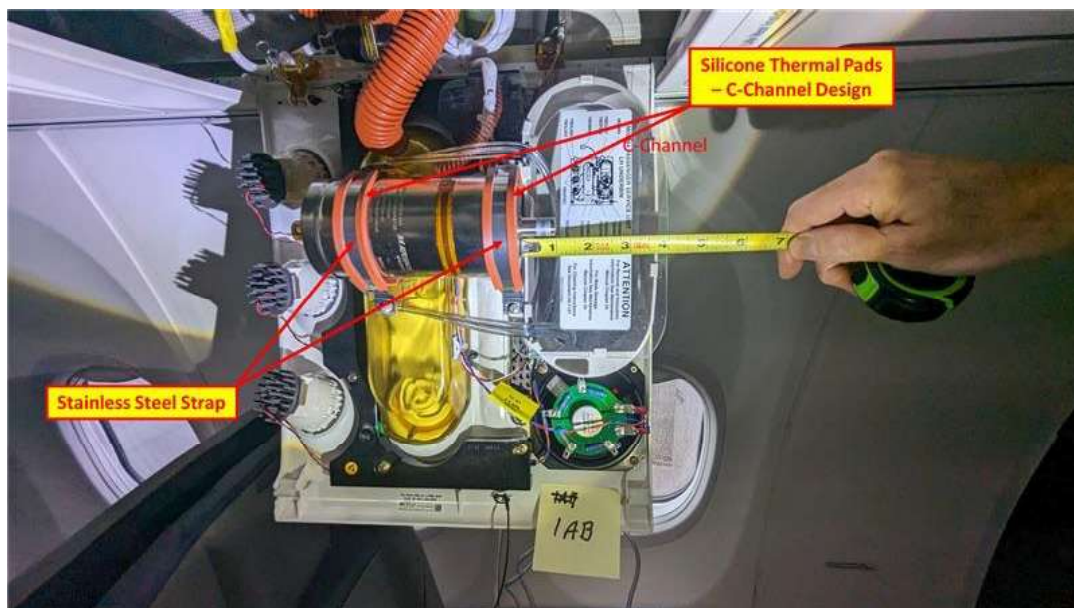
**Figure 2.** PSU Oxygen Generator Canister Non-Migration Example<sup>26</sup>

The accident airplane was equipped with 62 PSUs equipped with chemical oxygen generators. Chemical oxygen generator migration was observed at 60 PSUs that utilized a pressure sensitive adhesive silicon pad under the steel strap that secures the canister in the PSU. A documented example is provided in Figure 1. Two generators that did not migrate were equipped with the c-channel type silicon pad under steel strap and is documented in Figure 2. All oxygen generators remained engaged with supply tubing and were activated

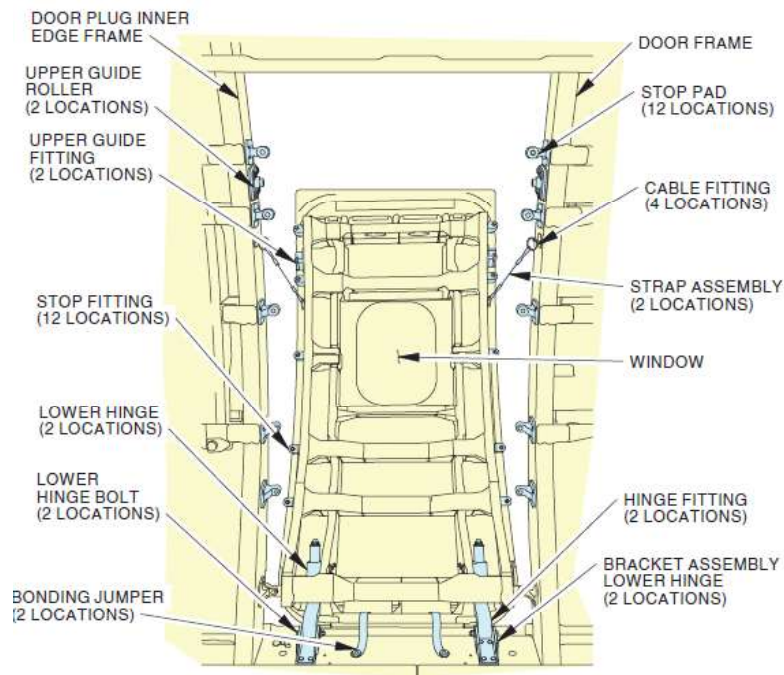
**Figure 3. MED plug Hardware Location Reference (Image Copyright © Boeing.)<sup>30</sup>**

As shown in Figure 3, an MED plug utilizes 12 stops to carry outboard pressure loads, and two upper guide fittings and rollers, as well as two lower hinge fittings, to assist with MED plug opening and closure. The plug is secured vertically by two vertical movement arrestor bolts, installed through the hinge fittings and hinge guide fittings, and two upper guide track bolts, installed through the upper guide fittings, as shown in Figure 4. Castellated nuts and cotter pins secure the four bolts. These four bolts must be removed to allow for the plug to translate upward to clear the 12 stop pads and then rotate outboard pivoting about the lower hinge bolts to open.<sup>28</sup> Because the MED plug is installed as primary structure and is only opened with tools for maintenance purposes, no indication system is required for the flight deck. Therefore, the existing wiring associated with the mid cabin emergency exit door configuration is capped and stowed.<sup>29</sup>

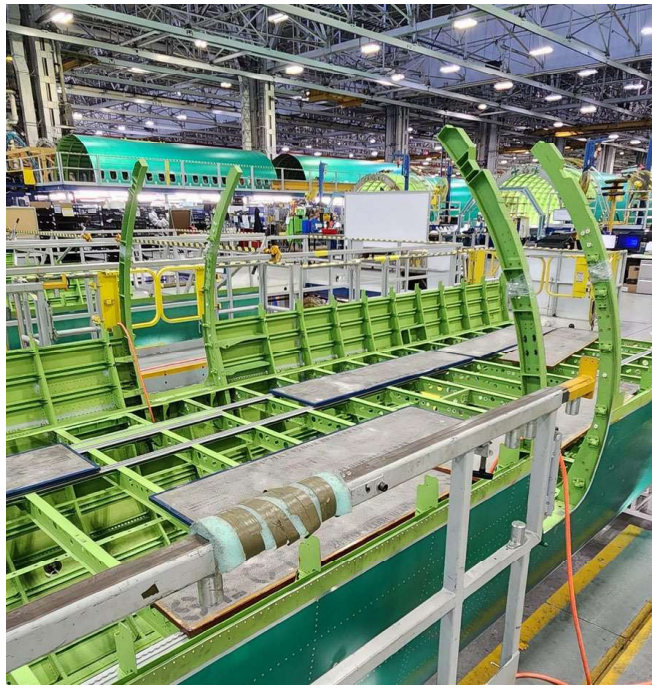
**Figure 6. MED plug Edge Frames Installed** <sup>40</sup>

MED plugs are installed during fuselage manufacturing at Spirit AeroSystems Wichita, KS, facility. The installation process includes a pre-rig process. Later in the fuselage production process, Spirit AeroSystems verifies the MED plug pre-rig, closes the MED plug, and installs the four bolts that prevent upward movement of the MED plug.
