737-9/-900ER MED Plug Enhancements  
Subject to final certification

Six Additional Safety Features Added

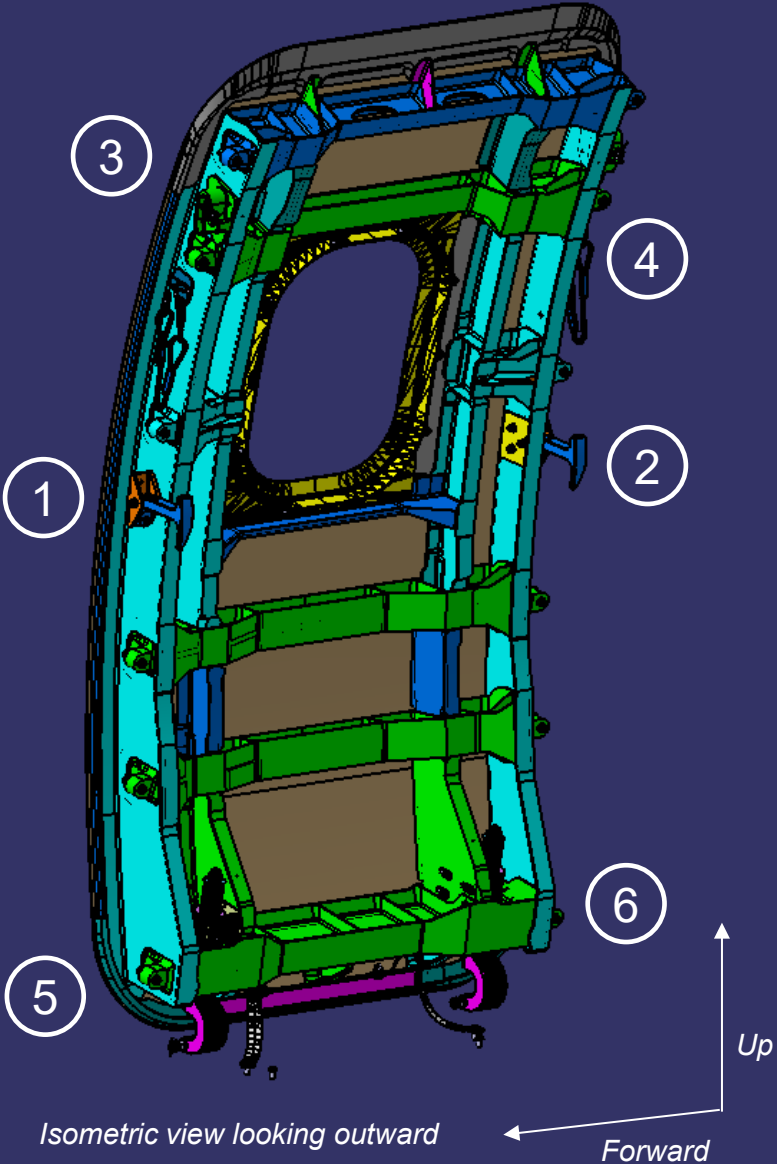
New Retention Arm Assemblies

- Two assemblies prevent the plug from translating upward and becoming misaligned from fuselage stop fittings.
- If Retention Arm is not in the properly stowed position, it interferes with the installation of the interior sidewall panel
