National  
Transportation  
Safety Board

# In-Flight Separation of Left Mid Exit Door Plug Alaska Airlines Flight 1282 Boeing 737-9 Portland, OR January 5, 2024

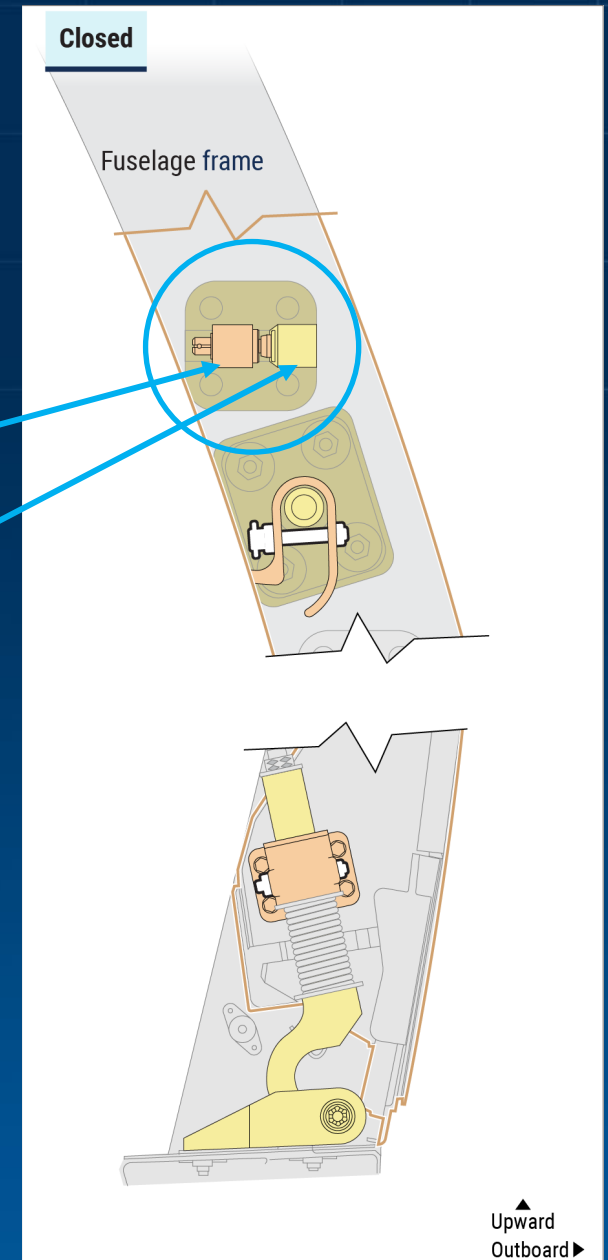
Closed

Stop fitting (1 of 6 shown)

Has two parts:

One on MED plug

One on fuselage frame

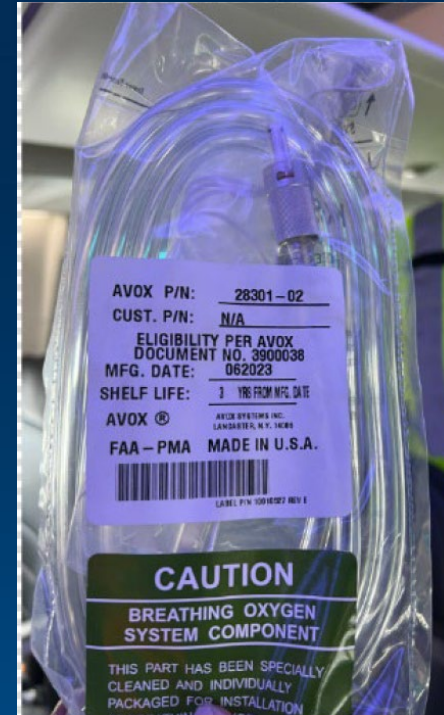
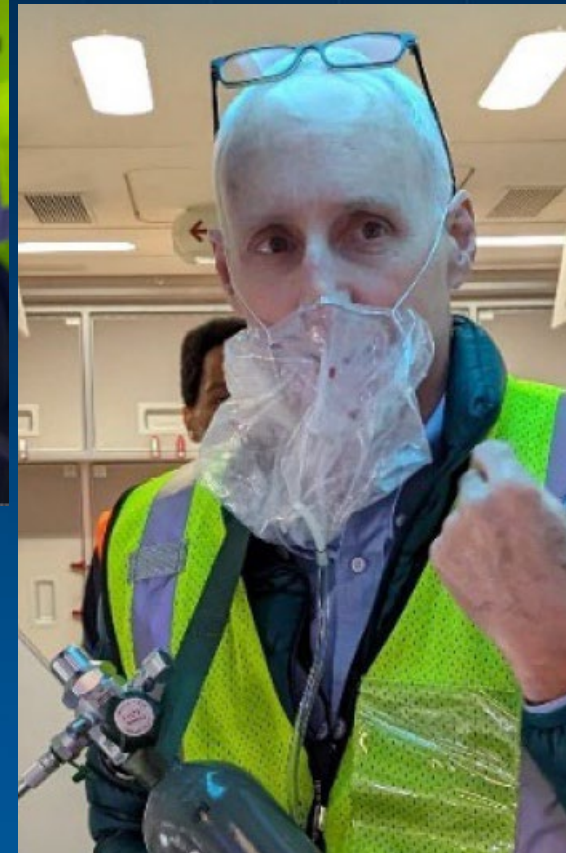
- Difficulty using portable oxygen bottle mask
- Differences between training and actual use
- Differences in equipment (mask type)

What we propose:

- One recommendation to the FAA in this area

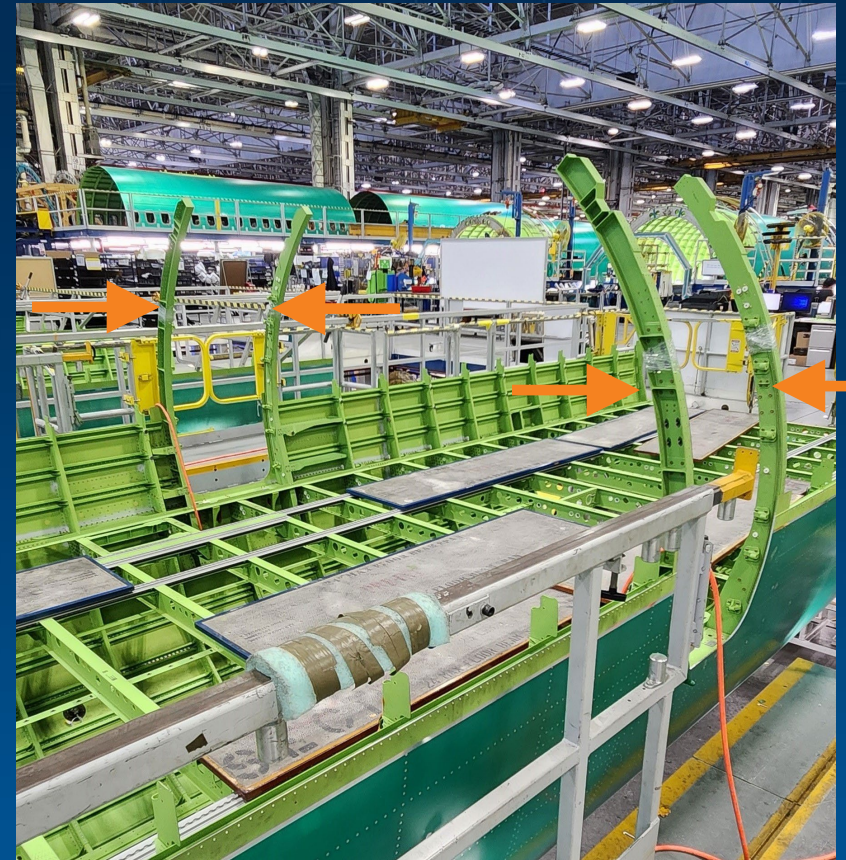
# Spirit AeroSystems – MED Plug Edge Frames

- Manufactured by Spirit AeroSystems supplier Quik Tek
- Edge frames installed on Line 8789 on June 16, 2023
- Postaccident actions by Spirit AeroSystems
  - Review of Quik Tek process
  - Inspection of all Quik Tek and in-stock edge frames
  - Inspection of edge frame fuselages in production

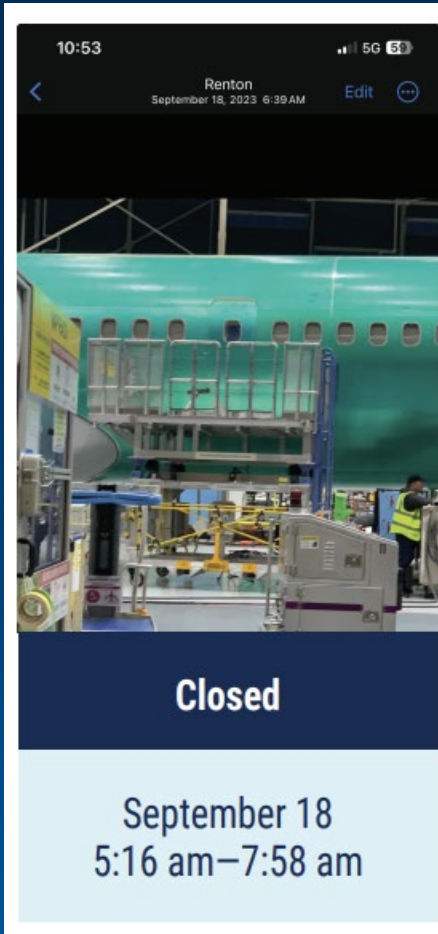
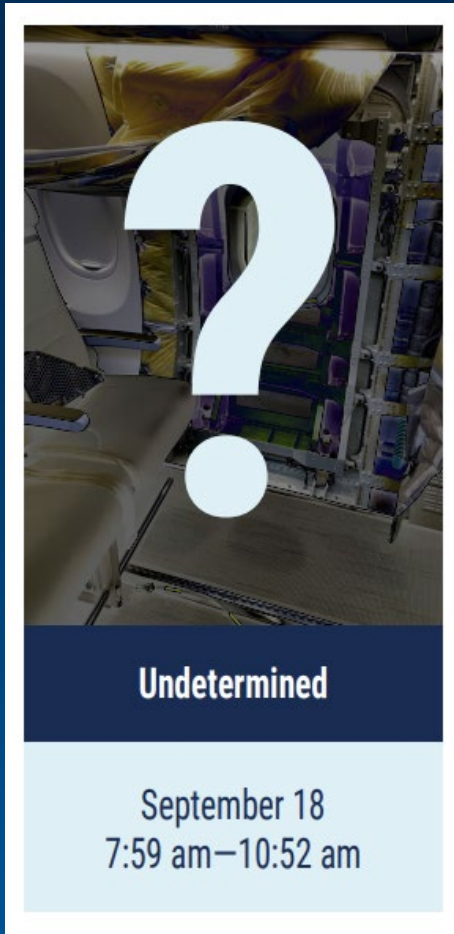
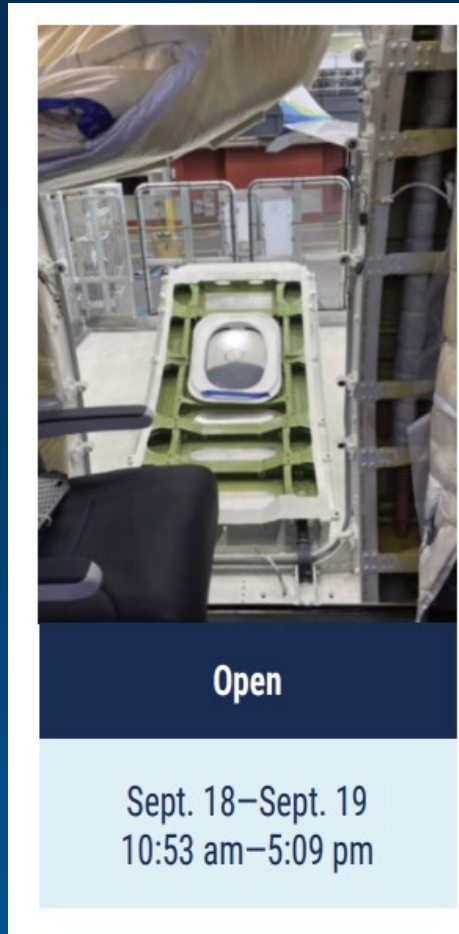
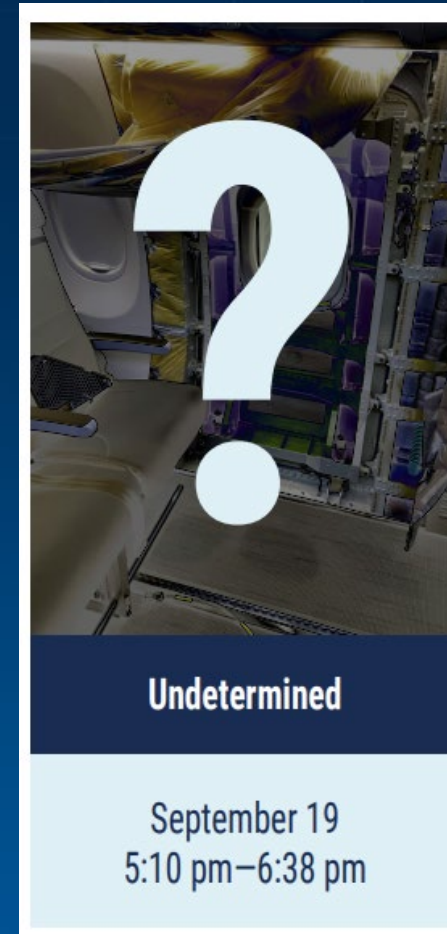
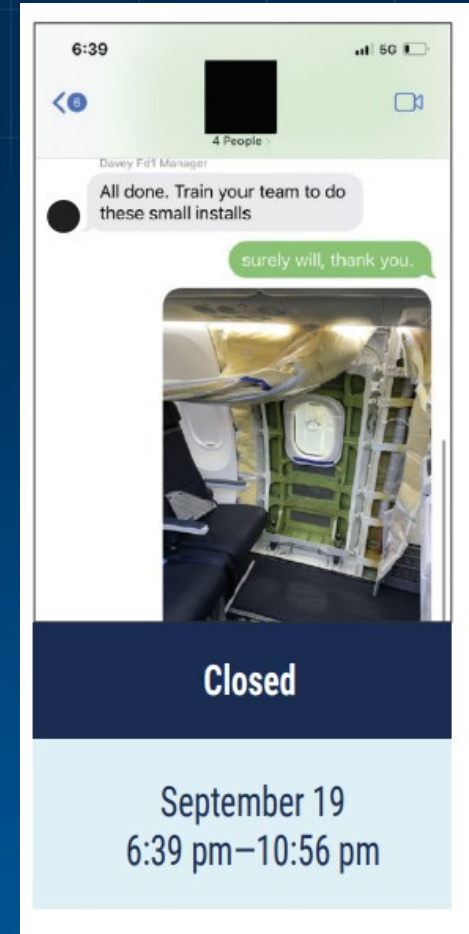
# What We Found: Most Likely Time Left MED Plug Was Opened and Closed

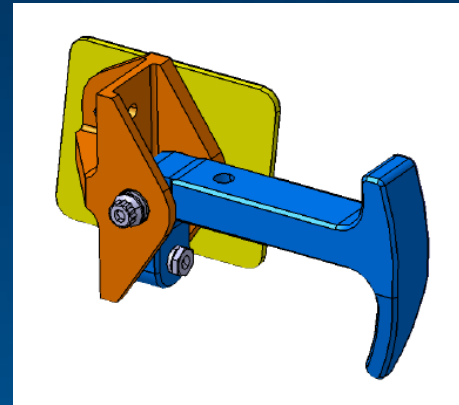
**737-9/-900ER MED Plug Enhancements**  
Subject to final certification

What we propose:

- One recommendation to Boeing
- One recommendation to FAA
