# National Transportation Safety Board

DCA25LA061

## STRUCTURES

Group Chair's Factual Report

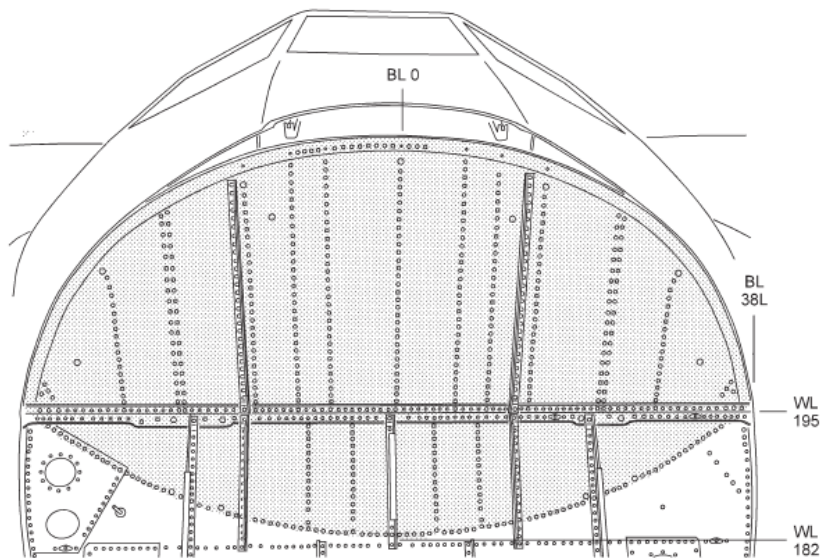
Lynden reported the airplane was climbing through flight level (FL) 220 when the crew “heard a loud bang and experienced a rapid depressurization”. The crew descended to 13,000 feet and continued to their destination where they landed safely. Post flight inspection of the fuselage station (FS) 93 forward pressure bulkhead behind the radome (Figure 1) found a fracture, about 14 inches long, in the canted web area adjacent to the fasteners along the centerline of the airplane at buttock line (BL) 0 (Figure 2).

**Figure 1.** Lockheed L-382G forward pressure bulkhead, view looking aft (Lockheed drawing).
