# DCA25LA275 – American Airlines 3023 Boeing 737-8, N306SW

Denver, Colorado

July 26, 2025

# LMLG Tire and Wheel Failure

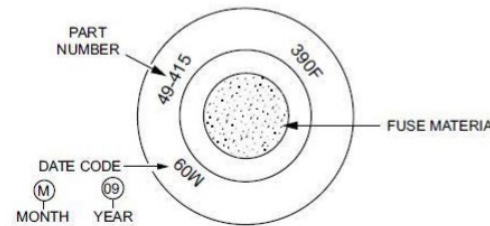
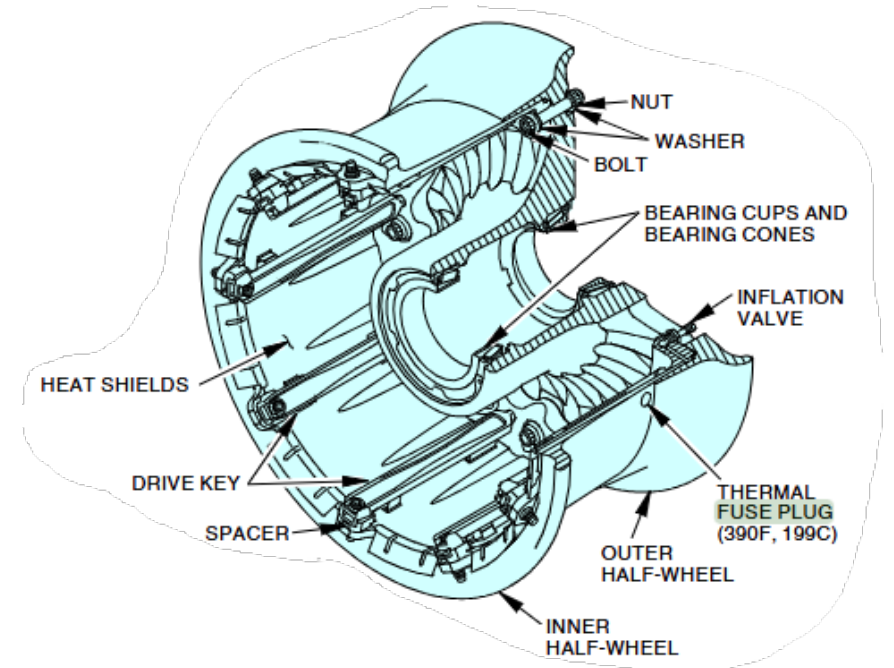
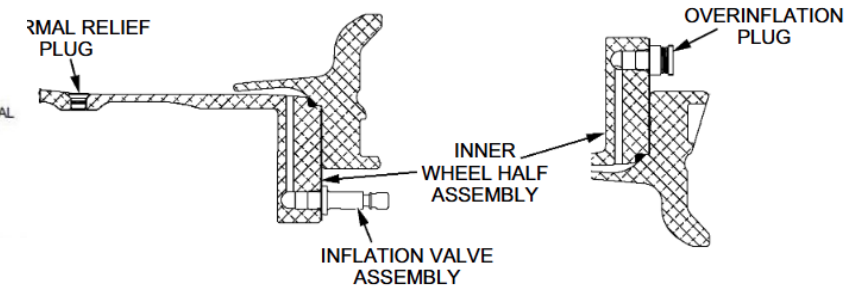
# 737-8 Wheel

- Equipped with 4 Thermal Relief Plugs per wheel
- Relieve tire pressure in overheat condition
- Press fit in wheel with o-ring

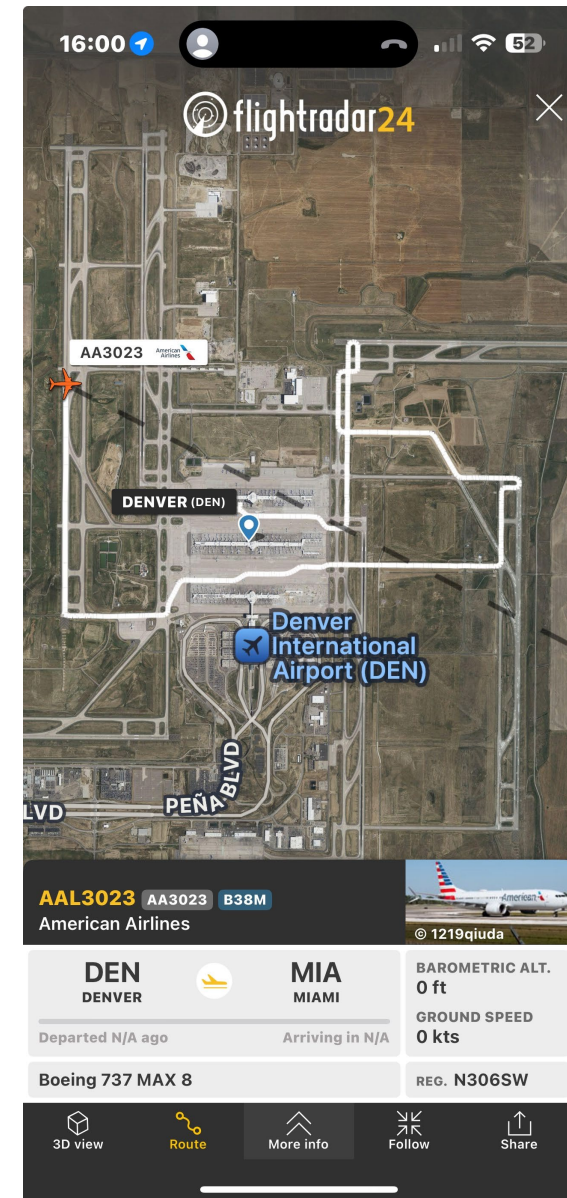
# AA 3023 ground path

- Taxi from gate to Runway 08
- Taxi from Runway 08 to Runway 17L
- Taxi from Runway 17L to Runway 34L
- Aborted takeoff on Runway 34L
- Changing wind conditions
