**NATIONAL TRANSPORTATION SAFETY BOARD  
OFFICE OF AVIATION SAFETY  
WASHINGTON, D.C. 20594**

**POWERPLANT GROUP CHAIRMAN'S FACTUAL REPORT  
NTSB ID: ENG16IA027**

Location: Jamaica, New York  
Date: July 7, 2016  
Time: 1307 UTC  
Aircraft: Boeing 757-200, N706TW, MSN 6804

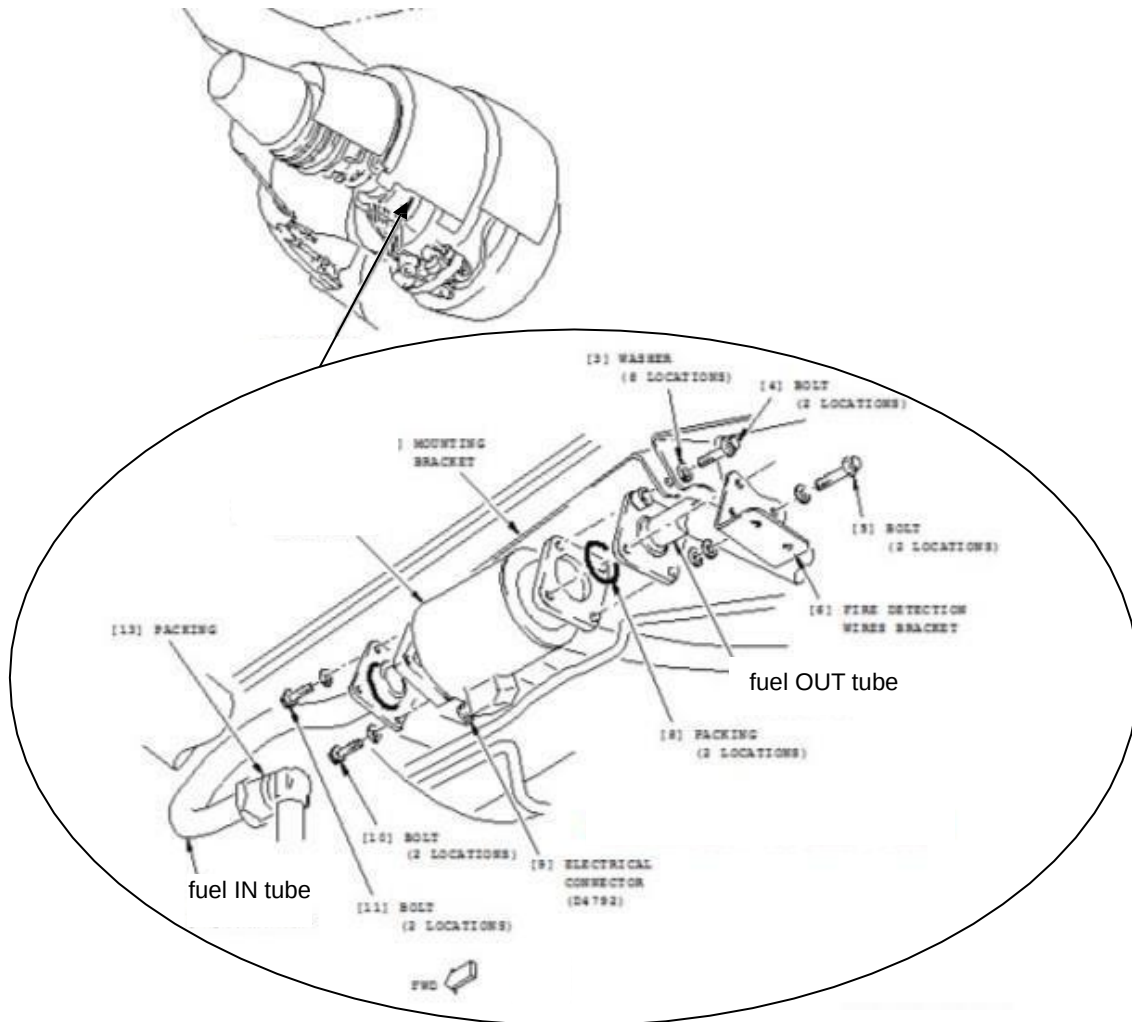
Figure 14. FFT installation

The FFT is an electro-mechanical measuring device installed in the metered fuel flow line between the main fuel control fuel outlet port and the engine fuel distribution valve to provide a cockpit indication of the fuel volume delivered to the engine combustor. It is located in the HPT diffuser case area at 6 o'clock. See Figure 14.

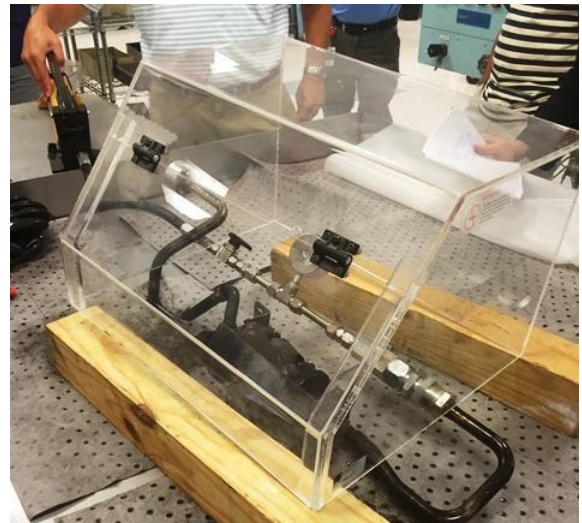
Figure 16. Test setup

The fuel OUT tube end was capped, and the assembly was filled with Stoddard solvent MIL-C-7024E (Royco 950 Type 2 calibration fluid). Fluid immediately leaked at the FFT-to-fuel OUT tube interface. A hand-operated hydraulic pump and pressure gauge was attached at the end of the fuel IN tube. See Figure 16.

Fluid was pumped into the rig. The drip became a steady spray with 8 psig applied at the inlet. See Table 2.
