# NATIONAL TRANSPORTATION SAFETY BOARD

MATERIALS LABORATORY FACTUAL REPORT

Report No. 17-002

Place : Miami, Florida  
Date : September 19, 2016  
Vehicle : Airbus A320-232, P4-AAA  
NTSB No. : ENG16IA037  
Investigator : Pocholo Cruz, AS-40

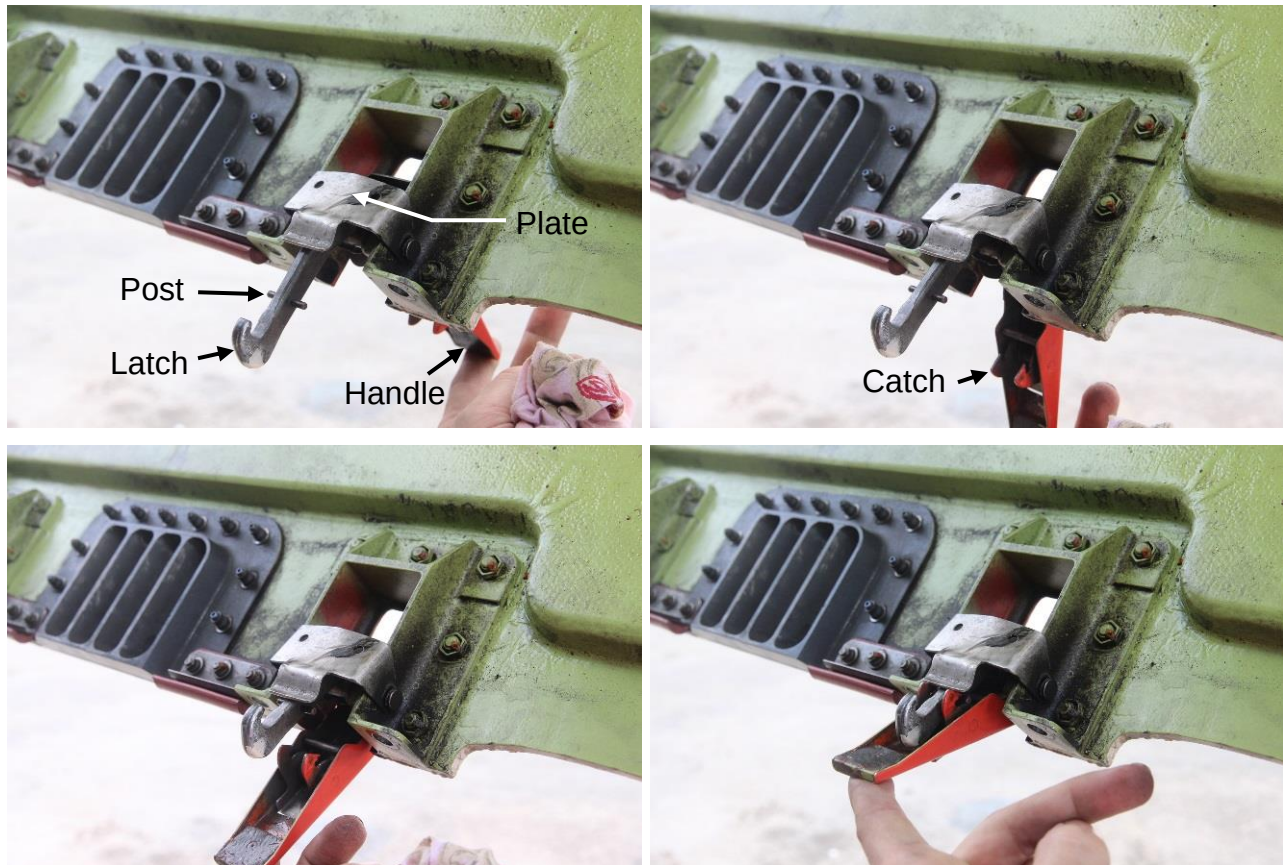
The operation of the latch/catch mechanism is illustrated in figure 5 using a series of images that was taken using a latch on the left (No. 1) engine fan cowl. The latch handle is spring-loaded so that the handle naturally moves to the open position. As the operator moves the handle to the closed position, the latch rotates up until it contacts a plate that limits further rotation of the latch. Continuing to move the handle toward the closed position causes the latch to retract, engaging the keeper on the opposite half of the cowl. The handle has two catches that engage with two posts, one on either side of the latch. When the catches are engaged with the posts, the handle is locked. Opening the latch requires releasing the catch, which is achieved by pressing a release lever in the center of the handle (see figure 3).

**Figure 5:** Series of photos illustrating the operation of the latch mechanism on the No. 1 engine fan cowl.
