**NATIONAL TRANSPORTATION SAFETY BOARD**  
**Office of Aviation Safety**  
**Washington, D.C. 20594**

**POWERPLANT GROUP CHAIRMAN'S FACTUAL REPORT**  
**NTSB No: ENG17IA003**

Aircraft: Airbus A330-223, N855NW, Delta Air Lines Flight 17

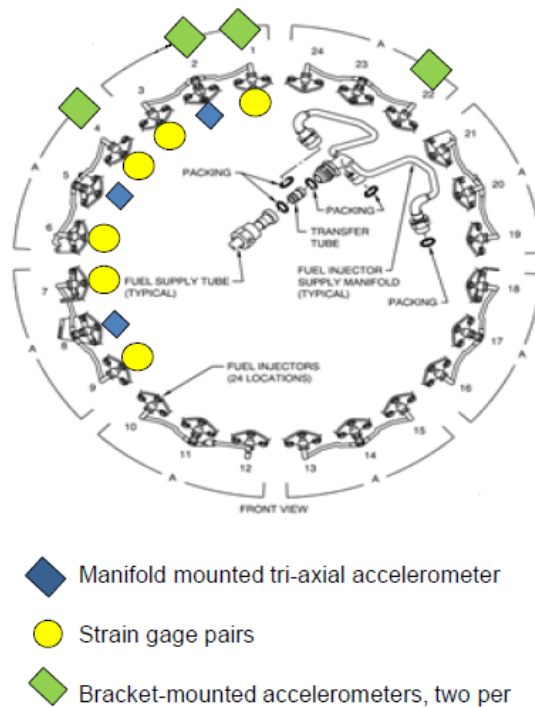
**Figure 3- PW4000 Vibration Test Instrumentation**

Between July 2017 and November 2017, P&W performed vibration testing on two PW4000-100 inch fan engines and two PW4000-94 inch fan engines with TALON II (A or B) combustors at ESA Singapore. One of the PW4000-94 inch fan engines had experienced three separate fuel leak events due to fuel manifold cracks. The other three engines tested had no history of fuel leaks. The engine instrumentation package included: 12 strain gages<sup>5</sup> and three tri-axial accelerometers<sup>6</sup> at the fuel manifolds and nine single axis accelerometers at the fuel nozzle pads (**Figure 3**). Thermocouples were installed at fuel nozzle pad No. 1 and triplet position No. 1. A dummy igniter probe was installed in place of one of the normal igniter plugs to measure acoustic tone, and an internal combustor pressure probe was installed. Accelerometers were installed on the K flange (HPC rear case-to-diffuser case) and N flange (HPT case-to-LPT case). The testing identified an acoustic tone created by the combustor during engine operation that excites a dynamic (resonant) response in the fuel manifold assembly. The amplitude of the vibratory response at the fuel manifolds varied between engines but was present at the same frequency on all engines tested. One engine was tested to correlate the combustor tone/resonant frequency to an engine speed range. The combustor tone peaked near the end of a 5 second snap acceleration<sup>7</sup> and then decreased when the engine was allowed to dwell at the higher speed. It is estimated that the tone occurred between 9,000 (86%) and 10,000 (95.6%) RPM N2.
