**NATIONAL TRANSPORTATION SAFETY BOARD  
Office of Aviation Safety  
Washington, D.C. 20594**

**POWERPLANT GROUP CHAIRMAN'S FACTUAL REPORT  
NTSB No: ENG17IA006**

Aircraft: Bombardier CRJ700, N367CA, GoJet Airlines LLC, Flight 6210

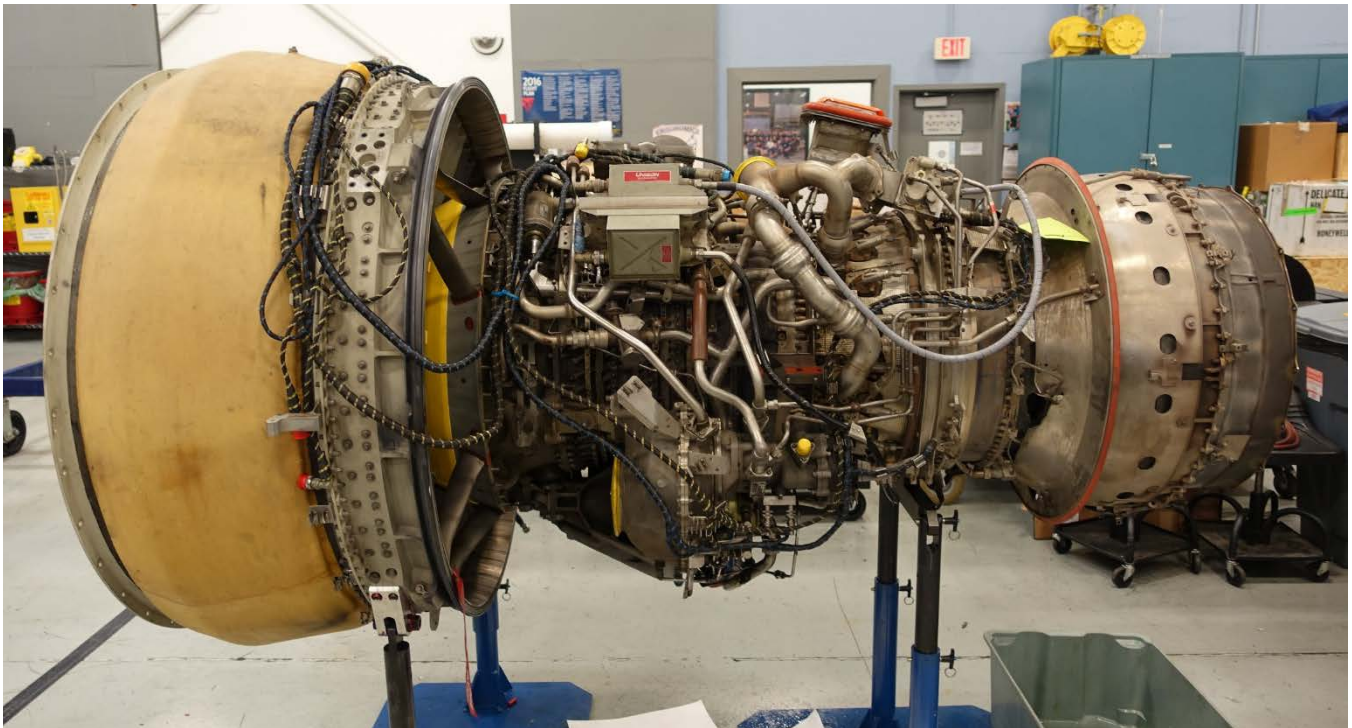
**Photo 1- Left Side of the Engine, As Received**

The No. 1 engine was shipped from STL in a transport dolly and was held in the NTSB quarantine cage at Delta TechOps until the investigative group arrived. The engine was then relocated to the TechOps CF34 shop where it was placed in work pedestals for visual examination and disassembly (**Photos 1, 2, and 3**).
