# GE Aviation

*CF34-8 ESN 965-352*  
*HPT S2B Under-Platform*  
*Separations*

TL-17-013

TL-17-026 update

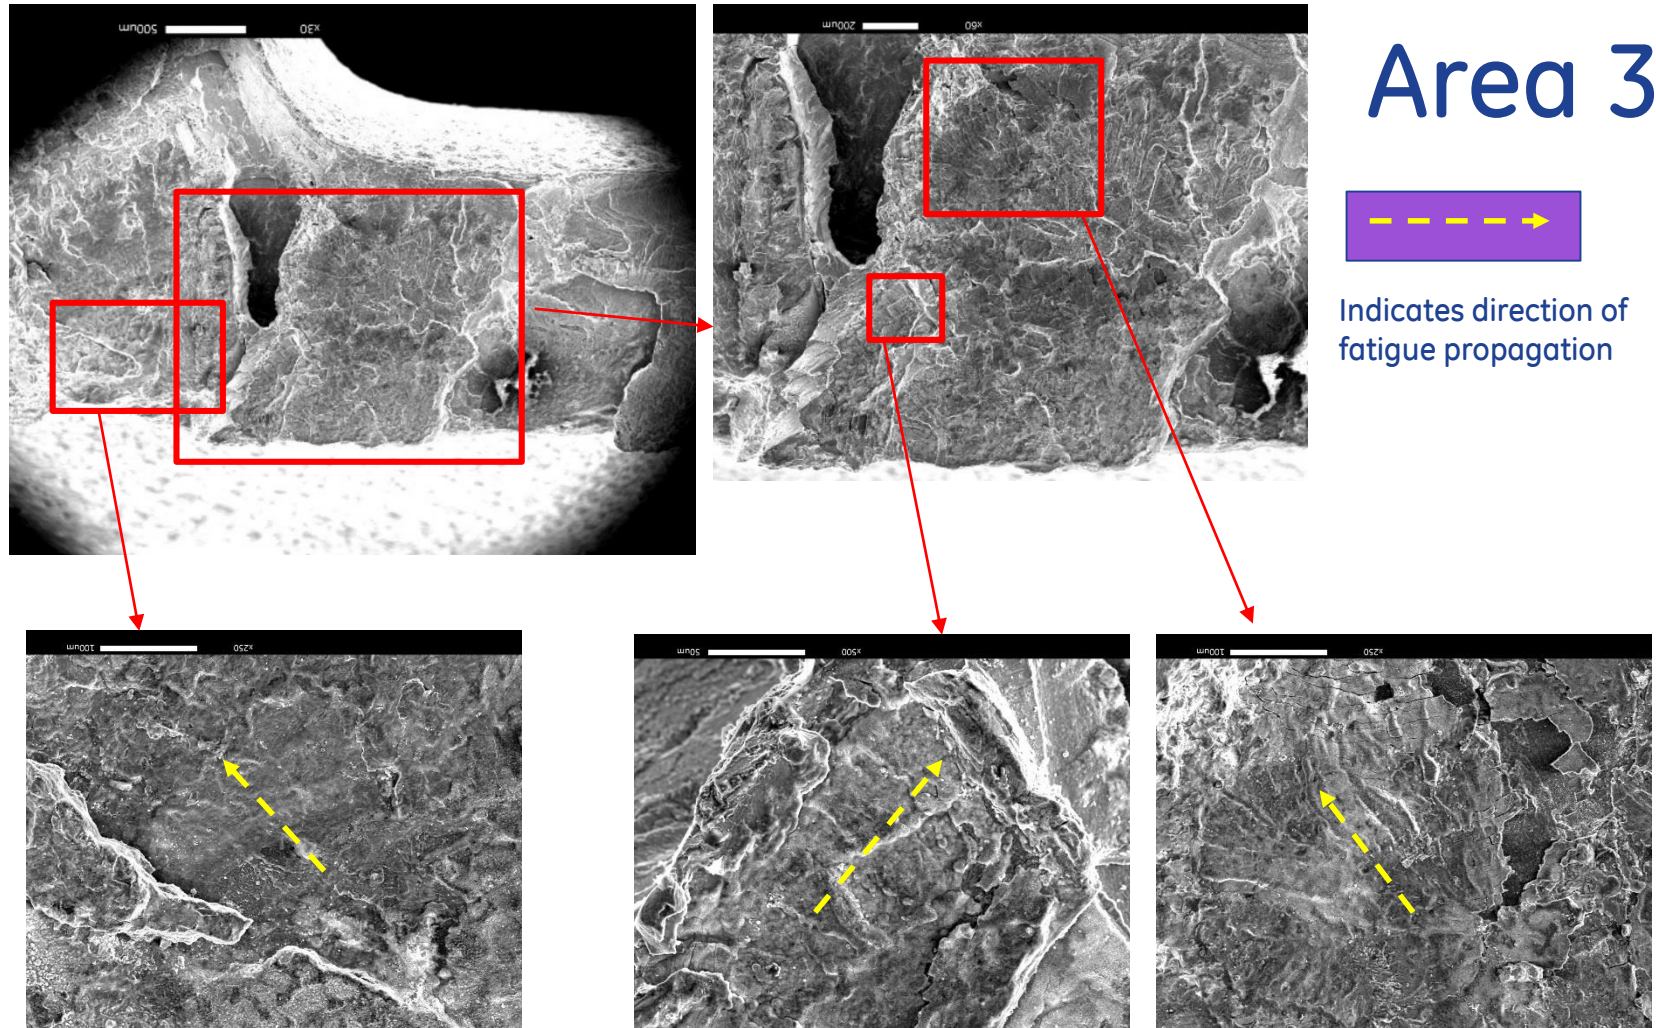
Figure 22

While corrosion products on the fracture surface often obscured fine details of the fracture surface, it was evident based on river lines and beach marks that fatigue had initiated at multiple origins along the convex surface of the shank upper radius and progressed toward the concave side. Figures 19-24.
