# Metallurgical Investigation Report

## Log No. FAL2017-17956

### METALLURGICAL EVALUATION OF A CF34-8C LPT CASE FROM ESN 965-352 OPERATED BY GOJET

P/N 4117T50G02  
S/N IHI355DA

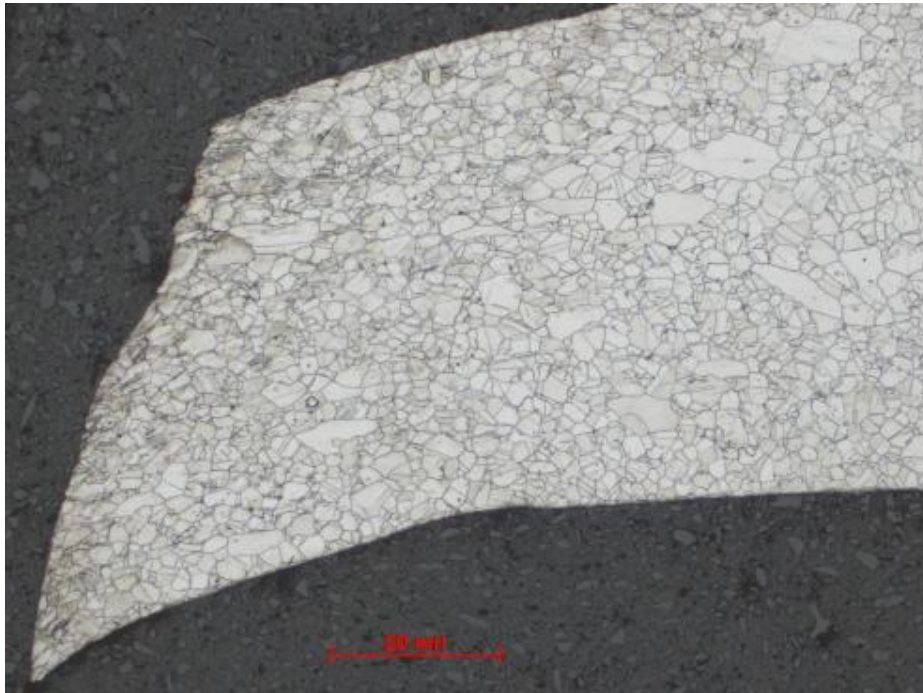
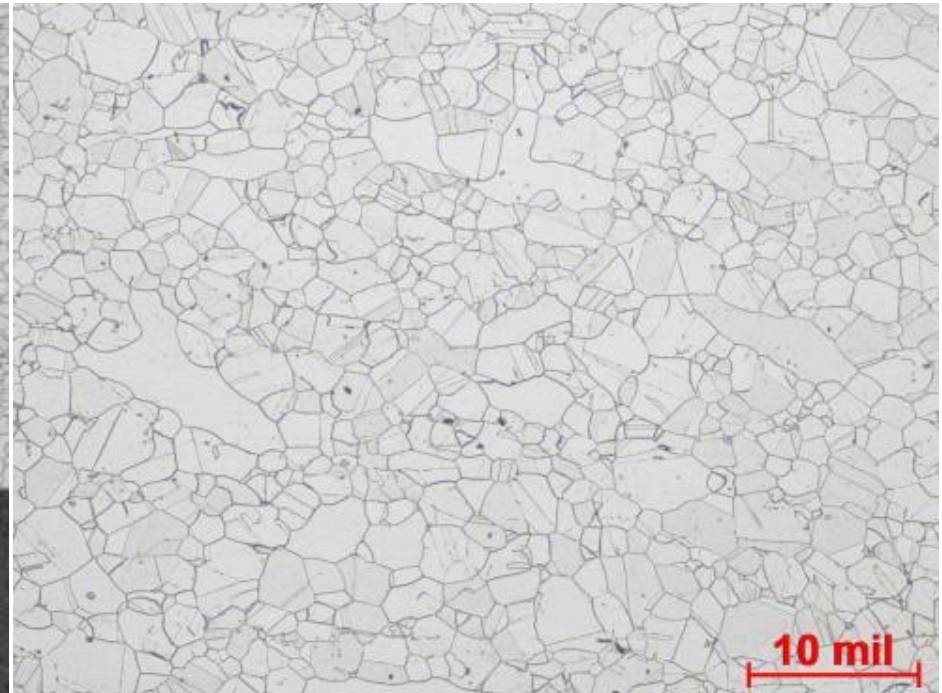
- A metallographic mount showed a wrought microstructure consistent with properly processed Waspaloy with an average grain size of approximately ASTM 5, conforming to the requirement of AMS 5707.

**Figure 6 :** A cross-sectional metallographic mount was made near the impact area showing a wrought structure with an average grain size of approximately ASTM 5, conforming to the requirement of AMS 5707. At the fracture (lower left) the wall was distorted and the grains were locally deformed consistent with a shear region.
