# NATIONAL TRANSPORTATION SAFETY BOARD

MATERIALS LABORATORY FACTUAL REPORT

Report No. 17-039

Place : Baltimore, Maryland  
Date : January 23, 2017  
Vehicle : Bombardier CRJ200, N8986B  
NTSB No. : ENG17IA008  
Investigator : Robert Hunsberger, AS-40

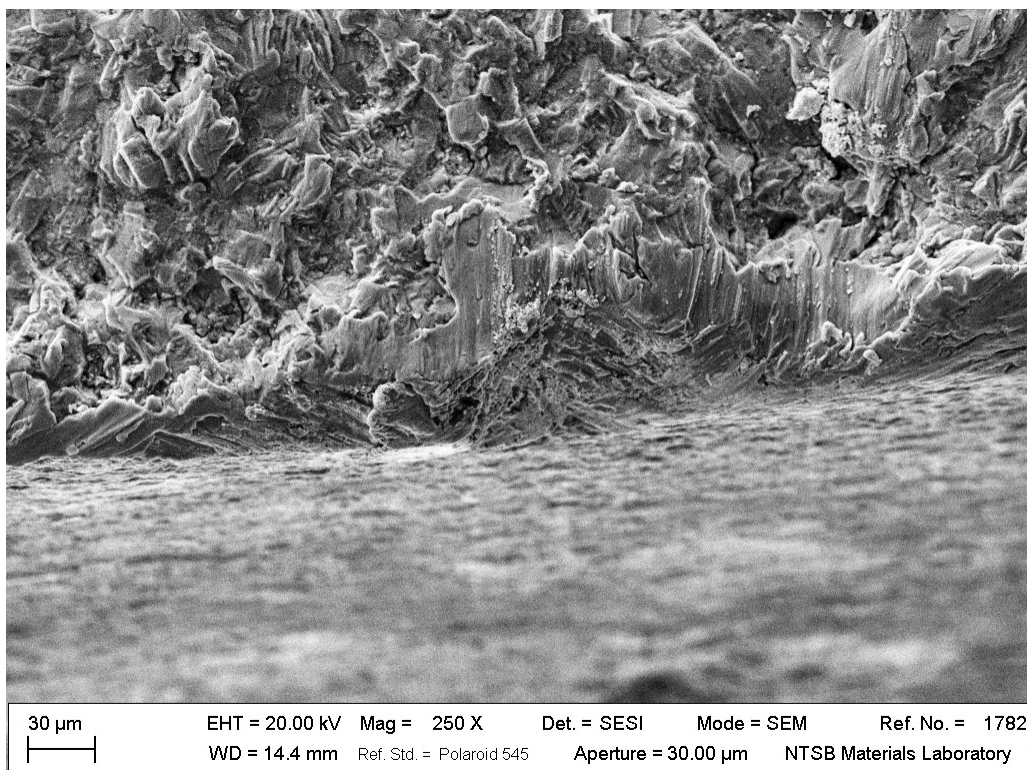
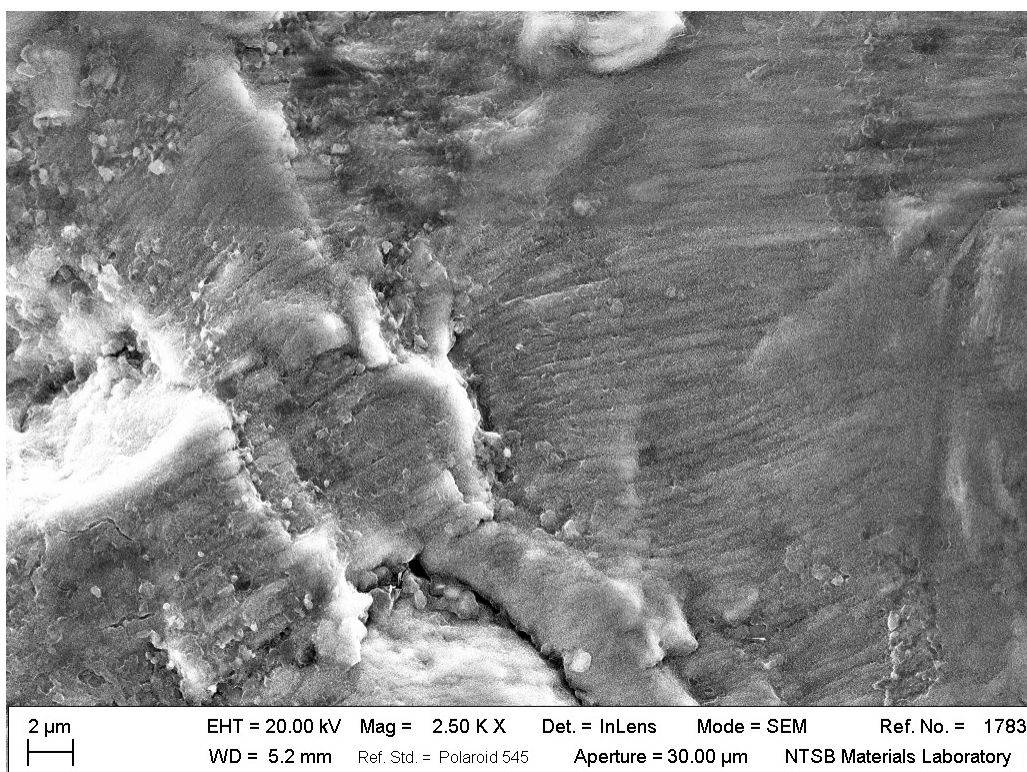
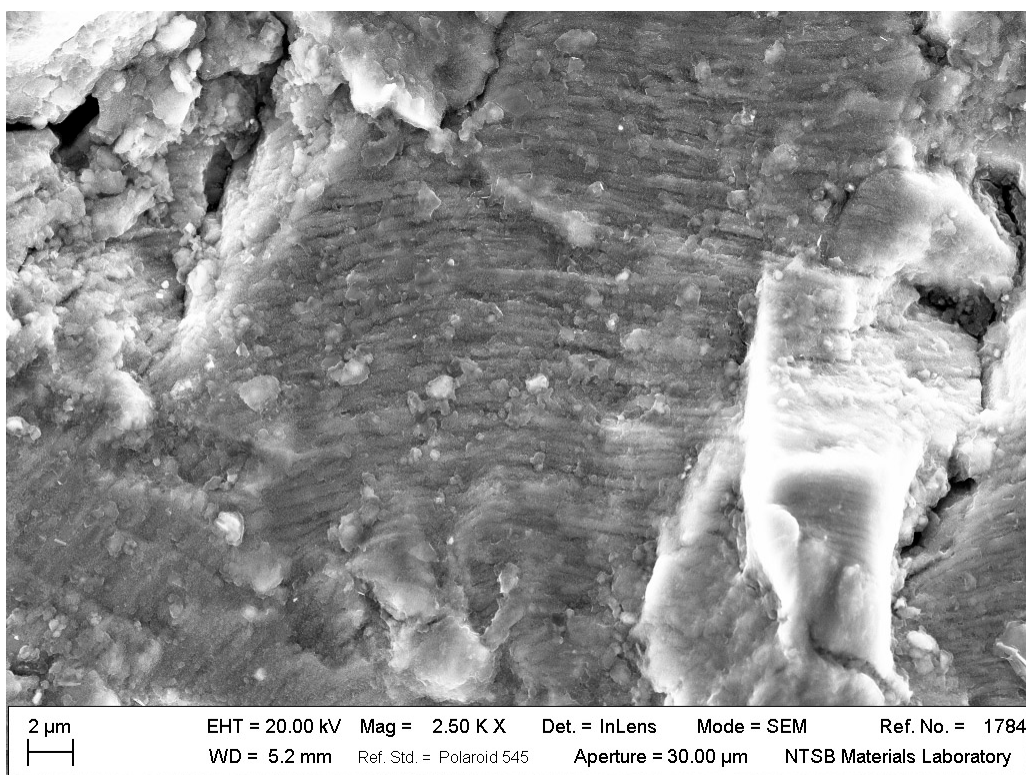
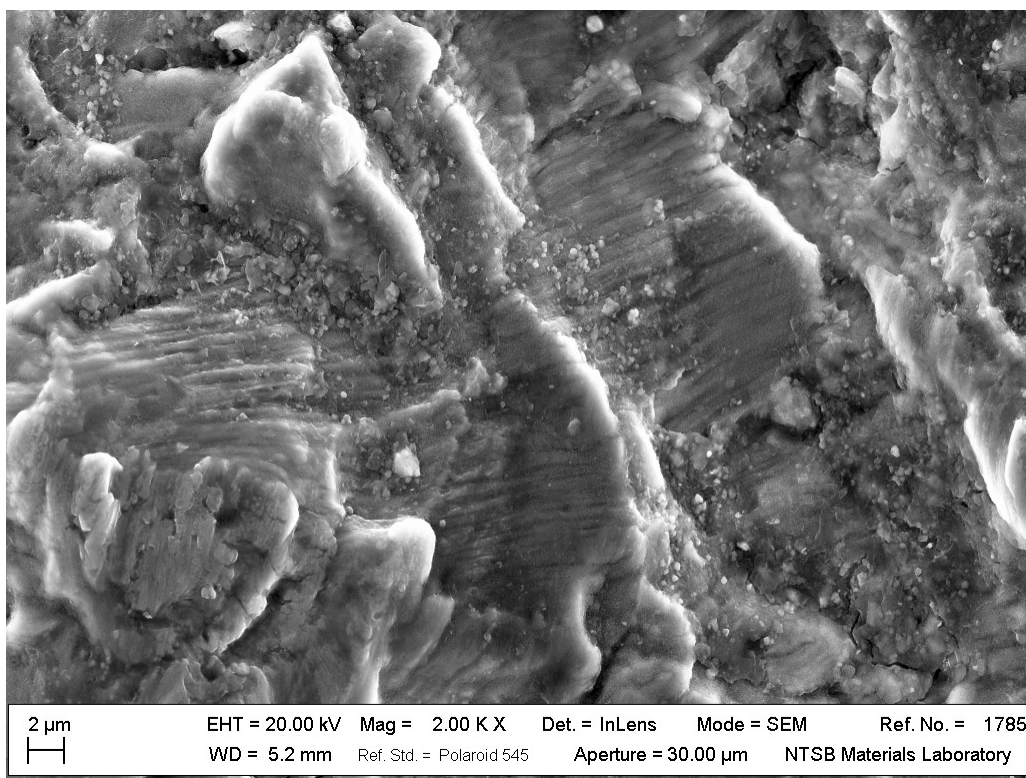
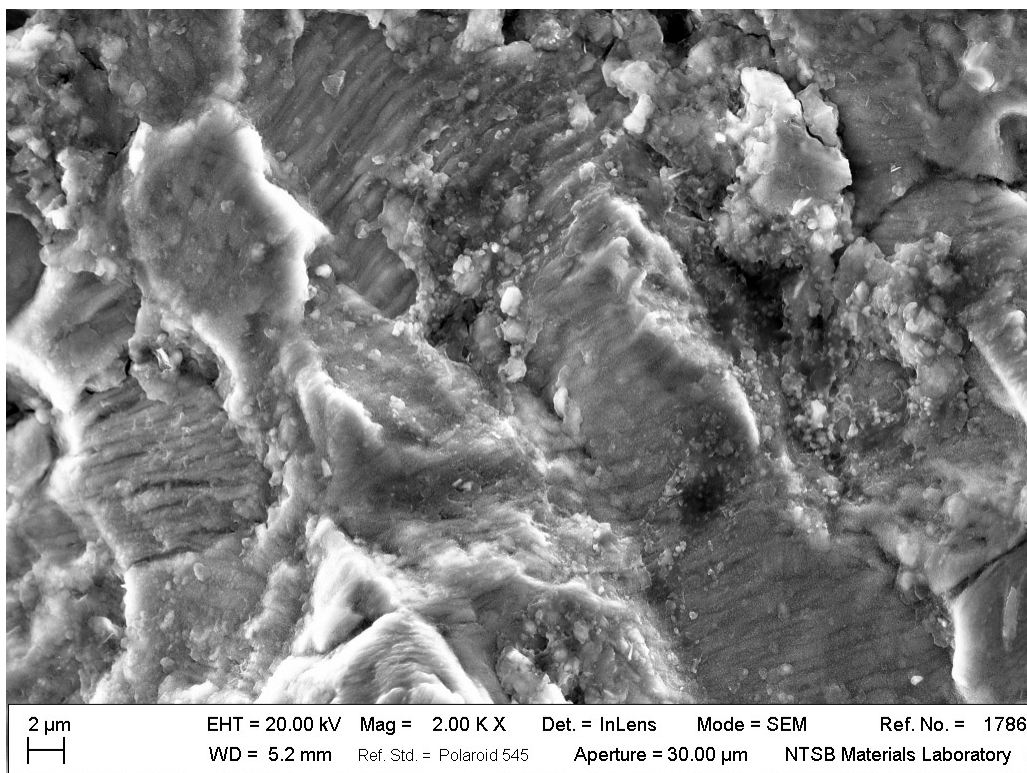
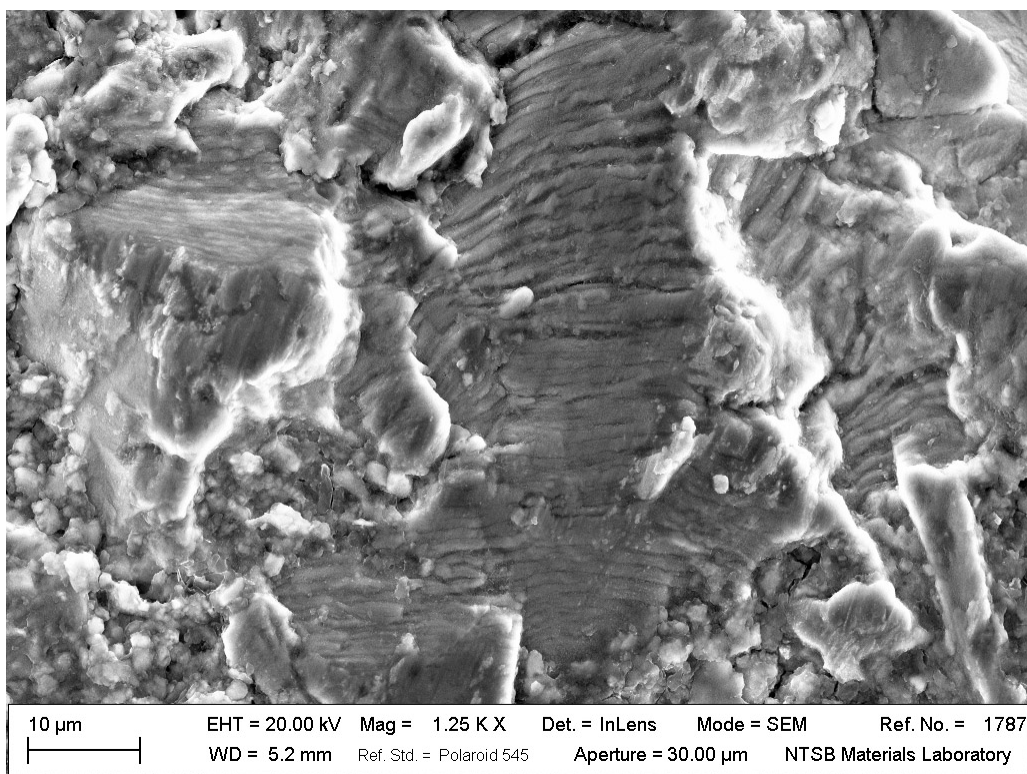
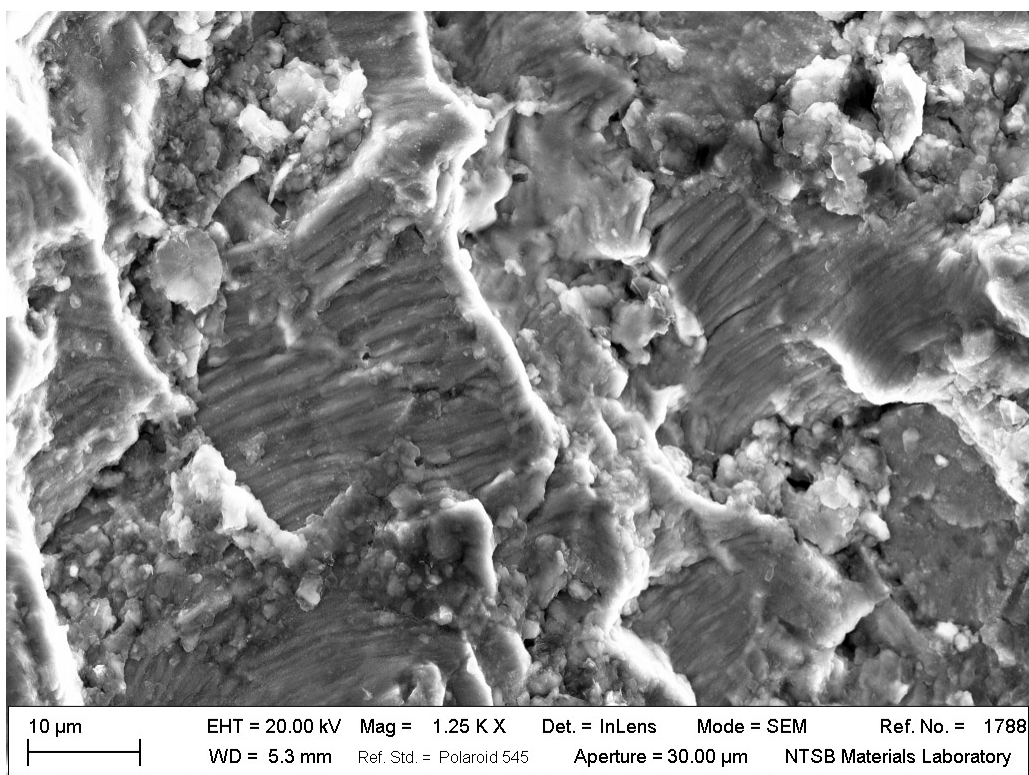
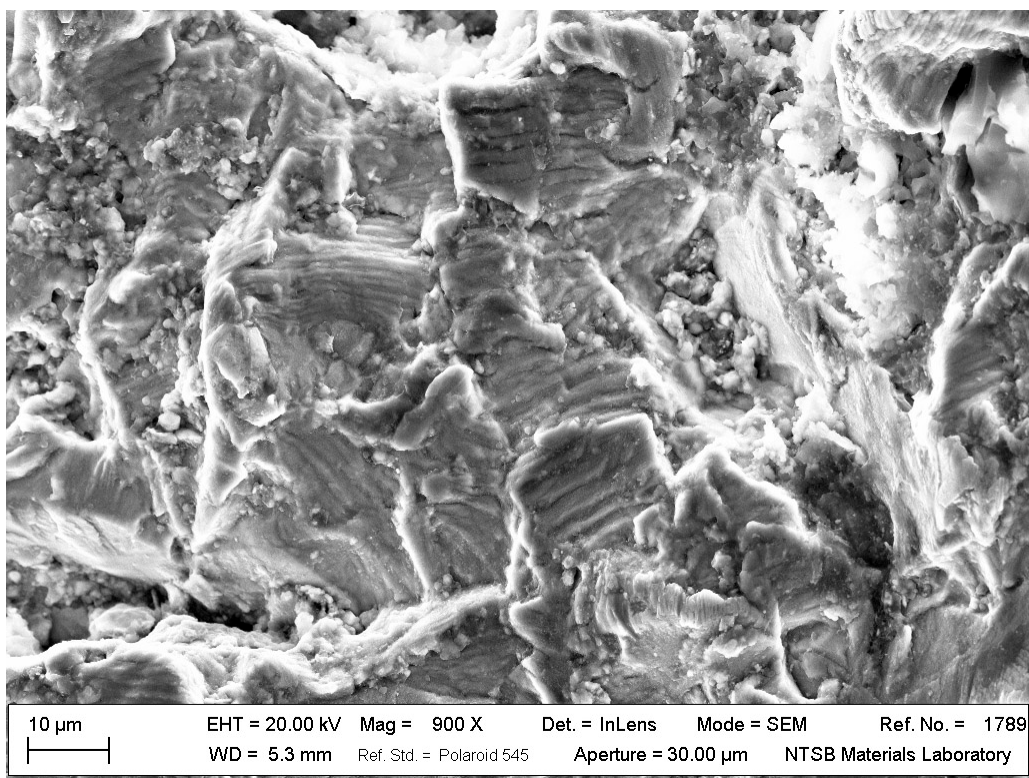
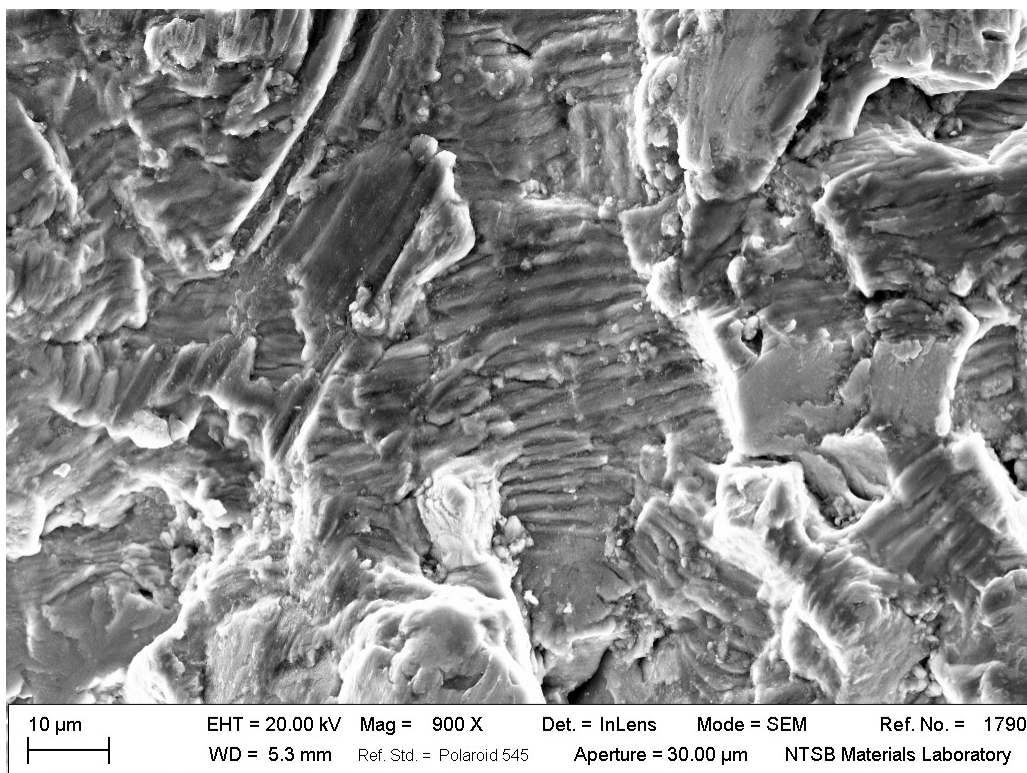
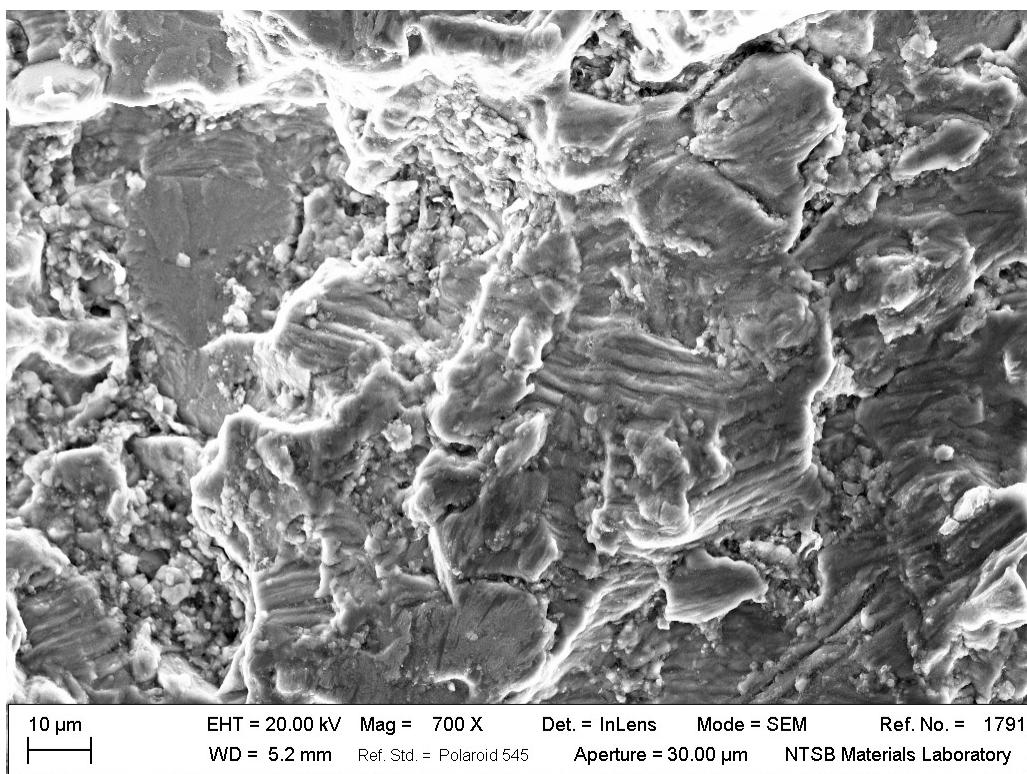
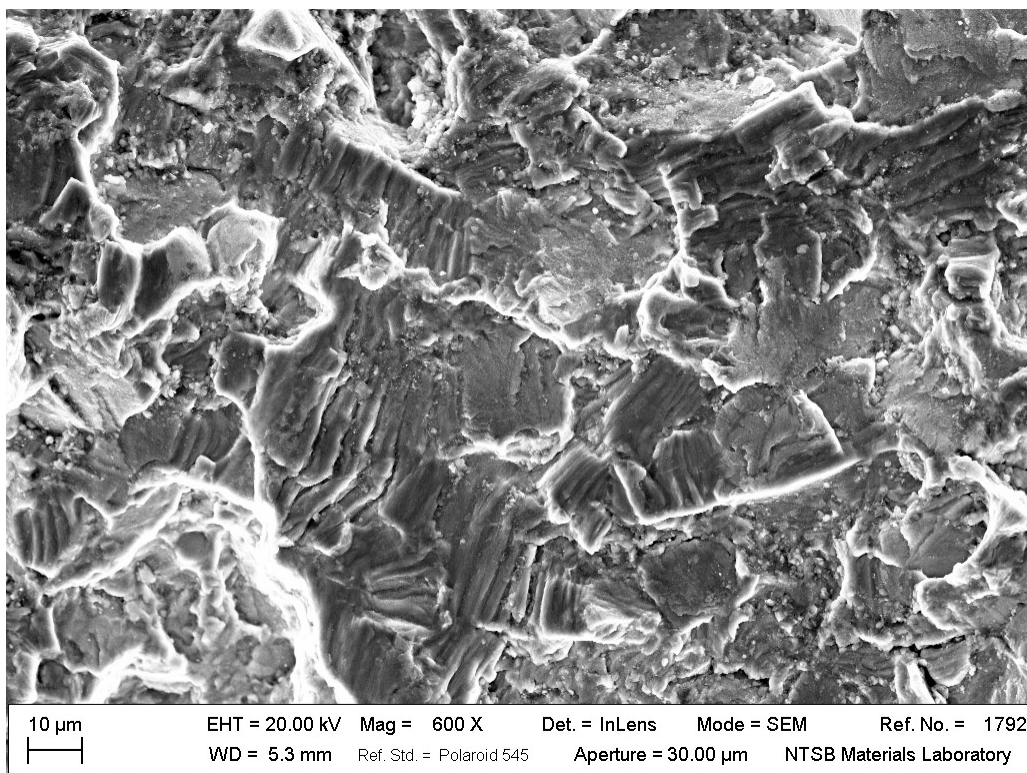
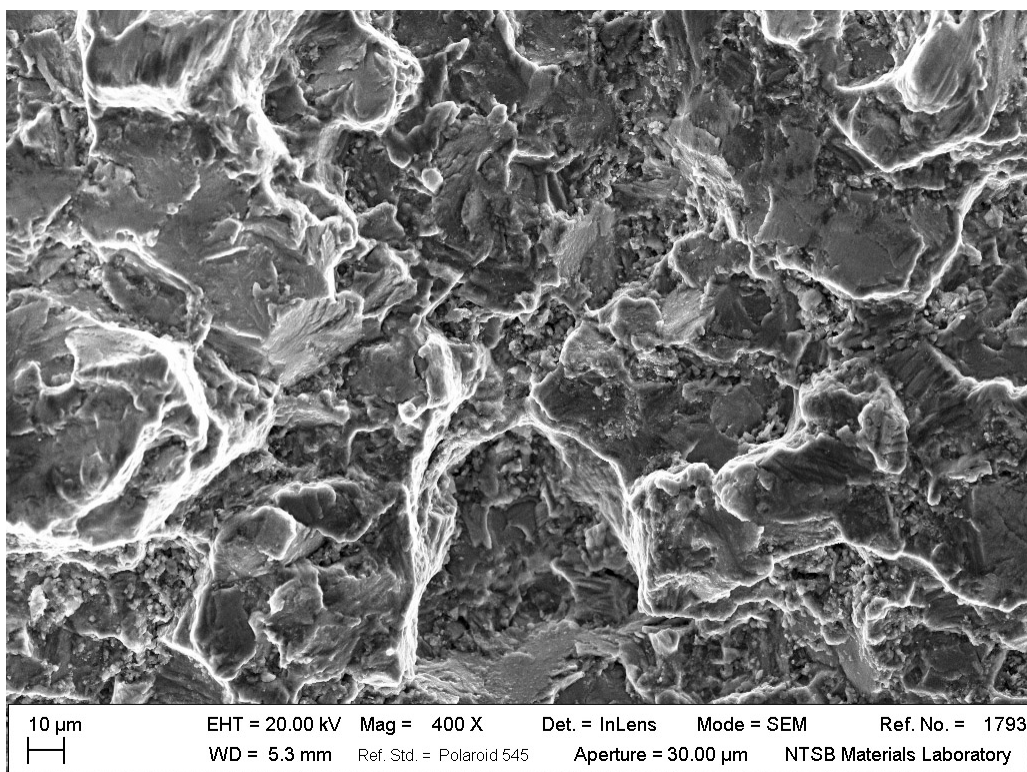
**A.1. Forward tang 9 o'clock position**

For each fracture surface, the striation density as a function of distance from the pin hole was measured in the LCF region on a series of SEM images starting at the pin hole and proceeding outward until the transition to the smeared region (cyclic tensile region). For the forward tang 9 o'clock position, the series was started at the single origin, 0.090 inch from the aft face of the tang. For the other straps, the series was taken where visual LCF crack arrest lines were observed furthest from the pin hole: 0.131 inch from the forward face for the forward tang 3 o'clock position, 0.330 inch from the forward face for the middle tang 9 o'clock position, and 0.106 inch from the forward face for the middle tang 3 o'clock position. The images used for the striation density measurements are included in appendix A and the density measurements are shown in tables 1 through 4. The density was measured by counting a series of successive striation marks on an SEM image and dividing by the distance spanned by those striations.
