# Metallurgical Investigation Report

## FA Log No. 2017- 18137

### **METALLURGICAL EVALUATION OF A RELEASED FAN BLADE FROM ENDEAVOR AIRLINES CF34-3B1**

ESN 873-642  
S/N KGACA251  
P/N 6018T30P14

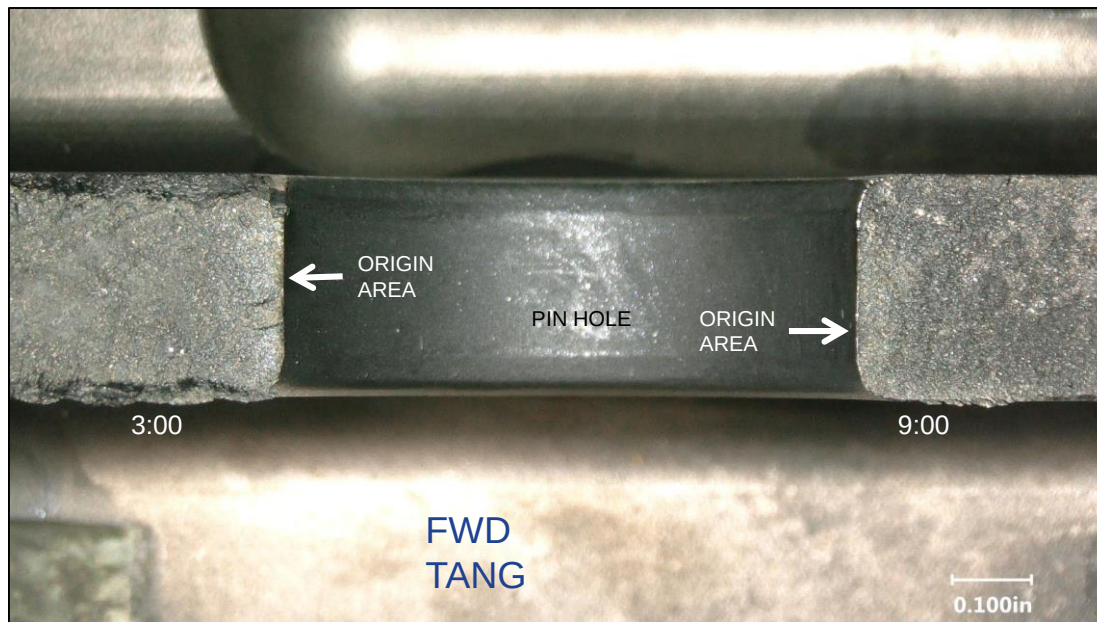
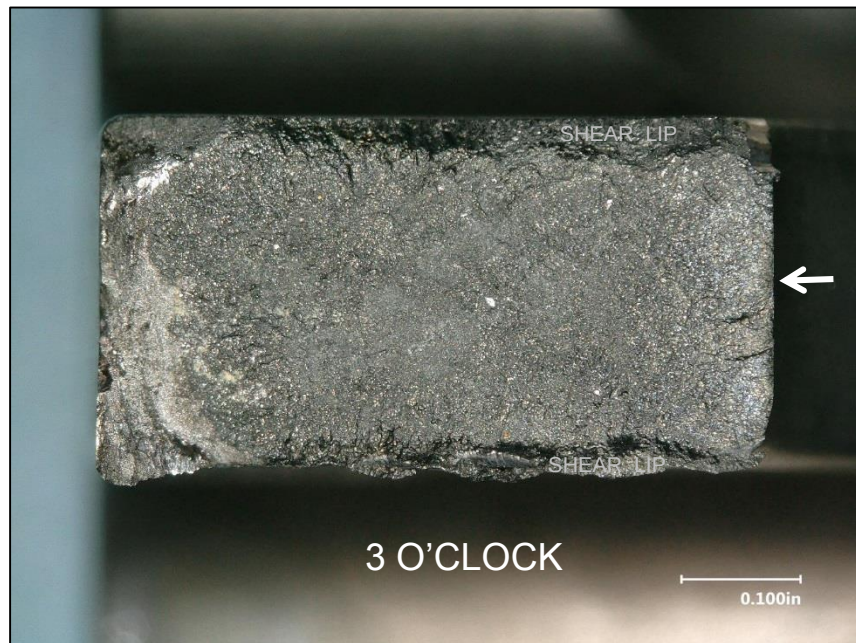
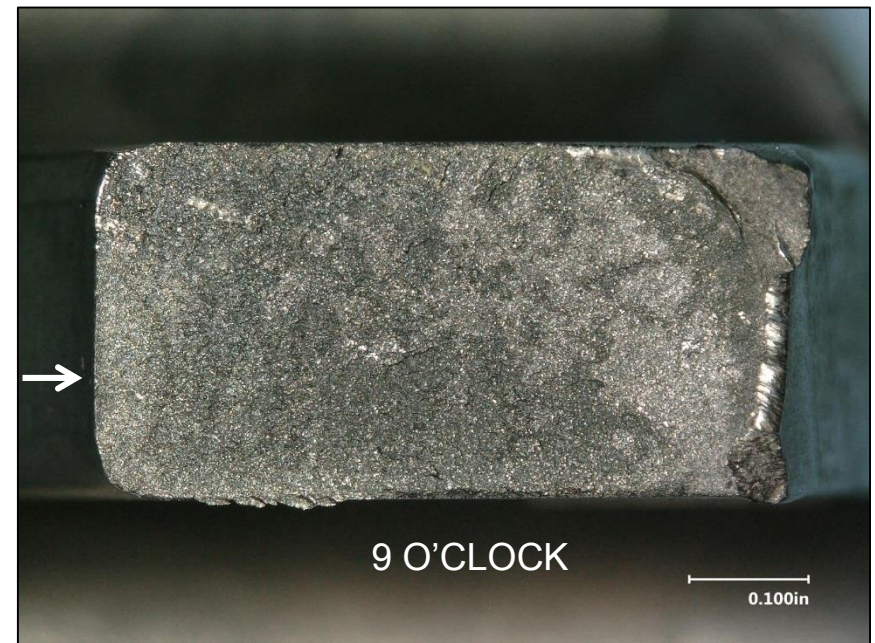
Views of the forward tang fracture at the 3 o'clock (ALF) position. Visual examination found no evidence of blending from a repair operation. The fracture surface was obscured by transferred aluminum.

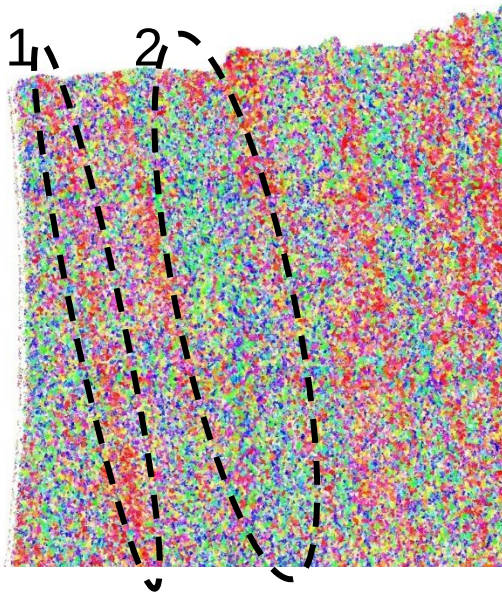
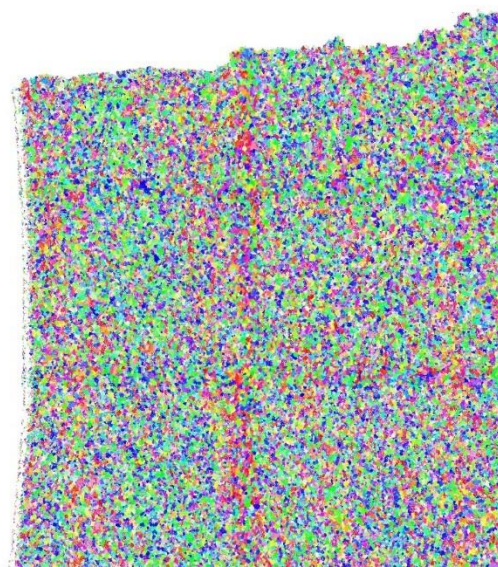
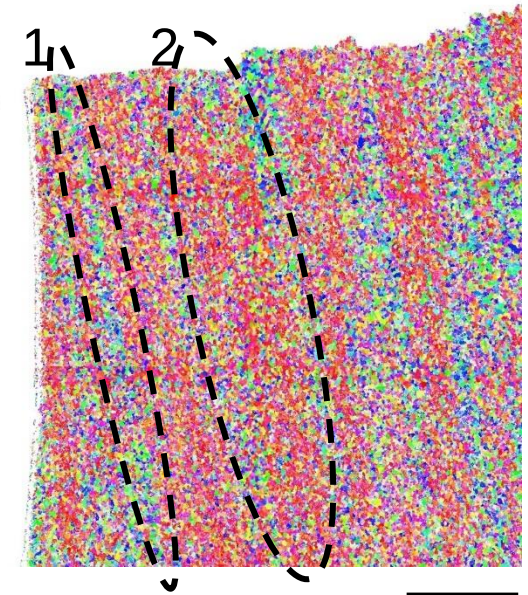
## FWD-TANG 3-o-clock FWD-looking-AFT

The metallographic mounts were sent to GE Global Research Center (GRC) in Niskayuna, New York for electron backscatter diffraction (EBSD) to evaluate the structure for aligned alpha colonies. EBSD results showed the alpha colonies were not aligned to the crystallographic orientation that would be susceptible to dwell-time fatigue crack initiation. The texturing noted was considered typical for the bar stock used to forge the fan blades. See pages 30-32.

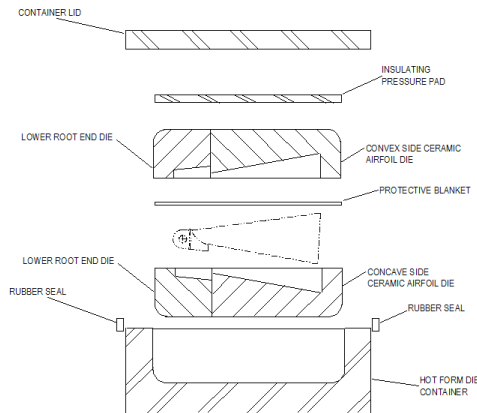
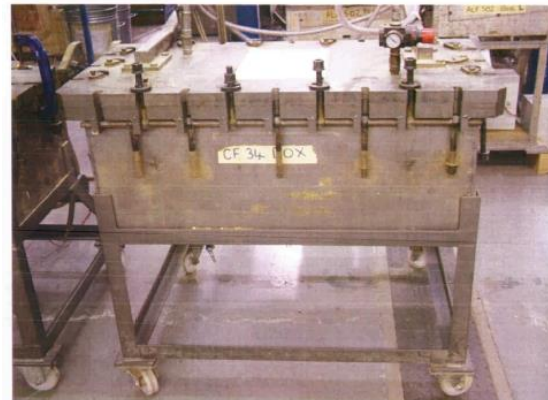
HOT FORMING CASKET

Records indicated event blade S/N KGACA251 was subjected to a creep hot forming repair process at ATI in the United Kingdom following a bird-strike event while installed in ESN 872-972 in 2007. The blade is placed in a "hot box" or "casket" between two ceramic dies to form the airfoil back to acceptable dimensions. The hot form process is sufficient to relax the compressive residual stress imparted by the shot peening in the pin holes and form an oxygen-stabilized layer on the surface referred to as alpha case. See pages 33-34.

Do a creep hot form of the airfoil by placing the blade in a “hot box” or “casket” between two ceramic dies to “reform” airfoil to acceptable dimensions.

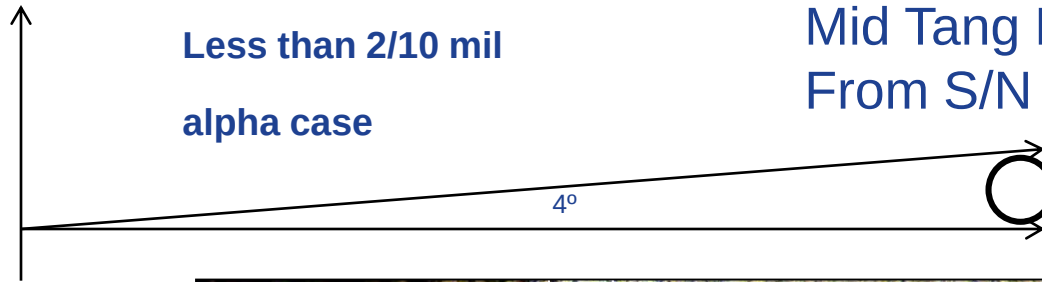
Mid Tang Face  
From S/N KGACA251

Metallographic evaluation of the face of the mid tang from blade S/N KGACA251 found approximately 0.0002 inch (2/10<sup>th</sup> mil) of alpha case consistent with predicted alpha case formation for the time and temperatures used for the creep hot forming process on the titanium alloy Ti 6Al-2Mo-4Zr-2Sn. See pages 33-34.

Less than 2/10 mil  
alpha case

Metallographic evaluation of blade S/N KGACA251 was performed by mounting the specimen on a 4° angle. Ammonium bifluoride etch revealed a white layer at the surface that was consistent with alpha case. Metallographic evaluation of S/N KGAK5302 showed no evidence of alpha case.

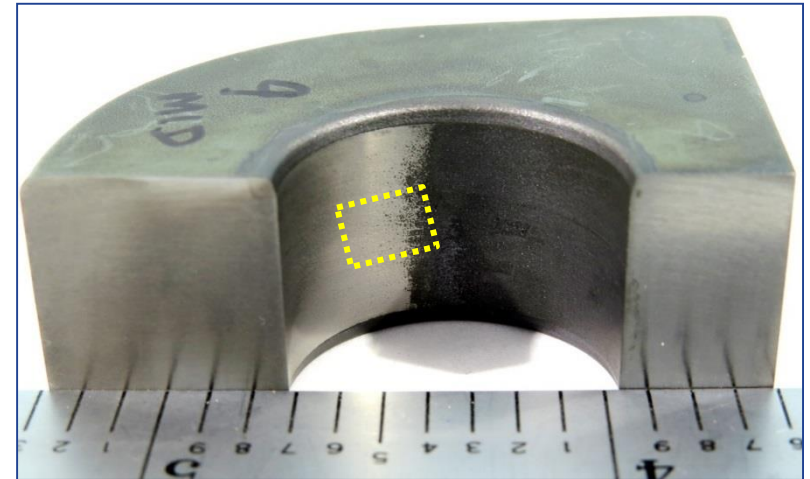
Residual stress analysis was performed on the pin holes from the event blade S/N KGACA251 and four additional fan blades. Results of the residual stress analysis showed a significant amount of the compressive residual stress from the original shot peening was lost during the creep hot forming process and subsequently was not restored resulting in a pin hole surface condition that was susceptible to crack initiation.

Representative of the additional four fan blade mid tangs

Residual stress analysis was performed on the pin holes from the event blade S/N KGACA251 and four additional fan blades at the area indicated on the mid tangs shown above. Results of the residual stress analysis showed a significant amount of the compressive residual stress from the original shot peening was lost during the creep hot form process and subsequently was not restored. See page 36.

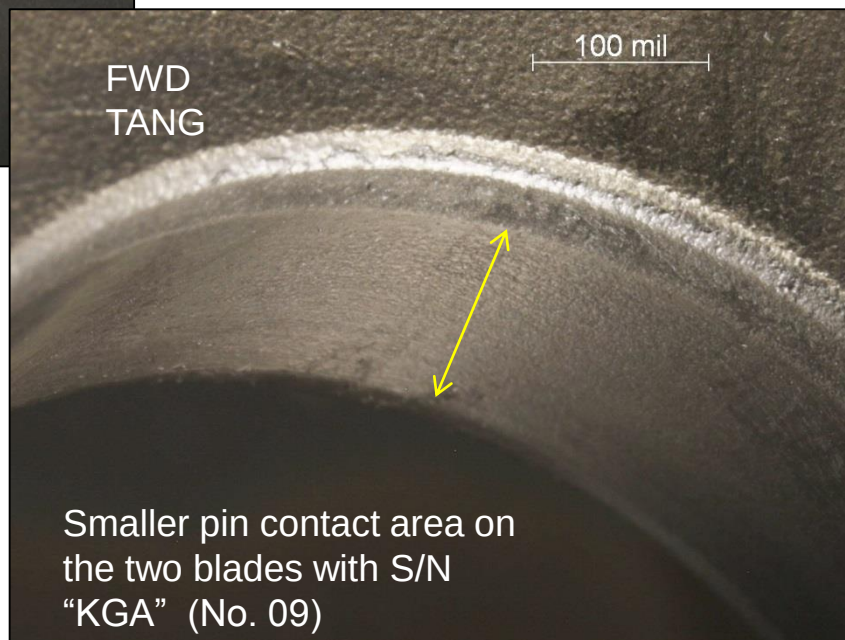
Visual examination of the blade set from ESN 873-642 revealed that one blade (No. 09) with a "KGA" serial number similar to the event blade S/N KGACA251 exhibited pin hole radii much larger than the remaining twenty-six (26) blades. Subsequent measurements revealed blade No. 09 had radii that exceeded the maximum allowed per the drawing. Measurements of the failed blade (No. 22) showed it also had radii exceeding the drawing limit. Subsequent analysis showed this condition had a minimal effect on stress and was not considered a major contributor.

The following slides show representative photos illustrating the over-max radii condition observed on the "KGA" serial number fan blades.

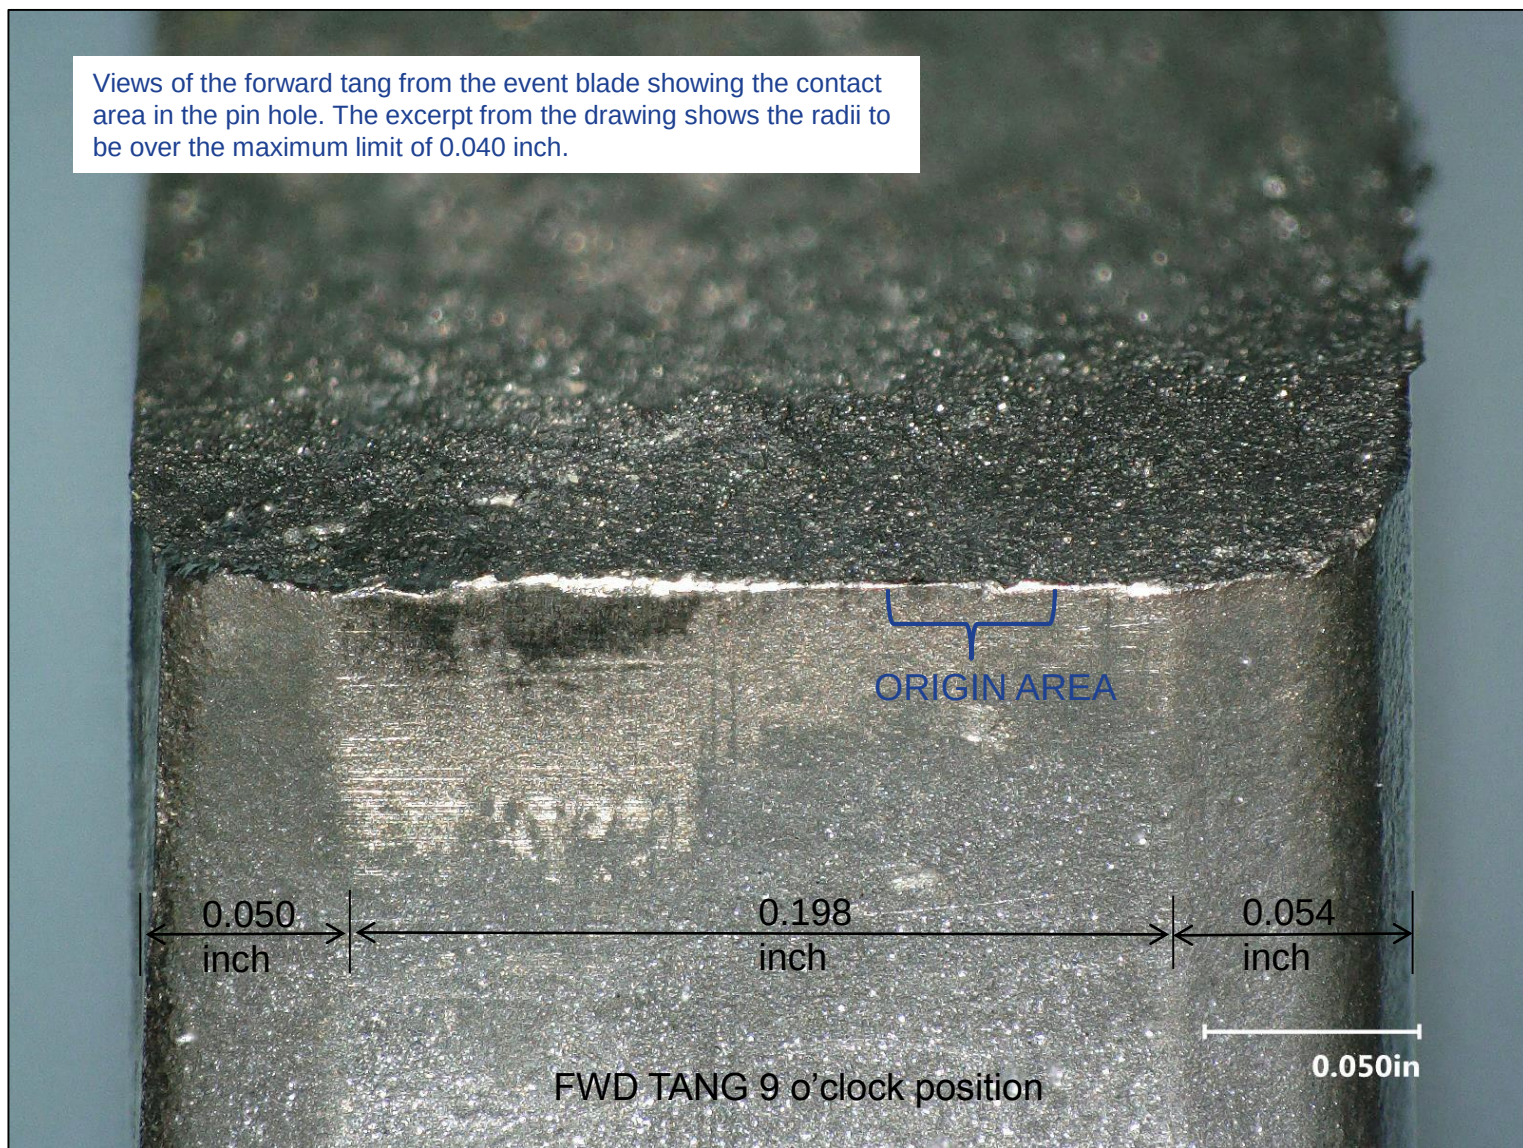
Views of the forward tang from the event blade showing the contact area in the pin hole. The excerpt from the drawing shows the radii to be over the maximum limit of 0.040 inch.
