NATIONAL TRANSPORTATION SAFETY BOARD  
OFFICE OF AVIATION SAFETY  
WASHINGTON, D.C. 20594

**POWERPLANTS GROUP CHAIRMAN'S FACTUAL REPORT**

NTSB ID No.: ENG17IA026

Location: G344 airway northeast of CUTE intersection  
Date: June 7, 2017  
Time: 0950 universal coordinated time  
Aircraft: Boeing 747-451, N668US, Delta Air Lines flight 276

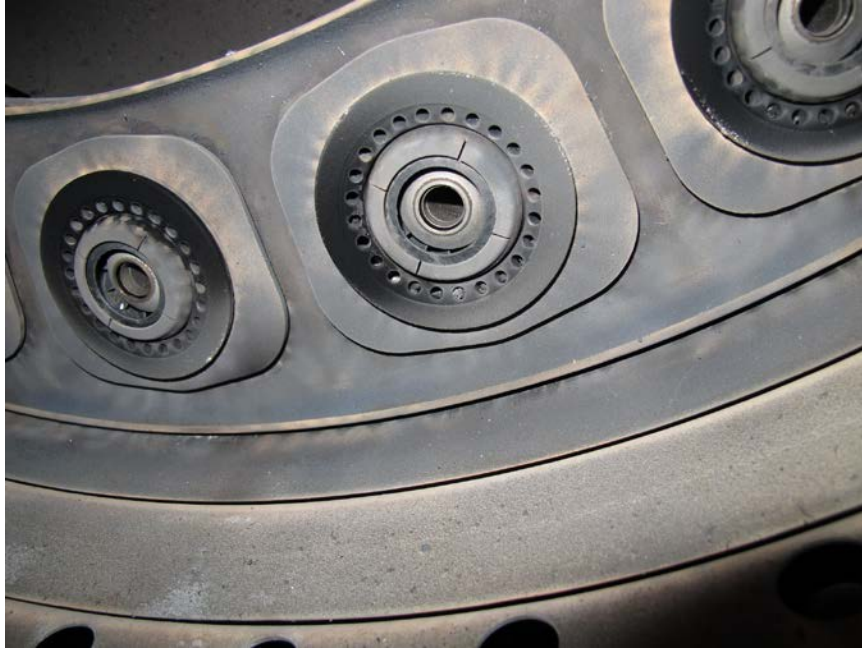
The fuel nozzles and manifolds were all in place. (Photo No. 38) The fuel nozzles and splash plates did not have any indications of thermal distress or streaking. The splash plates were sooted. (Photo No. 39)

Photo No. 39: Close up of fuel nozzles showing no thermal distress and the sooted splash plates. (P&W)

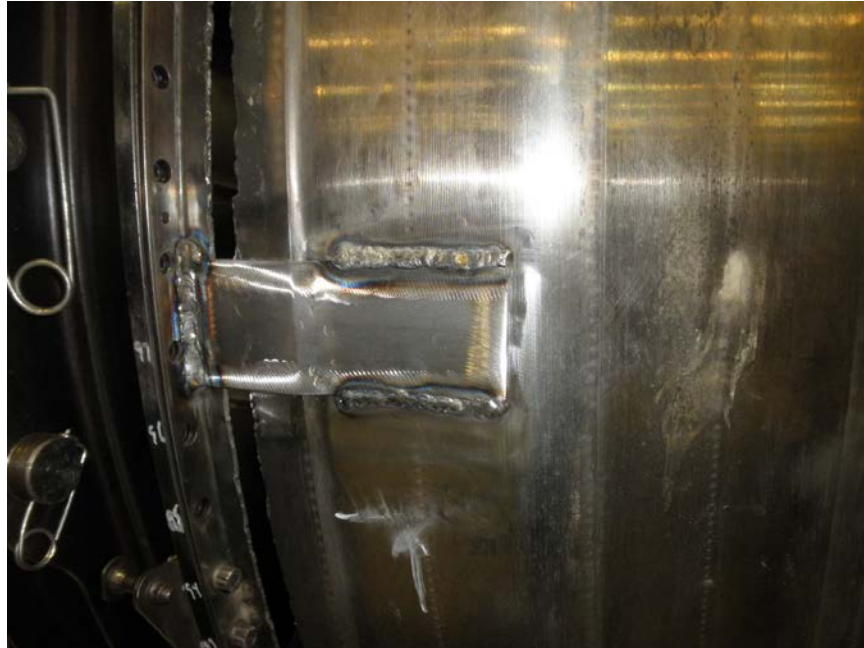
To facilitate the disassembly of the engine, 14 5-inch by 2-inch 0.040-inch thick plates made from a material similar to that of the LPT case were welded on the sides of the case to hold the rear flange to the rest of the LPT case when it was removed from the engine. (Photo No. 50)

Photo No. 50: View of one of the metal plates that was welded onto the LPT case to facilitate removal of the LPT and turbine exhaust case from the HPT case.

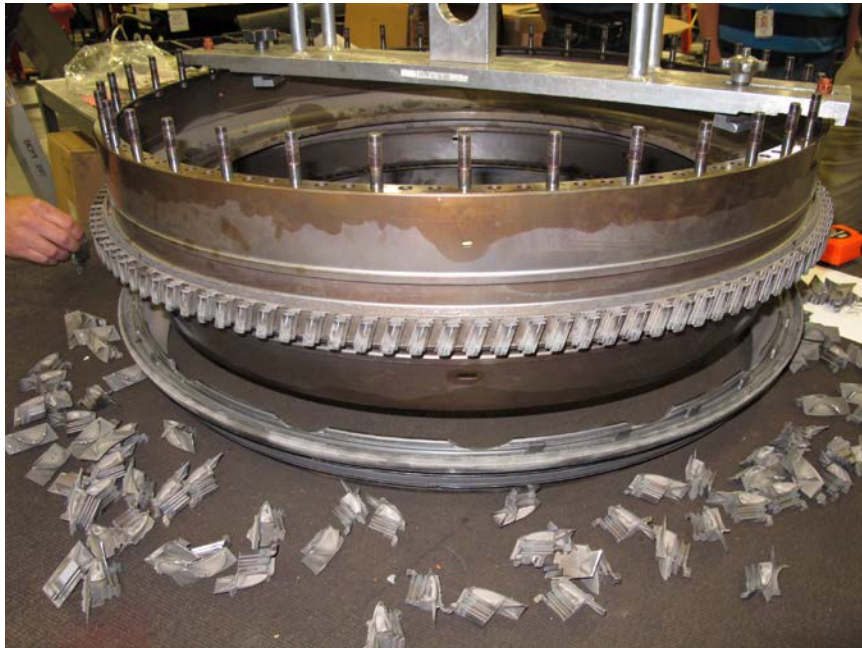
Photo No. 55: View of the 4th stage turbine disk showing that it was intact. (P&W)

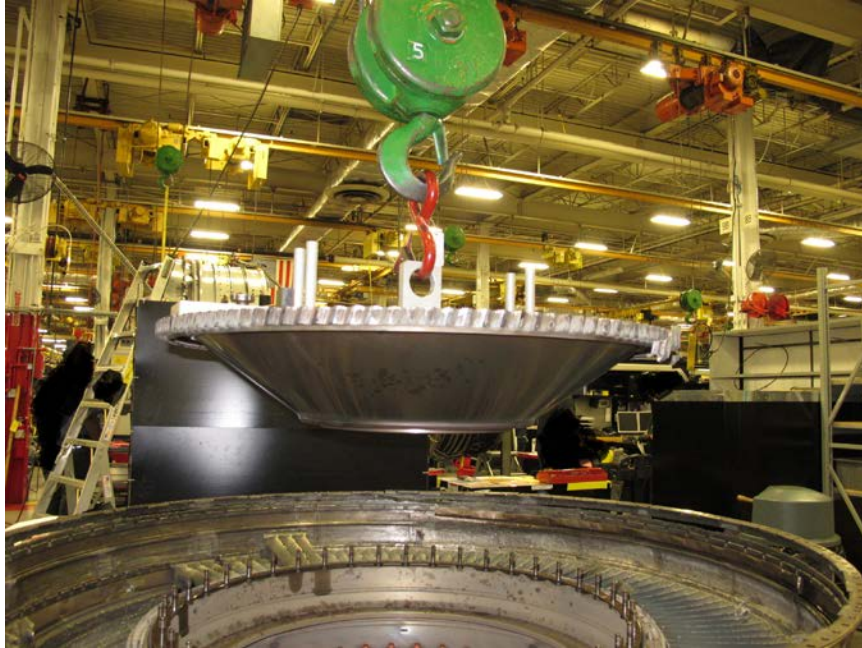
Photo No. 56: View of the 5th stage turbine disk showing that it was intact. (P&W)

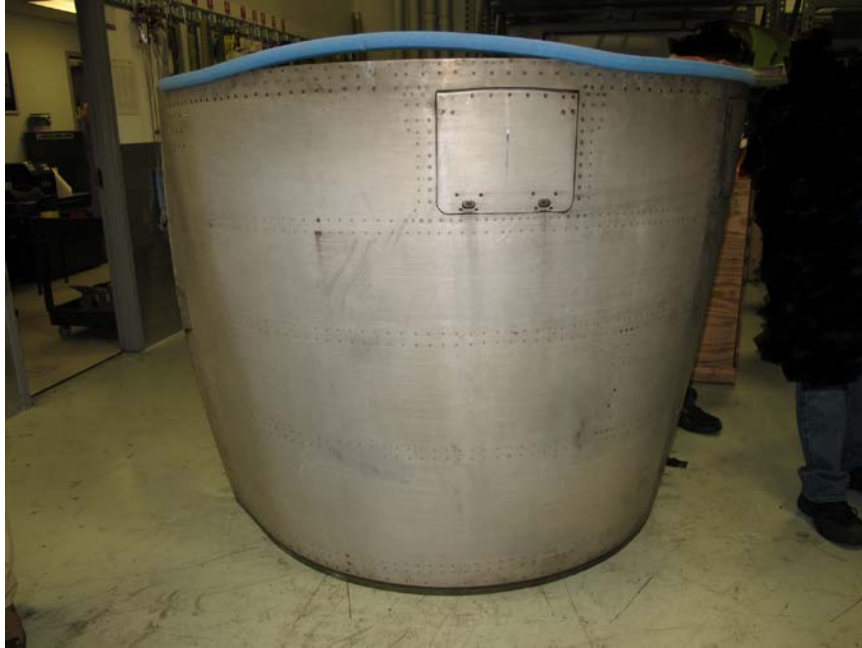
Photo No. 71: View of the inboard core cowl exterior showing no penetrations. (P&W)
