**NATIONAL TRANSPORTATION SAFETY BOARD**  
**Office of Aviation Safety**  
**Washington, D.C. 20594**

**POWERPLANT GROUP CHAIRMAN'S FACTUAL REPORT**  
**NTSB No: ENG17IA028**

Aircraft: Bombardier CRJ700, N715SK, SkyWest Airlines Flight 2985

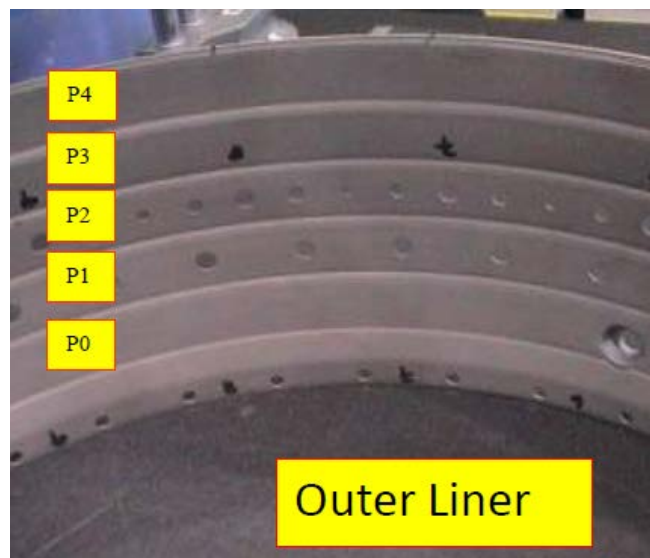
**Photo 17- Combustion Outer Liner Panel Identification**

GE documentation identifies the combustion outer liner sections by panel numbers, P0-P4 (**Photo 17**). The combustion outer liner on the incident engine had a 12 inch long circumferential crack that ran between the cooling air holes on panel P2, from the 10 o'clock to 12:30 positions. The circumferential crack was connected to an axial crack that ran approximately 2.5 inches from panel P2 to the aft flange/trailing edge of the panel P4 (interface with the HPT 1<sup>st</sup> stage nozzle). At the junction of the circumferential and axial cracks, the liner surface was displaced about 1.5 inches radially in towards the engine centerline (**Photo 18**). A second 2.5 inch axial crack was also present at the 2 o'clock position between panel P2 and the trailing edge of panel P4. There was no circumferential cracking in the area around the second crack.
