**NATIONAL TRANSPORTATION SAFETY BOARD  
OFFICE OF AVIATION SAFETY  
WASHINGTON, D.C. 20594**

NTSB ID: ENG18IA036  
POWERPLANT GROUP CHAIRMAN'S FACTUAL REPORT

March 4, 2022

Location: Atlanta, Georgia  
Date: September 5, 2018  
Time: 2332 Eastern Daylight Time  
Aircraft: Boeing 757-232, N668DN, MSN 25141, operated by  
Delta Air Lines

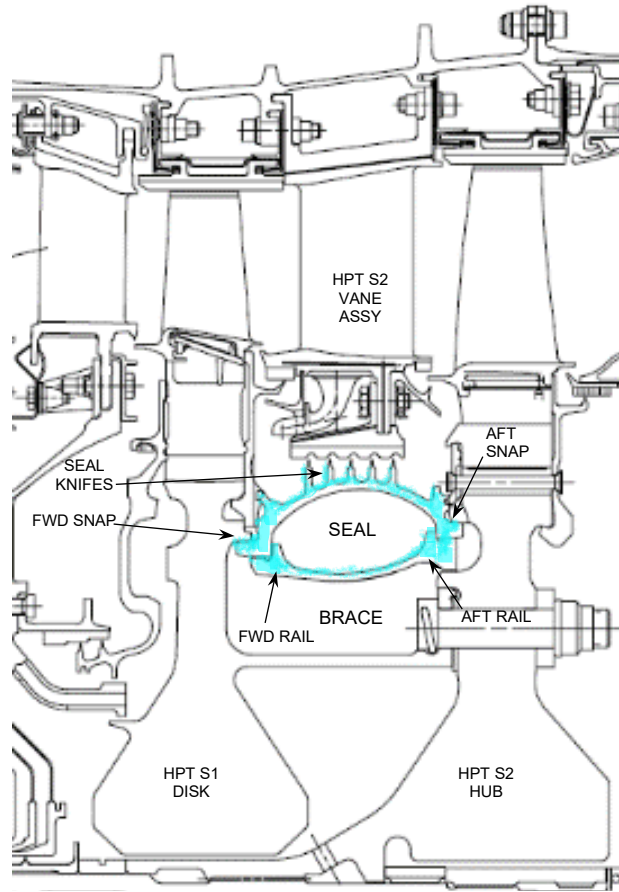
The HPT S2 air seal assembly (lenticular seal) is a labyrinth-type rotating seal located between the HPT S1 disk and HPT S2 hub. An outer seal piece includes five knife edges and forward and aft snap surfaces. The seal piece fits to an inner brace piece that includes forward and aft rails. See Figure 2.

Figure 2. HPT rotor cross section with lenticular seal highlighted

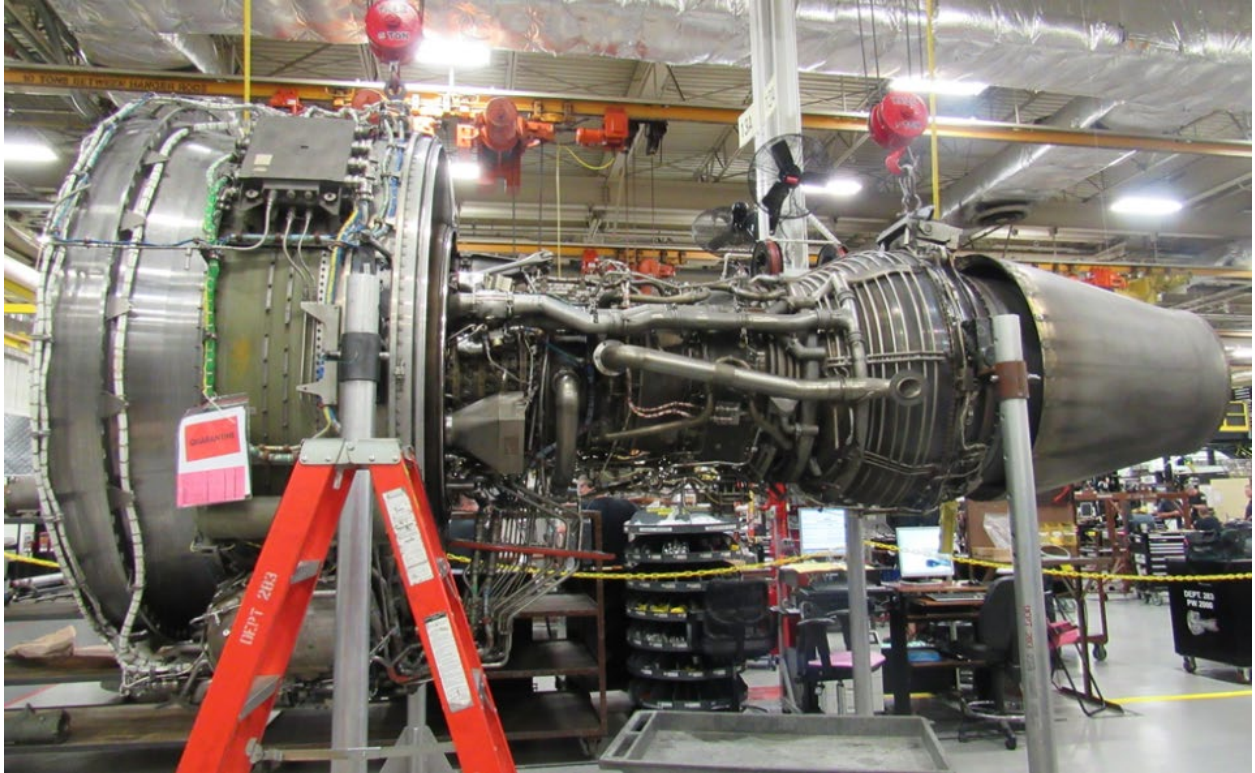
Figure 14. Left side view of ESN 716415

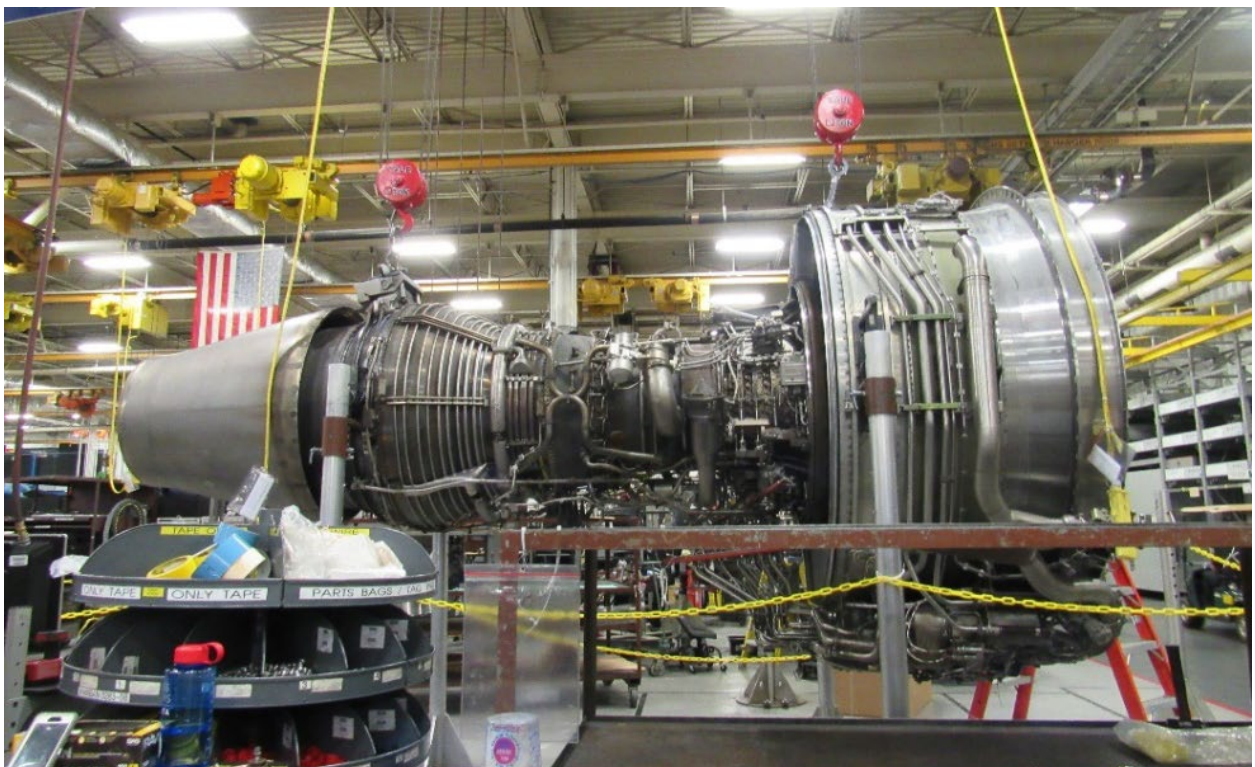
Figure 15. Right side view of ESN 716415

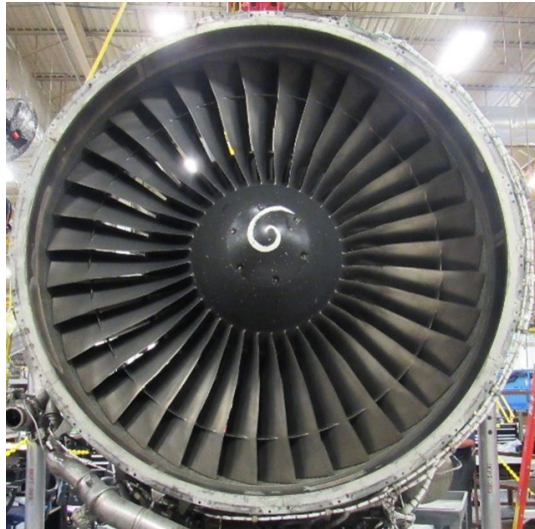
There was no obvious fan blade damage. The LPT S7 turbine blades were intact. Metal debris was collected from inside the tailpipe. See Figures 16 and 17.

Figure 16. Engine inlet
