# Metallurgical Investigation Report

## FA Log No. 18712

**METALLURGICAL EVALUATION OF  
CFM56-7B STG. 1-2 HPC SPOOL AND  
STG. 1 HPC VSV TRUNNION/LEVER  
ARM HARDWARE FROM ESN 875-  
318 OPERATED BY UNITED AIRLINES**

**Final Report Date: June 14, 2019**

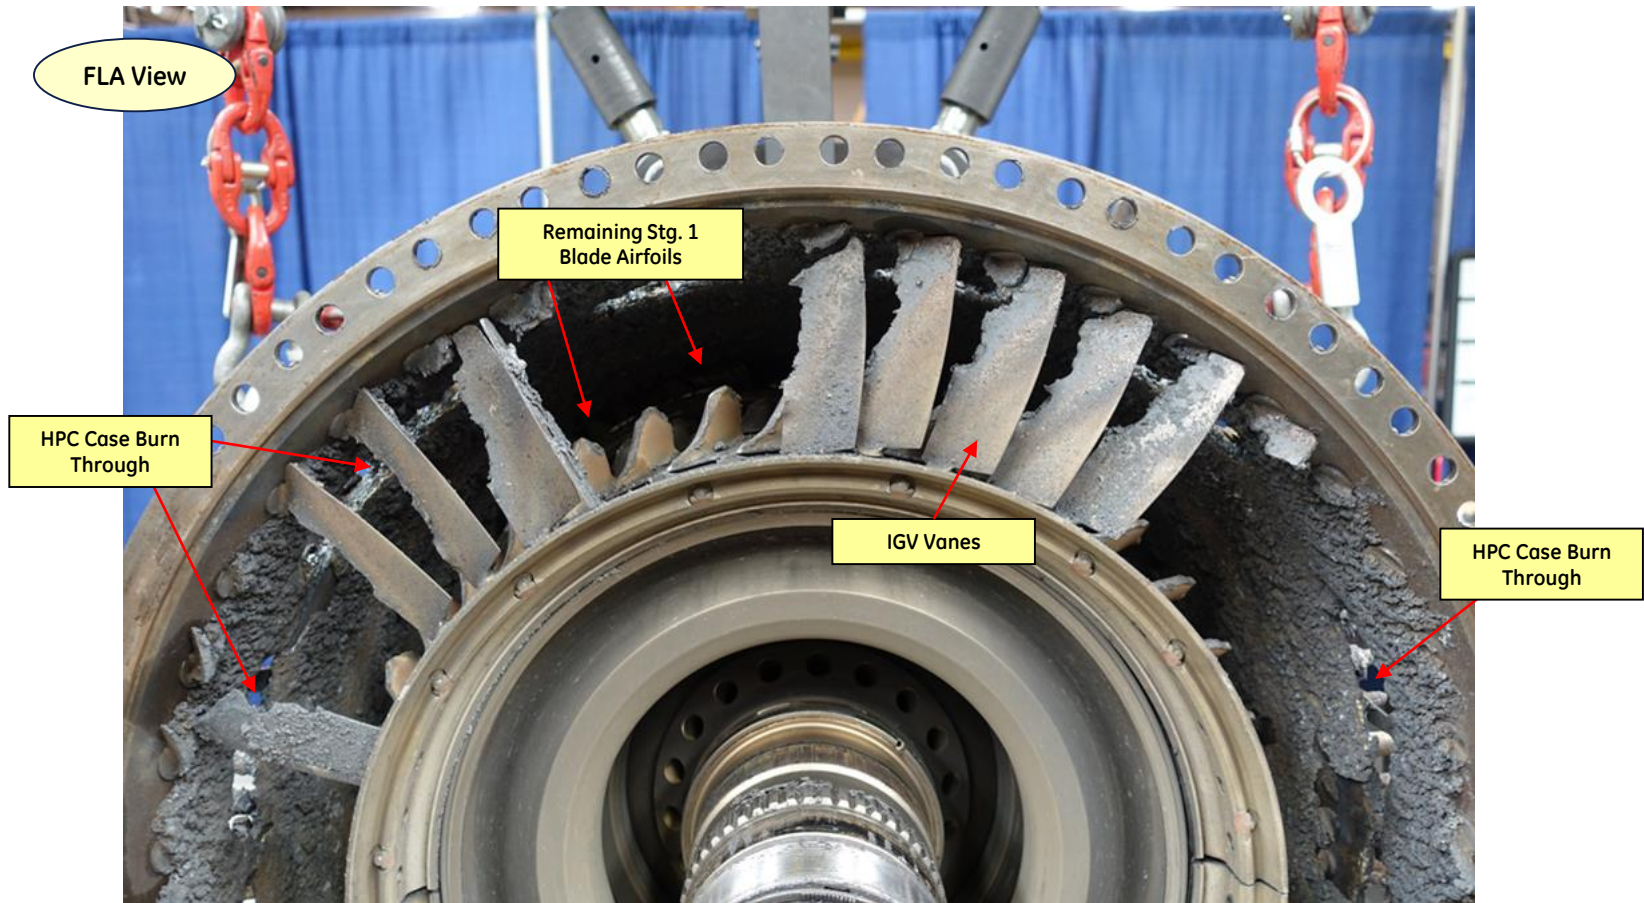
Compressor Inlet Condition

- Missing IGV Vanes and Significant Amounts Molten Material in Compressor Inlet
- Numerous Regions of HPC Case Burn Through in Plane of Stage 1 HPC Blades
- Shape Remaining Stg. 1 HPC Blade Airfoils Consistent With Burning

Figure 2. Photograph looking into compressor inlet (FLA). Numerous missing IGV's and abundant molten metal splatter observed on HPC Case ID surface.

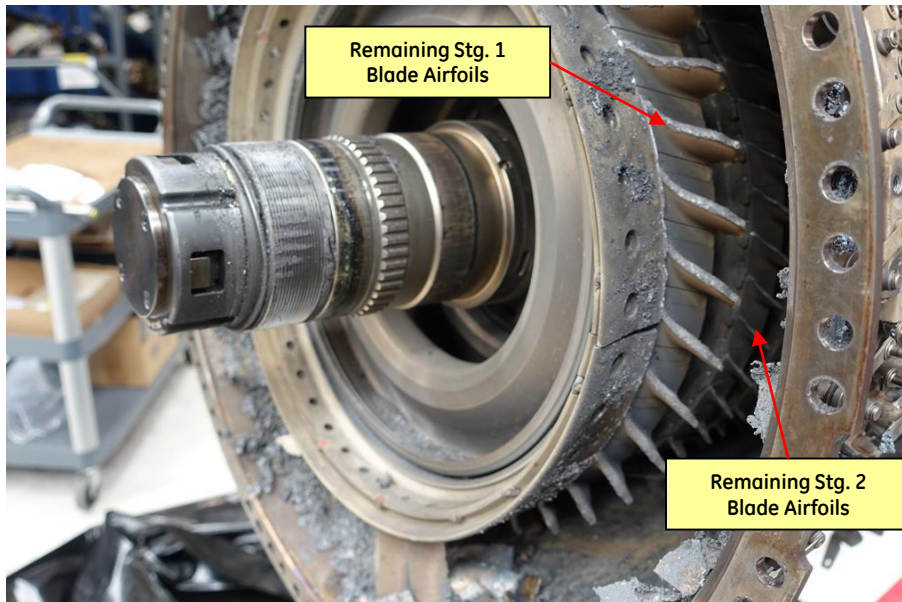
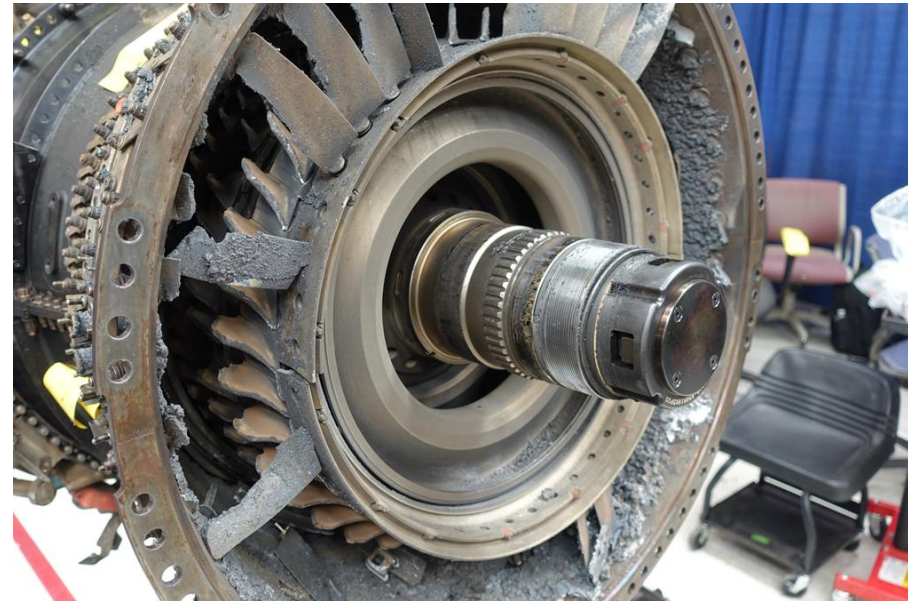
- Missing IGV Vanes and Significant Amounts Molten Material in Compressor Inlet
- Shape Remaining Stg. 1 HPC Blade Airfoils Consistent With Burning

Figure 3. Photographs looking at angle into compressor inlet. Numerous missing IGV's and abundant molten metal splatter observed on HPC Case ID surface.

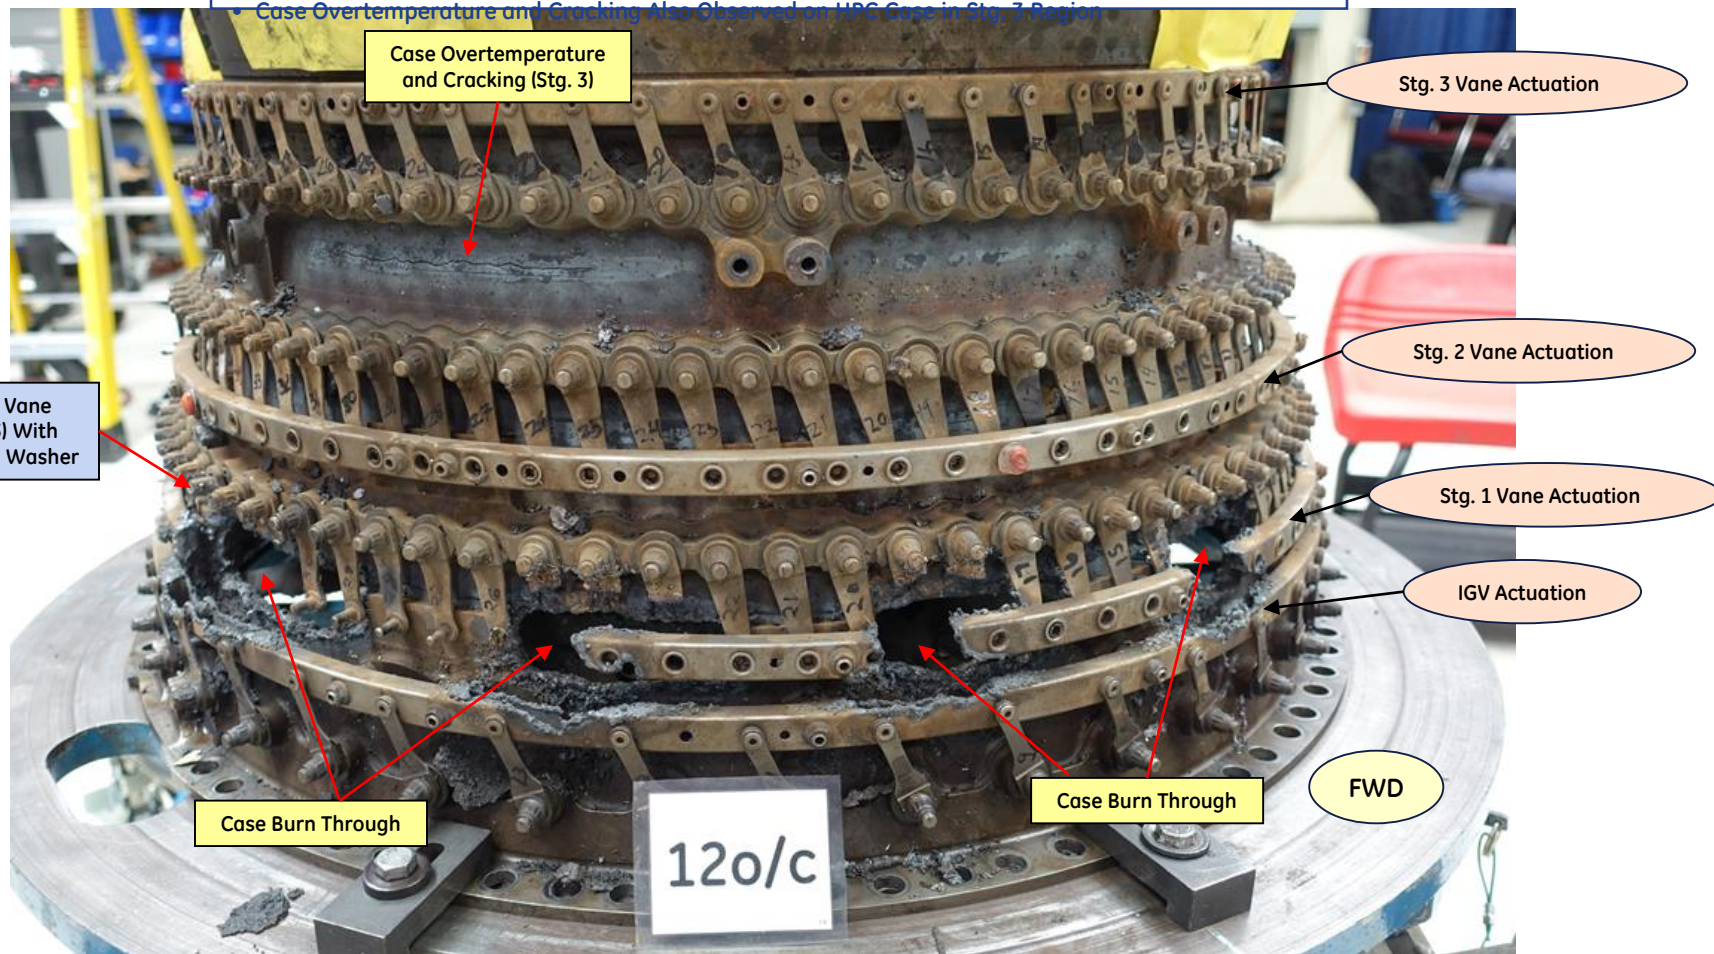
HPC Case - 12:00 Position

- Several Regions of Upper HPC Case Burn Through Plus Consumption of Lever Arms and Actuation Rings - Burn Throughs Located Between Thicker Rub Button Pad Regions in Plane With Stg. 1 HPC Rotor
- One (1) Stg. 1 Vane Trunnion With Missing Nut and Washer (Location #33)
- Case Overtemperature and Cracking Also Observed on HPC Case in Stg. 3 Region

Figure 4. Photograph documenting condition HPC Case at 12 o'clock position denoting some of the locations of case burn through. Retaining nut and washer was missing at Stg. 1 HPC Vane Trunnion #33.

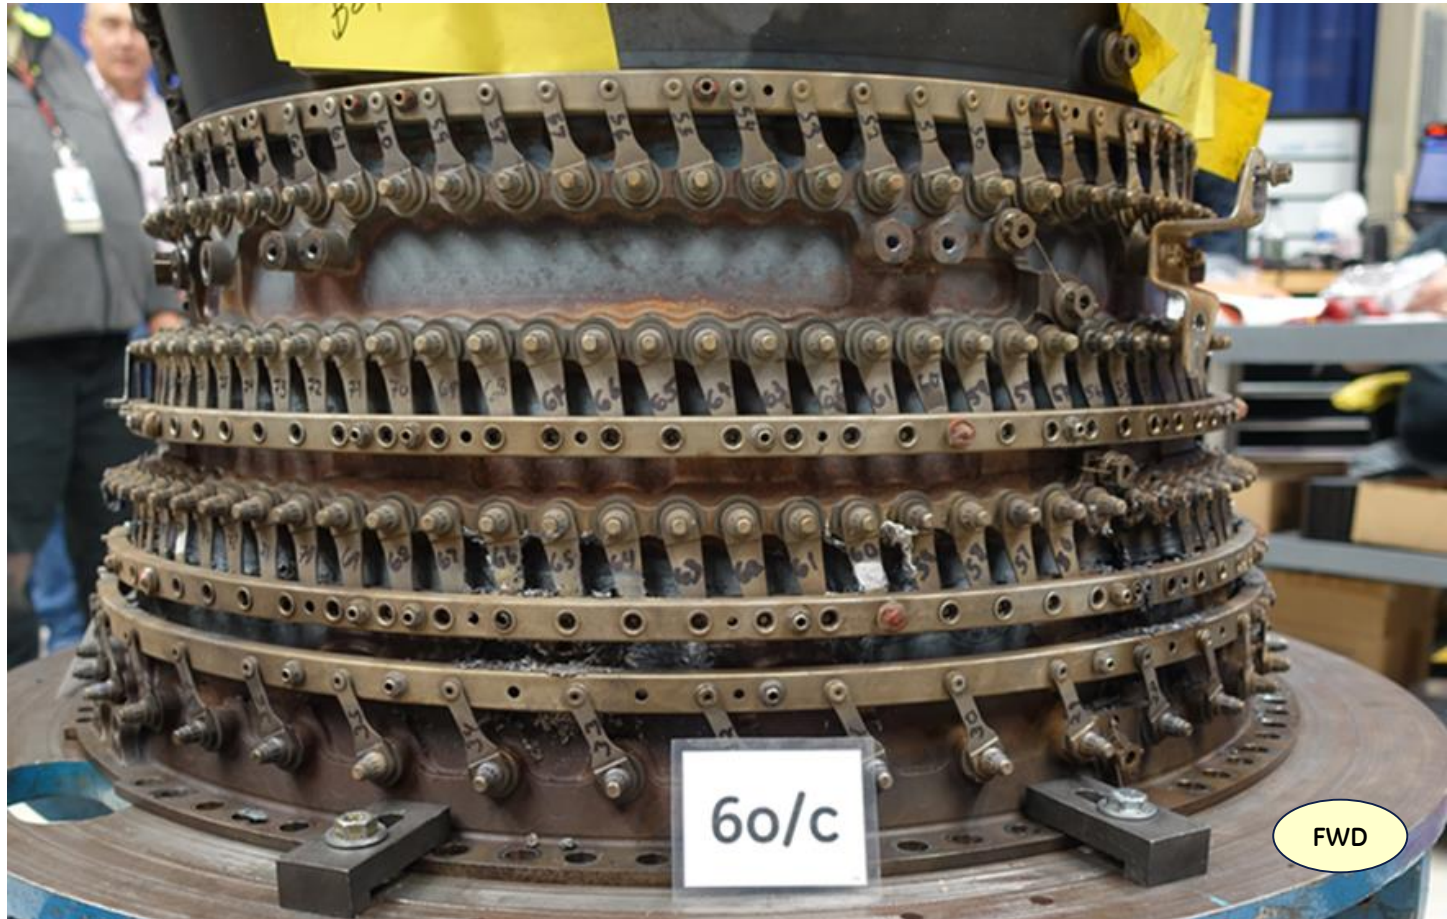
HPC Case – 6:00 Position

- Condition of Lower HPC Case - Several Regions of HPC Case Burn Through Plus Consumption of Lever Arms - Burn Throughs Located Between Thicker Rub Button Pad Regions in Plane With Stg. 1 HPC Rotor

Figure 5. Photograph documenting condition HPC Case at 6 o'clock position.

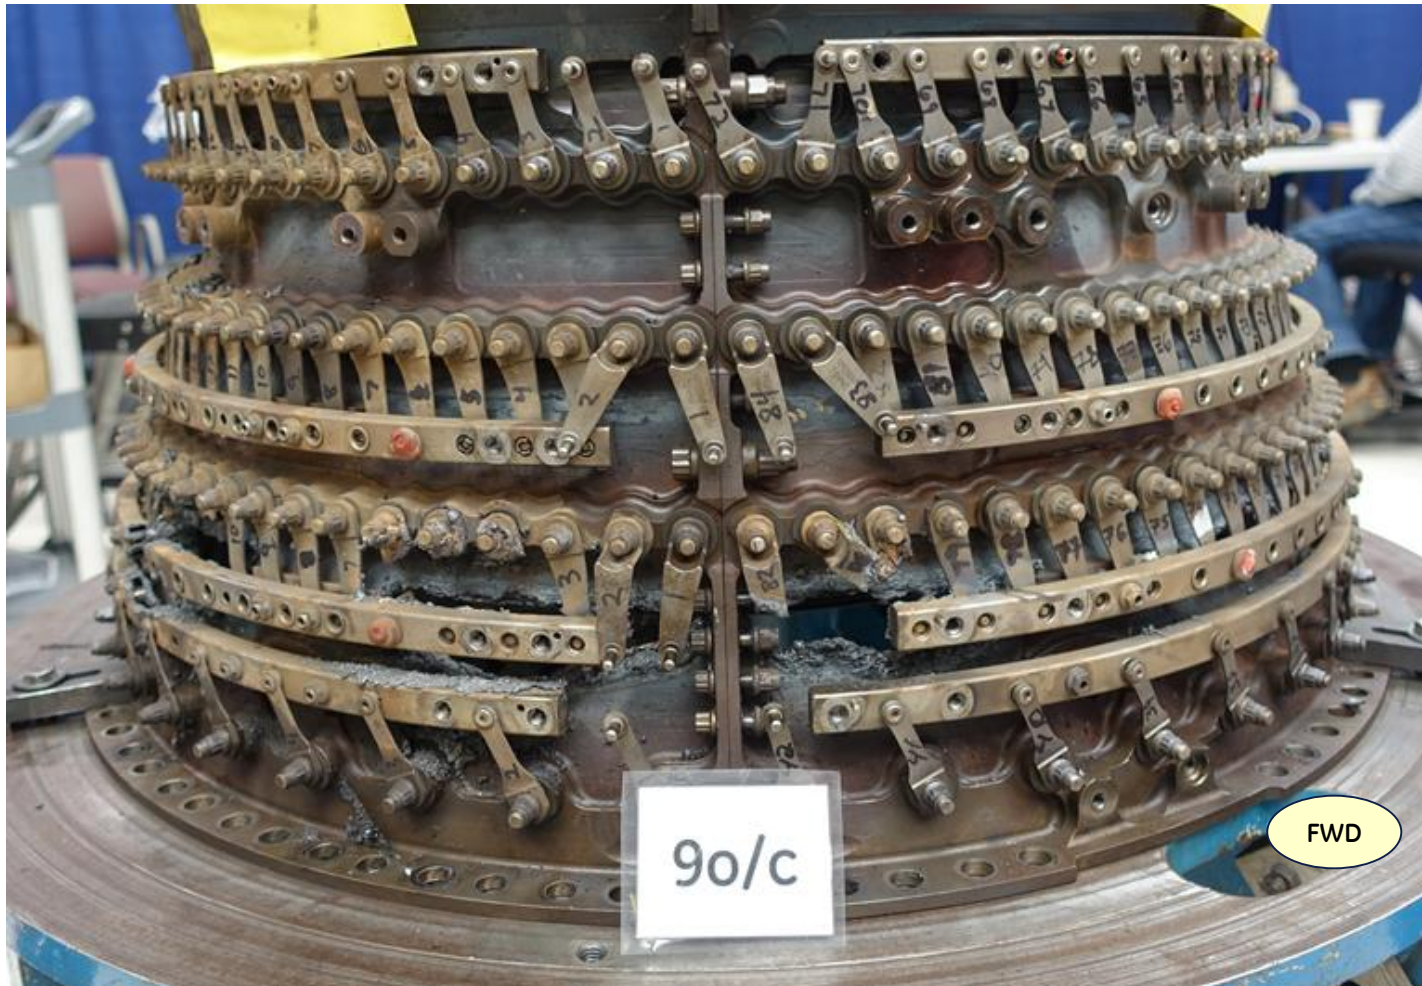
HPC Case - 9:00 Position

- Condition of Lower HPC Case - Several Regions of HPC Case Burn Through Plus Consumption of Lever Arms - Burn Throughs Located Between Thicker Rub Button Pad Regions in Plane With Stg. 1 HPC Rotor

Figure 6. Photograph documenting condition HPC Case at 9 o'clock position.

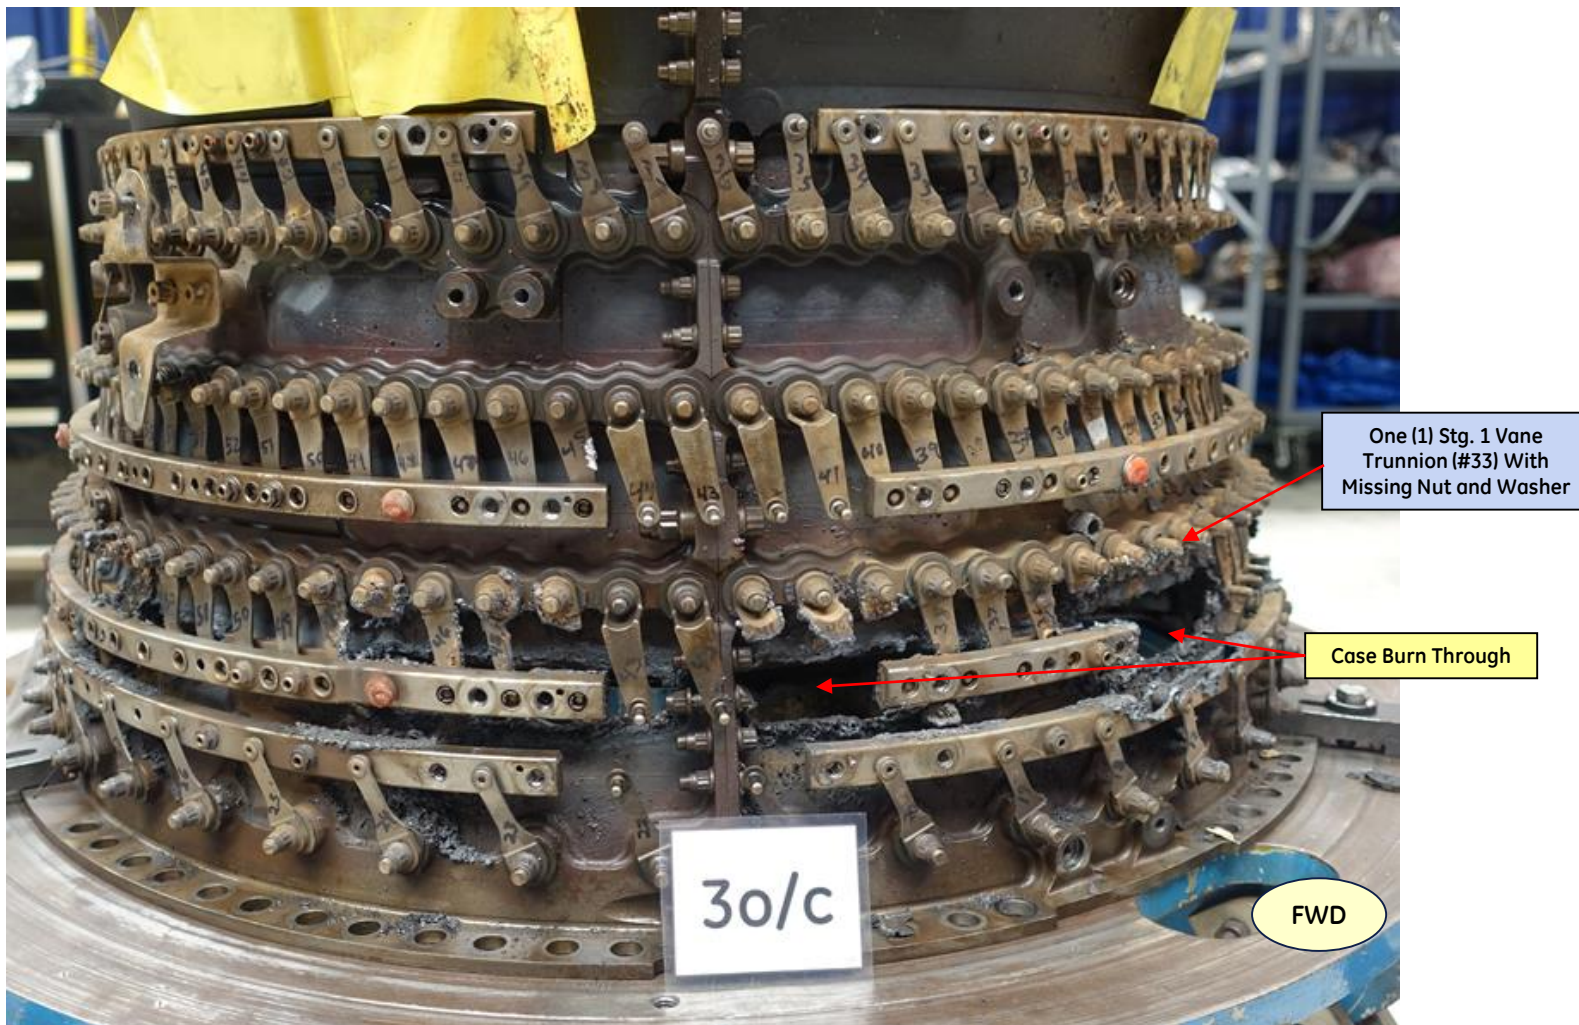
HPC Case - 3:00 Position

- Condition of Lower HPC Case - Several Regions of HPC Case Burn Through Plus Consumption of Lever Arms - Burn Throughs Located Between Thicker Rub Button Pad Regions in Plane With Stg. 1 HPC Rotor

Figure 7. Photograph documenting condition HPC Case at 12 o'clock position denoting some of the locations of case burn through. Retaining nut and washer was missing at Stg. 1 HPC Vane Trunnion #33.

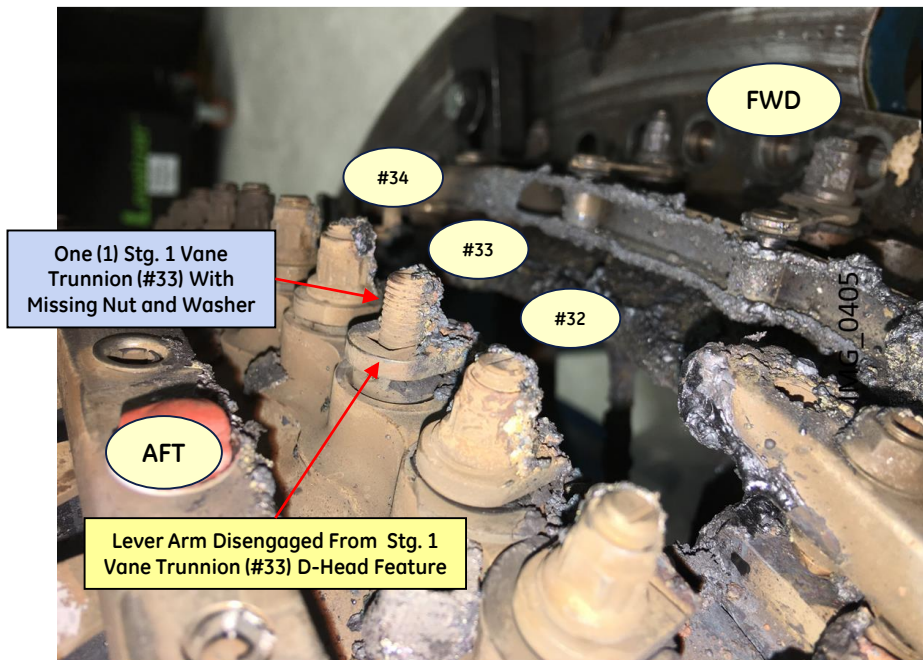
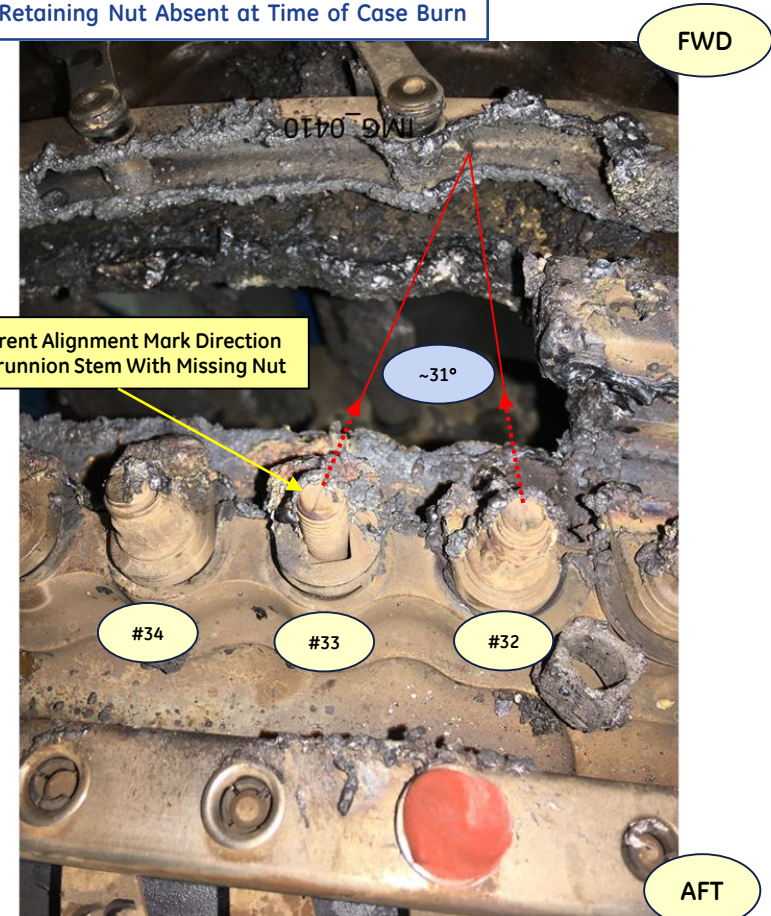
Stg. HPC Case – Stg. 1 Vane Positions #32, #33 and #34

- One (1) Stg. 1 Vane Trunnion With Missing Nut and Washer (Location #33) Located on Upper HPC Case
- Lever Arm Found Disengaged With Stg. 1 HPC Vane Trunnion D-Head
- Different Alignment Mark Angle on Top Trunnion Stem #33 Compared to Adjacent Trunnion #32 (Dashed Red Arrows) – Trunnion #33 Currently Off-Angle  $\sim 31^\circ$
- Molten Splatter on Fwd Side Trunnion #33 Threads Indicating Retaining Nut Absent at Time of Case Burn Through

Figure 8. Photographs documenting missing nut and washer on Stg. 1 HPC Vane Trunnion #33 compared to adjacent Stg. 1 HPC Vane assemblies #32 and #34.

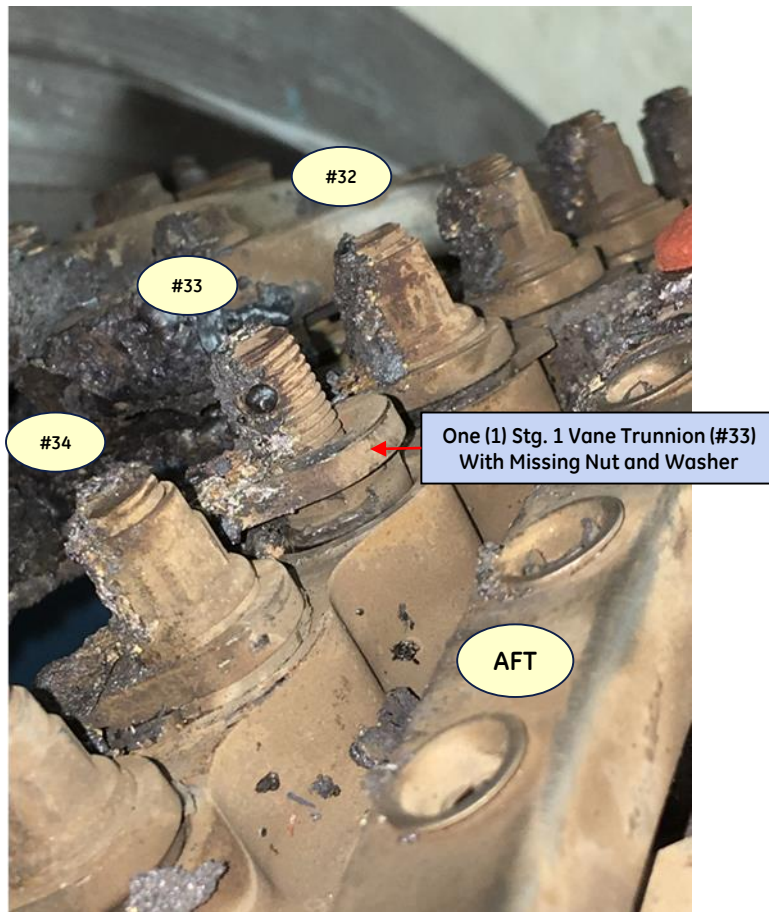
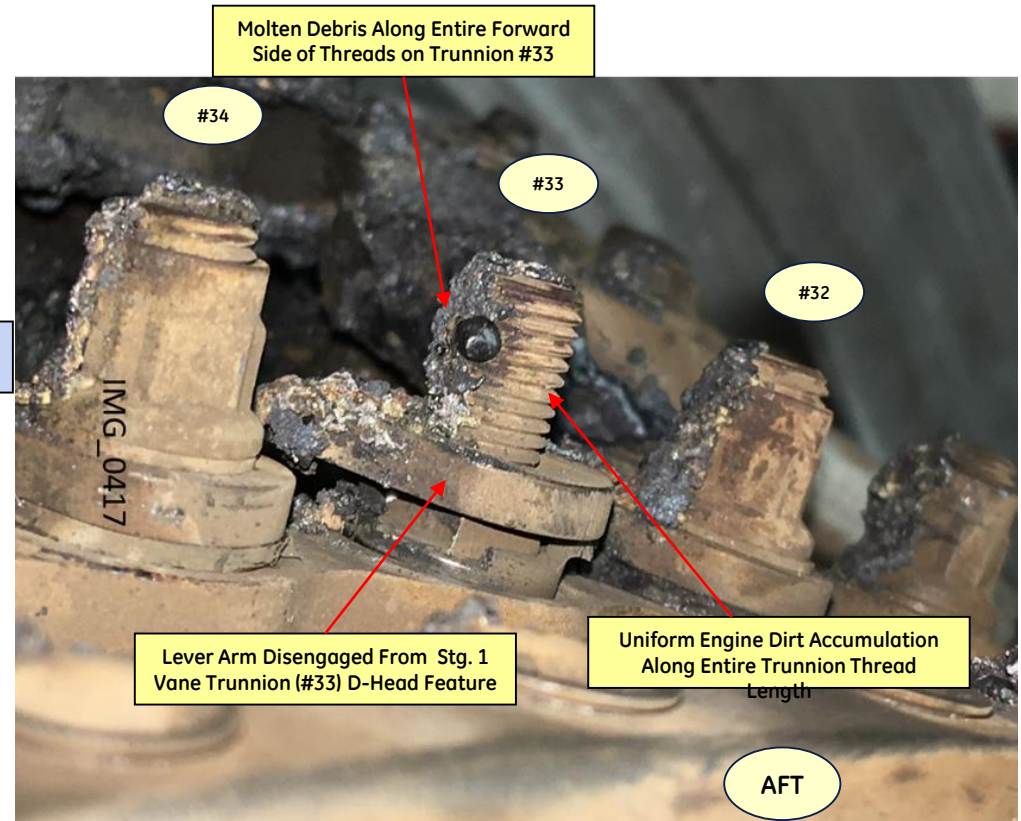
Stg. HPC Case – Stg. 1 Vane Positions #32, #33 and #34

- One (1) Stg. 1 Vane Trunnion With Missing Nut and Washer (Location #33) Located on Upper HPC Case
- Lever Arm Found Disengaged With Stg. 1 HPC Vane Trunnion D-Head
- Molten Splatter on Forward Side Trunnion #33 Threads Indicating Retaining Nut Absent at Time of Case Burn Through

Figure 9. Photographs documenting missing nut and washer on Stg. 1 HPC Vane Trunnion #33 compared to adjacent Stg. 1 HPC Vane assemblies #32 and #34.

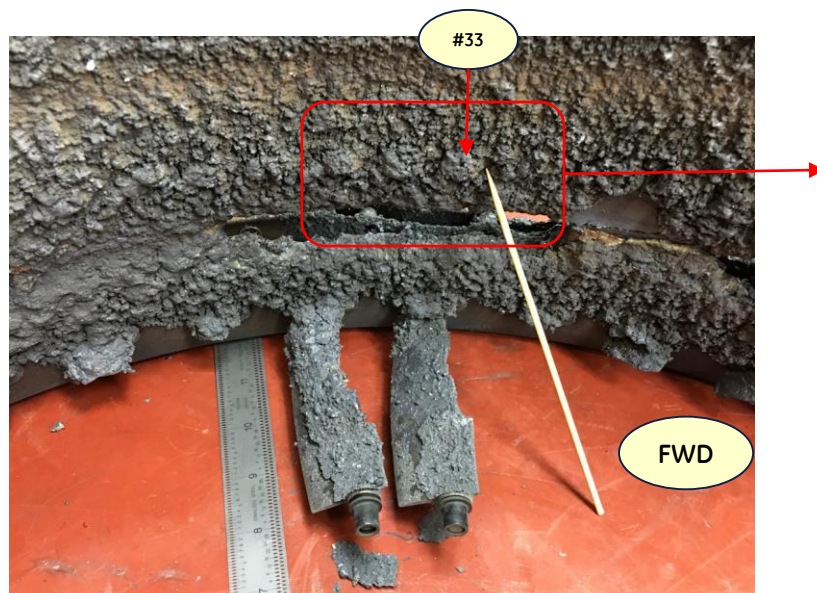
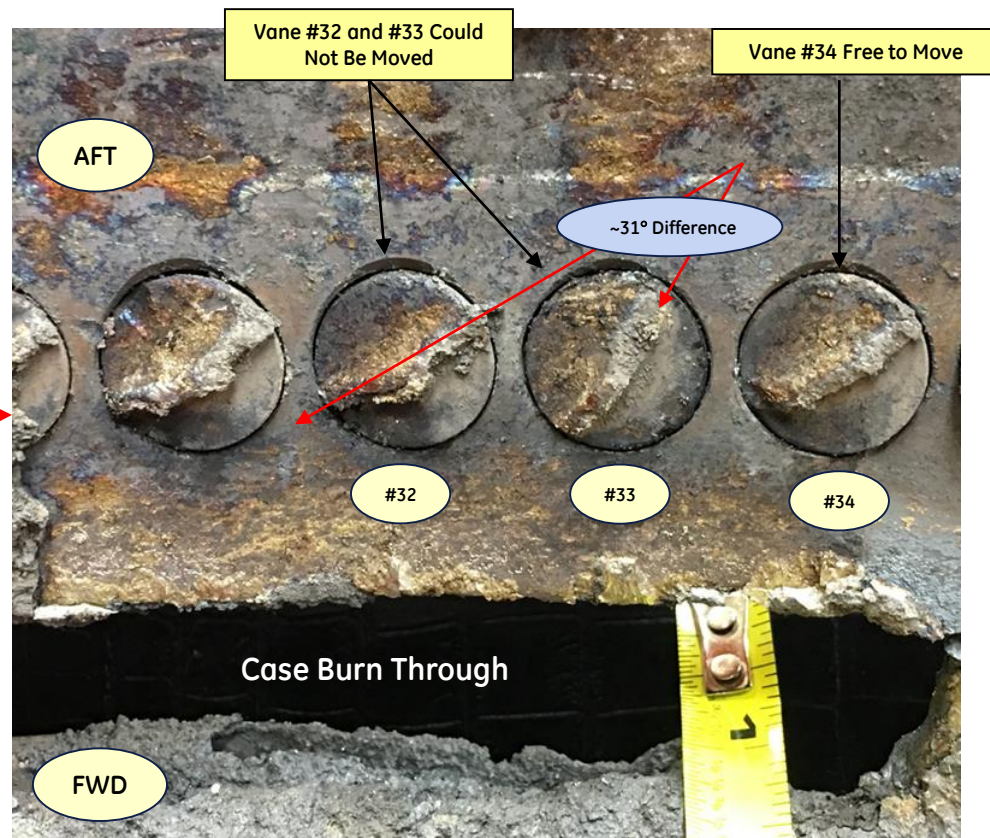
HPC Upper Case – IGV #33 Location

The condition of the internal surfaces of the HPC upper and lower cases are shown in Figures 10 and 11. Considerable amounts of molten material lined the ID surface of the HPC Case. Molten material was chipped away to reveal Stg. 1 VSV location #33 as shown in Figure 12. In their current state, a different vane angle difference of ~31° was observed between Stg. 1 VSV locations #33 (nut absent) and #32 (nut present). Panoramic views of the HPC Case halves following removal of Stg. 1 VSV hardware are shown in Figures 13 and 14. Approximately 60% circumferential burn through of the forward HPC Case was observed above the Stg. 1 HPC Blades. The only portions of the HPC Case not burned through were at the thicker rub button pad regions.

- Chipping Away Molten Material Revealed Stg. 1 Vane #33 With Different Vane Angle (Currently ~31°) Compared to Adjacent Vane #32

Figure 12. Photographs documenting location of Stg. 1 HPC Vane #33 on upper HPC Case following removal of molten splatter. Note difference in the vane angle compared to adjacent vane #32.

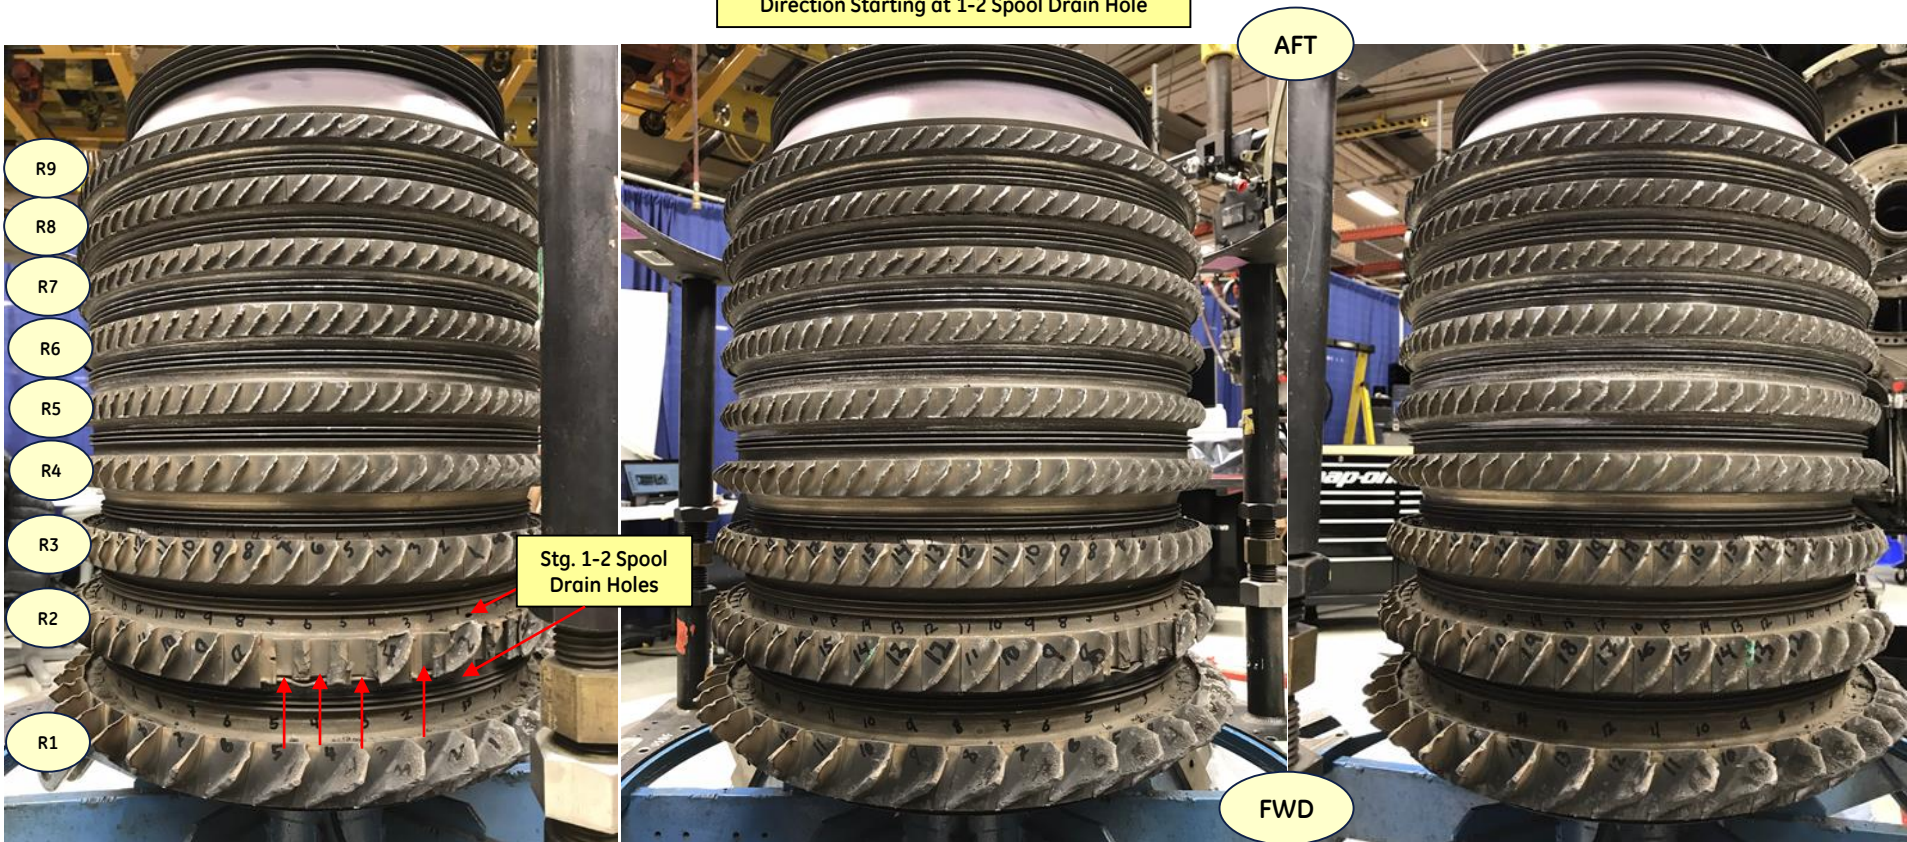
Various views of the Compressor Rotor from CFM56-7B ESN 875-318 are shown in Figures 15, 16 and 17. A total of eight (8) Stg. 2 HPC Blades were completely missing with missing material observed found on ten (10) Stg. 2 HPC disk posts, all associated with missing blade locations. A sketch illustrating Stg. 2 HPC disk post corner nomenclature is provided in Figure 18.

- HPC Rotor Condition – Eight (8) Stg. 2 HPC Blades Observed (Locations #1, #3, #5, #6, #7, #34, #40 and #53)
- Missing Material Observed on Ten (10) Stg. 2 Disk Posts (#1, #2, #4, #5, #6, #7, #33, #39, #40 and #53) All Associated With Missing Stg. 2 HPC Blades

Figure 15. Photographs documenting condition of HPC Rotor assembly during disassembly. Arrows denote locations of entirely missing Stg. 2 HPC Blades.

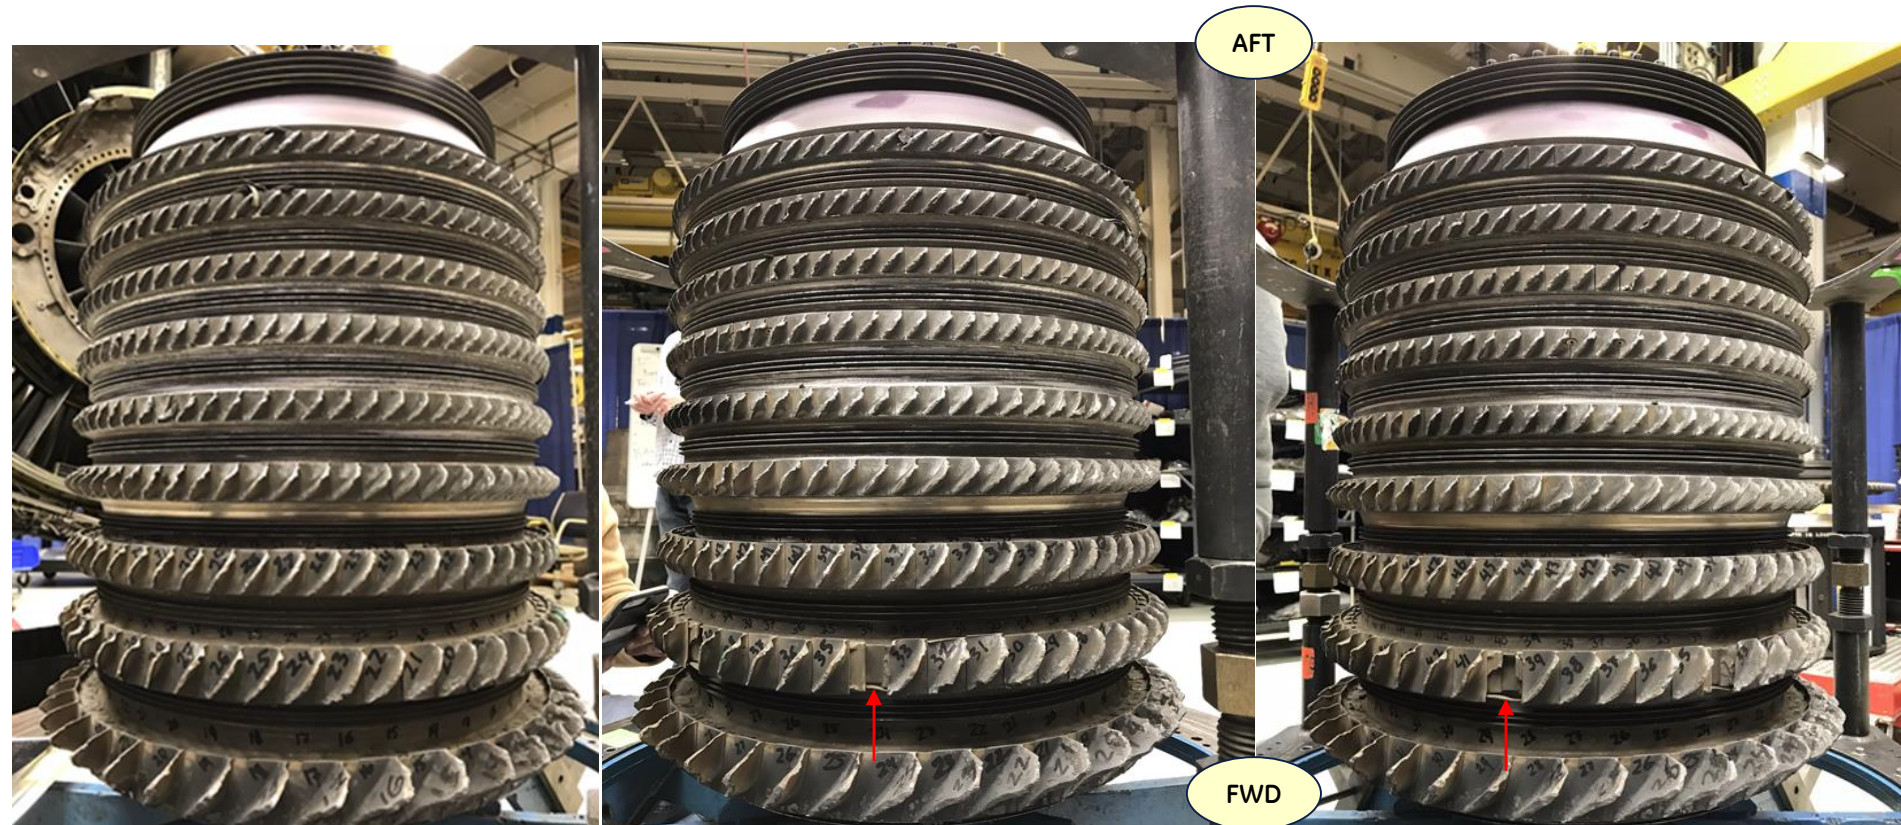
- HPC Rotor Condition – Eight (8) Stg. 2 HPC Blades Observed (Locations #1, #3, #5, #6, #7, #34, #40 and #53)
- Missing Material Observed on Ten (10) Stg. 2 Disk Posts (#1, #2, #4, #5, #6, #7, #33, #39, #40 and #53) All Associated With Missing Stg. 2 HPC Blades

Figure 16. Photographs documenting condition of HPC Rotor assembly during disassembly. Arrows denote locations of entirely missing Stg. 2 HPC Blades.

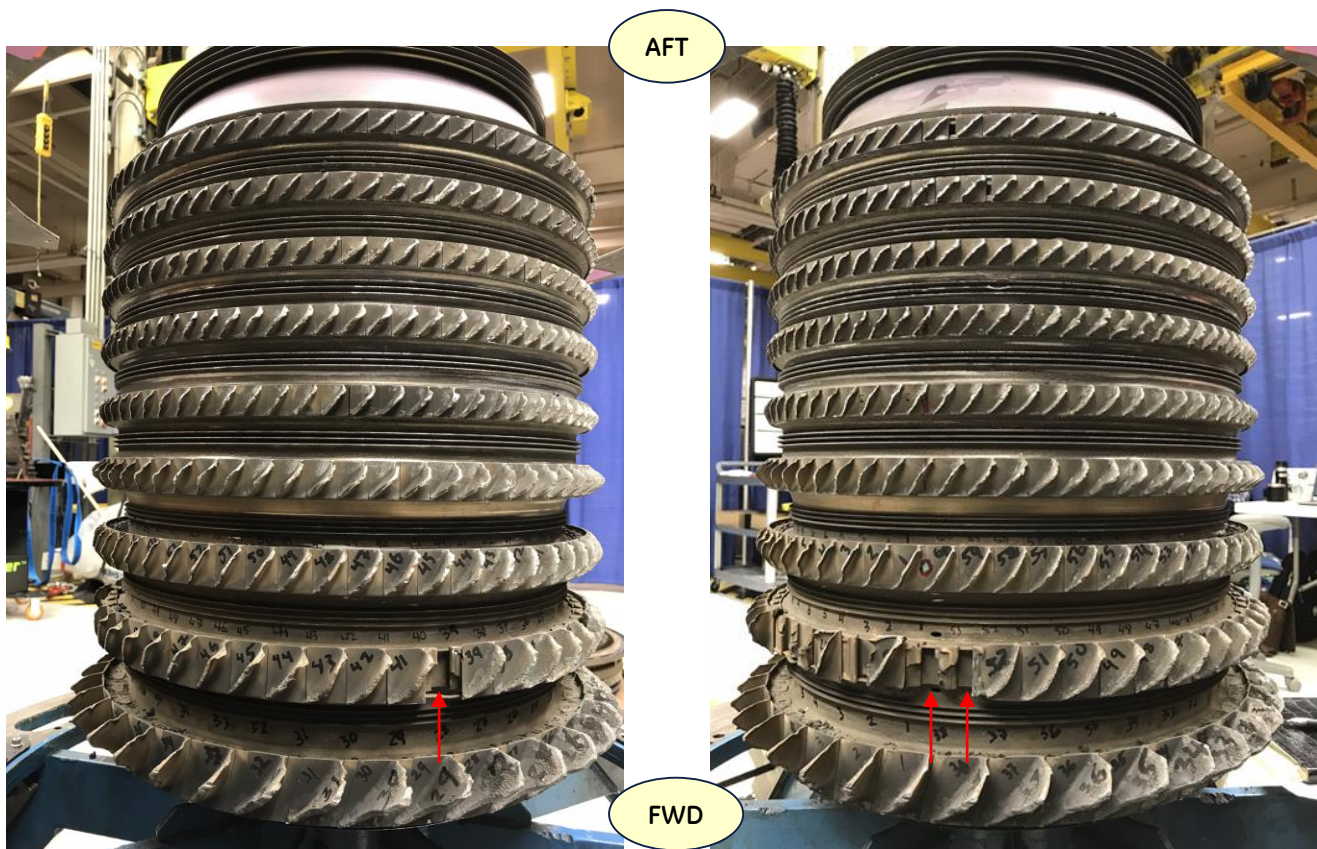
- HPC Rotor Condition – Eight (8) Stg. 2 HPC Blades Observed (Locations #1, #3, #5, #6, #7, #34, #40 and #53)
- Missing Material Observed on Ten (10) Stg. 2 Disk Posts (#1, #2, #4, #5, #6, #7, #33, #39, #40 and #53) All Associated With Missing Stg. 2 HPC Blades

Figure 17. Photographs documenting condition of HPC Rotor assembly during disassembly. Arrows denote locations of entirely missing Stg. 2 HPC Blades.

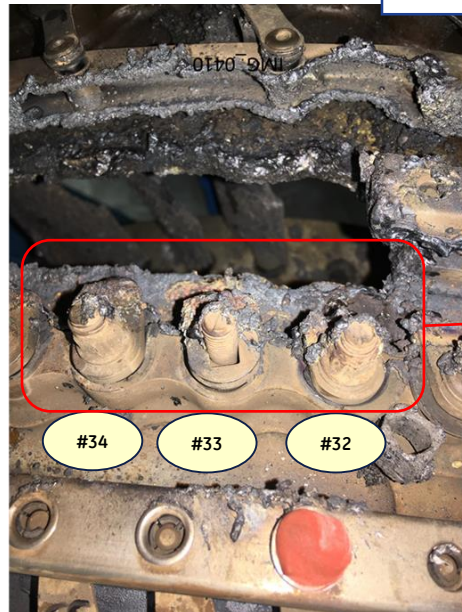
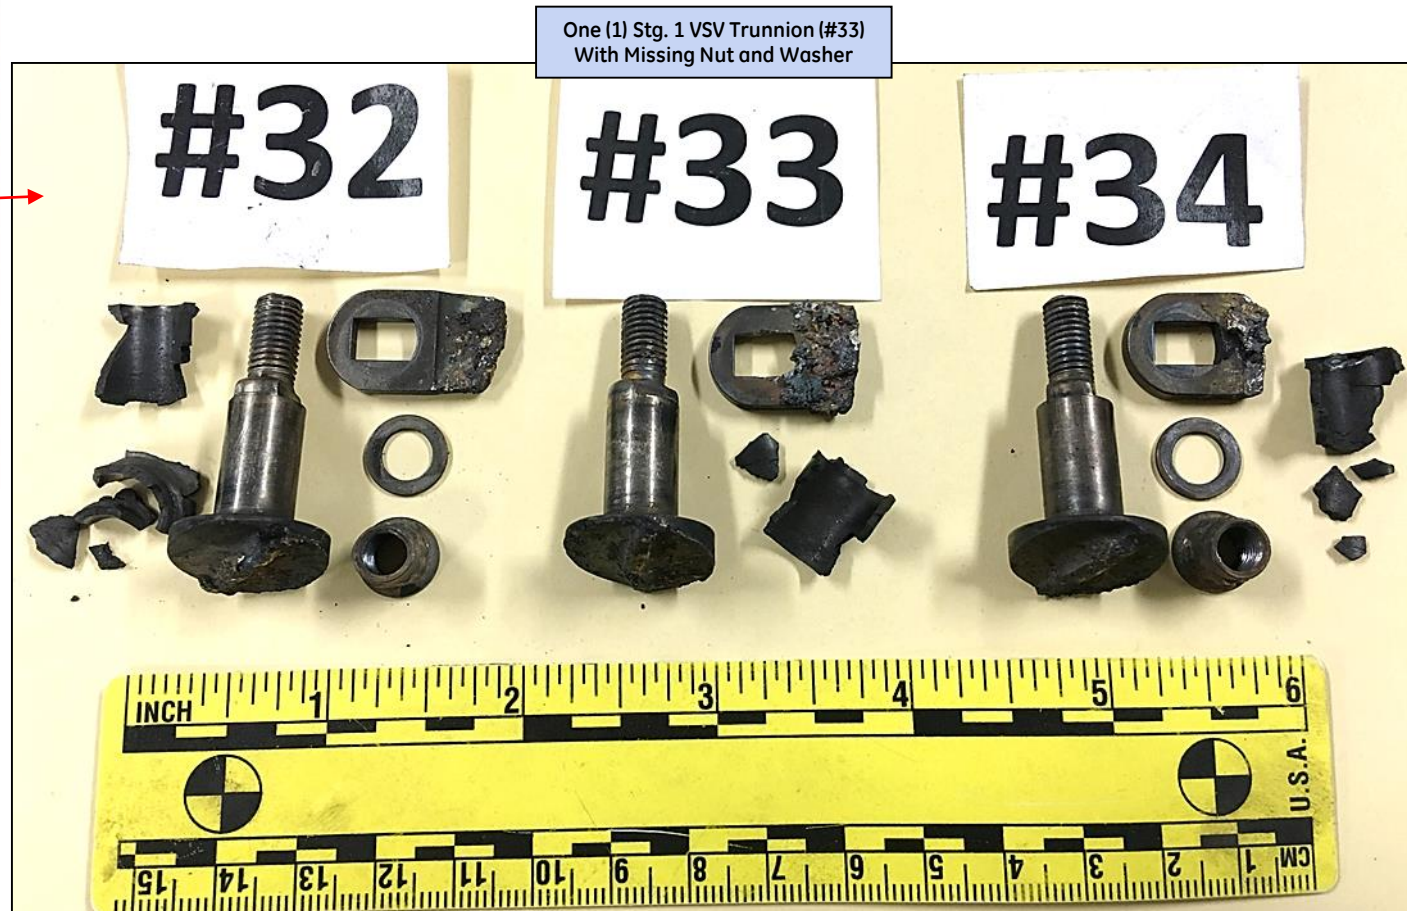
Stg. 1 VSV Hardware Positions #32, #33 and #34

Photographs documenting remaining Stg. 1 VSV hardware removed from locations #32, #33 and #34 are shown in Figure 19. All three (3) locations exhibited consumed portions of the titanium based lever arms and fragmented polymeric bushings (note absence of both the retaining nut and washer at location #33). Closer views of both the OD and ID sides of remaining lever arms in the slot regions in the uncleaned condition are shown in Figures 20 and 21. Lever arm OD surfaces at locations #32 and #34 exhibited a distinct, circular witness mark from contact with the washer supporting proper assembly. A faint, similarly shaped witness mark was observed on the lever arm OD surface at location #33 implying that a washer was likely present at one time. Lever arm ID surfaces at locations #32 and #34 revealed uniform contact patterns from contact with the Stg. 1 IGV trunnion surface, again supporting proper assembly. Although the lever arm ID surface a location #33 was more discolored and covered with debris a similarly shaped witness was present implying lever arm was properly in place at one time. Local deformation was also observed within the slot feature from abnormal contact/turning with the mating Stg. 1 IGV trunnion D-head feature as the lever arm started to disengaged from the trunnion D-head. Closer views of OD and ID sides of the remaining lever arm from position #33 are shown in Figure 22.

- Remaining VSV Hardware Removed From Stg. 1 Vane Positions #32, #33 and #34 – Exposed Portion of Lever Arm Consumed/Melted During Event

Figure 19. Photographs documenting condition of Stg. 1 HPC VSV Hardware from locations #32, #33 and #34 following removal from HPC Case.

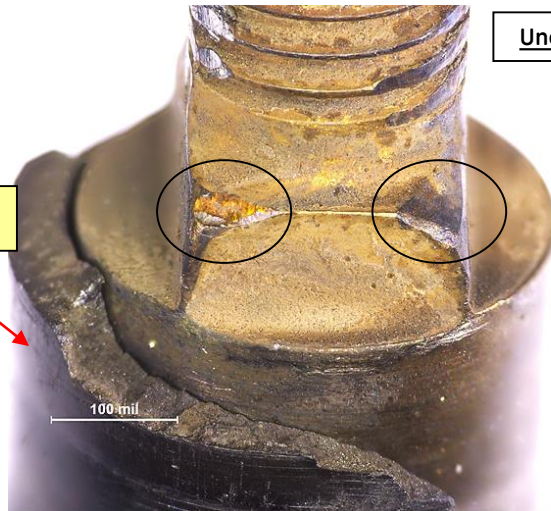
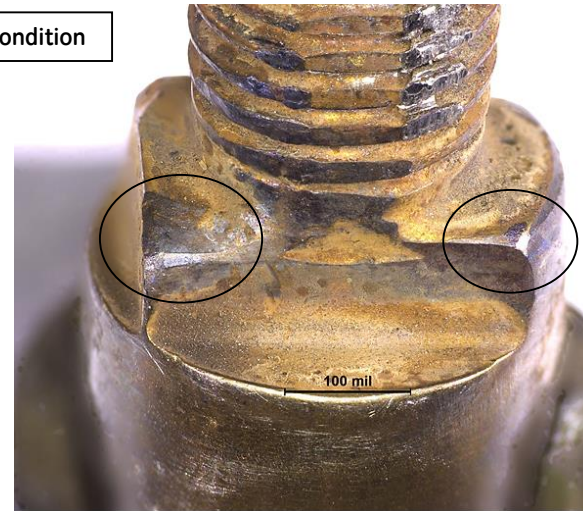
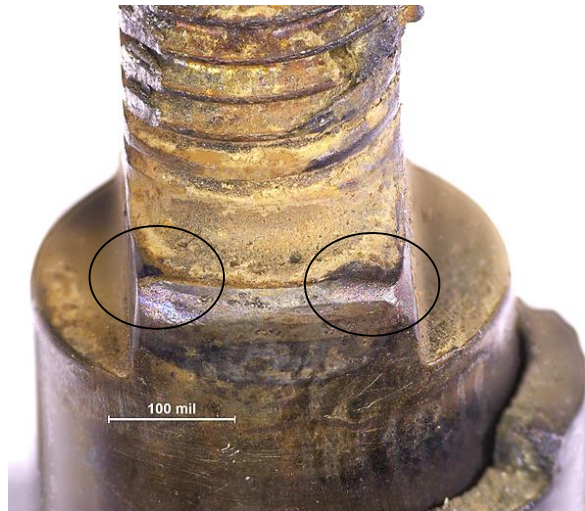
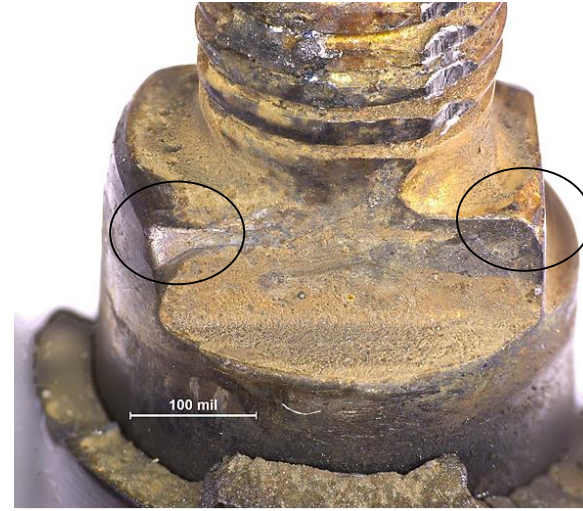
Stg. 1 Vane Trunnion #33 – Corner Damage

Photographs documenting Stg. 1 IGV trunnion threads from position #33 in the uncleaned condition are shown in Figures 27 and 28. Threads (aft side) exhibited uniform engine dirt accumulation along the entire length of the threads indicating retaining nut and washer had been completely missing for some period of time. The trunnion D-head surfaces also exhibited uniform engine dirt accumulation from the lever arm not being properly seated. Trunnion D-head corner and thread deformation was consistent with the lever arm D-slot turning/rotating around the corners and moving up the threads either in the complete absence of a retaining nut or as a loose nut moved outward. Various views of D-head corner damage from trunnion #33 are shown in Figure 29.

Figure 29. Photographs documenting Stg. 1 HPC Trunnion #33 corner damage in the uncleaned condition
