# Metallurgical Investigation Report

## FA Log No. 18712

**METALLURGICAL EVALUATION OF  
CFM56-7B STG. 1-2 HPC SPOOL AND  
STG. 1 HPC VSV TRUNNION/LEVER  
ARM HARDWARE FROM ESN 875-  
318 OPERATED BY UNITED AIRLINES**

**Final Report Date: June 14, 2019**

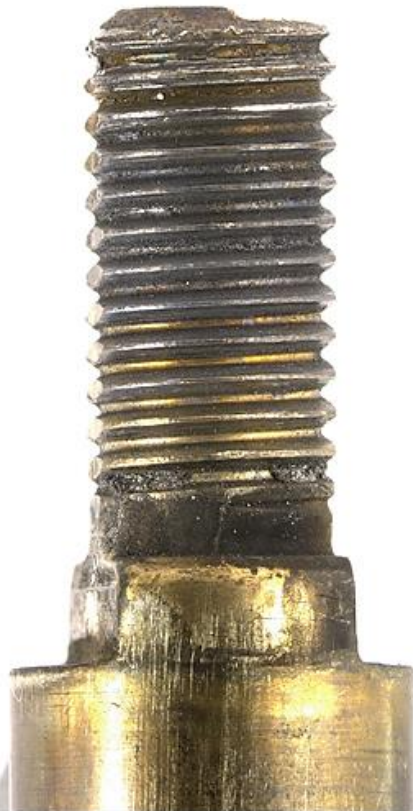
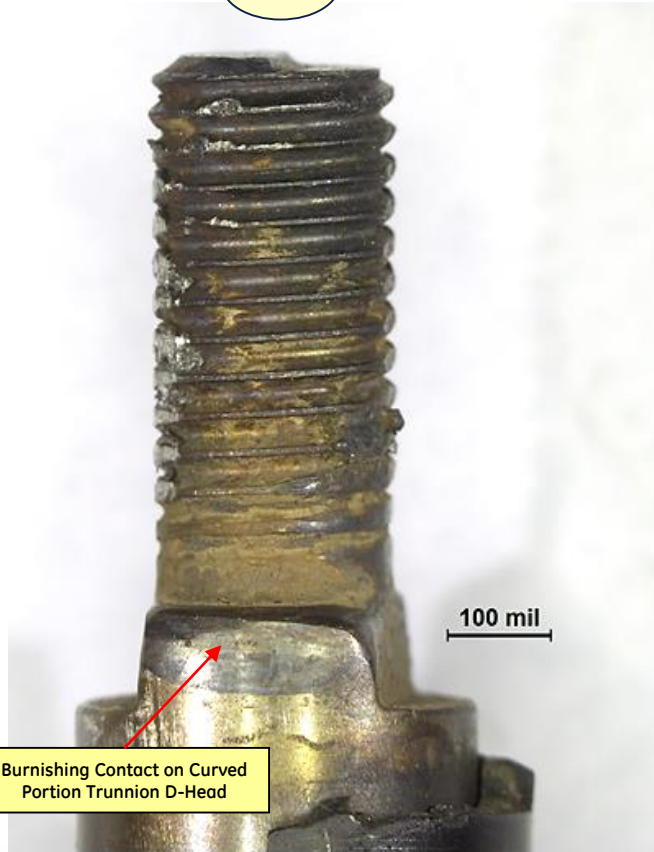
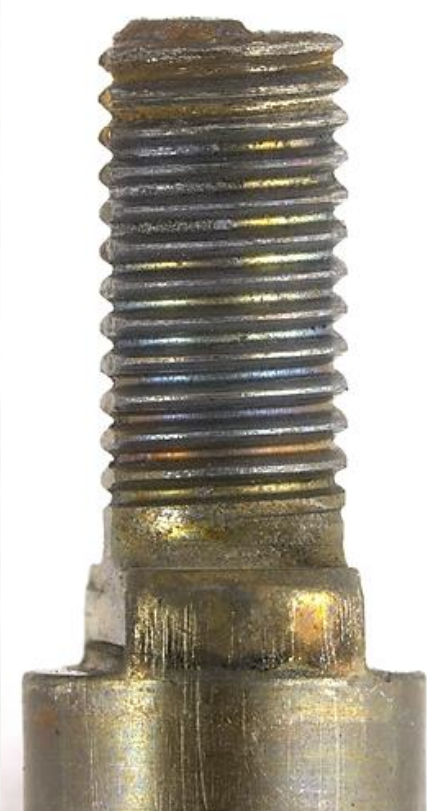
Comparative views of Stg. 1 IGV trunnion threads from locations #32, #33 and #34 in the uncleaned condition are shown in Figures 30 and 31. Once again, uniform engine dirt accumulation was observed along the entire length of the threads on trunnion #33 indicating retaining nut and washer had been completely missing for some period of time. General condition of trunnion D-head faces from locations #32, #33 and #34 in the uncleaned condition are shown in Figures 32, 33, 34 and 35. Trunnion #33 exhibited deformation at all four (4) corners from abnormal contact with the mating lever arm D-slot where as locations #32 and #34 exhibited rectangular contact marks from properly assembled lever arms. The general condition of washers removed from trunnion locations #32 and #34 are shown in Figures 36 and 37, respectively. Expected witness marks were observed on both the nut and trunnion sides of the washers.

Figure 30. Photographs comparing general condition of Stg. 1 HPC Trunnions #32, #33 and #34 in the uncleaned condition.

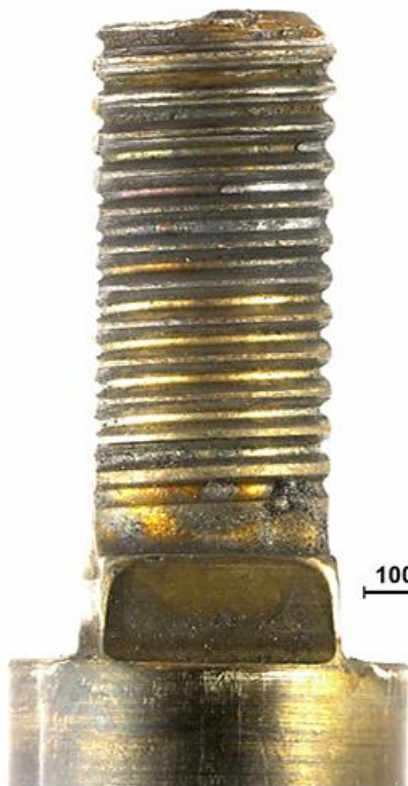
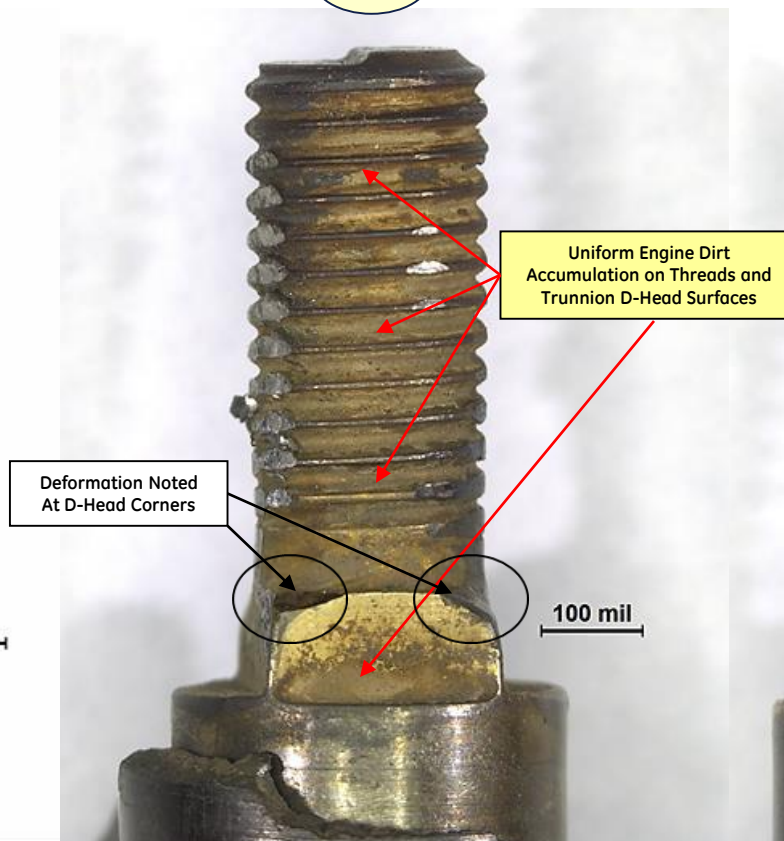
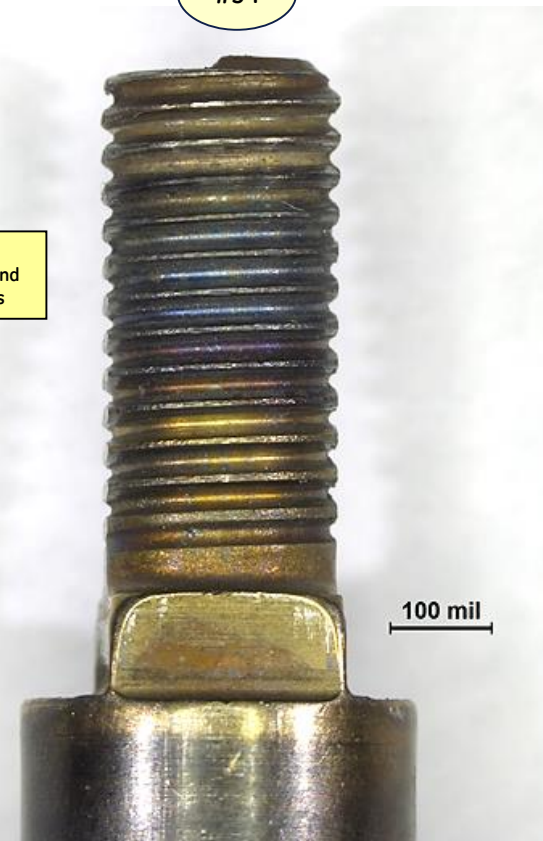
Figure 31. Photographs comparing general condition of Stg. 1 HPC Trunnions #32, #33 and #34 in the uncleaned condition (opposite side).

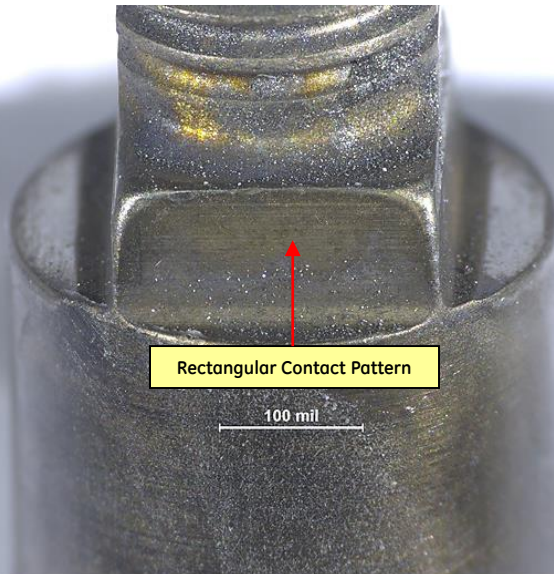
Stg. 1 Vane Trunnion #32

Rectangular Contact Pattern

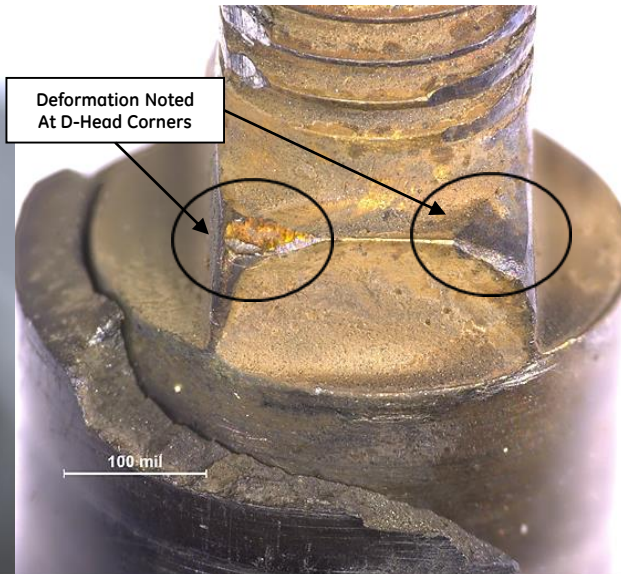
Stg. 1 Vane Trunnion #33

A direct comparison of Stg. 1 IGV trunnion D-head features from locations #32, #33 and #34 in the uncleaned condition is shown in Figure 24. Correct/fresh contact patterns with no evidence of corner deformation was observed on the outboard trunnion contact surface at locations #32 and #34 consistent with proper assembly and operation with the mating lever arm D-slot feature. Location #33 exhibited trunnion D-head deformation on all four (4) corners resulting from abnormal contact and seating with the mating lever arm D-slot feature.

Deformation Noted  
At D-Head Corners

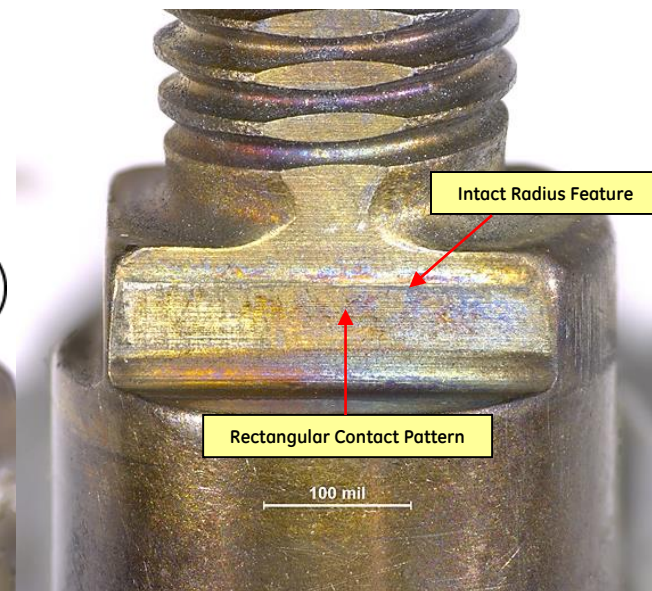
Figure 33. Photographs documenting comparing general condition of Stg. 1 HPC Trunnions #32, #33 and #34 in the uncleaned condition (opposite side).

- General Condition of Stg. 1 Vane Trunnion D-Head - Corner Deformation/Smearing Noted on Trunnion #33 Attributed to Abnormal Contact With Mating Lever Arm During Engine Operation

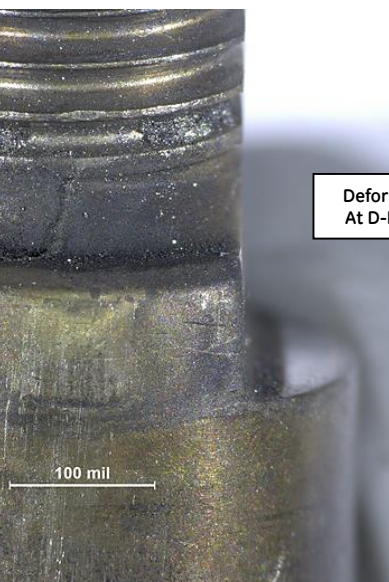
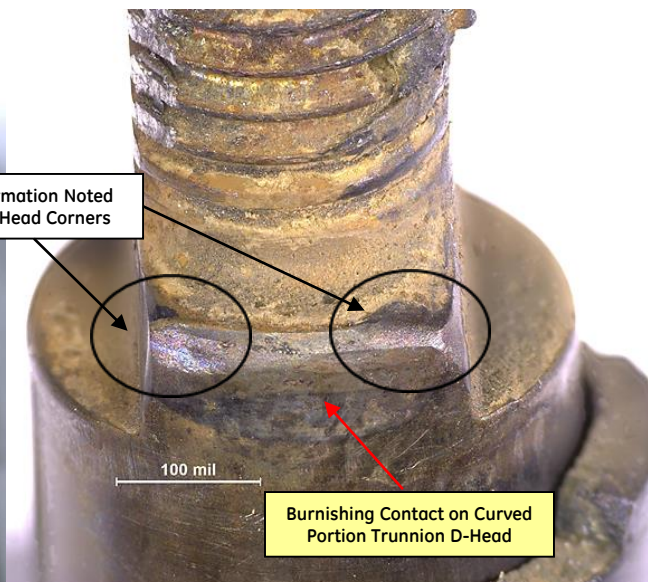
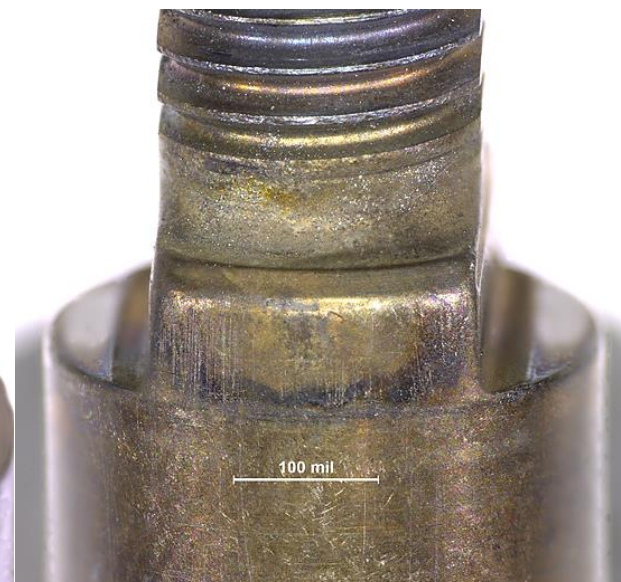
Figure 34. Photographs documenting comparing general condition of Stg. 1 HPC Trunnions #32, #33 and #34 in the uncleaned condition (opposite side).

- General Condition of Stg. 1 Vane Trunnion D-Head - Corner Deformation/Smearing Noted on Trunnion #33 Attributed to Abnormal Contact With Mating Lever Arm During Engine Operation

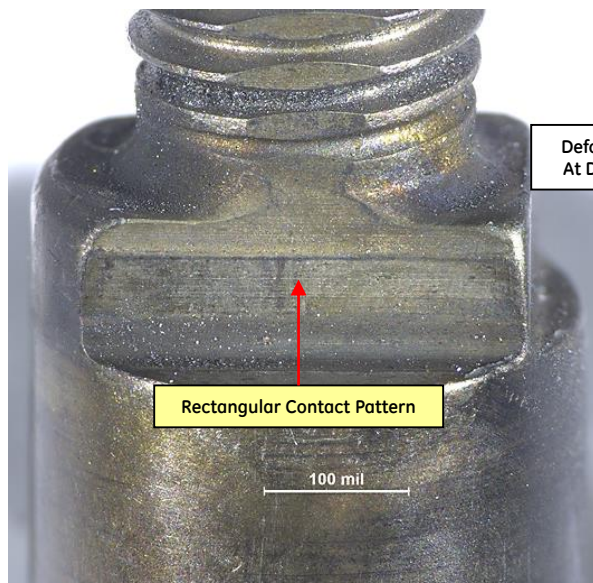
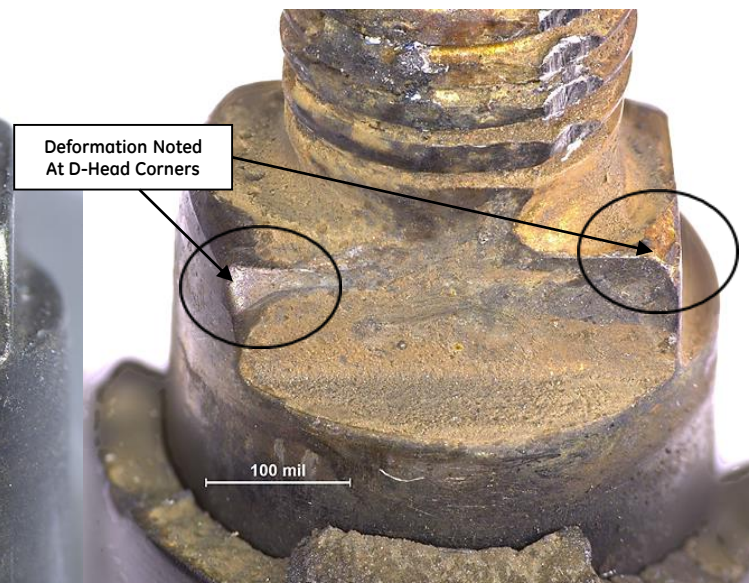
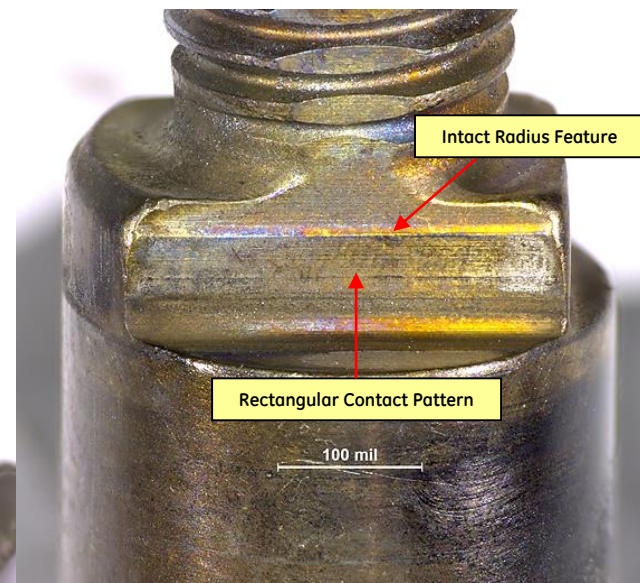
Figure 35. Photographs documenting comparing general condition of Stg. 1 HPC Trunnions #32, #33 and #34 in the uncleaned condition (opposite side).

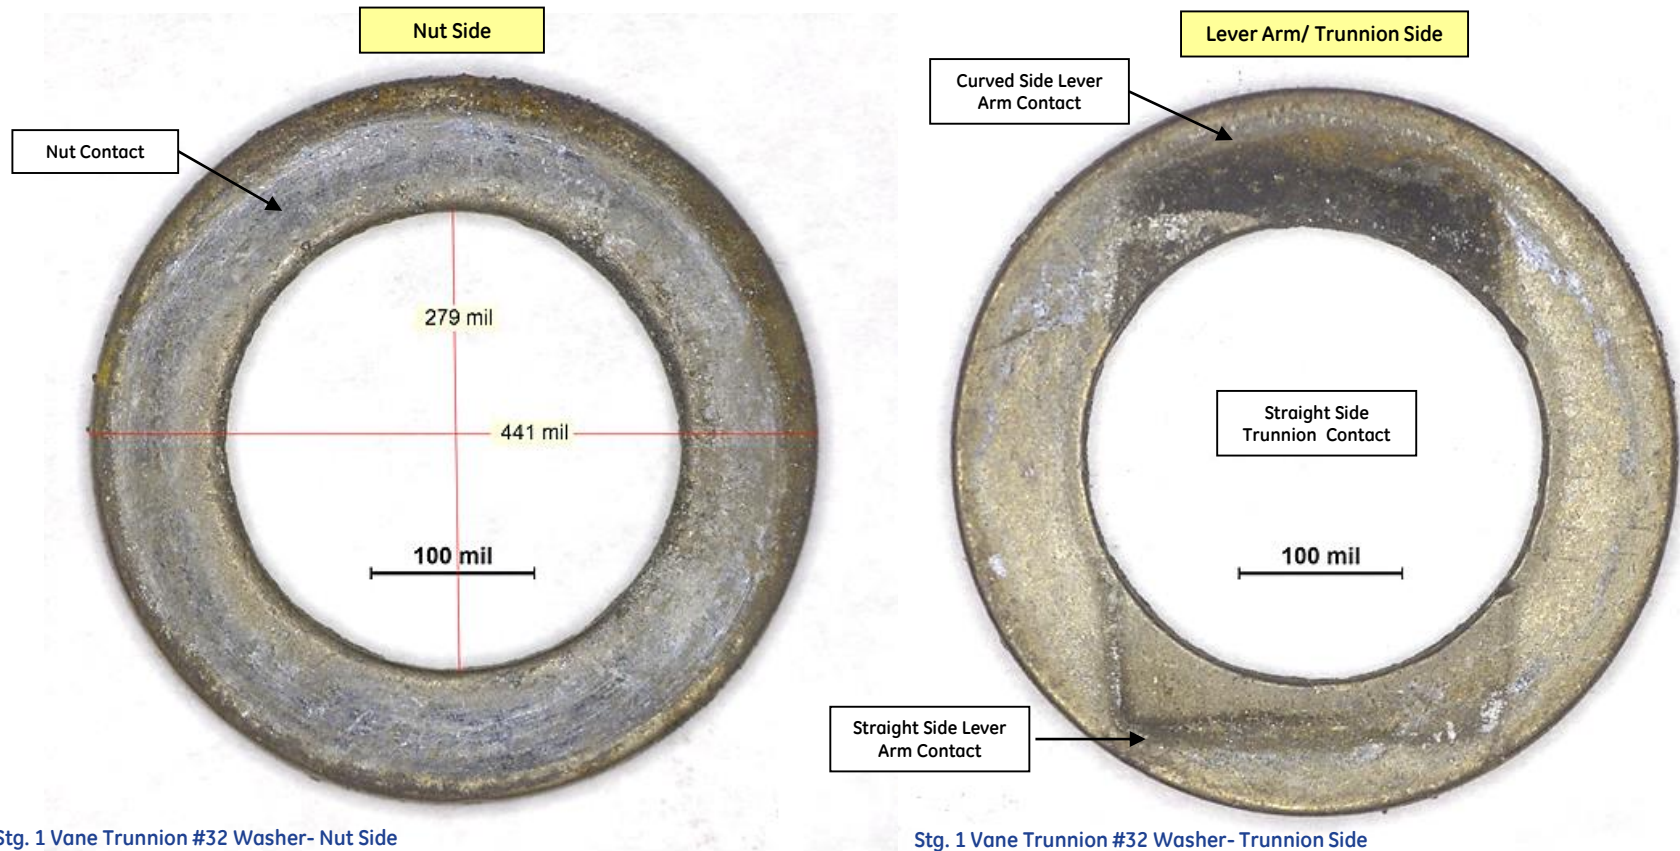
- General Condition of Stg. 1 Vane Trunnion #32 Washer – Trunnion Witness Marks From Contact With Retaining Nut and Lever Arm Face

Figure 36. Photographs documenting contact patterns present on both sides of washer from Stg. 1 HPC Trunnions #32 in the uncleaned condition.

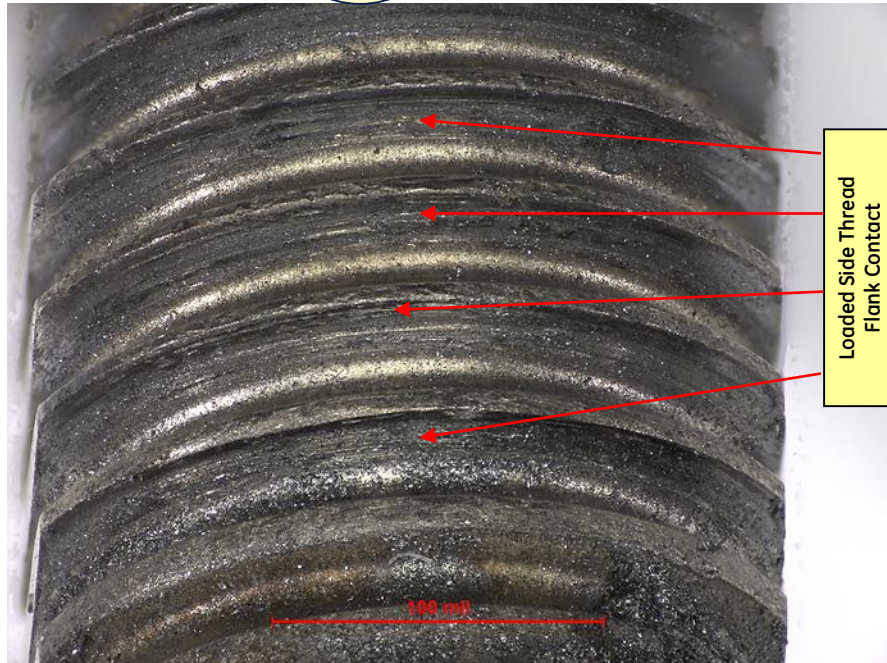
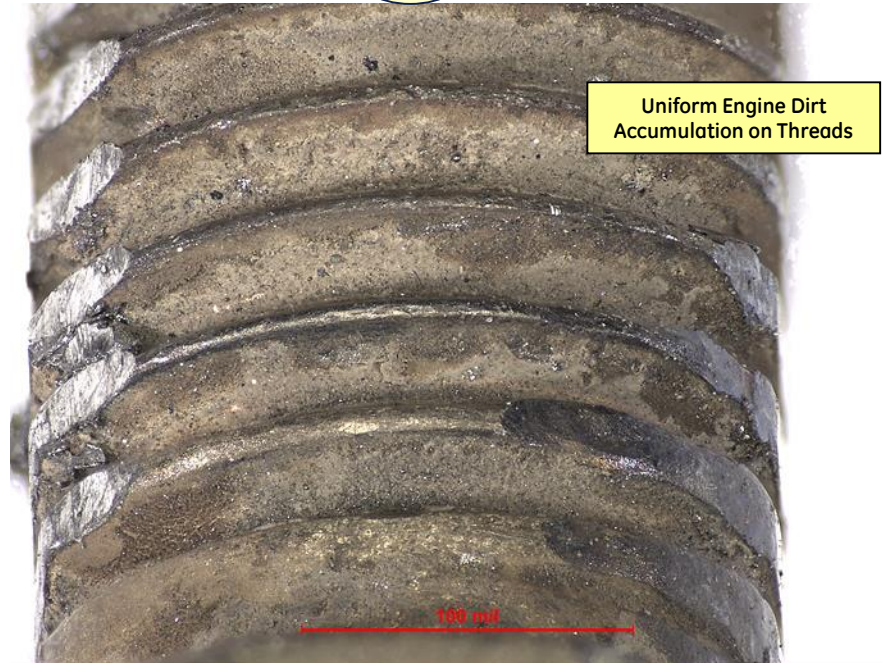
- Thread Comparison Between Stg. 1 Vane Trunnion #32 With Nut and Stg. 1 Vane Trunnion #33 Without Nut
- Circumferential Contact Marks Observed on Lower Loaded Side Thread Flanks on Trunnion #32 Consistent With Nut Contact
- Debris Obscured Any Evidence of Lower Loaded Side Thread Flank Contact on Trunnion #33

Uniform Engine Dirt  
Accumulation on Threads

Figure 39. Photographs showing closer views comparing loaded thread side of Stg. 1 HPC Trunnions #32 and #33 in the uncleaned condition (lower threads).

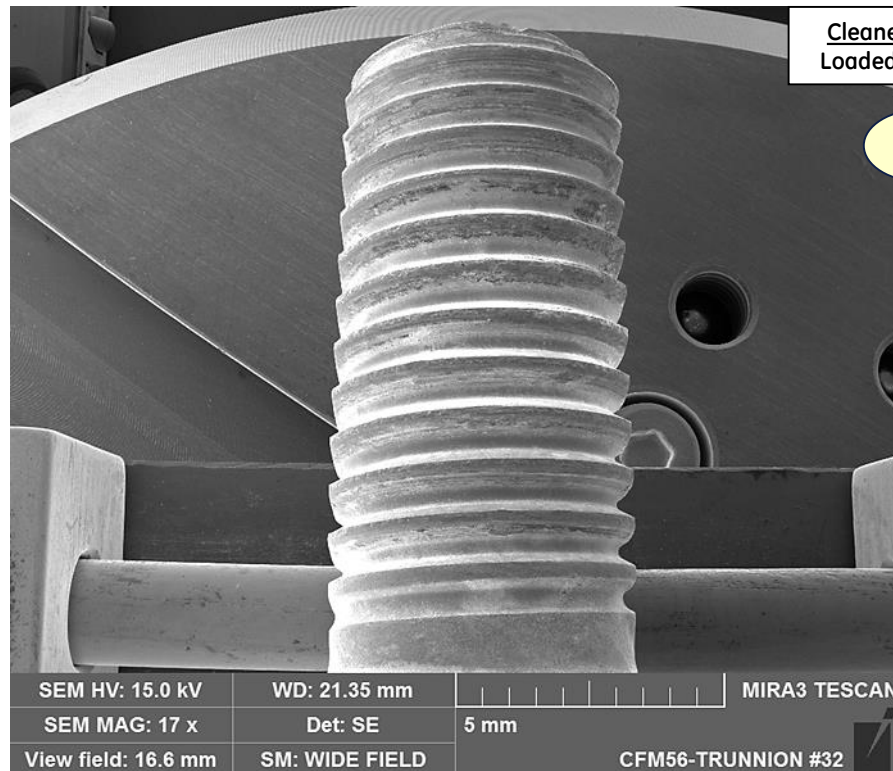
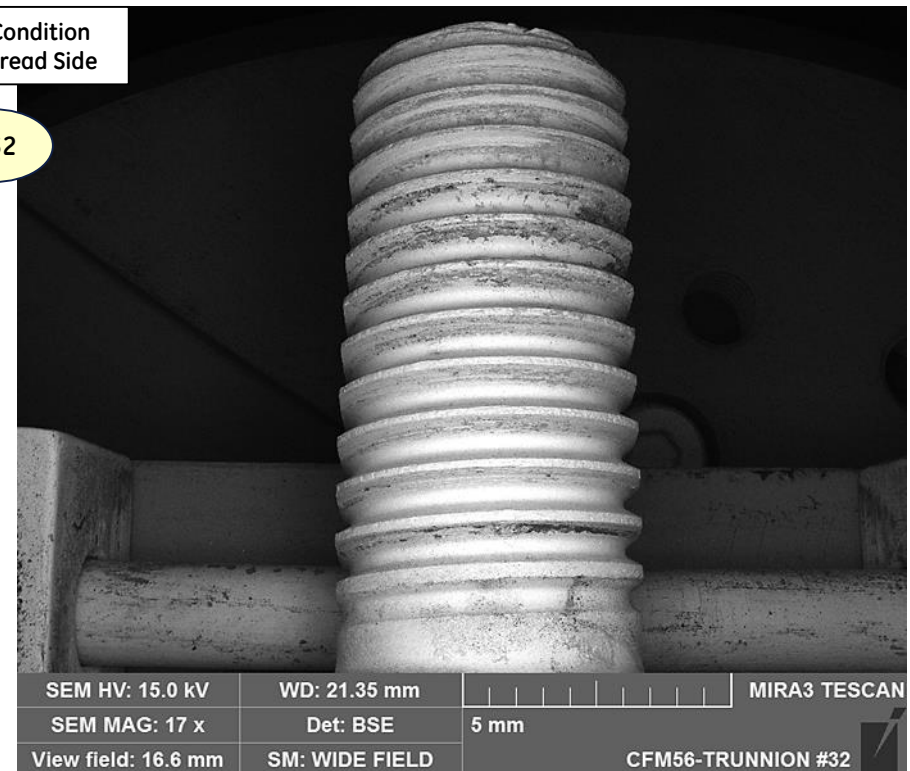
- Loaded Side Thread Flank Contact With Nut Observed on Stg. 1 Vane Trunnion #32

Figure 44. SEM secondary (SEI) and backscatter (BEI) images documenting Stg. 1 HPC Trunnion #32 threads in the cleaned condition.

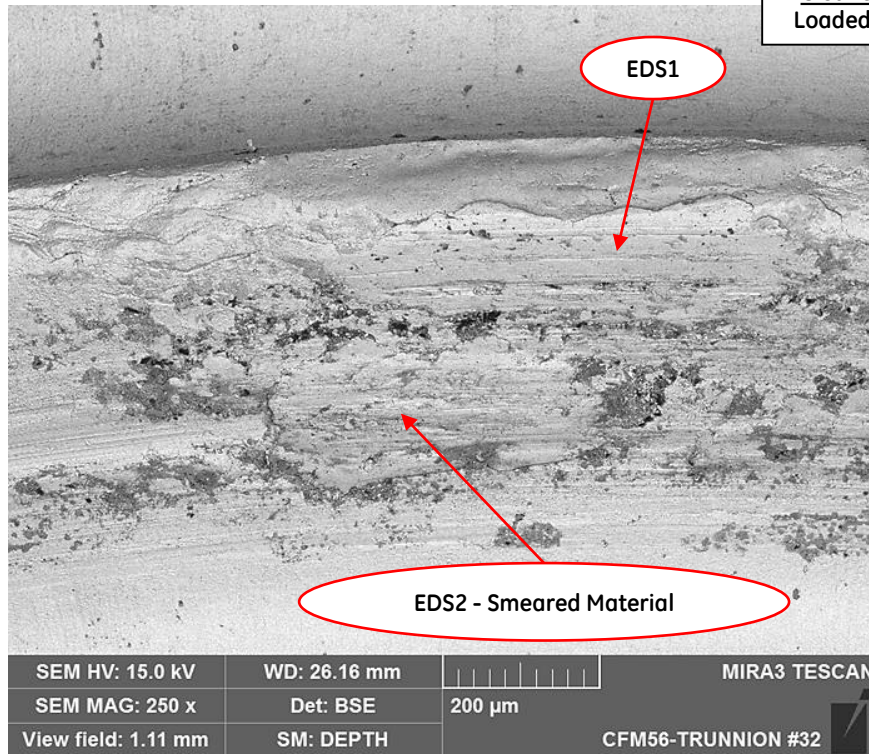
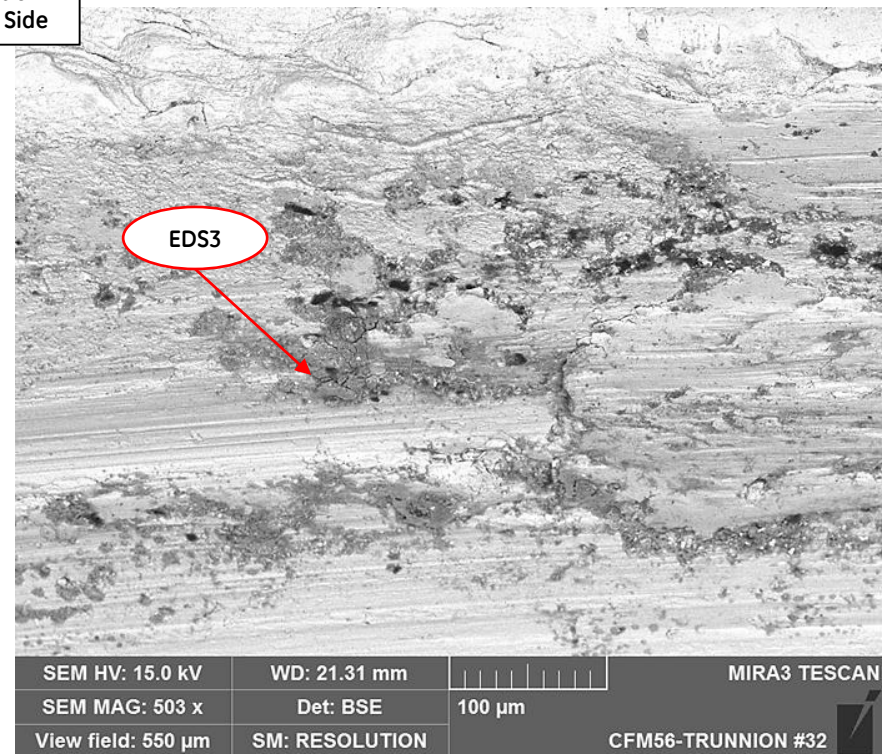
Figure 46. SEM backscatter (BEI) images showing closer views of Stg. 1 HPC Trunnion #32 threads in the cleaned condition (lower threads). EDS spectrum obtained at locations EDS1, EDS2 and EDS3.

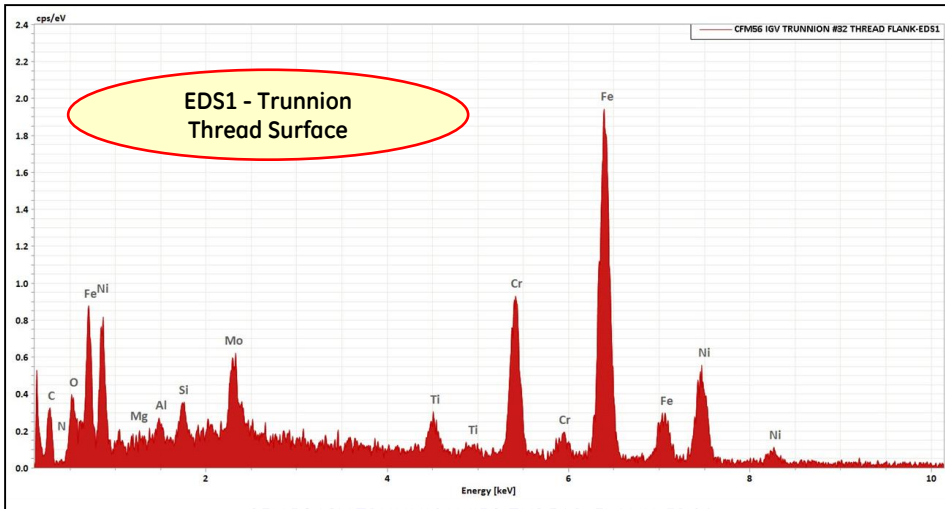
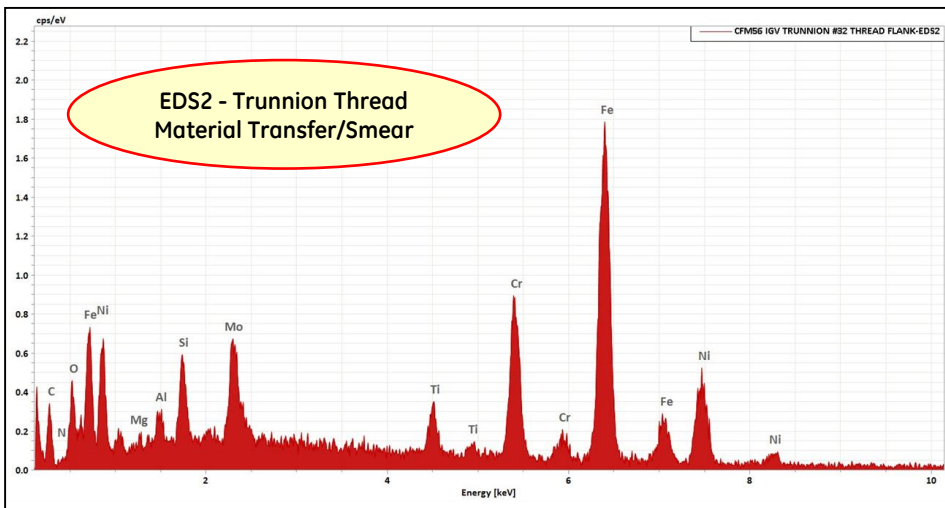
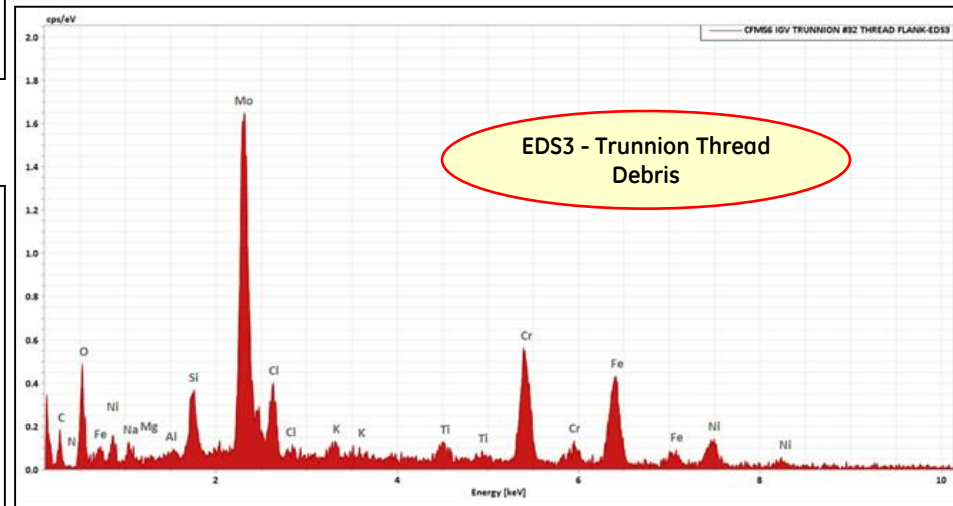
- EDS1: IGV Trunnion Thread Surface - Spectrum Consistent With A286 With Elevated Molybdenum (Mo) and Silicon (Si)
- EDS2: IGV Trunnion Thread Material Transfer/Smear - Spectrum Consistent With A286 With Elevated Molybdenum (Mo) and Silicon (Si)
- EDS3: IGV Trunnion Thread Debris - Spectrum Consistent With A286 With Elevated Molybdenum (Mo), Chlorine (Cl), Sodium (Na) and Potassium (K)

Figure 47. EDS spectrum obtained from the lower threads of Stg. 1 HPC Trunnion #32 at locations EDS1, EDS2 and EDS3.

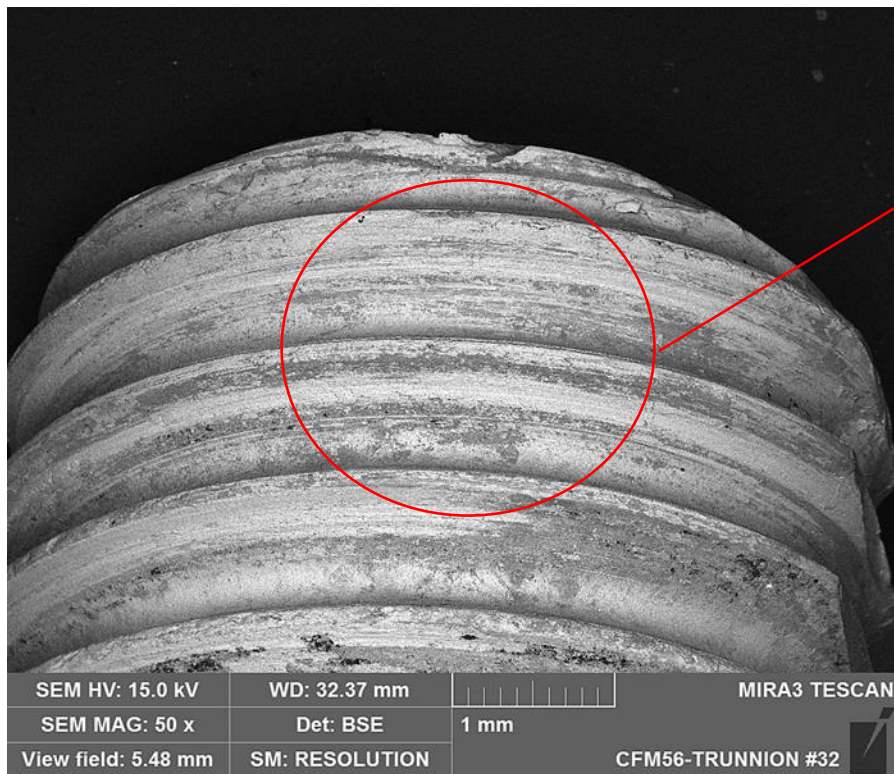
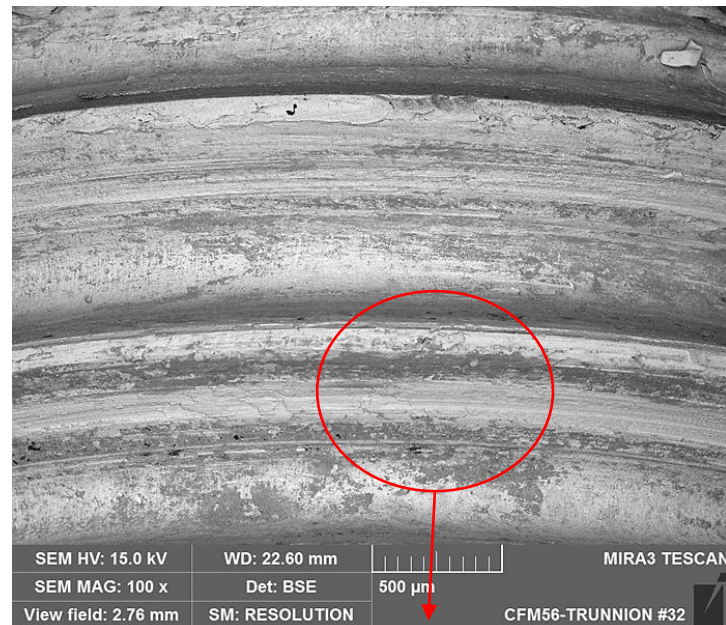
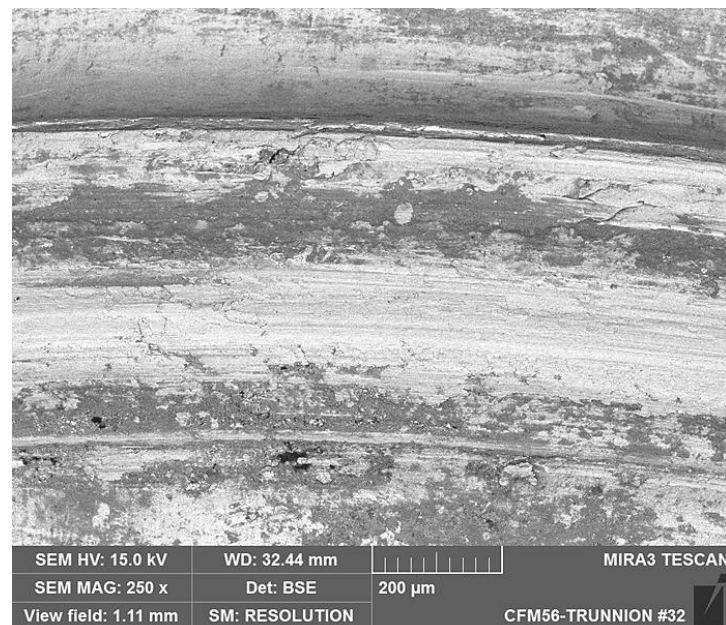
- Circumferential Loaded Side Thread Flank Contact Observed on Upper Threads of Stg. 1 Vane Trunnion #32 Consistent With Nut Contact

Figure 48. SEM backscatter (BEI) images documenting Stg. 1 HPC Trunnion #32 threads in the cleaned condition (upper threads).

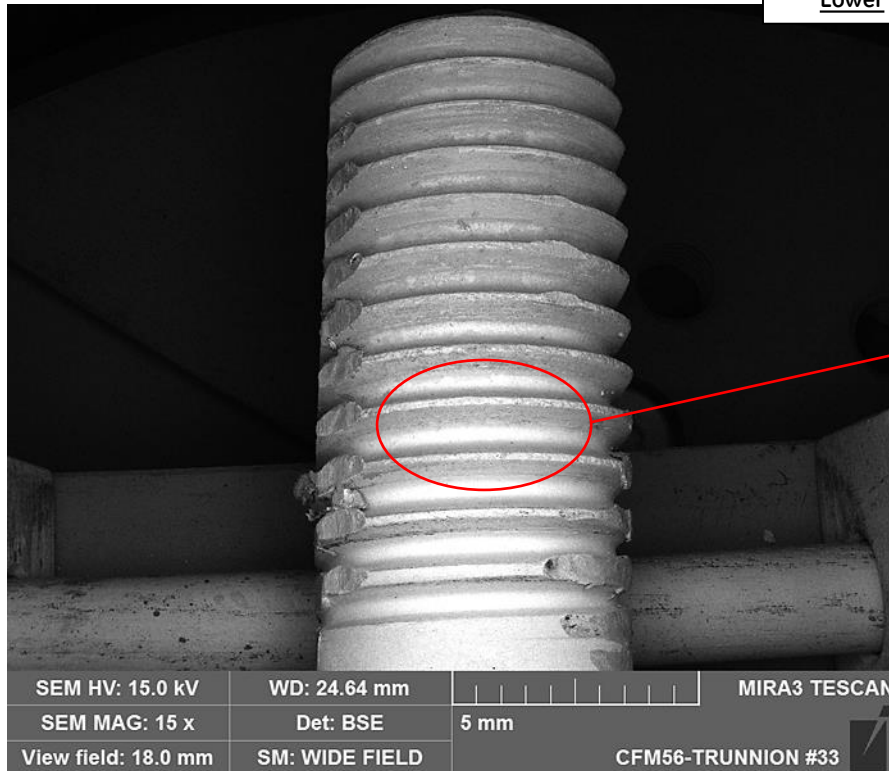
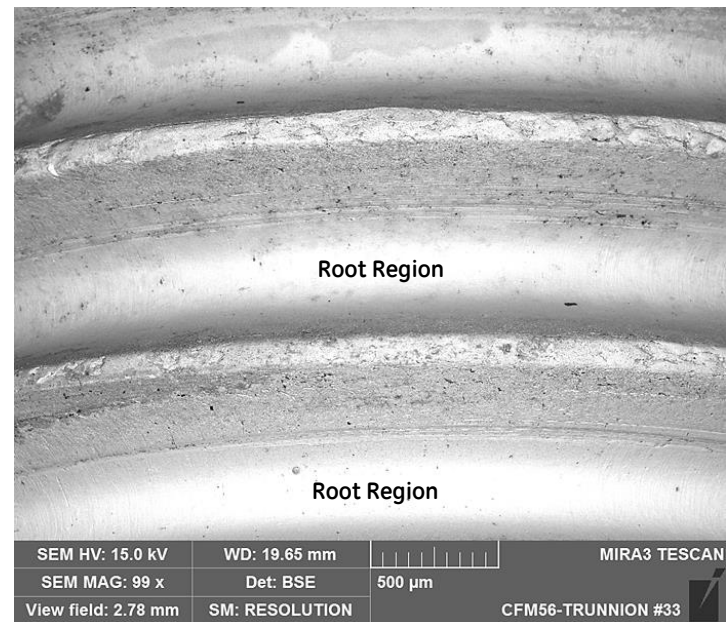
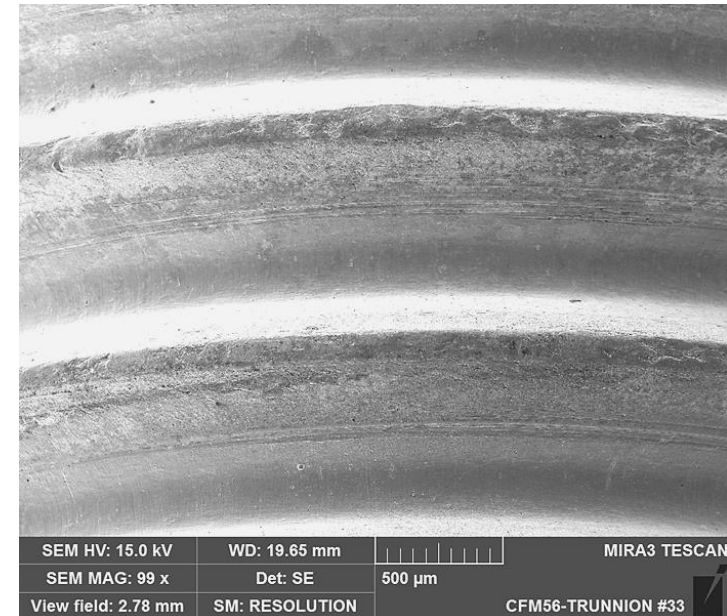
- Loaded Side Thread Flank Contact Observed on Lower Threads of Stg. 1 Vane Trunnion #33 Consistent With Nut Contact at Some Point
- Note Circumferential Grooves Present on Thread Flank But Not in Root Region

Figure 49. SEM backscatter (BEI) and secondary (SEI) images documenting Stg. 1 HPC Trunnion #33 threads in the cleaned condition (lower threads).

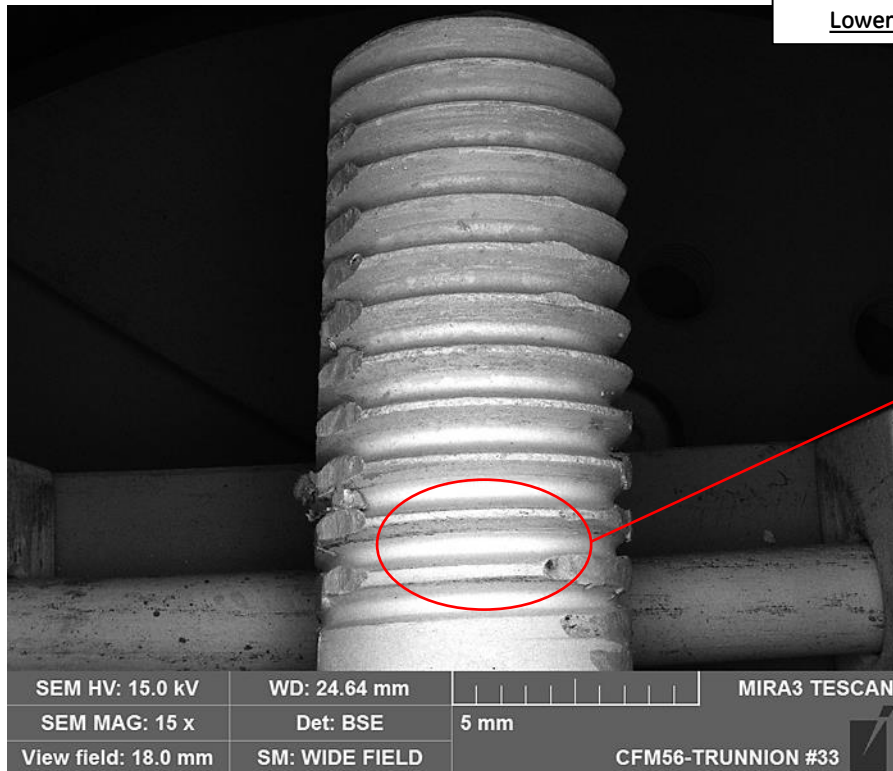
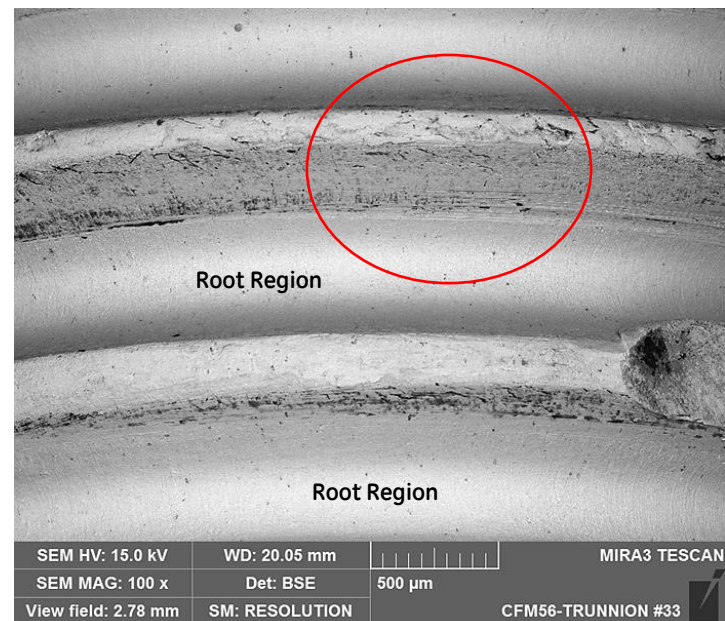
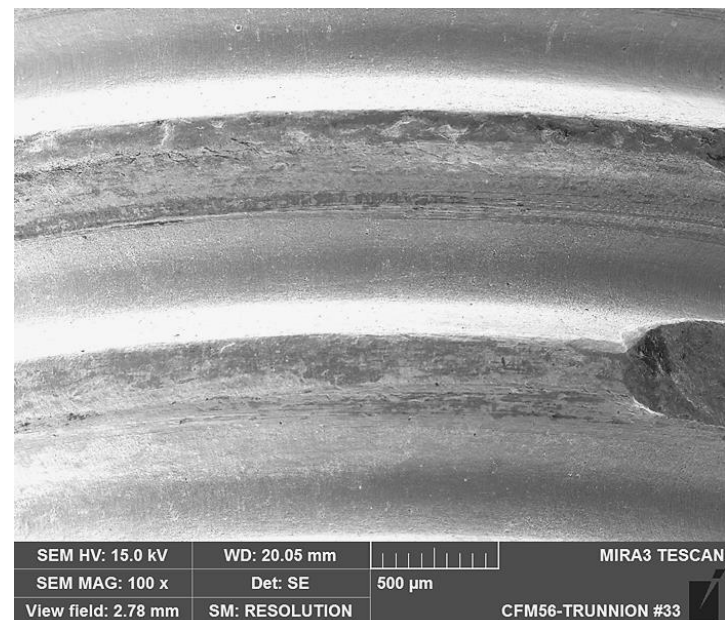
- Loaded Side Thread Flank Contact Observed on Lower Threads of Stg. 1 Vane Trunnion #33 Consistent With Nut Contact at Some Point
- Note Circumferential Grooves Present on Thread Flank But Not in Root Region

Figure 50. SEM backscatter (SEI) images documenting Stg. 1 HPC Trunnion #33 threads in the cleaned condition (lower threads).

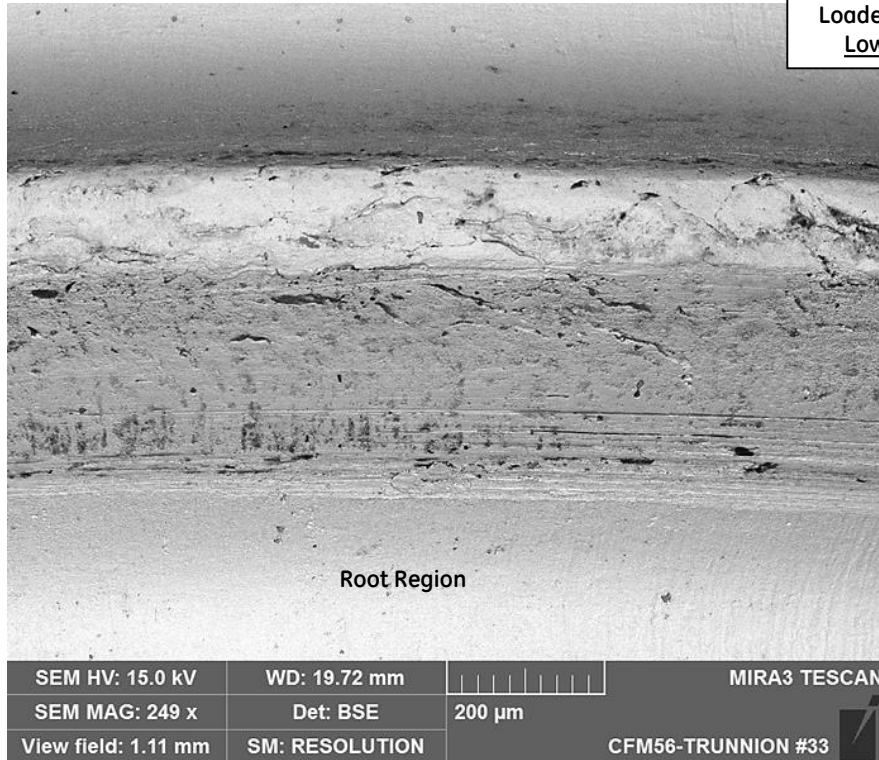
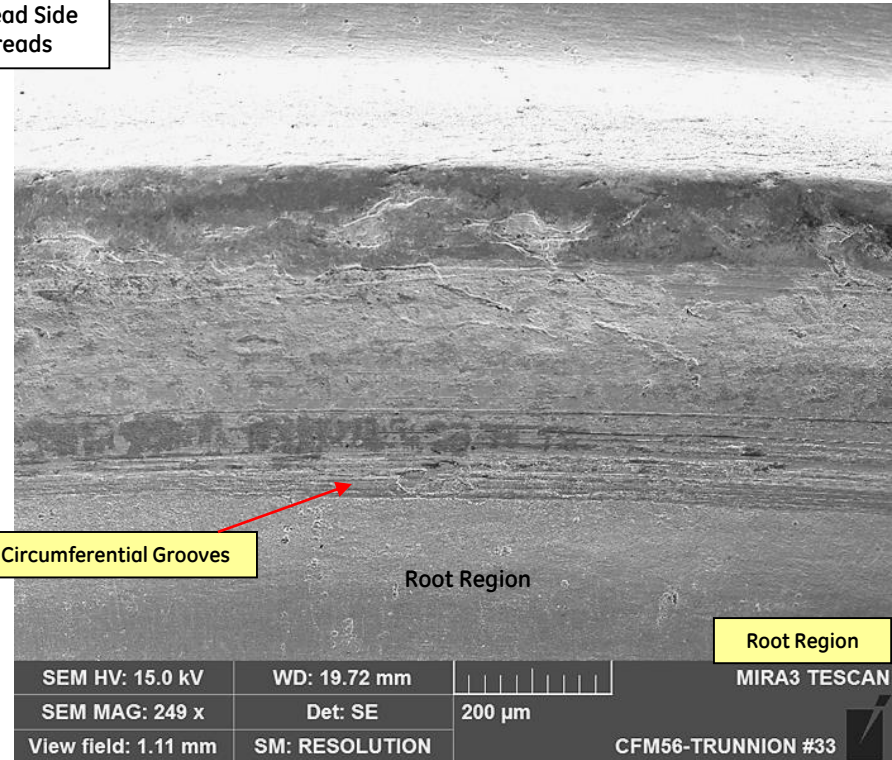
- Loaded Side Thread Flank Contact Observed on Lower Threads of Stg. 1 Vane Trunnion #33 Indicating Contact With a Nut Occurred at Some Point
- Note Circumferential Grooves Present on Thread Flank But Not in Root Region

Figure 51. Closer SEM backscatter (BEI) and secondary (SEI) images showing closer views of Stg. 1 HPC Trunnion #33 thread contact after cleaning (lower threads).

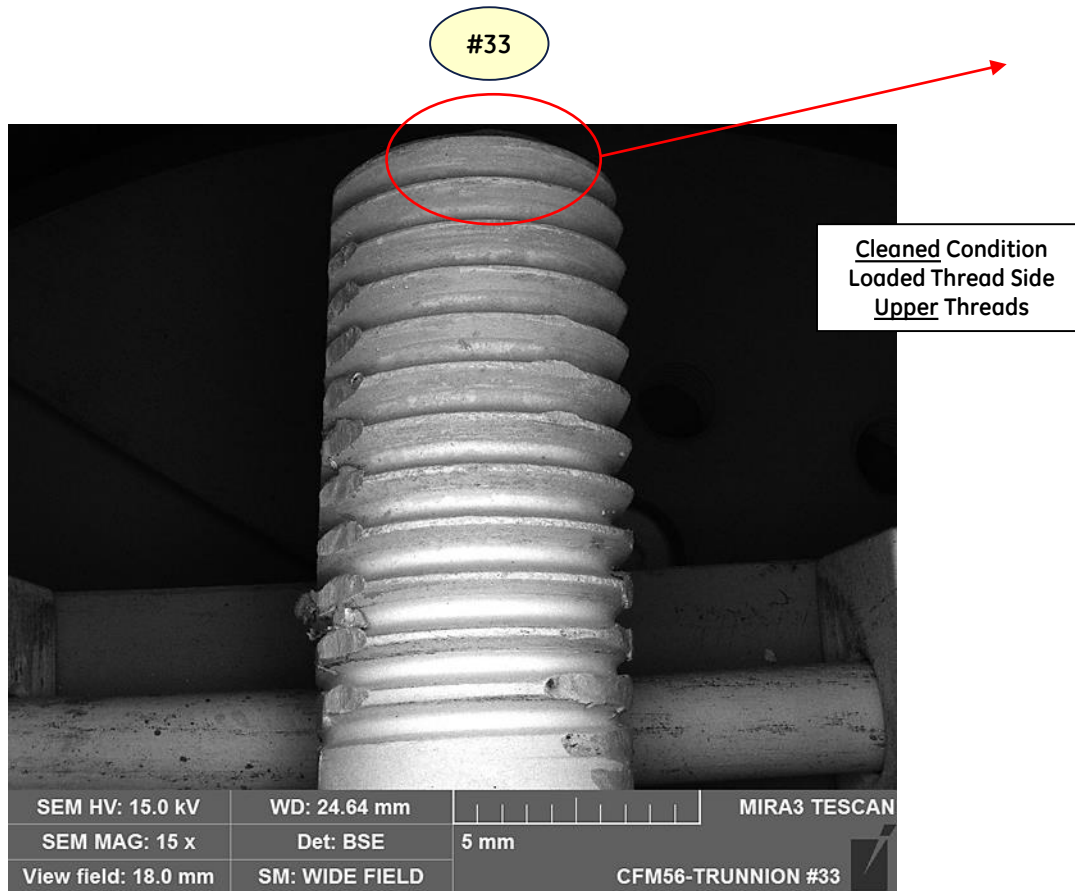
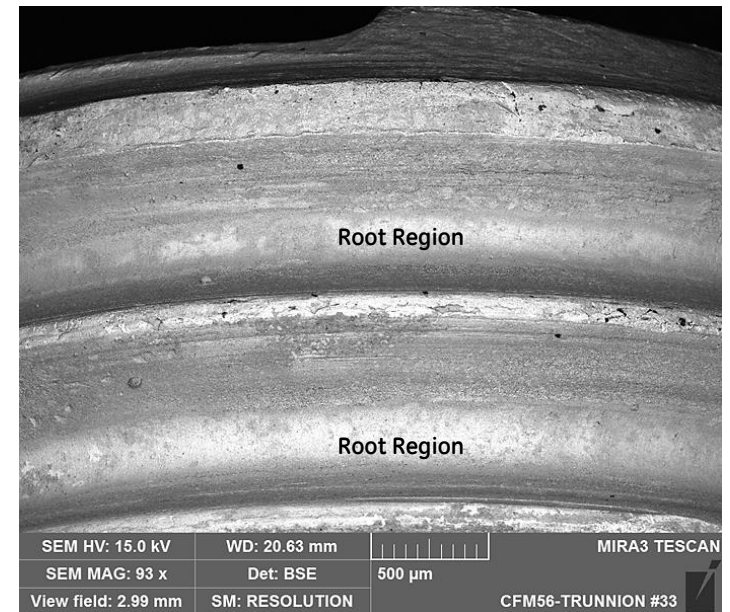
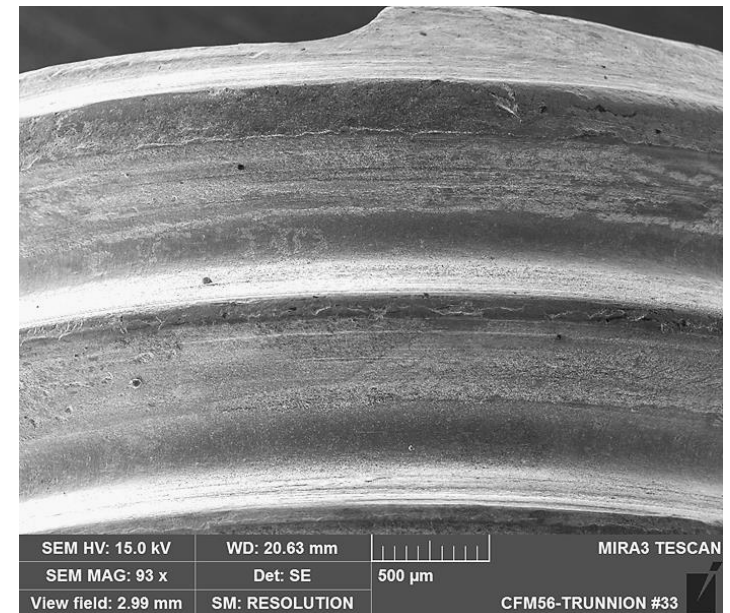
- Loaded Side Thread Flank Contact Observed on Upper Threads of Stg. 1 Vane Trunnion #33 Compared to Trunnion #34
- Note Circumferential Grooves Present on Thread Flank But Not in Root Region

Figure 52. SEM backscatter (SEI) images documenting Stg. 1 HPC Trunnion #33 threads in the cleaned condition (upper threads).
