# Metallurgical Investigation Report

## FA Log No. 18712

**METALLURGICAL EVALUATION OF  
CFM56-7B STG. 1-2 HPC SPOOL AND  
STG. 1 HPC VSV TRUNNION/LEVER  
ARM HARDWARE FROM ESN 875-  
318 OPERATED BY UNITED AIRLINES**

**Final Report Date: June 14, 2019**

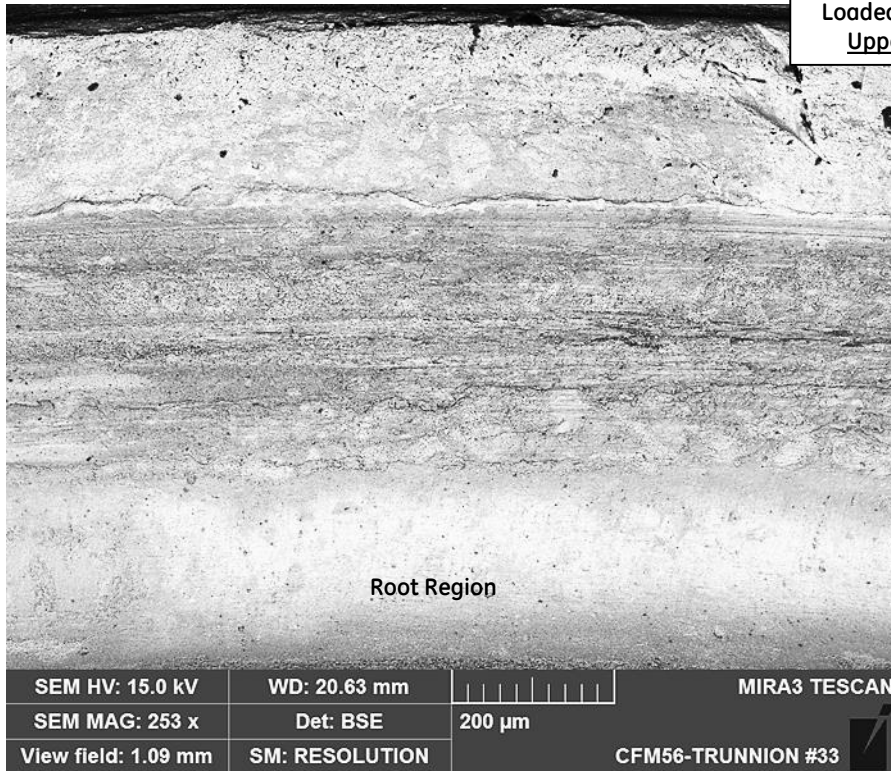
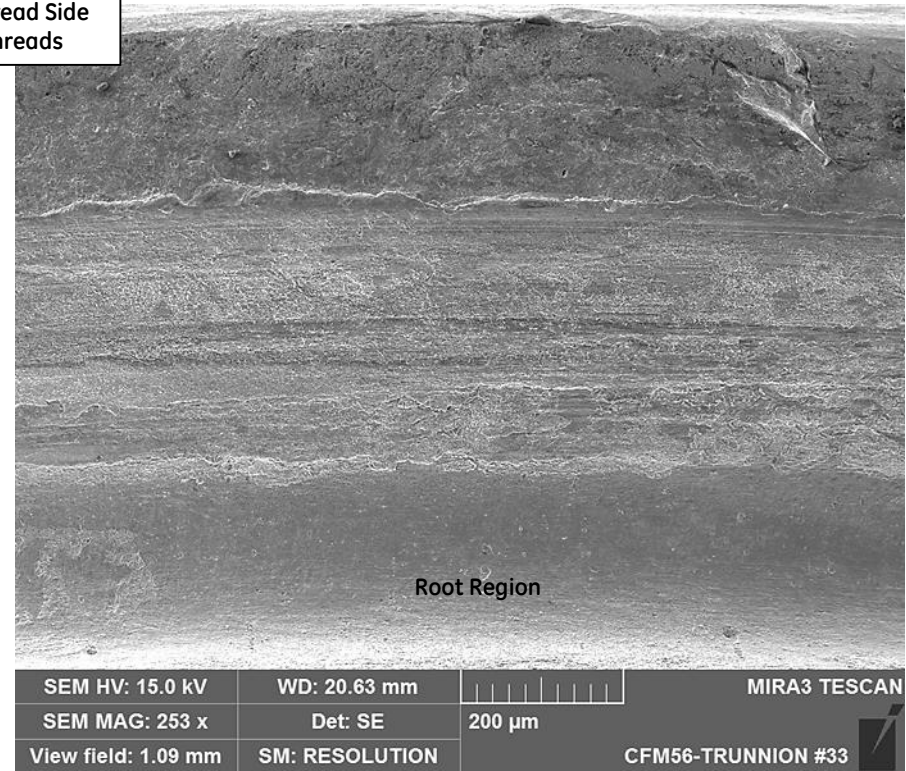
- Loaded Side Thread Flank Contact Observed on Lower Threads of Stg. 1 Vane Trunnion #33 Compared to Trunnion #34
- Note Circumferential Grooves Present on Thread Flank But Not in Root Region

Figure 53. Closer SEM backscatter (BEI) and secondary (SEI) images showing closer views of Stg. 1 HPC Trunnion #33 thread contact after cleaning (upper threads).

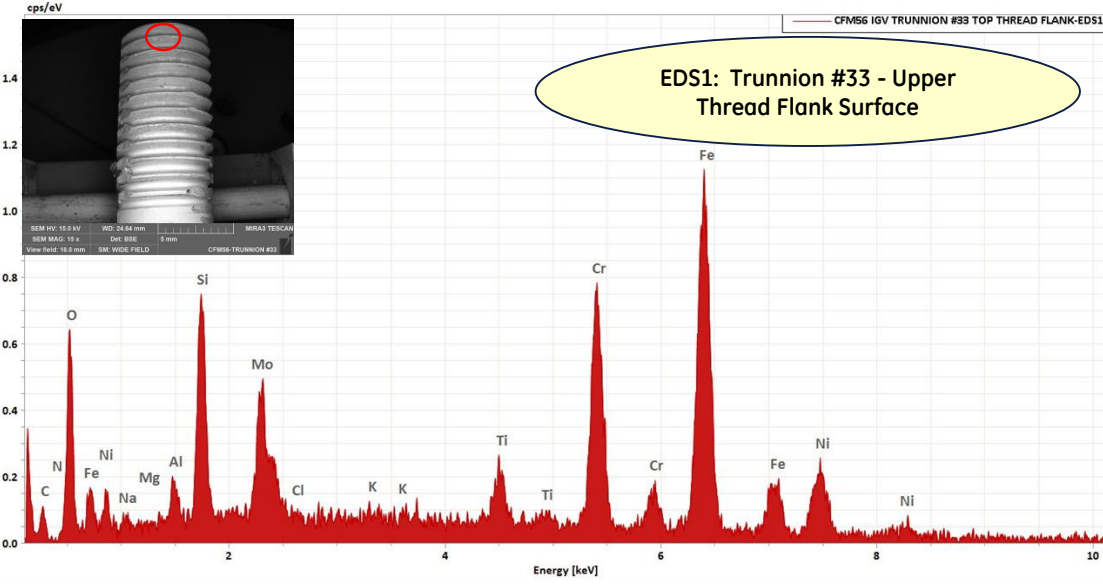
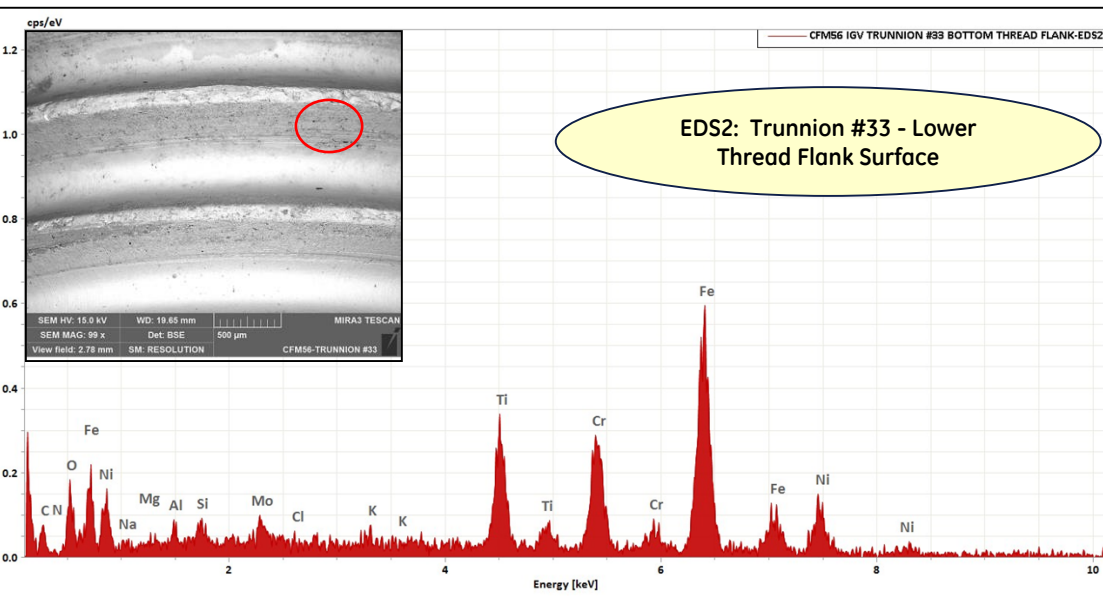
- EDS1: Upper Thread Flank Surface - Spectrum Consistent With A286 With Elevated Molybdenum (Mo) and/or Sulfur (S) With Silicon (Si)
- EDS2: Lower Thread Flank Surface - Spectrum Consistent With A286

Figure 54. EDS spectra obtained from both the upper and lower thread flank surfaces of Stg. 1 HPC Trunnion #33 threads after cleaning. Trunnion most consistent with A286 type material as required.

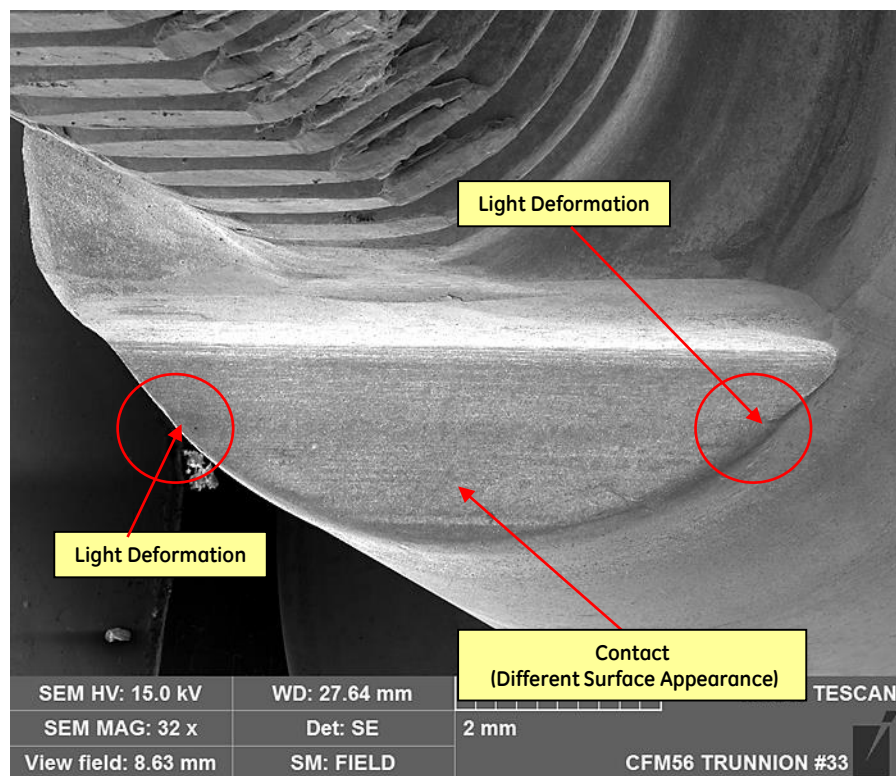
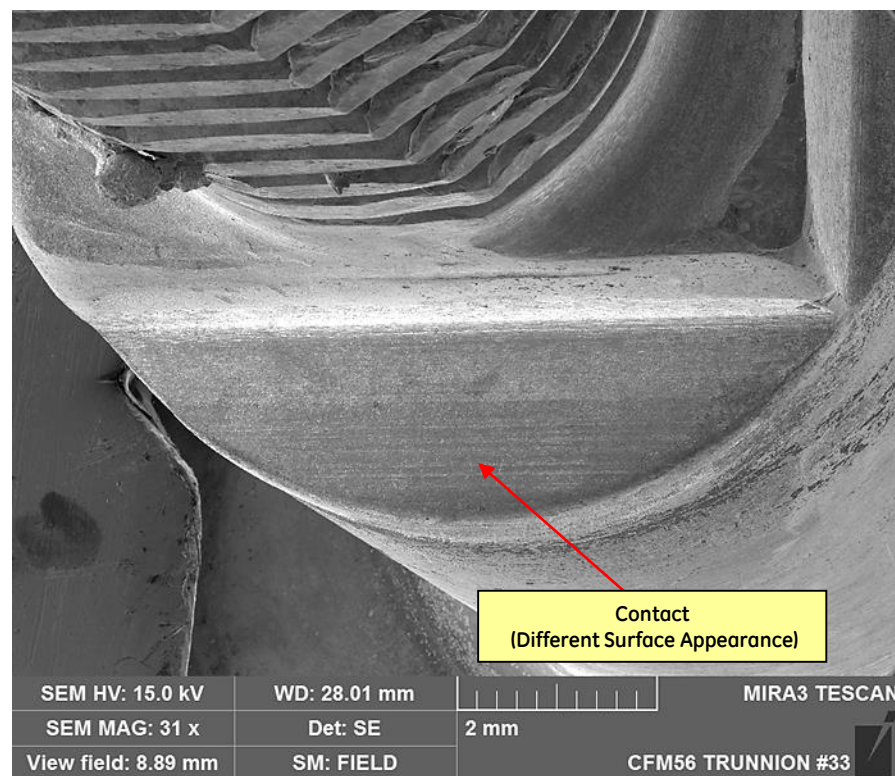
Surface contact and local deformation at the edge of trunnion #33 in the cleaned condition was confirmed as shown in Figures 55, 56 and 57 indicating that the mating lever arm D-slot had been properly installed at some point in time. Closer examination of trunnion #33 D-head corners revealed smearing type damage consistent with rotation of the lever arm D-slot feature as it was lifting off the D-head feature as shown in Figures 58-65. Some Ti-6Al-4V lever arm material transfer within the smearing damage. On one (1) trunnion corner, evidence of tensile shear dimples and pushed out material was present due to the abnormal lever arm D-slot contact as the lever arm started to become disengaged.

- Witness Marks With Lever Arm Along With Light Edge Deformation Observed on Stg. 1 Vane Trunnion #33

Figure 55. SEM backscatter secondary (SEI) images documenting presence of witness mark and light deformation attributed to contact with a properly installed lever arm at some point on Stg. 1 Vane Trunnion #33.

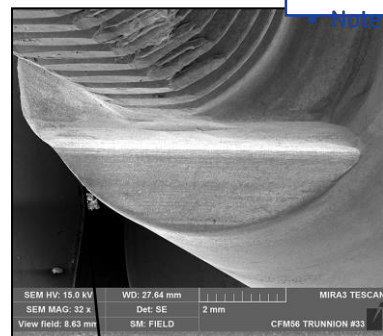
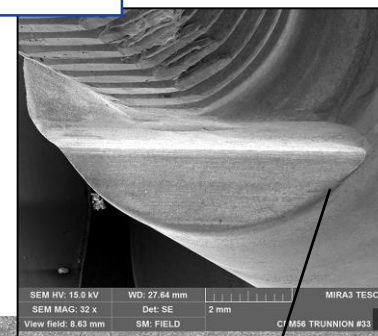
- Light Deformation Observed on Trunnion Edge From Lever Arm Contact For Properly Installed Trunnion #33
- Note Difference in Surface Appearance Between Contacted and Non-Contacted Surfaces

Light Deformation

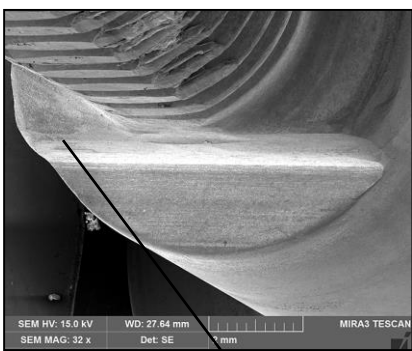
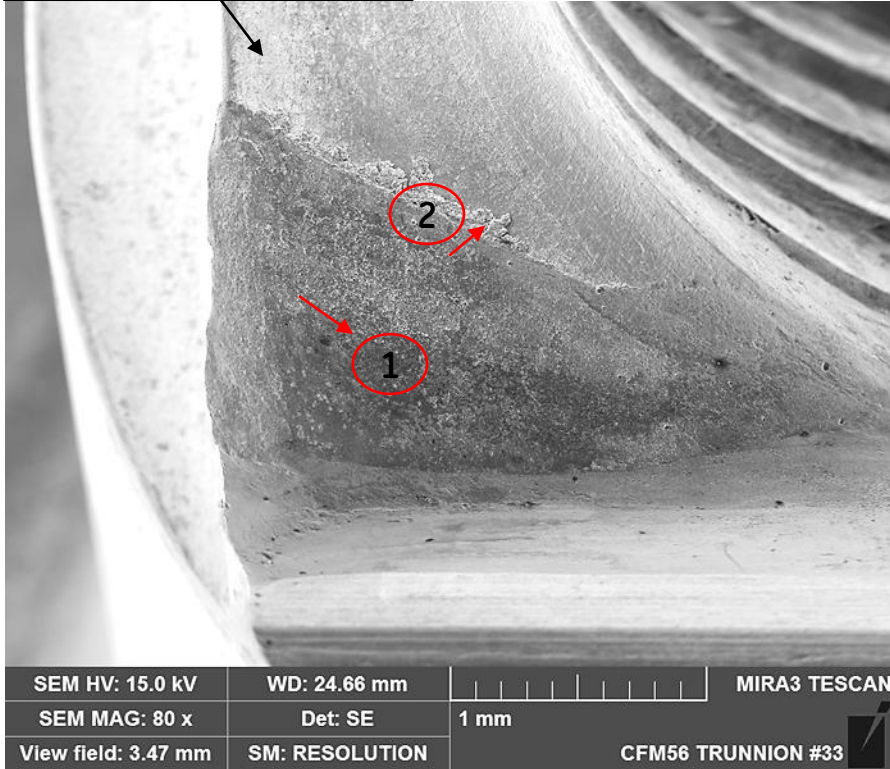
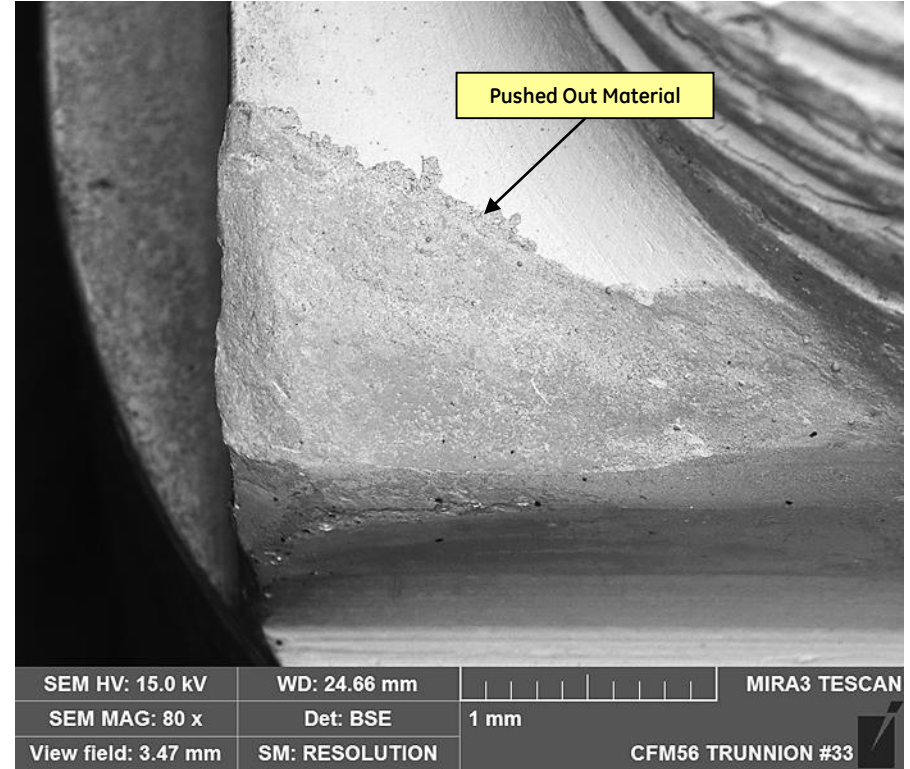
- Rotational Smearing Type Damage Observed on Stg. 1 Vane Trunnion #33 Corner Region

Figure 58. SEM backscatter secondary (SEI) and backscatter (BEI) images documenting Stg. 1 Vane Trunnion #33 corner damage attributed to contact with the mating lever arm slot. Areas 1 and 2 were examined in greater detail. Red arrows denote smearing direction.

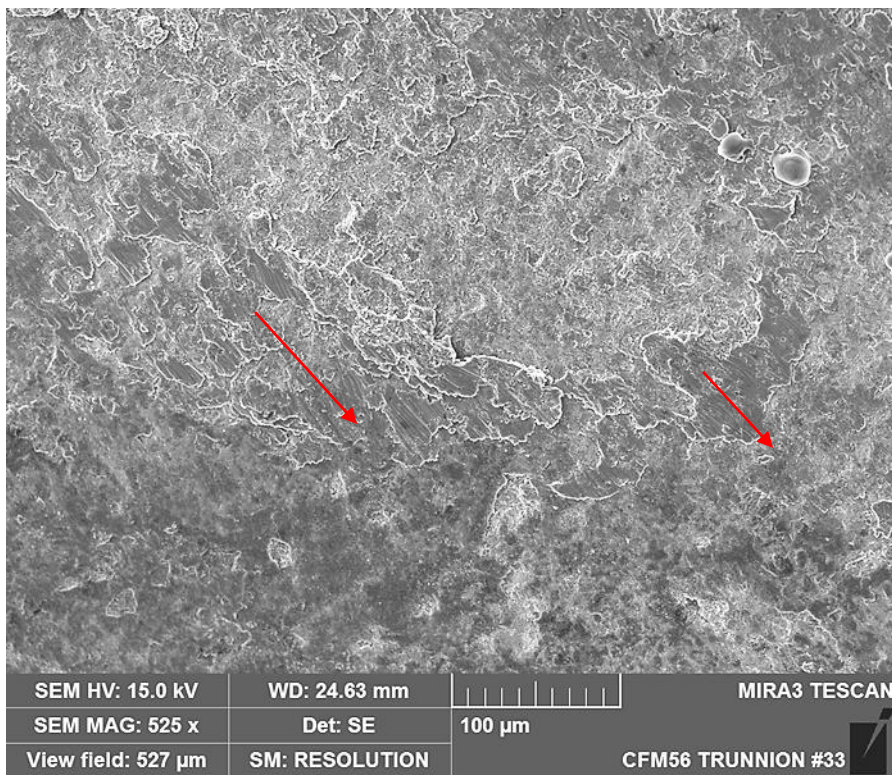
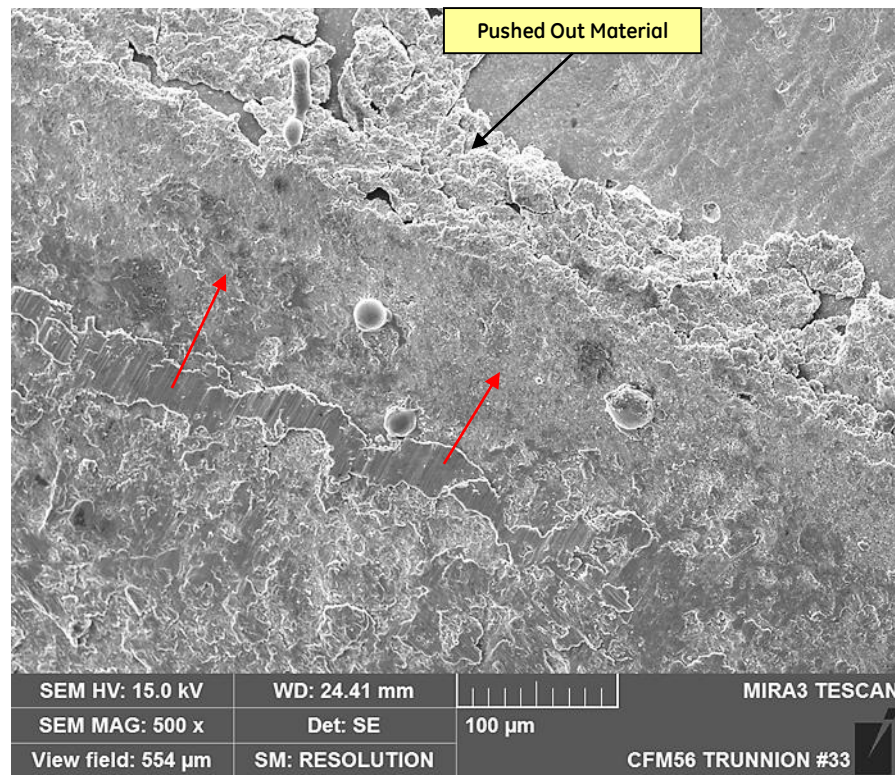
- Rotational and Outboard Smearing Type Damage Observed on Stg. 1 Vane Trunnion #33 Corner Region

Figure 59. SEM backscatter secondary (SEI) images documenting Stg. 1 Vane Trunnion #33 trunnion smearing damage at areas 1 and 2 as shown in Figure 58. Red arrows denote smearing direction.

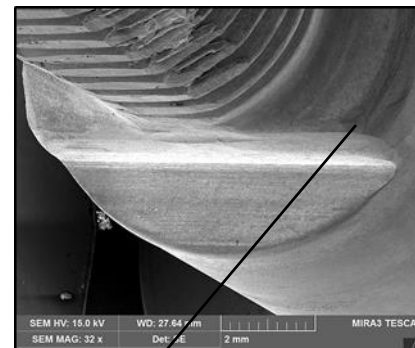
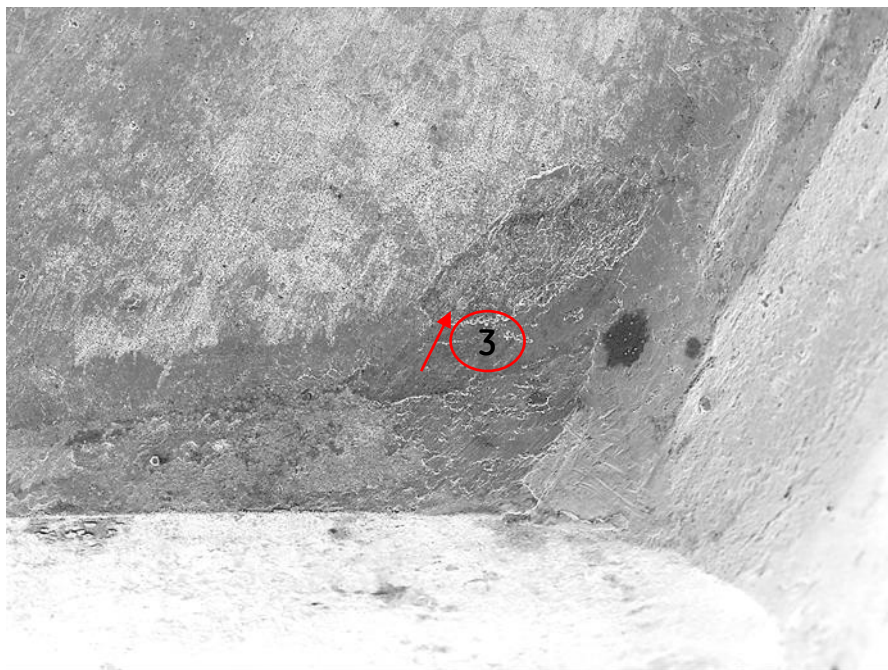
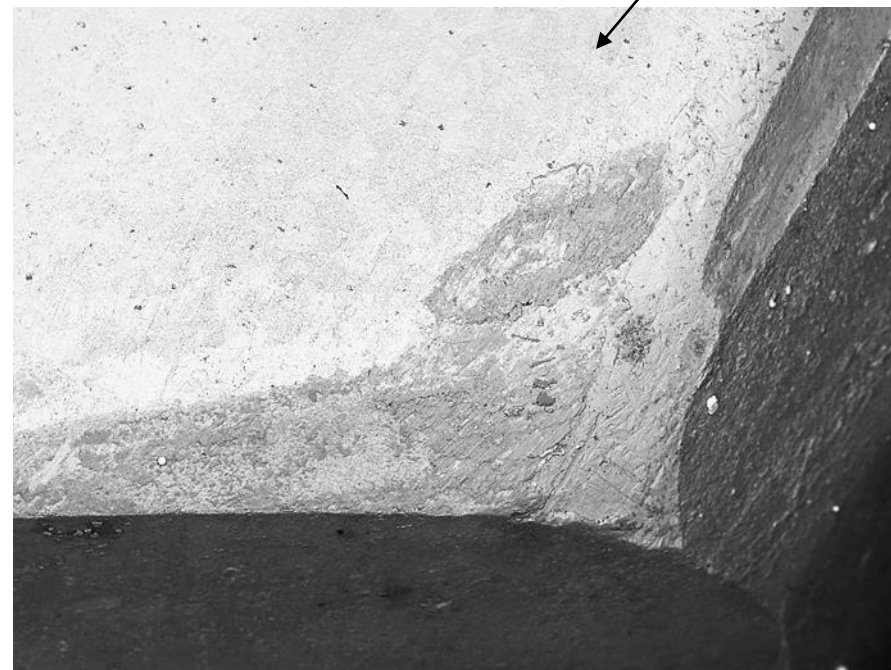
- Rotational Smearing Type Damage Observed on Stg. 1 Vane Trunnion #33 Corner Region

Figure 60. SEM backscatter secondary (SEI) and backscatter (BEI) images documenting Stg. 1 Vane Trunnion #33 corner damage attributed to contact with the mating lever arm slot. Area 3 was examined in greater detail. Red arrow denote smearing direction.

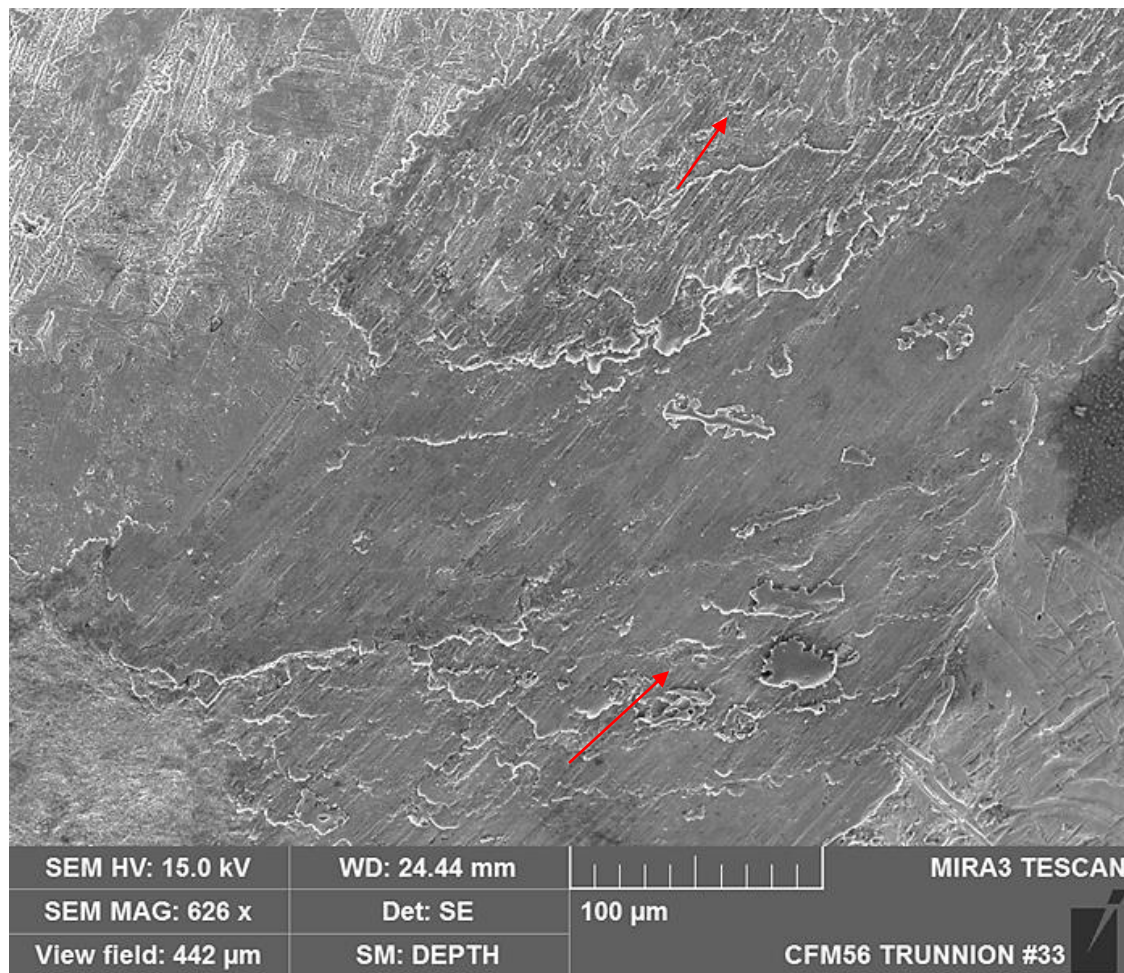
- Rotational Smearing Type Damage Observed on Stg. 1 Vane Trunnion #33 Corner Region

Figure 61. SEM backscatter secondary (SEI) images documenting Stg. 1 Vane Trunnion #33 trunnion smearing damage at area 3 as shown in Figure 60. Red arrow denotes smearing direction.

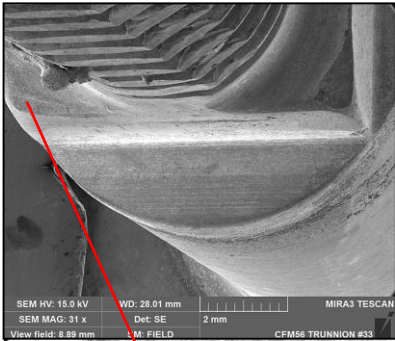
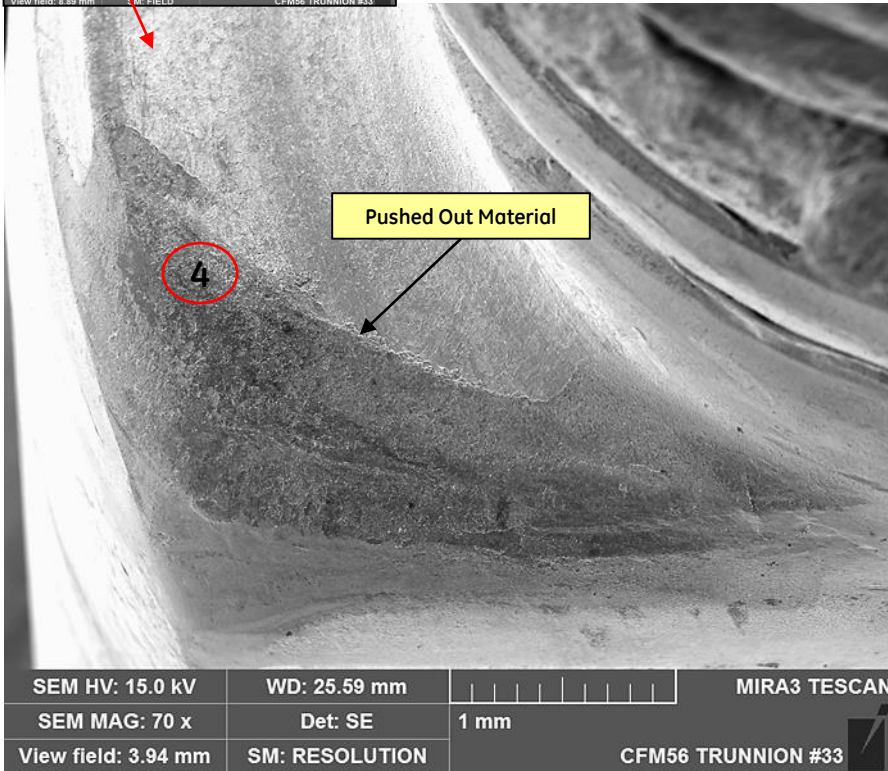
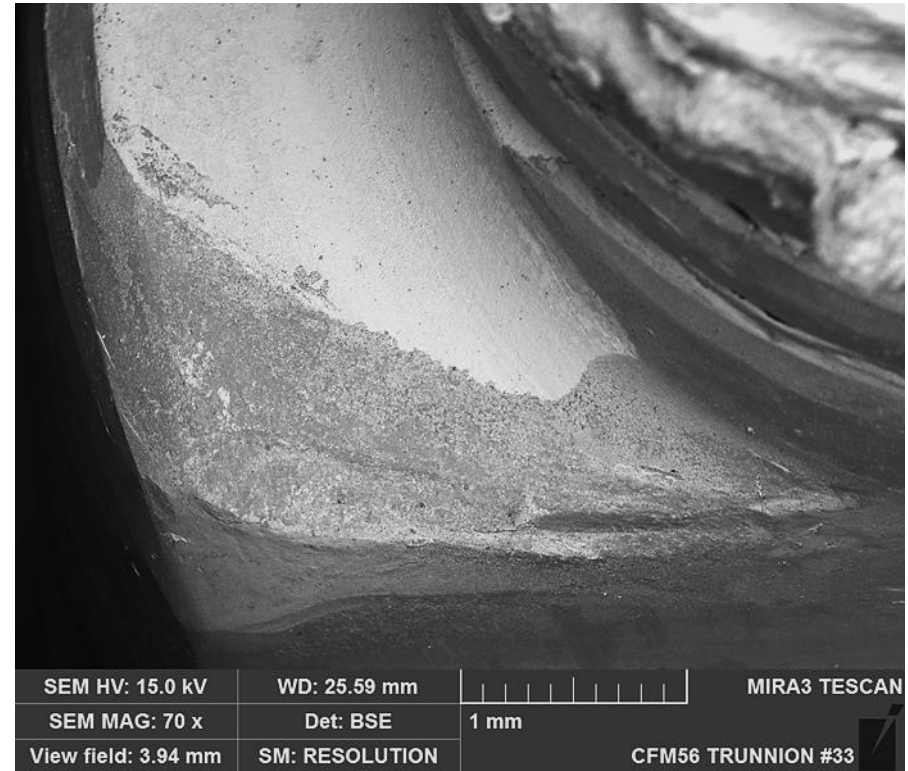
- Rotational and Outboard Smearing Type Damage Observed on Stg. 1 Vane Trunnion #33 Corner Region

Figure 62. SEM backscatter secondary (SEI) and backscatter (BEI) images documenting Stg. 1 Vane Trunnion #33 corner damage attributed to contact with the mating lever arm slot. Area 4 was examined in greater detail.

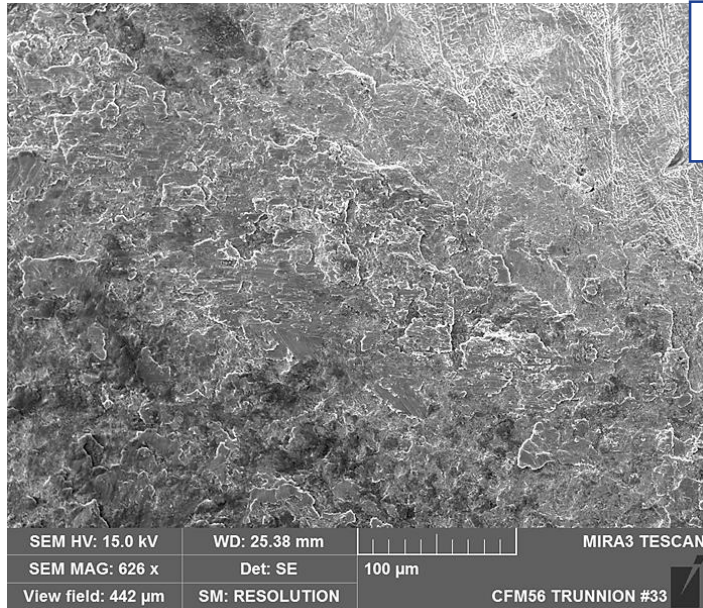
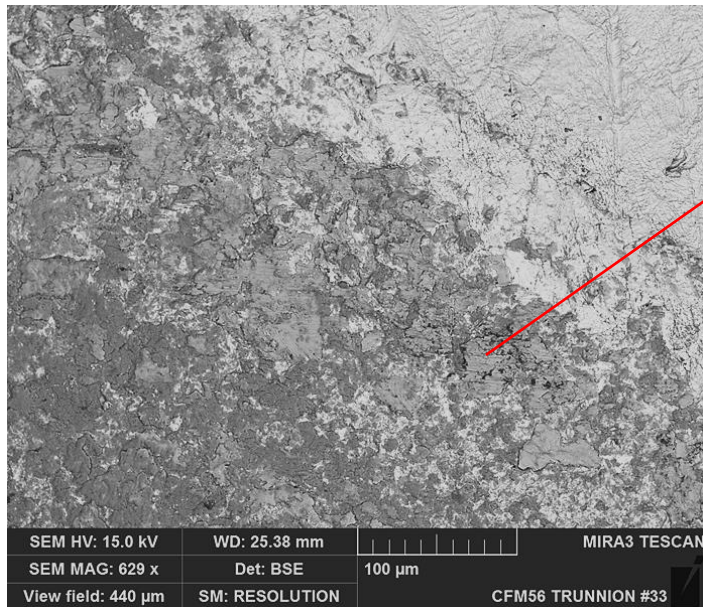
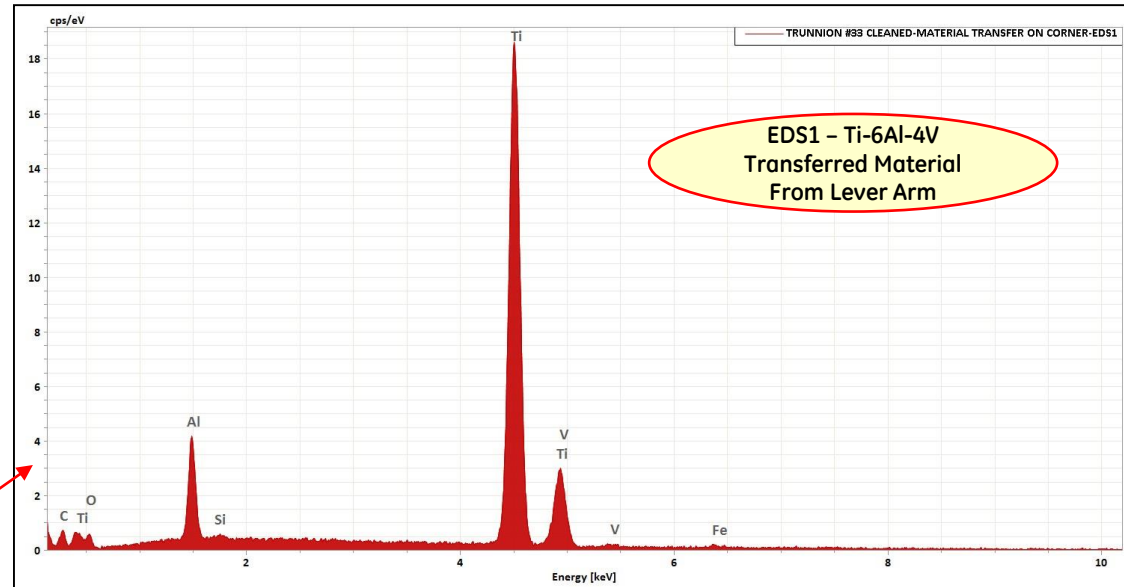
- Rotational and Outboard Smearing Type Damage Observed on Stg. 1 Vane Trunnion #33 Corner Region
- Evidence of Ti-6Al-4V Metal Transfer on Smeared Trunnion Corner From Lever Arm

Figure 63. SEM backscatter secondary (SEI) images and accompanying EDS spectrum documenting Stg. 1 Vane Trunnion #33 trunnion smearing damage at area 4 as shown in Figure 62.

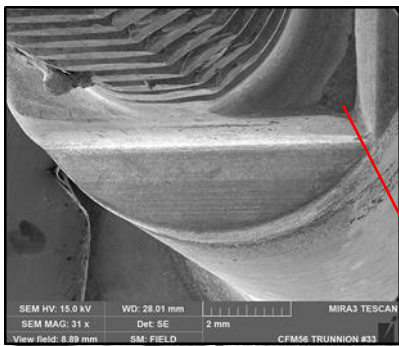
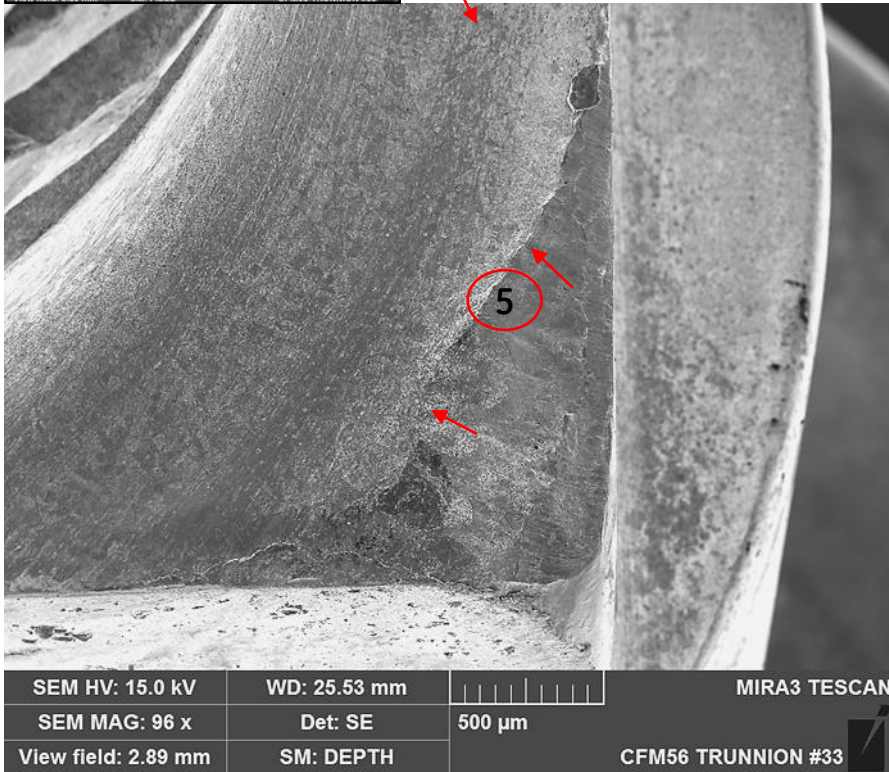
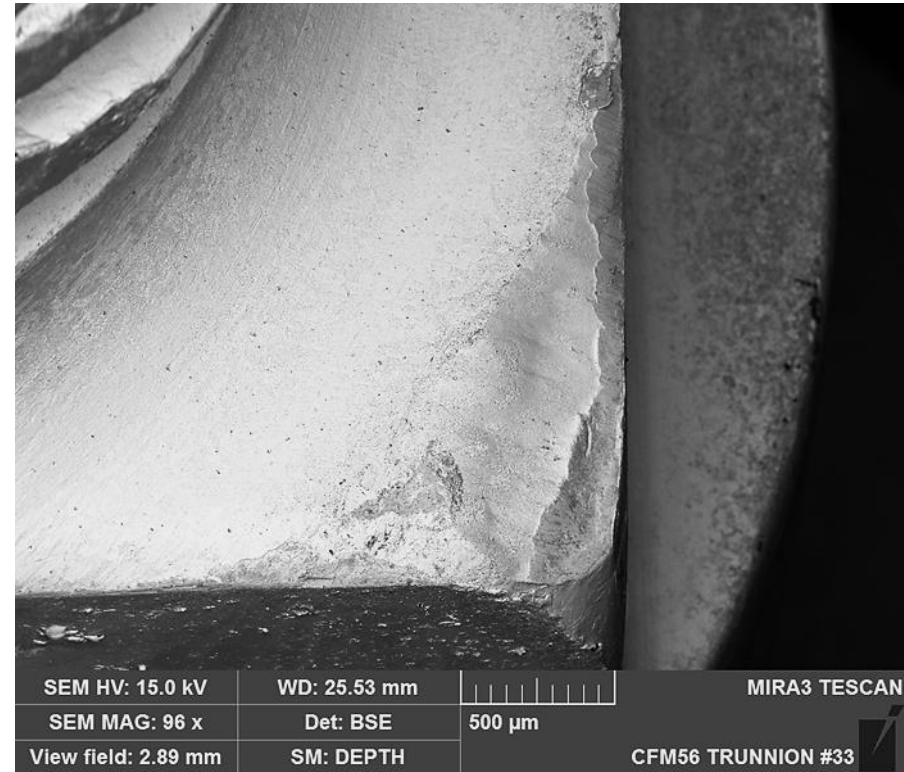
- Primarily Outward Smearing Damage Observed on Stg. 1 Vane Trunnion #33 Corner Region

Figure 64. SEM backscatter secondary (SEI) and backscatter (BEI) images documenting Stg. 1 Vane Trunnion #33 corner damage attributed to contact with the mating lever arm slot. Area 5 examined in greater detail. Arrows denote an outward smearing direction.

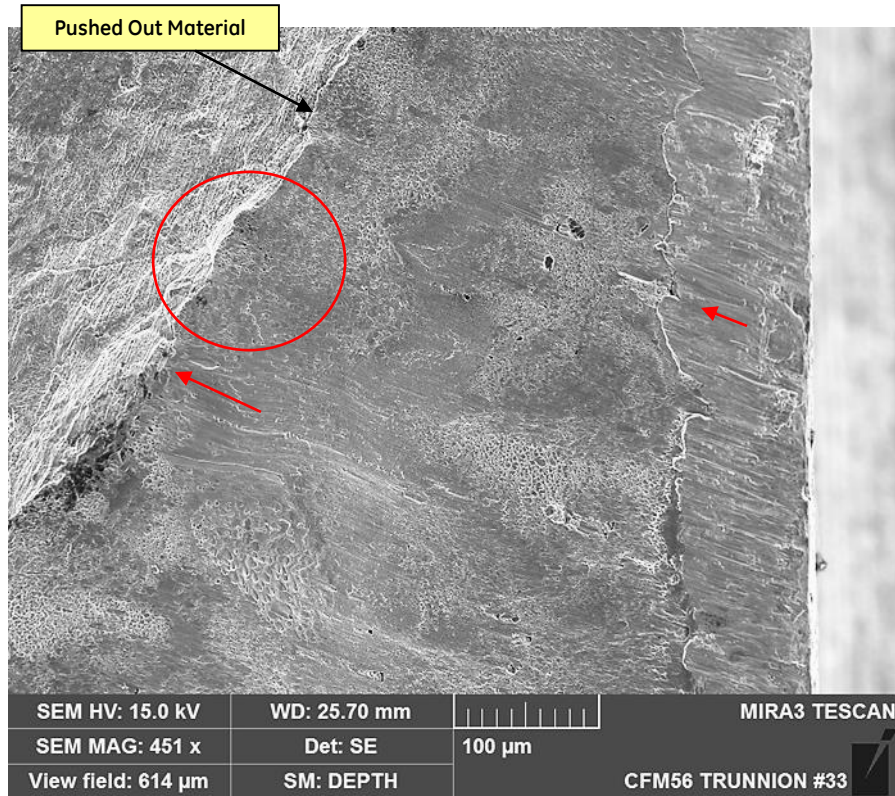
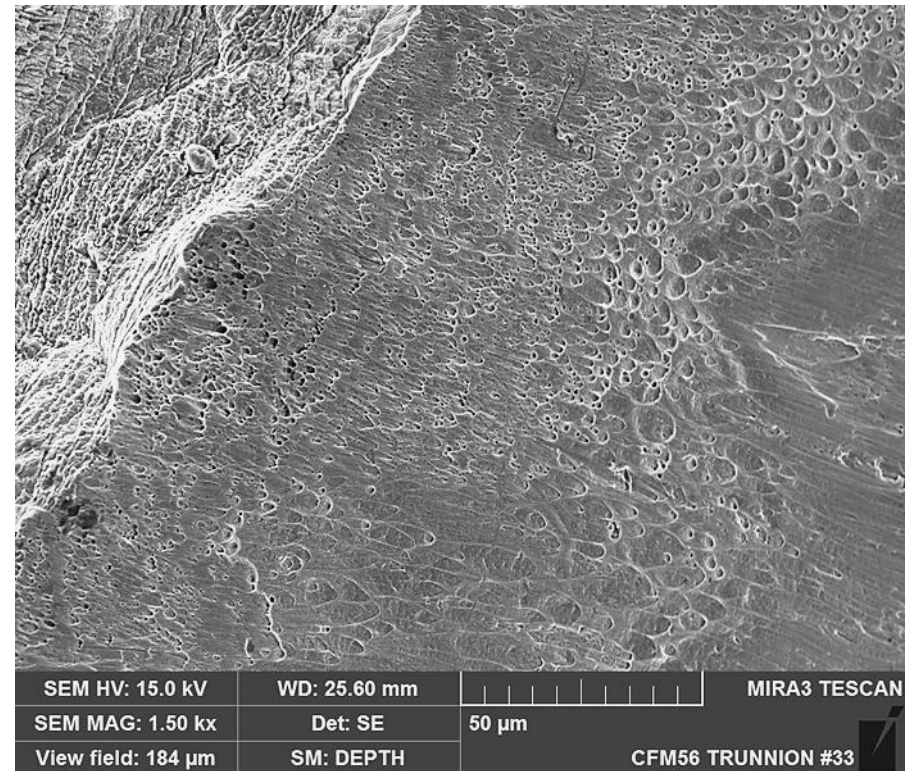
- Primarily Outboard Smearing Type Damage Observed on Stg. 1 Vane Trunnion #33 Corner Region – Tensile Shear Dimples Present on Smeared Corner Surface

Stg. 1 Vane Trunnion #33 – Damaged Corner – SEI  
Tensile Shear Dimples

Figure 65. SEM backscatter secondary (SEI) images documenting Stg. 1 Vane Trunnion #33 trunnion smearing damage at area 5 as shown in Figure 64. Red arrow denotes smearing direction. Tensile shear dimples observed on surface.

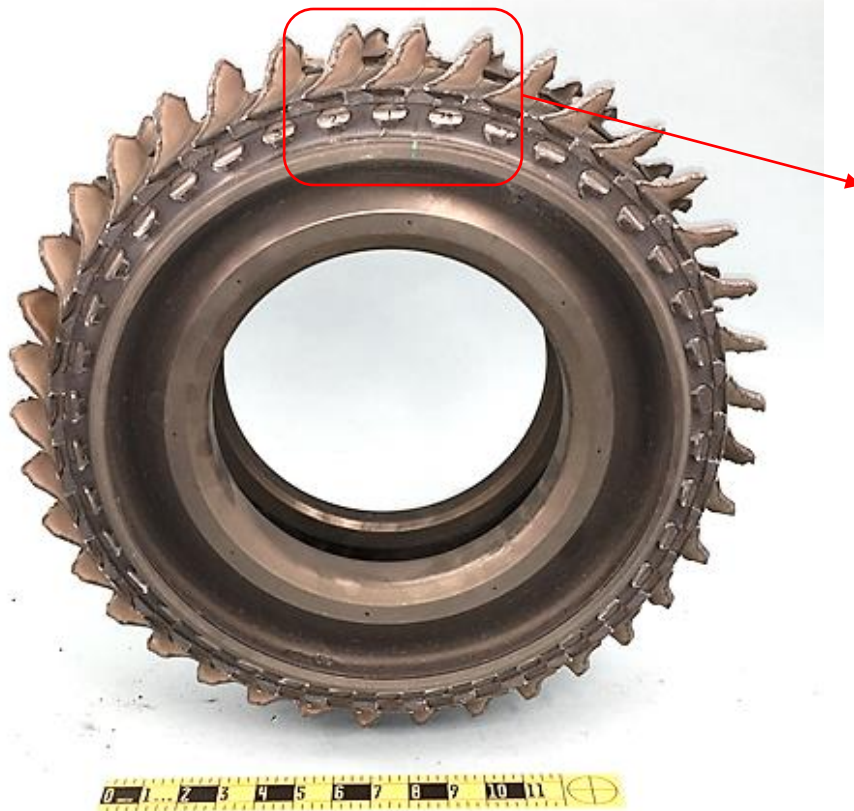
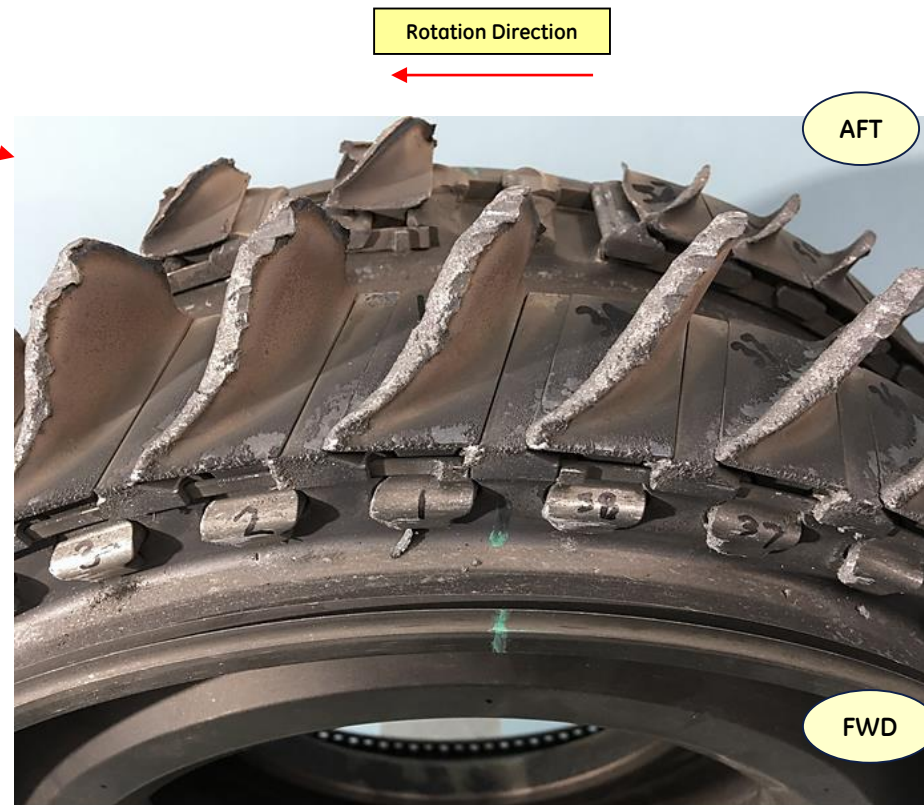
Overall views of the Stg. 1-2 HPC Spool prior to removal of blade remnants are shown in Figures 66 and 67. Remaining airfoil portions of both Stg. 1 and Stg. 2 HPC Blades both exhibited “tombstone” shape consistent with titanium airfoil burning. Additional photographs documenting the general condition of the Stg. 1-2 HPC Spool are shown in Figures 68-75. All Stg. 1 HPC Blade dovetails were intact and accounted for. A total of eight (8) Stg. 2 HPC Blades were completely missing. Ten (10) Stg. 2 HPC Disk posts exhibited missing material, all associated with missing Stg. 2 HPC Blades.

- All Stg. 1 HPC Blade Dovetails Were Present – Eight (8) Stg. 2 HPC Blades Completely Missing With Missing Material Observed on Ten (10) Disk Posts
- Both Remaining Stg. 1 and Stg. 2 Airfoils Exhibited Shape/Appearance Consistent With Burning

Figure 66. Photographs documenting Stg. 1-2 HPC Spool prior to removing remnant HPC Blades.

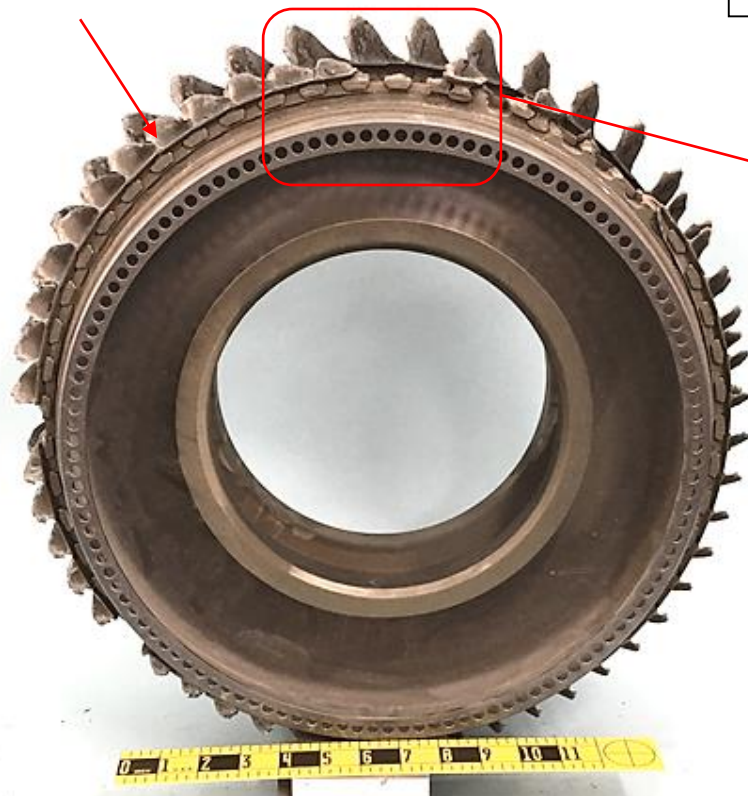
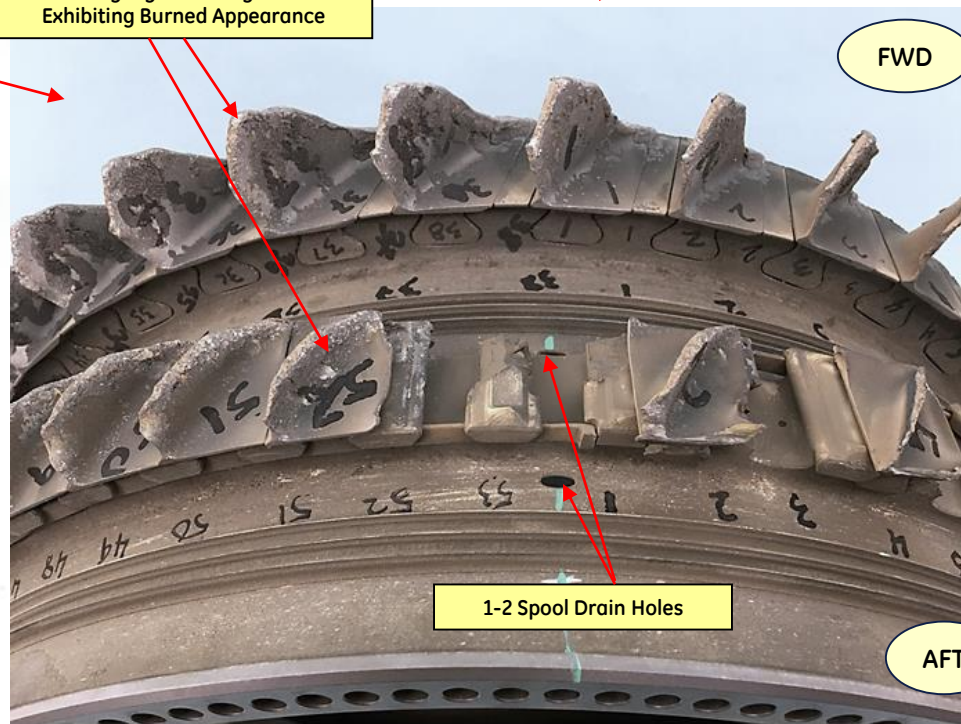
- All Stg. 1 HPC Blade Dovetails Were Present – Eight (8) Stg. 2 HPC Blades Completely Missing With Missing Material Observed on Ten (10) Disk Posts
- Both Remaining Stg. 1 and Stg. 2 Airfoils Exhibited Shape/Appearance Consistent With Burning

Remaining Stg. 1 and Stg. 2 Airfoils  
Exhibiting Burned Appearance

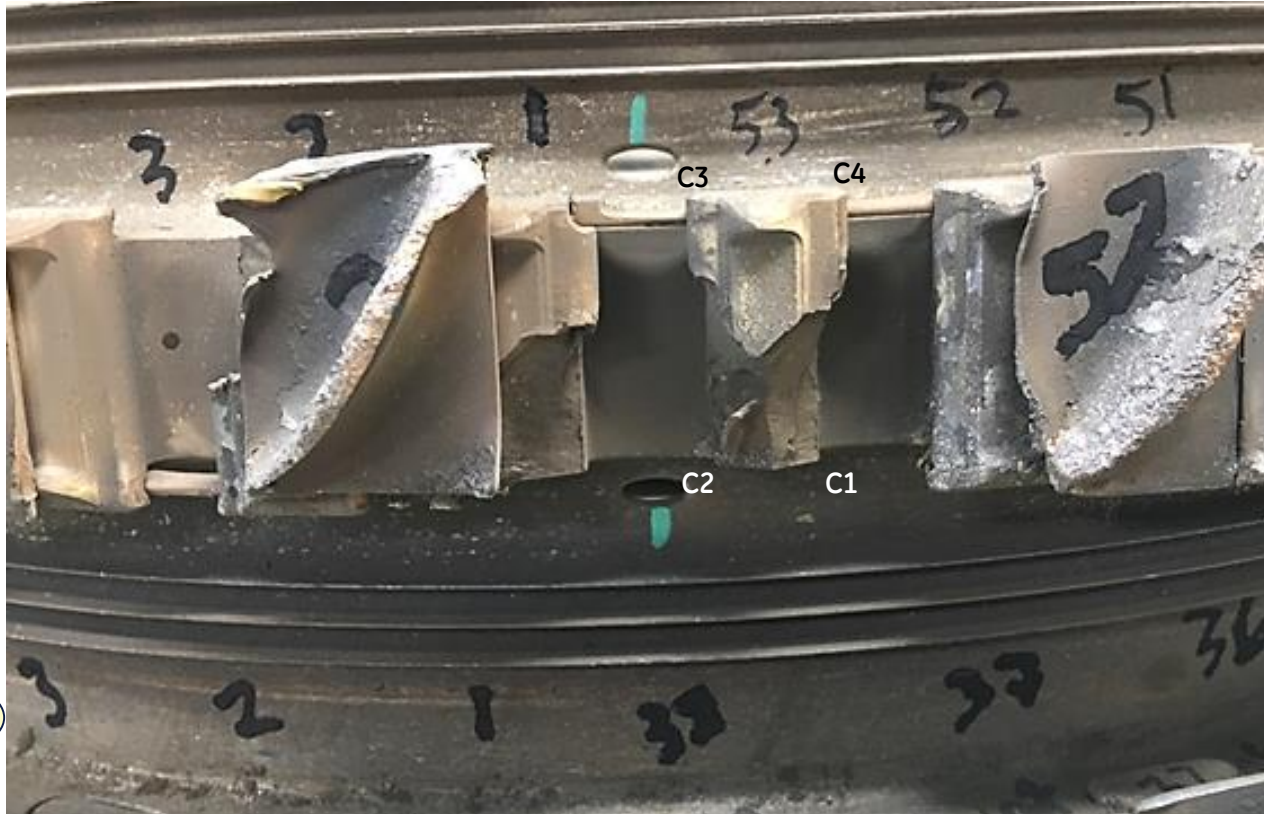
- Missing Stg. 2 HPC Blades #1, #3 and #53 – Missing Stg. 2 Disk Post Material at Posts #1, #2 and #53

Figure 72. Photograph showing closer view of missing Stg. 2 HPC Blades and missing Stg. 2 disk post material.

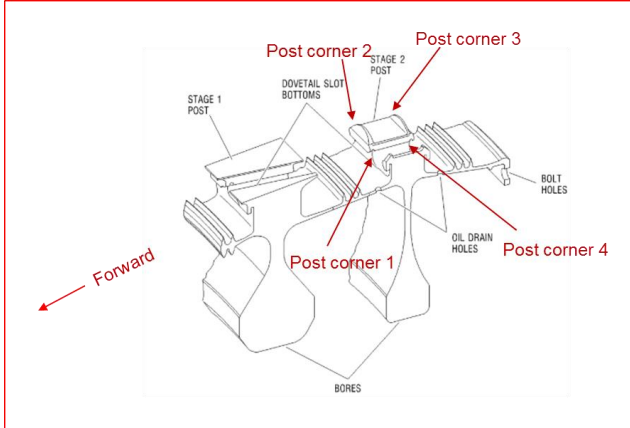
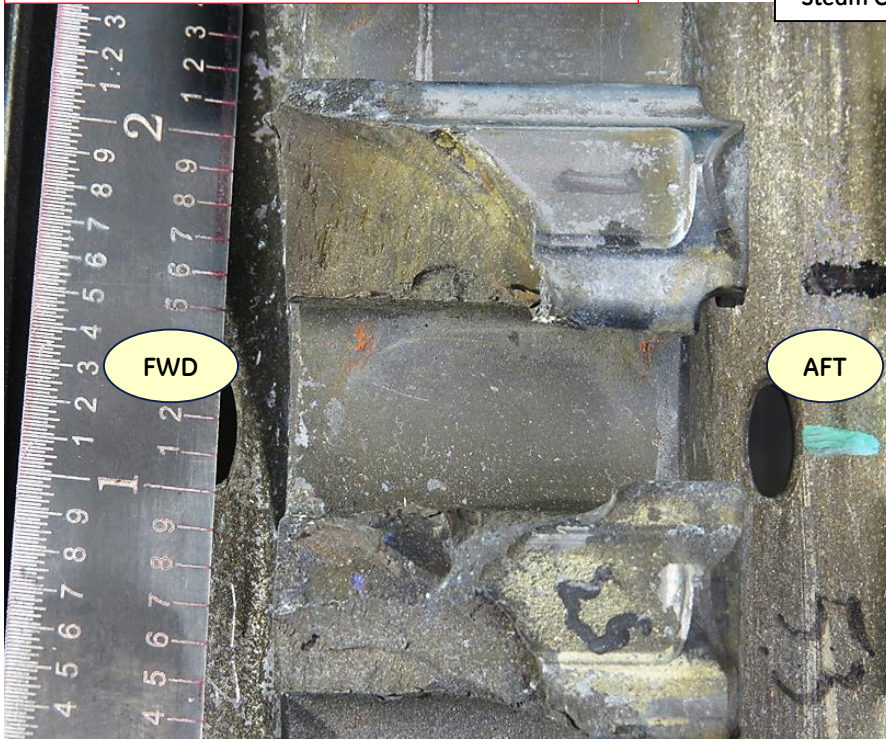
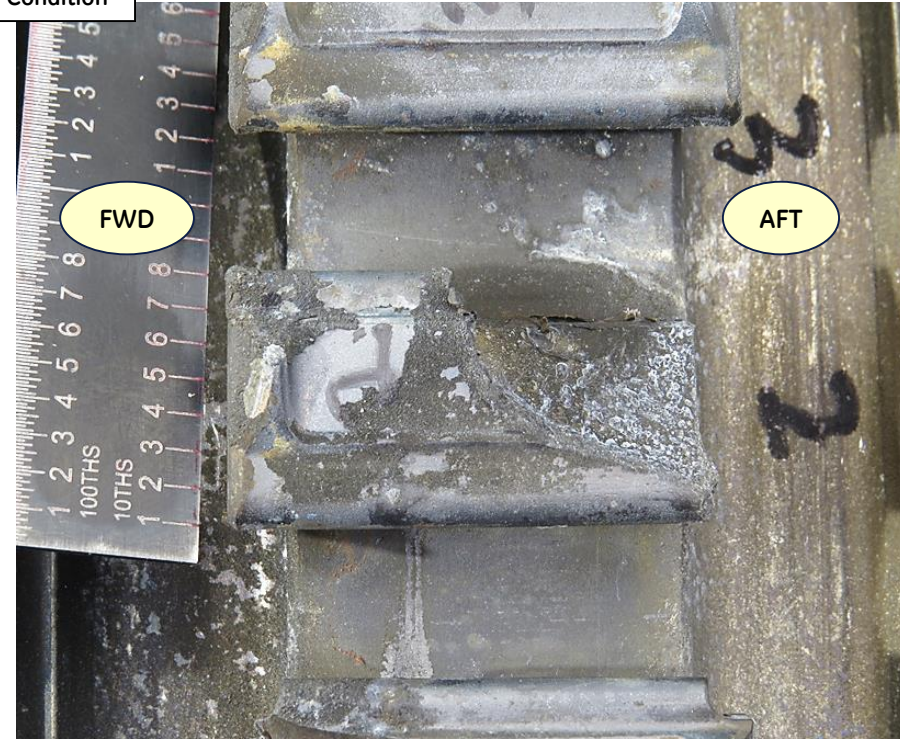
- Stg. 2 Disk Post Cracking Leading to Liberated Post Material (#1, #2 and #53) - Fractures Consistent With Fatigue

Figure 77. Photographs documenting missing Stg. 2 disk post material following removal of Stg. 2 HPC Blades and steam cleaning.
