# Metallurgical Investigation Report

## FA Log No. 18712

**METALLURGICAL EVALUATION OF  
CFM56-7B STG. 1-2 HPC SPOOL AND  
STG. 1 HPC VSV TRUNNION/LEVER  
ARM HARDWARE FROM ESN 875-  
318 OPERATED BY UNITED AIRLINES**

**Final Report Date: June 14, 2019**

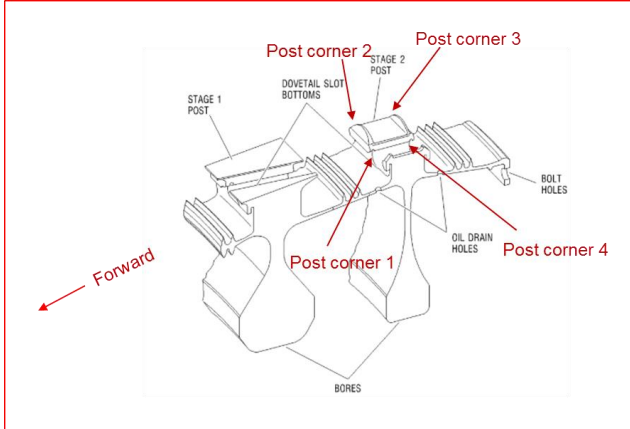
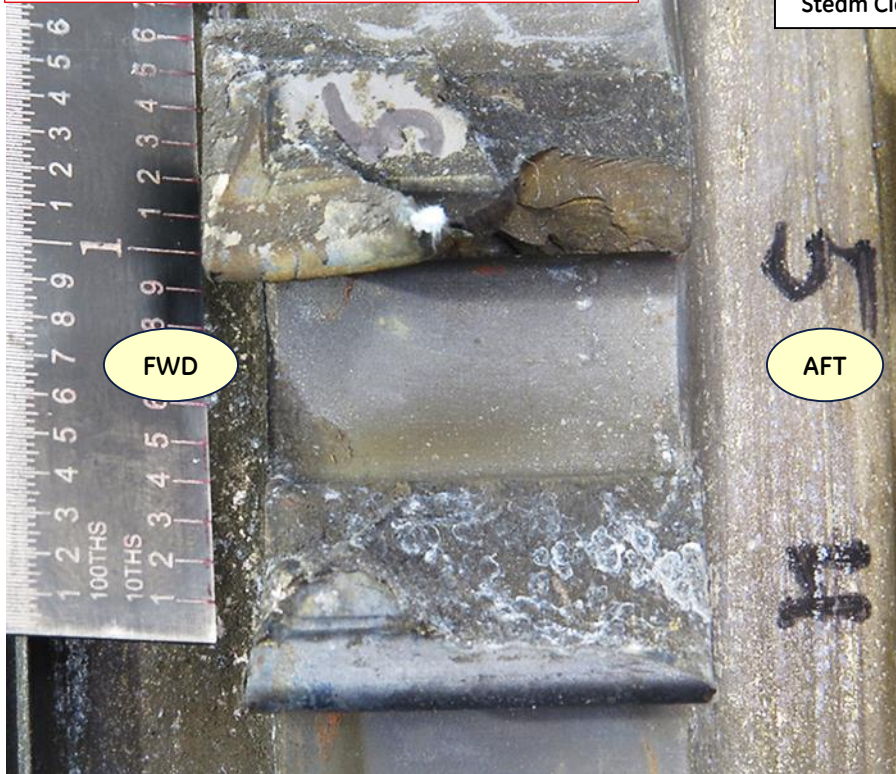
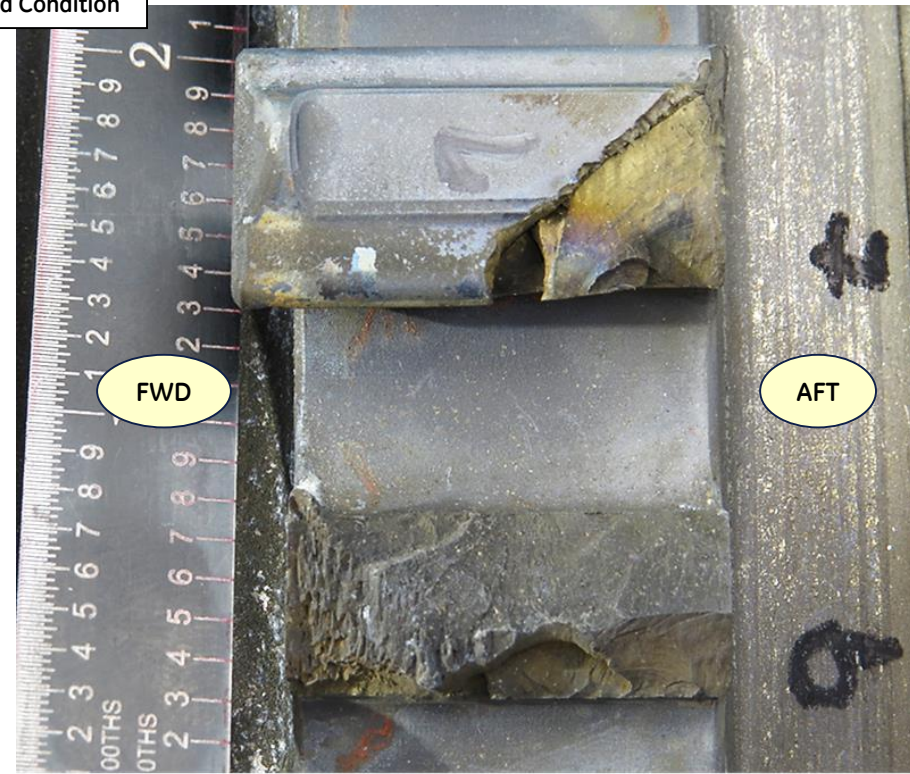
- Stg. 2 Disk Post Cracking Leading to Liberated Post Material (#4, #5, #6 and #7) - Exposed Fractures Consistent With Fatigue

Figure 78. Photographs documenting missing Stg. 2 disk post material following removal of Stg. 2 HPC Blades and steam cleaning.

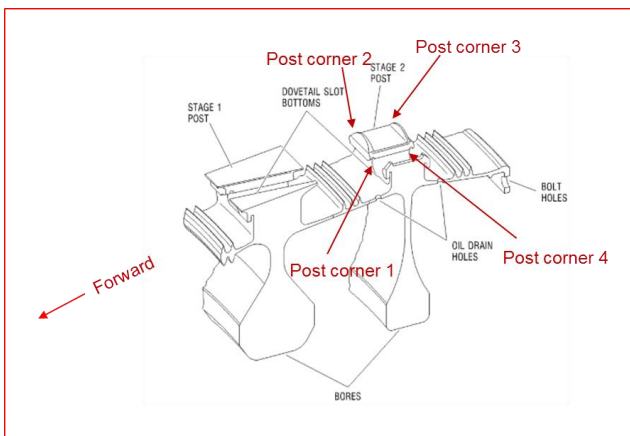
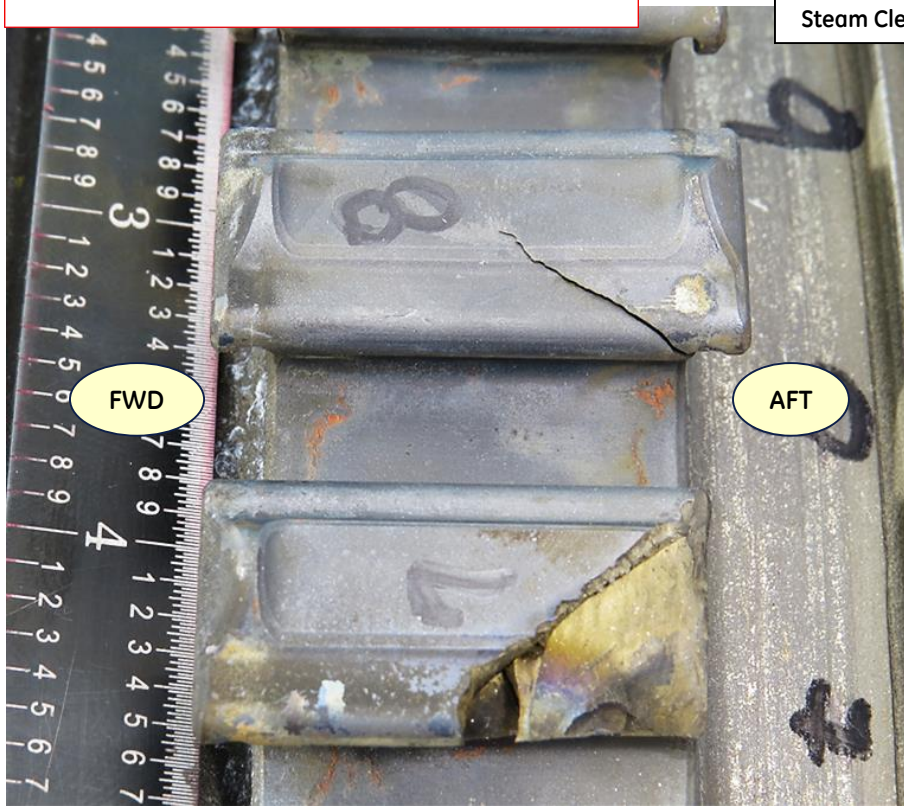
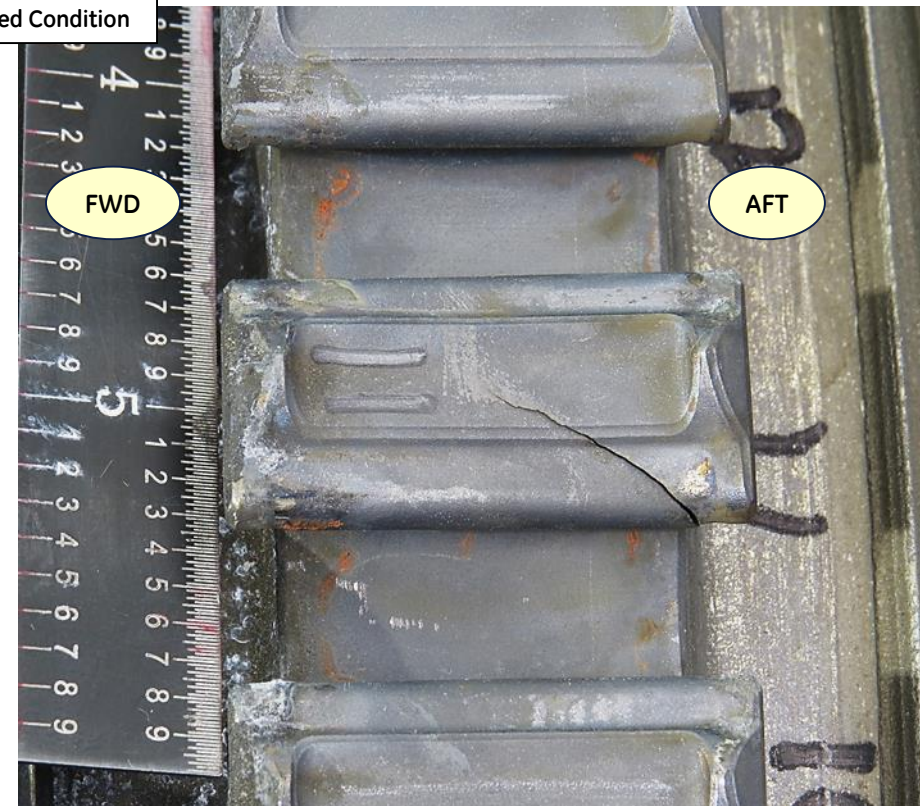
- Stg. 2 Disk Post Cracking Leading to Liberated Post Material (#7) and Cracking Extending Into Top of Disk Post (#8 and #11) - Exposed Fractures Consistent With Fatigue

Figure 79. Photographs documenting cracked and missing Stg. 2 disk post material following removal of Stg. 2 HPC Blades and steam cleaning.

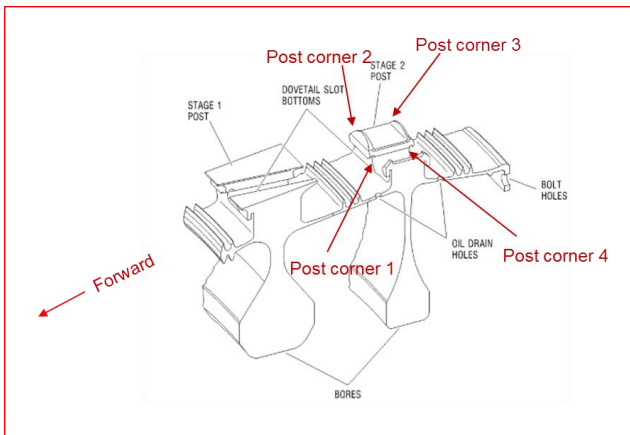
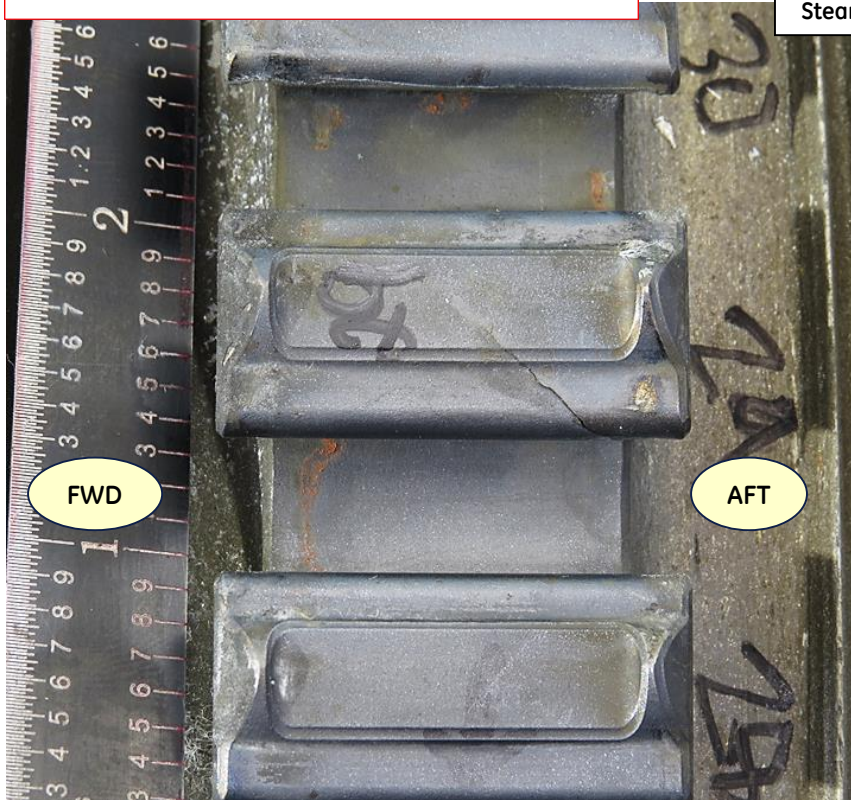
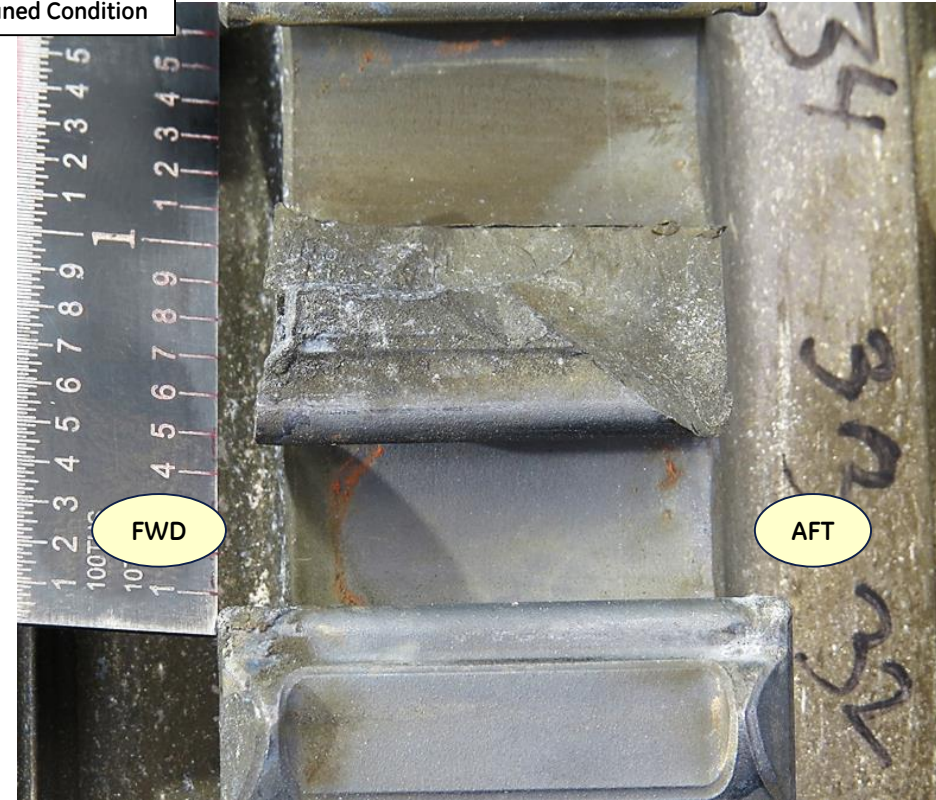
- Stg. 2 Disk Post Cracking Extending Into Top of Disk Post (#29) Plus Liberated Material (#33) – Exposed Fractures Consistent With Fatigue

Figure 80. Photographs documenting cracked and missing Stg. 2 disk post material following removal of Stg. 2 HPC Blades and steam cleaning.

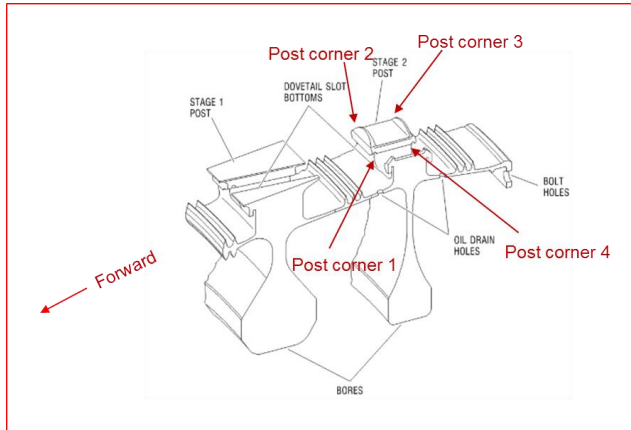
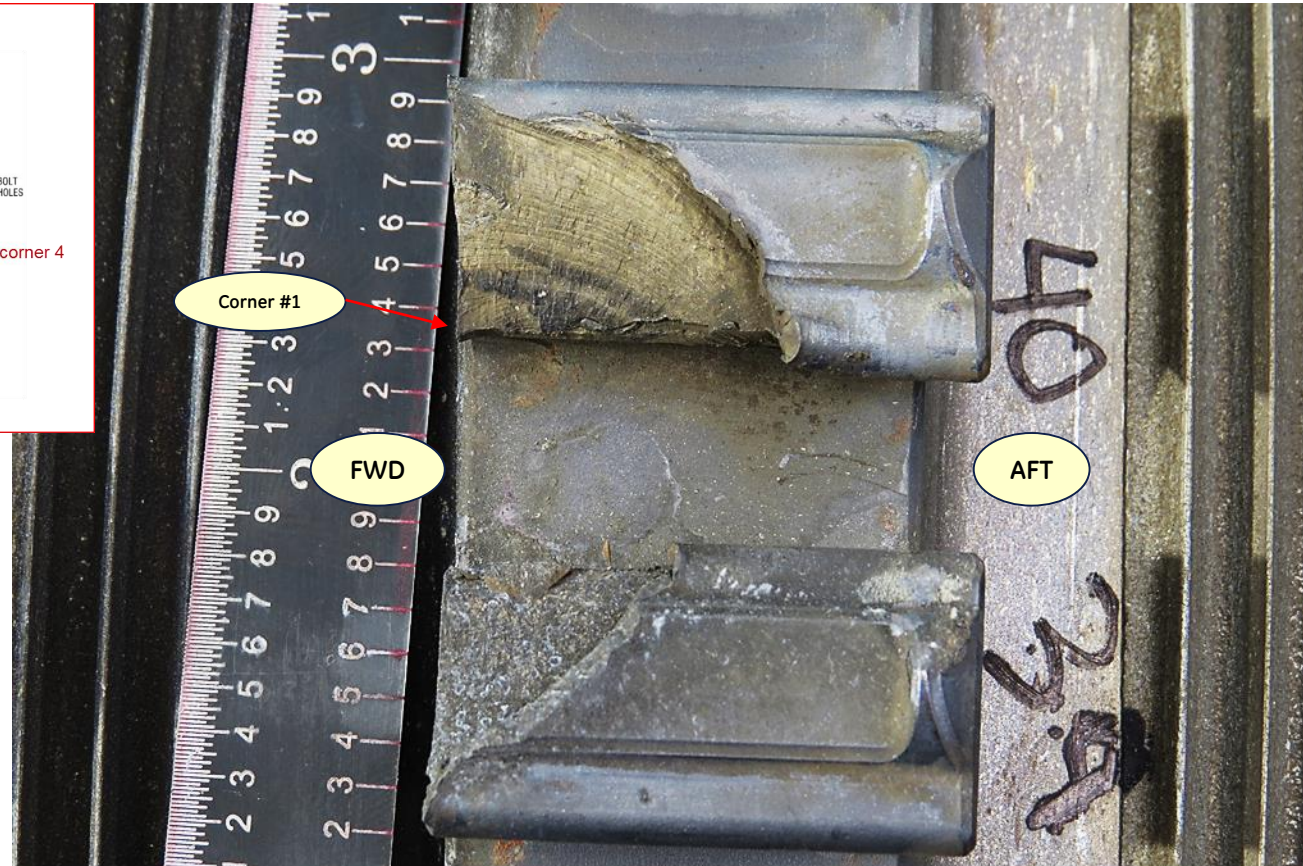
Stg. 1-2 HPC Spool Stg. 2 Disk Posts #39 and #40

- Stg. 2 Disk Post Cracking Leading to Liberated Post Material (#39 and #40) – Exposed Fractures Consistent With Fatigue

Figure 81. Photographs documenting cracked and missing Stg. 2 disk post material following removal of Stg. 2 HPC Blades and steam cleaning.

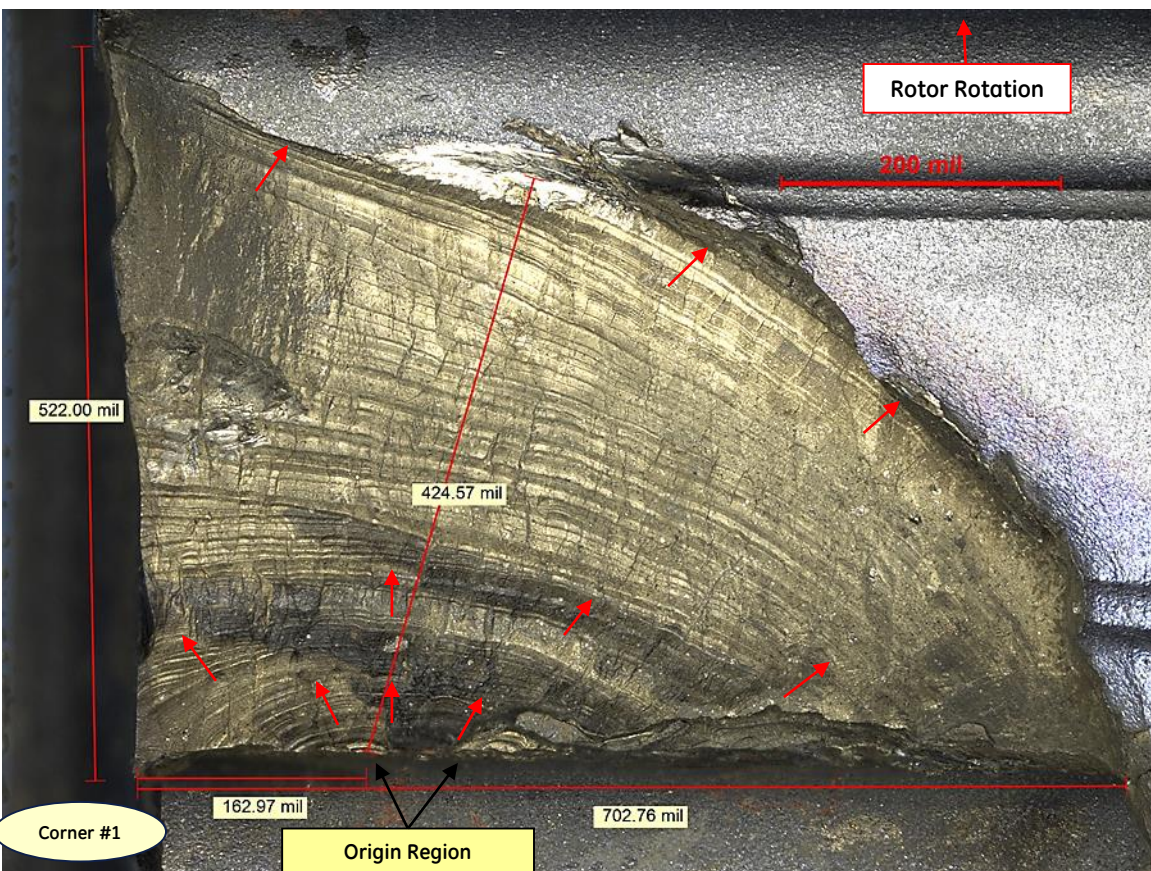
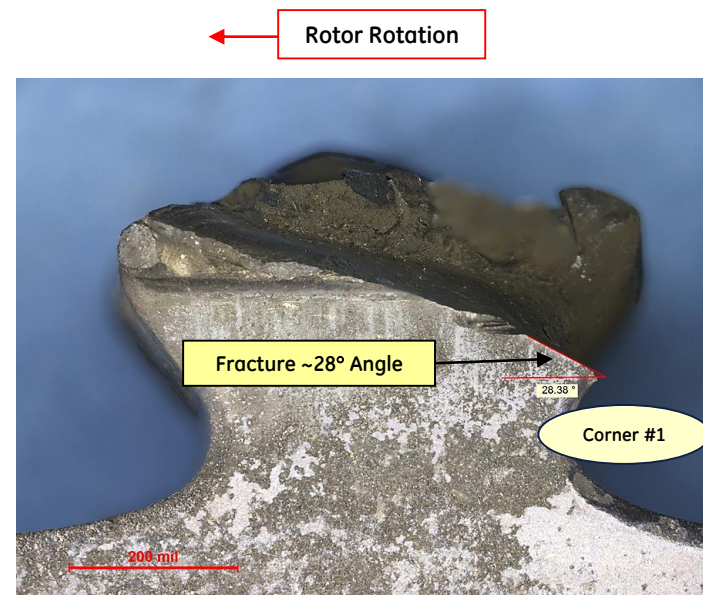
Part markings present on the Stg. 1-2 HPC spool following removal of HPC Blades are shown in Figure 76. Total weight of removed Stg. 1 and Stg. 2 HPC Blades was 2647 gms (5.81 lbs) and 1206 gms (2.66 lbs), respectively. Photographs documenting Stg. 2 HPC disk posts with missing material and cracked posts following steam cleaning are shown in Figures 77-81. Evidence of fatigue was observed on exposed disk post fractures. A closer view of the disk post fracture at post #40 is shown in Figure 82. Fracture exhibited a gold heat tint with numerous “beachmark” features consistent with fatigue propagation. Primary origin region was located ~0.16 inch off the corner #1 position progressing axially along the pressure face ~0.70 inch and along the forward post face ~0.52 inch and an angle of ~28° prior to liberation.

- Gold Heat Tinted Stg. 2 Disk Post #40 Fracture Surface Exhibiting Fatigue Morphology With Numerous “Beachmark” Features
- Crack Measured ~0.70 Inch Along the Pressure Face and ~0.52 Inch Along the Forward Post Face Prior to Liberation of Disk Post Top Fragment
- Origin Region Located ~0.16 Inch From Corner #1 (Fwd Face)

Figure 82. Photographs documenting Stg. 2 disk post #40 fracture surface and forward face. Origin region located ~0.16 inch off corner #1. Red arrows denote crack propagation direction.

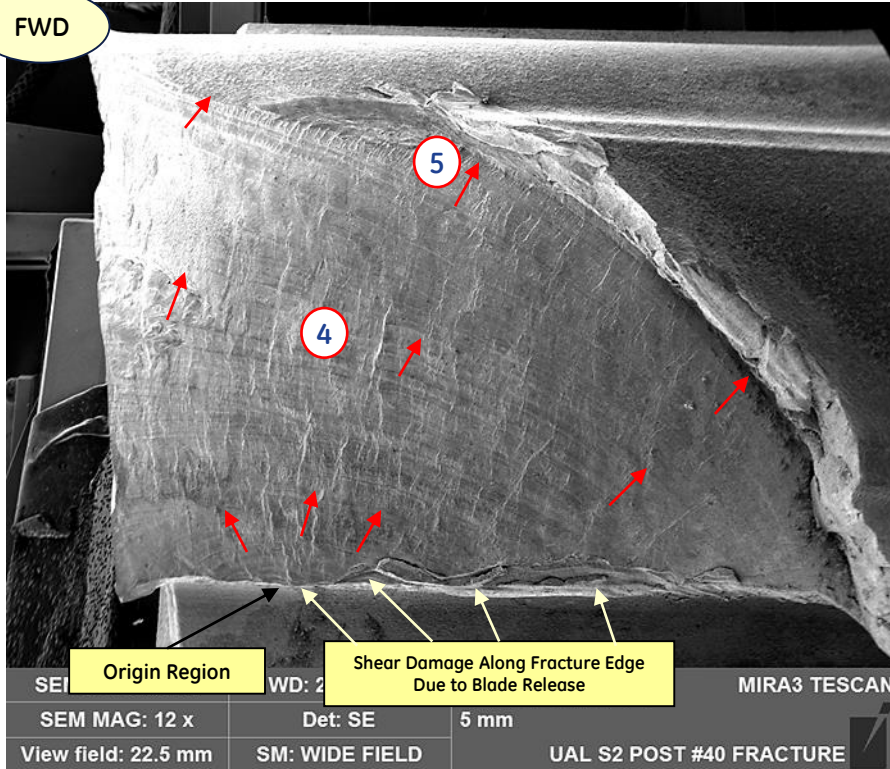
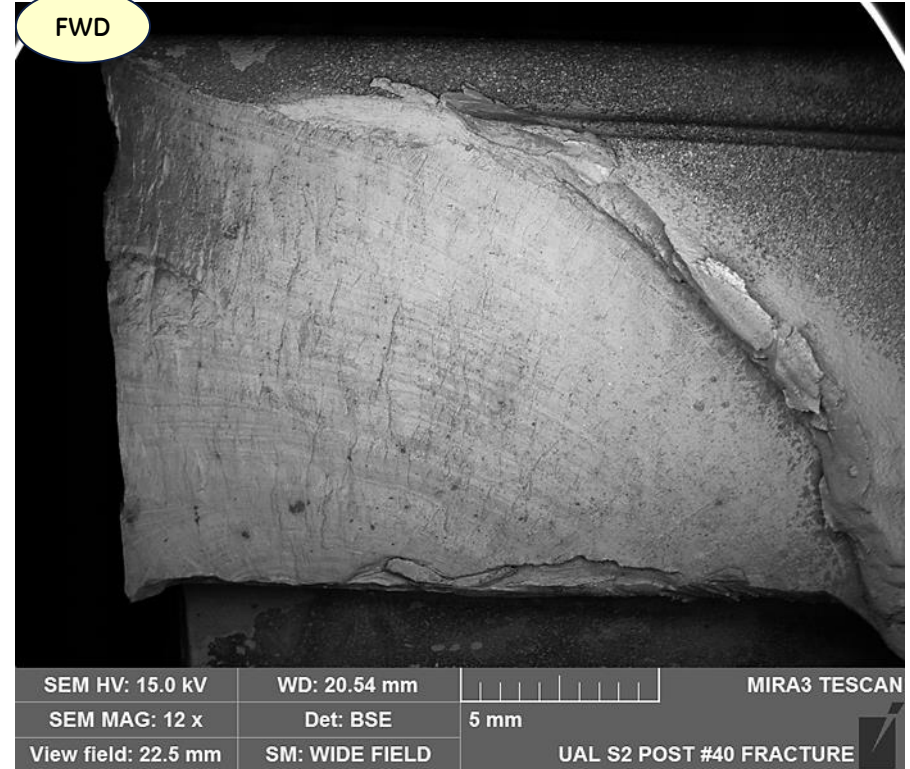
Overall SEM views of Stg. 2 HPC disk post fracture #40 are shown in Figure 83. Primary origin region sustained secondary shear damage as the mating blade exited the disk slot as shown in Figure 84. Initial examination of the fracture surface at area 1 revealed light surface oxidation along with finer striations features at higher magnification as shown in Figure 85. Continued examination at areas 2, 3, 4 and 5 exhibited morphology consistent with lower alternating stress, high cycle fatigue (HCF) and/or mixed-mode LCF/HCF crack propagation mechanisms as shown in Figures 86-89.

- Stg. 2 Disk Post #40 Fatigue Initiation ~0.16 Inch From Corner #1 Location - Fracture Surface Exhibited Numerous "Beachmark" Features

Figure 83. SEM secondary (SEI) and backscatter (BEI) images documenting Stg. 2 disk post #40 fracture surface. Arrows denote crack propagation direction. Areas 4 and 5 were examined in greater detail.

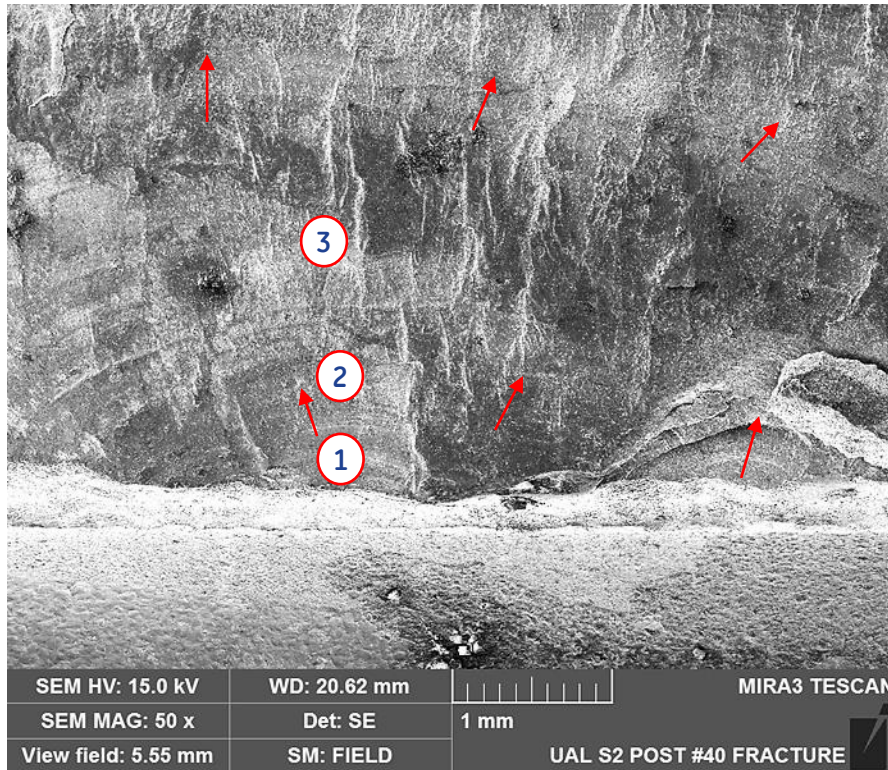
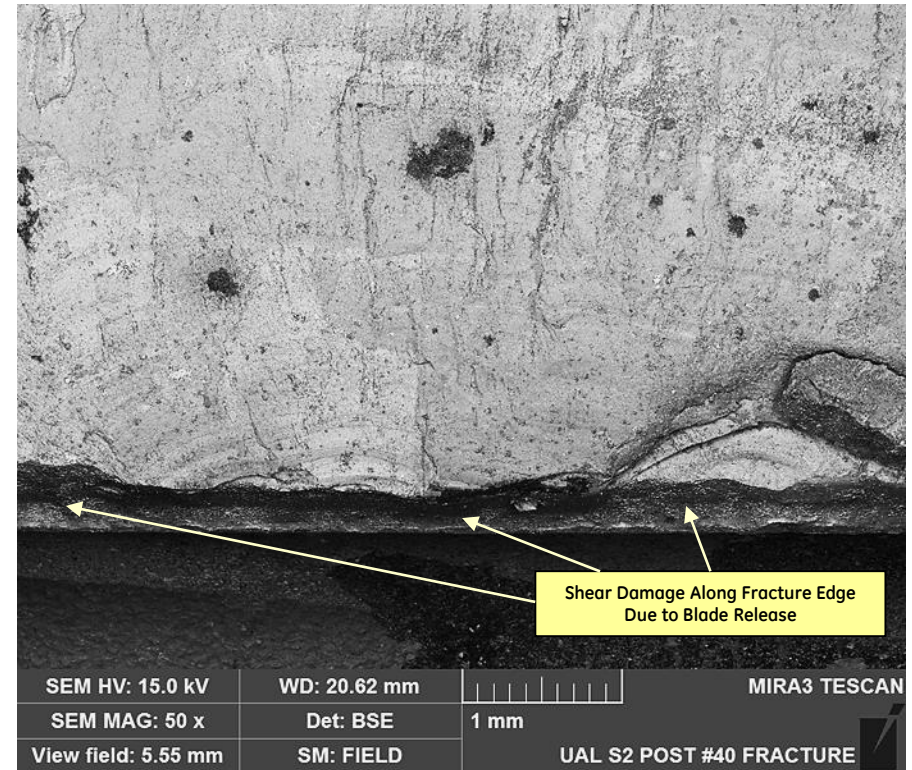
- Stg. 2 Disk Post #40 Fatigue Crack Origin Region - Secondary Shear Damage Observed Along Fracture Edge Attributed to Stg. 2 HPC Blade Release

Figure 84. SEM secondary (SEI) and backscatter (BEI) images documenting origin region of Stg. 2 disk post #40 fracture surface. Arrows denote crack propagation direction. Areas 1, 2 and 3 were examined in greater detail.

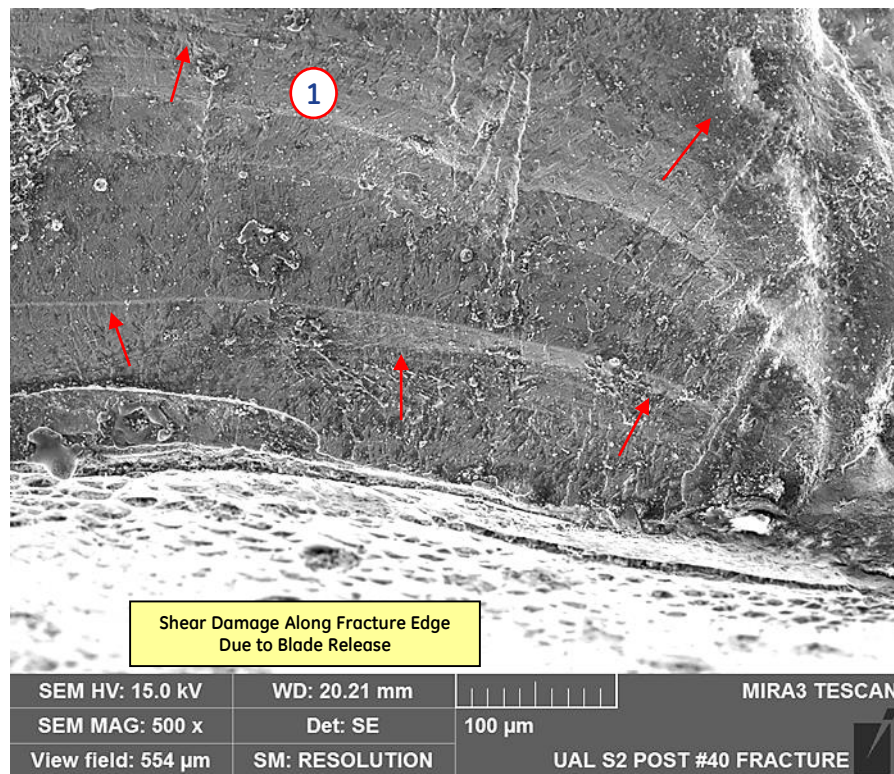
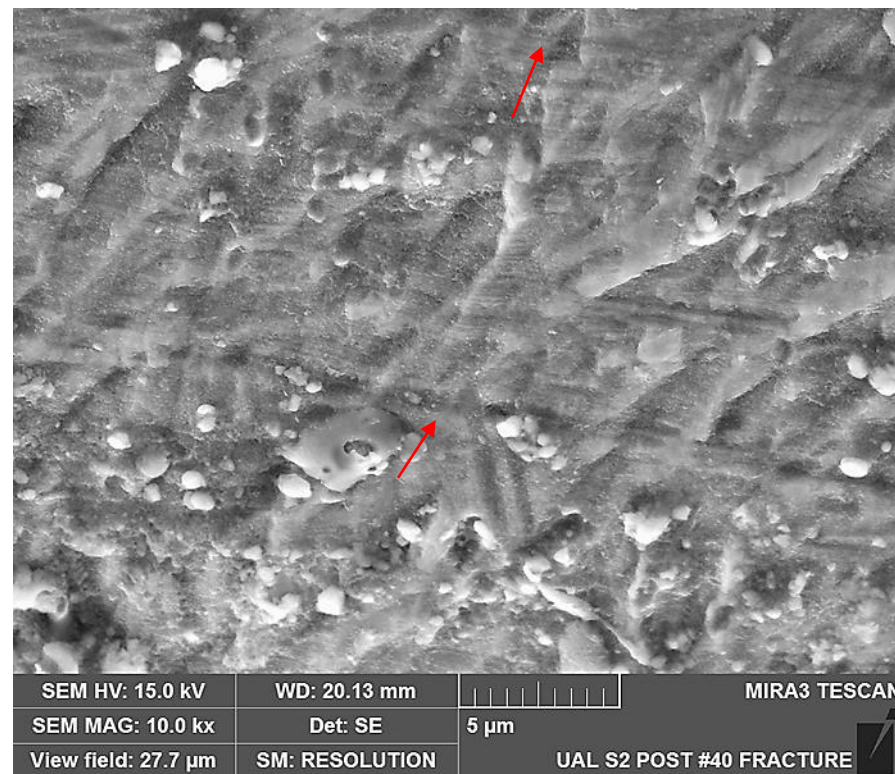
- Stg. 2 Disk Post #40 Fatigue Crack Origin Region Damaged By Secondary Shear Along Fracture Edge Due to Blade Release - Finer Striation Appearing Features Observed at Area 1
- Entire Fracture Surface Exhibited Light Surface Oxidation Along With Regions of Molten Debris Splatter

Figure 85. SEM secondary (SEI) images documenting fracture morphology at area 1 in the origin region on Stg. 2 disk post #40 fracture surface. Arrows denote crack propagation direction.

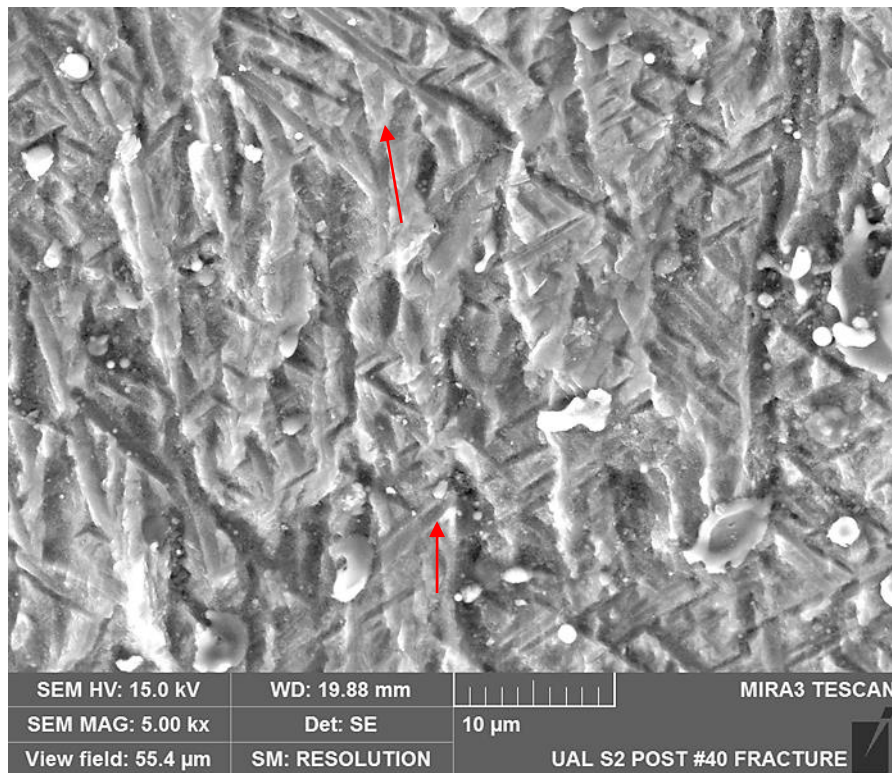
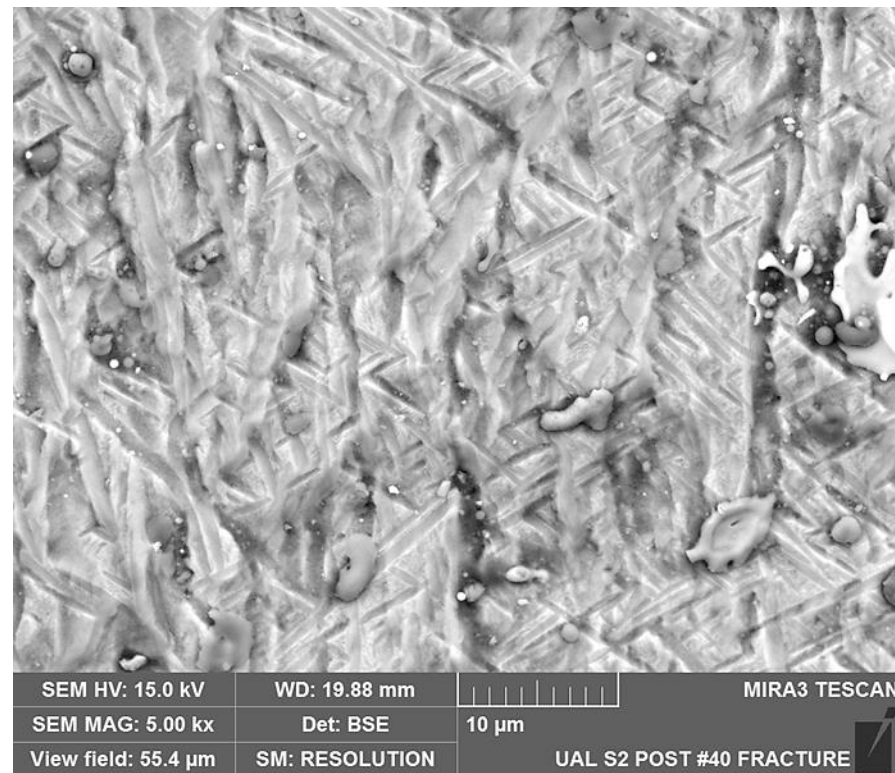
- Fracture Morphology Consistent With Lower Alternating Stress, High Cycle Fatigue (HCF) or Mixed-Mode LCF/HCF Crack Propagation Mechanisms – No Evidence of Coarser Fatigue Striations Observed
- Acicular Microstructure Resulting From Beta ( $\beta$ ) Processing Showing Through on Fracture

Figure 86. SEM secondary (SEI) images documenting fracture morphology at area 2 on Stg. 2 disk post #40 fracture surface. Arrows denote crack propagation direction.

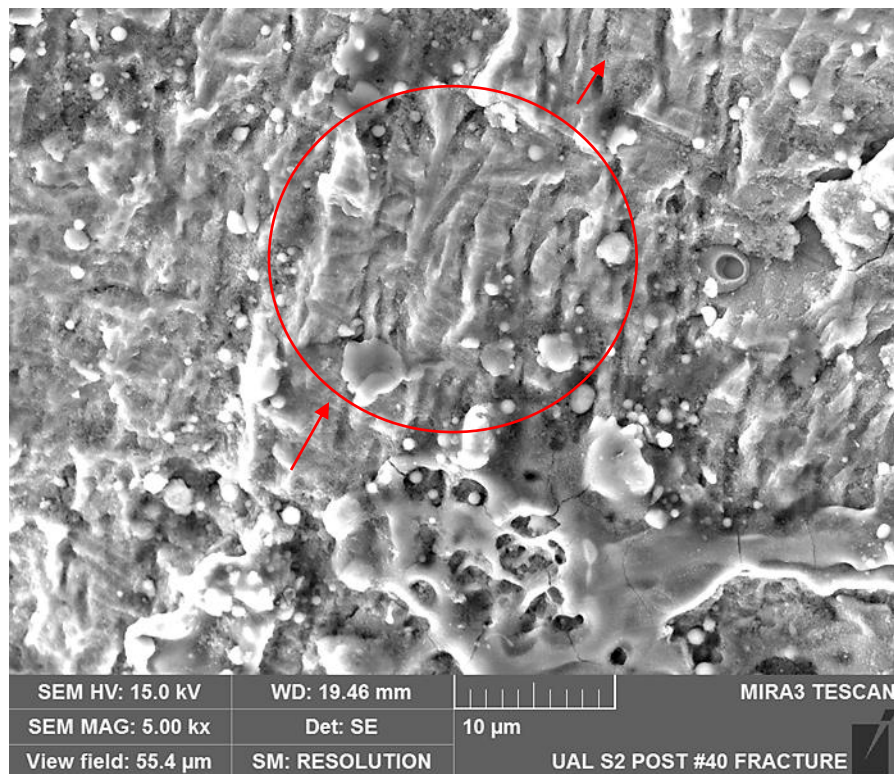
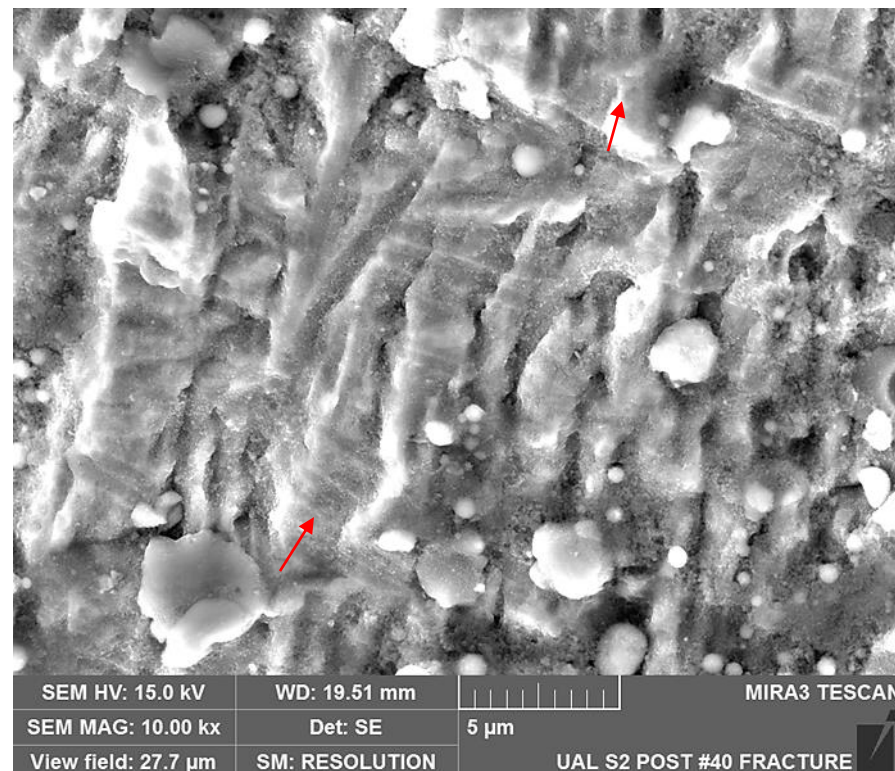
- Fracture Morphology Consistent With Lower Alternating Stress, High Cycle Fatigue (HCF) or Mixed-Mode LCF/HCF Crack Propagation Mechanisms – No Evidence of Coarser Fatigue Striations Observed
- Entire Fracture Surface Exhibited Light Surface Oxidation Along With Regions of Molten Debris Splatter

Figure 87. SEM secondary (SEI) images documenting fracture morphology at area 3 on Stg. 2 disk post #40 fracture surface. Arrows denote crack propagation direction.

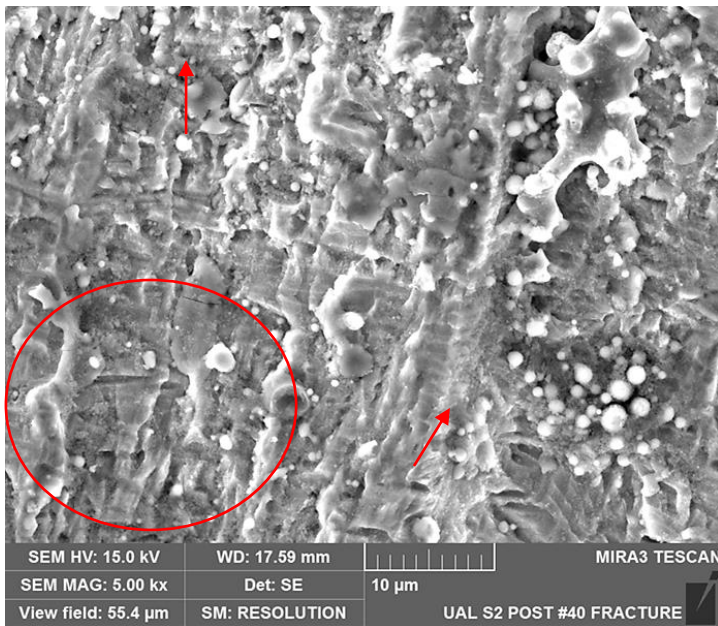
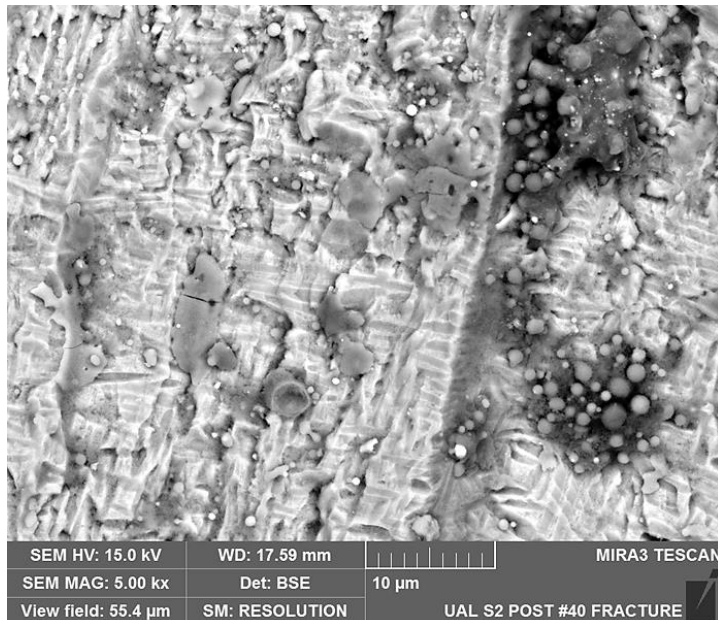
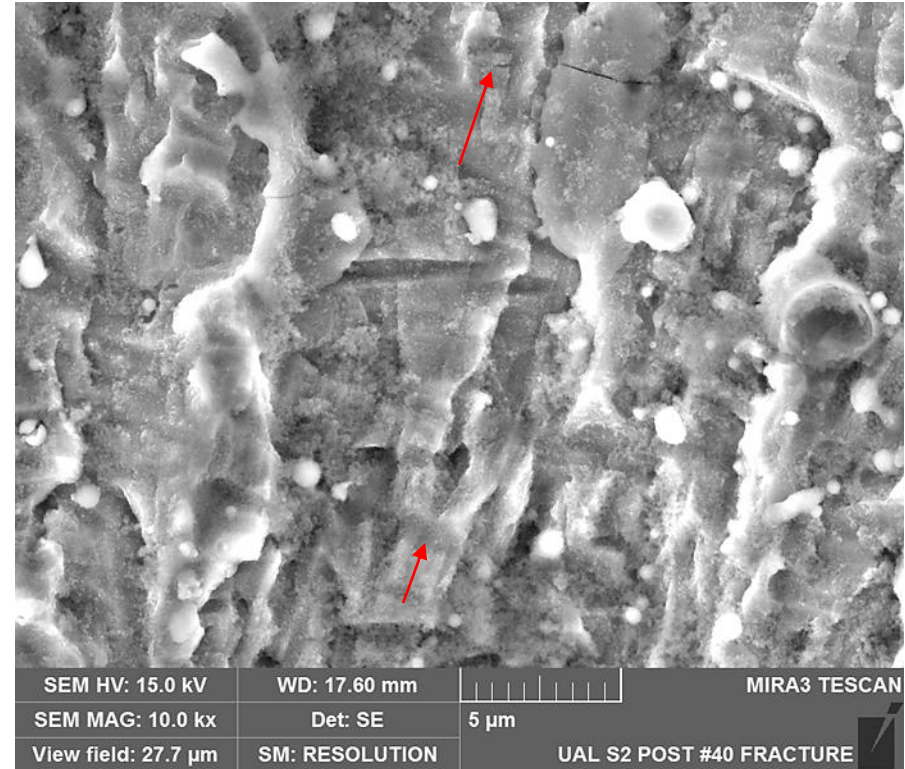
- Fracture Morphology Consistent With Lower Alternating Stress, High Cycle Fatigue (HCF) or Mixed-Mode LCF/HCF Crack Propagation Mechanisms – No Evidence of Coarser Fatigue Striations Observed
- Entire Fracture Surface Exhibited Light Surface Oxidation Along With Regions of Molten Debris Splatter

Figure 88. SEM secondary (SEI) images documenting fracture morphology at area 4 on Stg. 2 disk post #40 fracture surface. Arrows denote crack propagation direction.

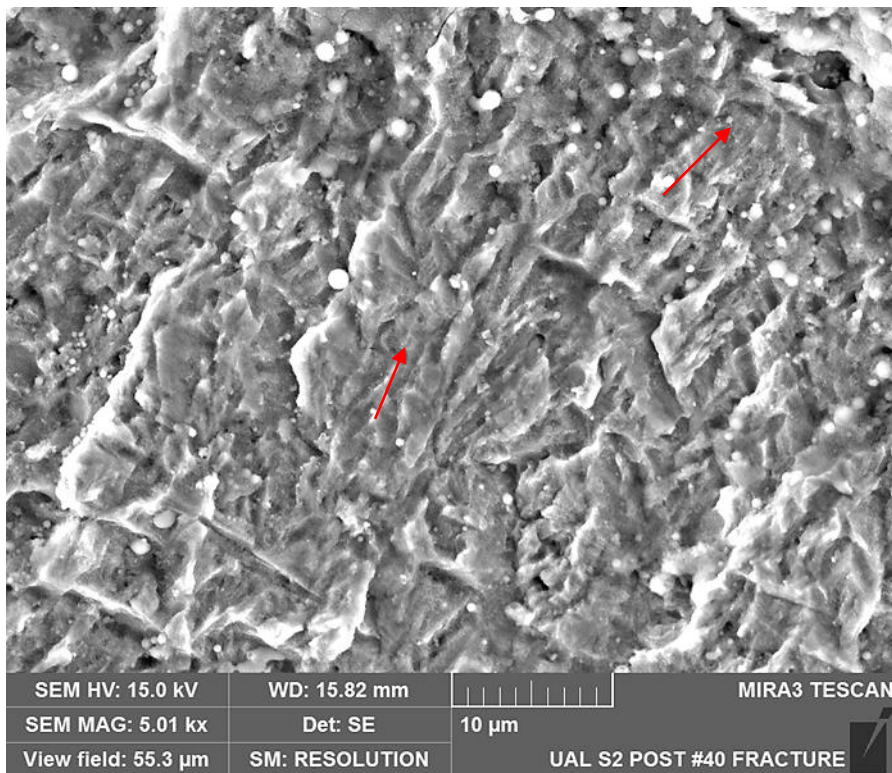
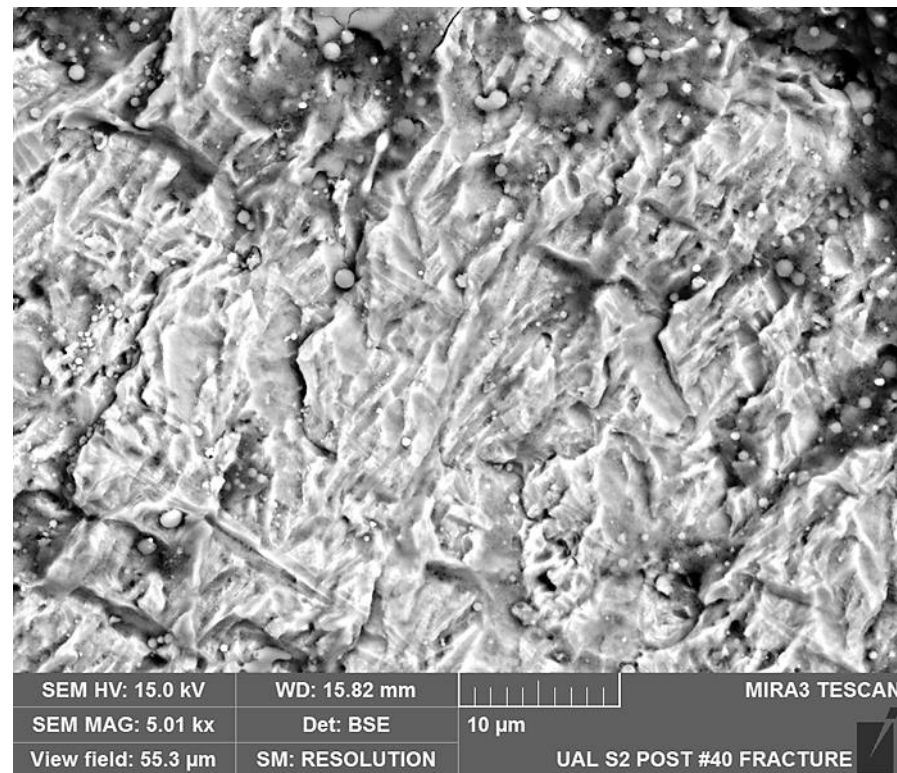
- Fracture Morphology Consistent With Lower Alternating Stress, High Cycle Fatigue (HCF) or Mixed-Mode LCF/HCF Crack Propagation Mechanisms – No Evidence of Coarser Fatigue Striations Observed
- Entire Fracture Surface Exhibited Light Surface Oxidation Along With Regions of Molten Debris Splatter

Figure 89. SEM secondary (SEI) images documenting fracture morphology at area 5 on Stg. 2 disk post #40 fracture surface. Arrows denote crack propagation direction.

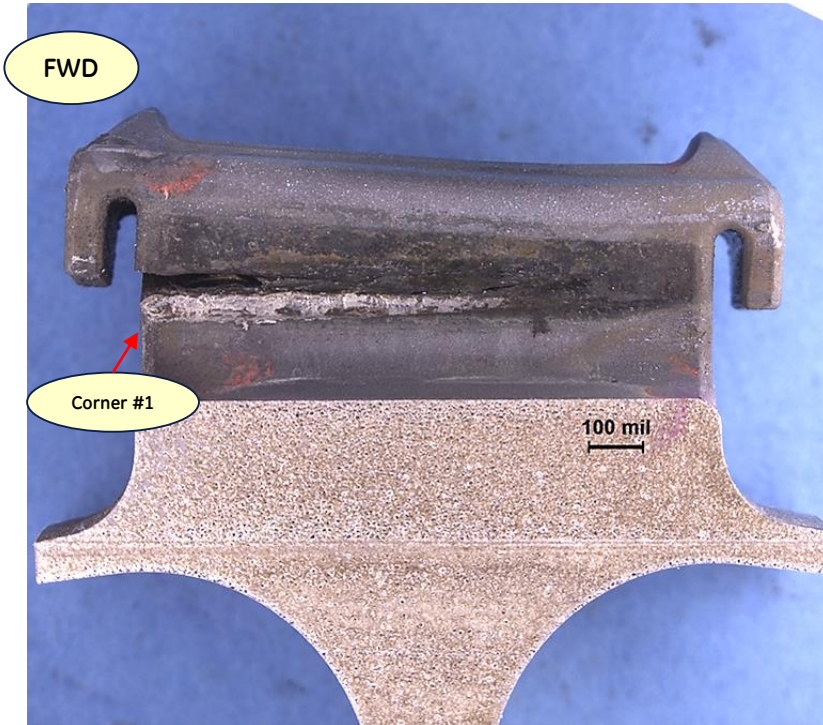
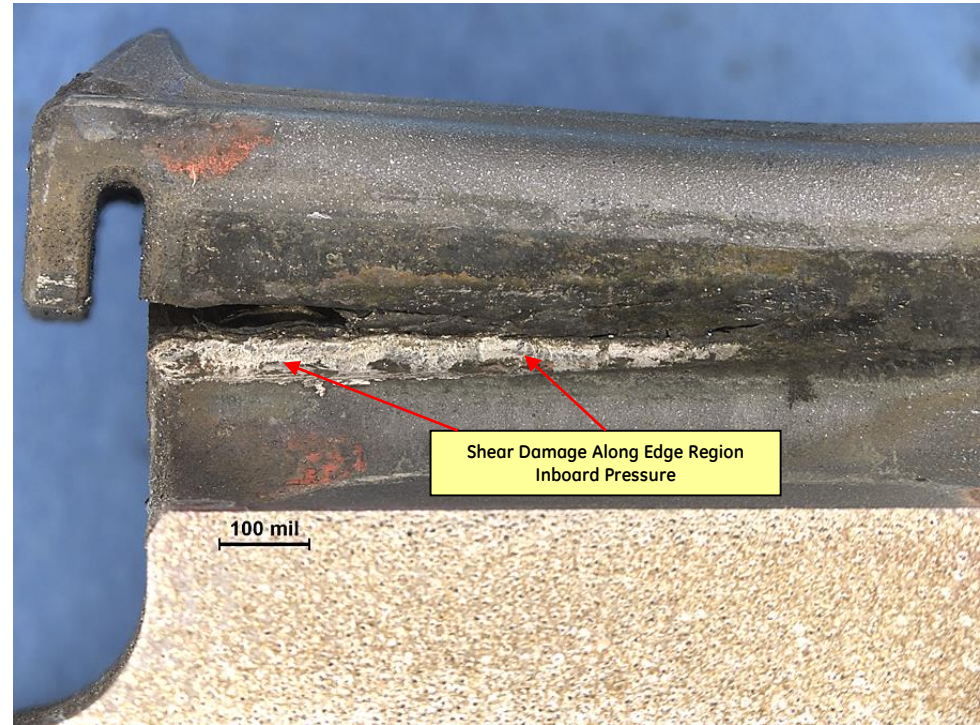
Optical views of cracked Stg. 2 disk post #44 are shown in Figures 90 and 91. Cracks were observed at both the corner #1 and corner #3 locations with the crack at corner #1 starting to yield open in an outward direction. Fracture surface following lab fracture of the corner #1 from post #44 crack is shown in Figures 92 and 93. Fracture was exhibited numerous “beachmark” features, very similar to that observed on previously documented post #40 fracture.

- Stg. 2 Disk Post #44 Exhibiting Corner #1 Crack Along Inboard Pressure Face Edge

Figure 90. Photographs documenting cracked Stg. 2 disk post #44 at the corner #1 location.

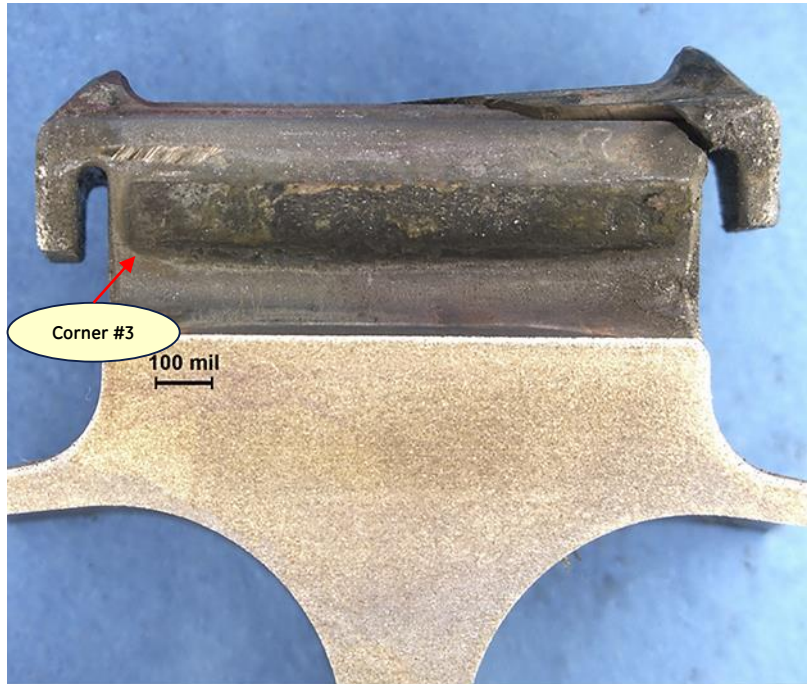
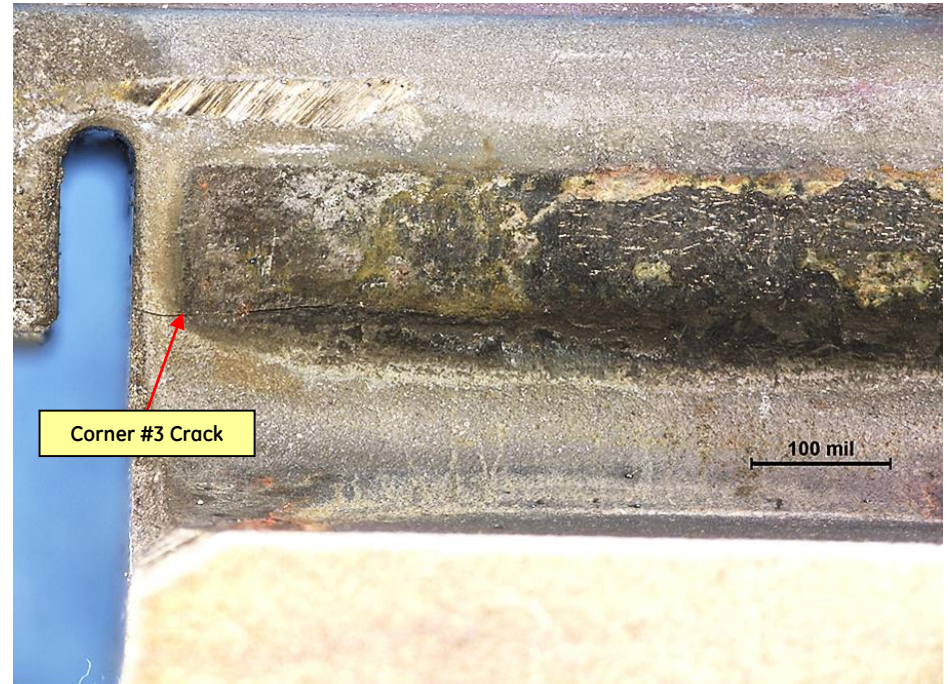
- Stg. 2 Disk Post #44 Exhibiting Corner #3 Crack Along Inboard Pressure Face Edge

Figure 91. Photographs documenting cracked Stg. 2 disk post #44 at the corner #3 location.
