# Metallurgical Investigation Report

## FA Log No. 18712

**METALLURGICAL EVALUATION OF  
CFM56-7B STG. 1-2 HPC SPOOL AND  
STG. 1 HPC VSV TRUNNION/LEVER  
ARM HARDWARE FROM ESN 875-  
318 OPERATED BY UNITED AIRLINES**

**Final Report Date: June 14, 2019**

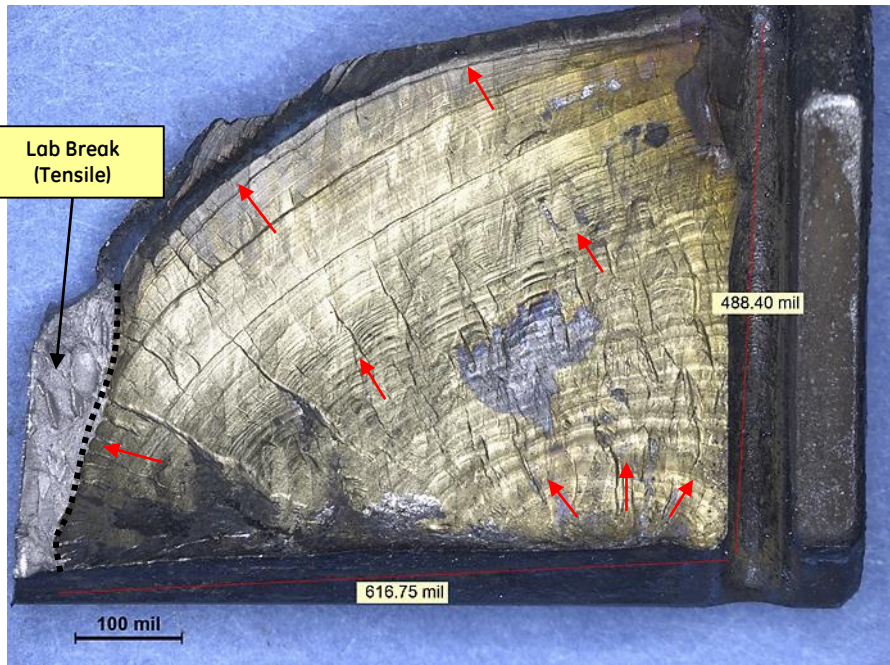
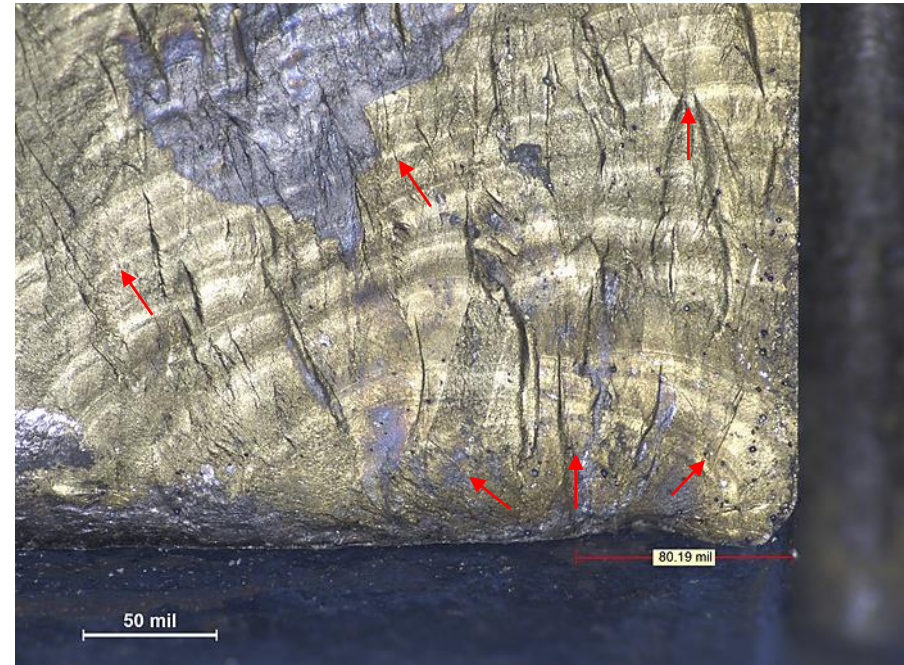
- Lab Fractured Stg. 2 Disk Post #44 Corner #1 Fracture Surface (Outboard Half) Exhibiting Fatigue Morphology With Numerous "Beachmark" Features
- Crack Measured ~0.62 Inch Along the Pressure Face and ~0.49 Inch Along the Forward Post Face
- Origin Region Located ~0.080 Inch From Corner #1 (Fwd Face)

Figure 92. Photographs documenting Stg. 2 disk post #44 fracture surface at the corner #1 location (outboard half) following lab fracture. Origin region located ~0.080 inch off corner #1. Arrows denote crack propagation direction.

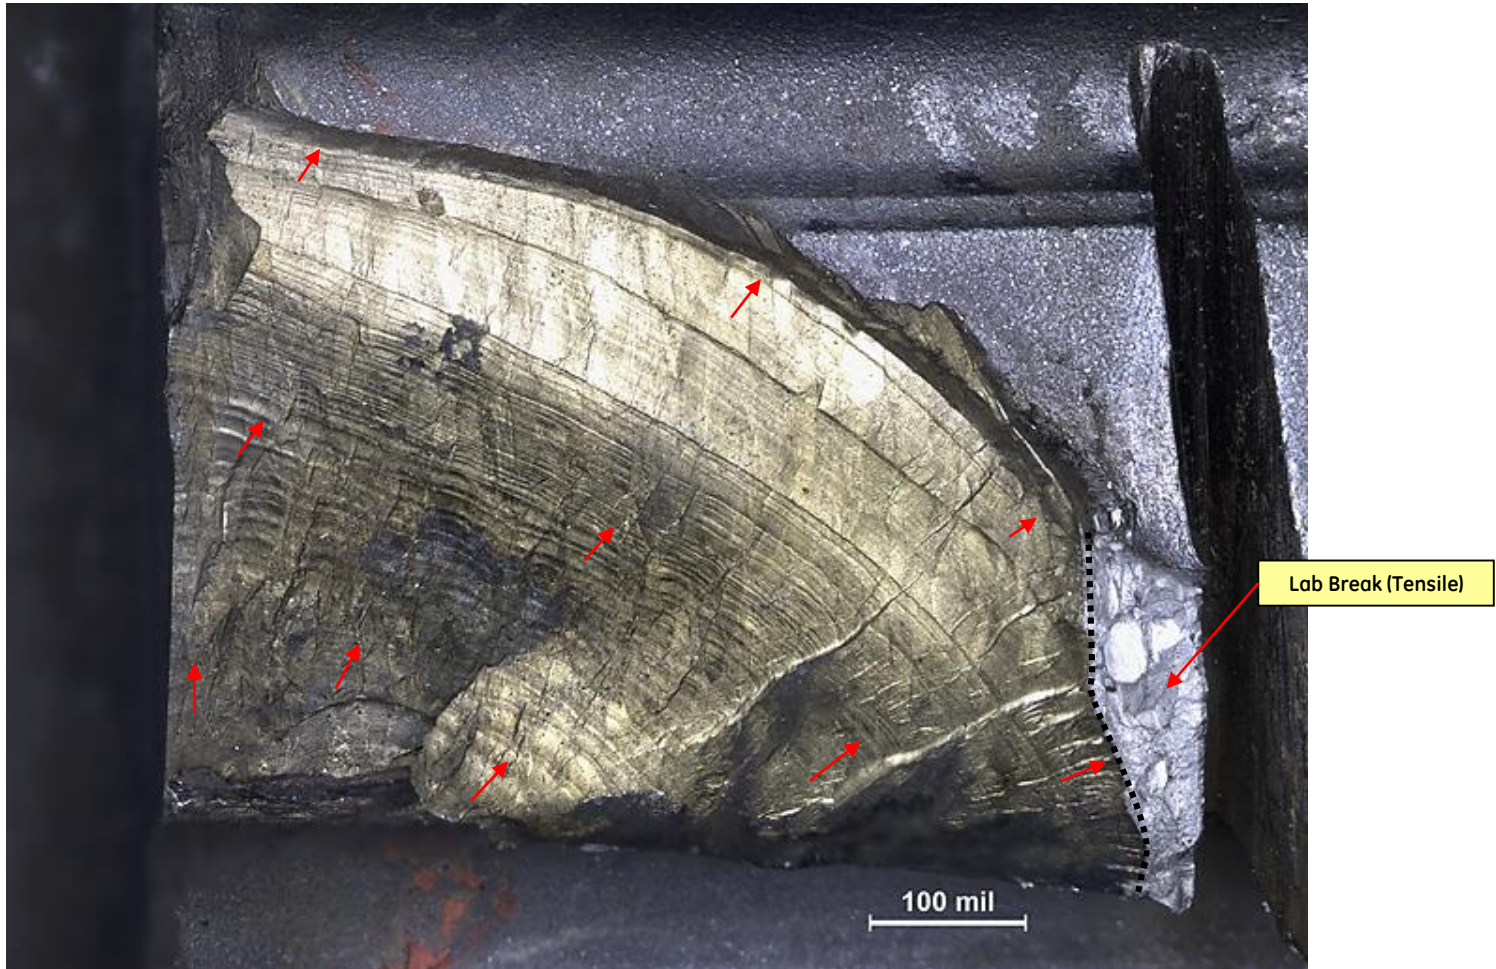
Stg. 1-2 HPC Spool Stg. 2 Disk Post #44 - Inboard Fracture Half - Corner #1 Crack

- Stg. 2 Disk Post #44 Corner #1 Fracture Surface Exhibiting Fatigue Morphology With Numerous "Beachmark" Features

Figure 93. Photographs documenting Stg. 2 disk post #44 fracture surface at the corner #1 location (inboard half) following lab fracture. Arrows denote crack propagation direction.

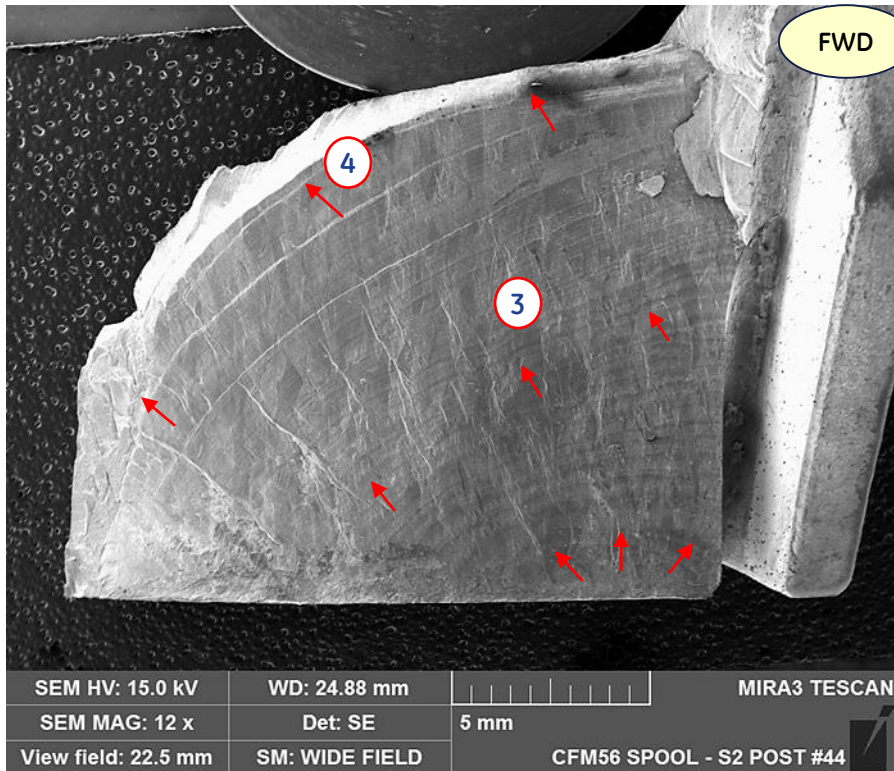
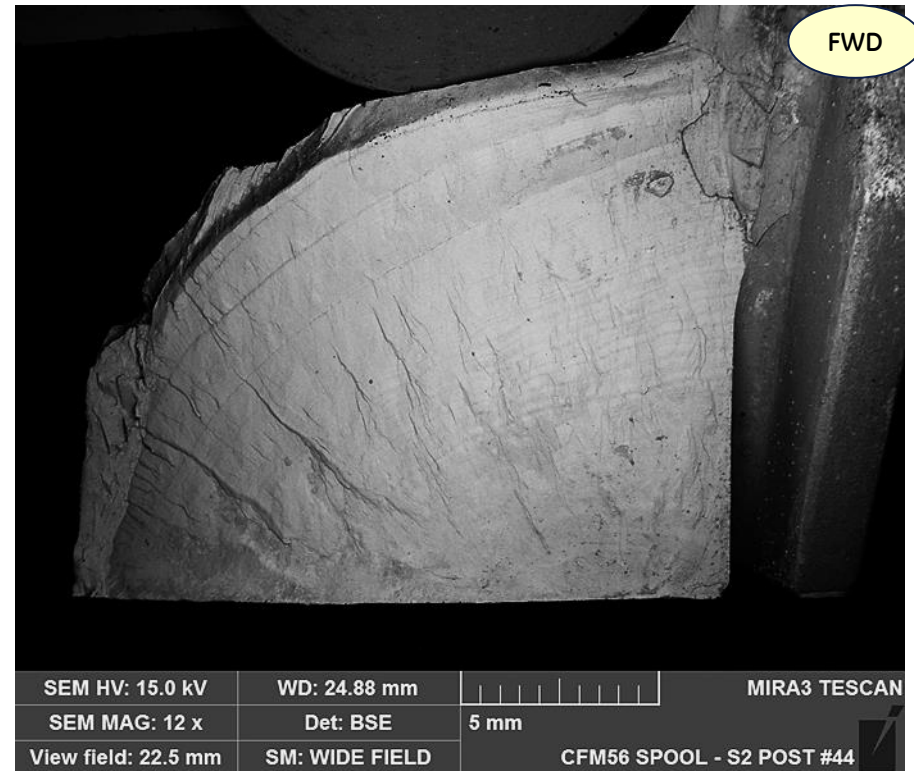
Overall SEM views of Stg. 2 HPC disk post fracture #44 (outboard half) are shown in Figure 94. Primary origin region was located ~0.080 inch off the corner #1 position as shown in Figure 95. Examination of the fracture surface at areas 1, 2 and 3 revealed morphology consistent with lower alternating stress, high cycle fatigue (HCF) and/or mixed-mode LCF/HCF crack propagation mechanisms as shown in Figures 96, 97 and 98. Evidence of coarser fatigue striations features were observed inside the “beachmark” features near the crack end region implying two different propagation stimuli were active at this location on the fracture as shown in Figure 99. EDS spectrum obtained from a region of fresh tensile overload from Stg. 2 disk post #44 was consistent with Ti-17 material as required by the engineering drawing as shown in Figure 100.

- Stg. 2 Disk Post #40 Fatigue Fracture Emanating From Corner #1 Region - Fracture Surface Exhibited Numerous "Beachmark" Features

Figure 94. SEM secondary (SEI) and backscatter (BEI) images documenting Stg. 2 disk post #44 fracture surface (outboard half). Arrows denote crack propagation direction. Areas 3 and 4 were examined in greater detail.

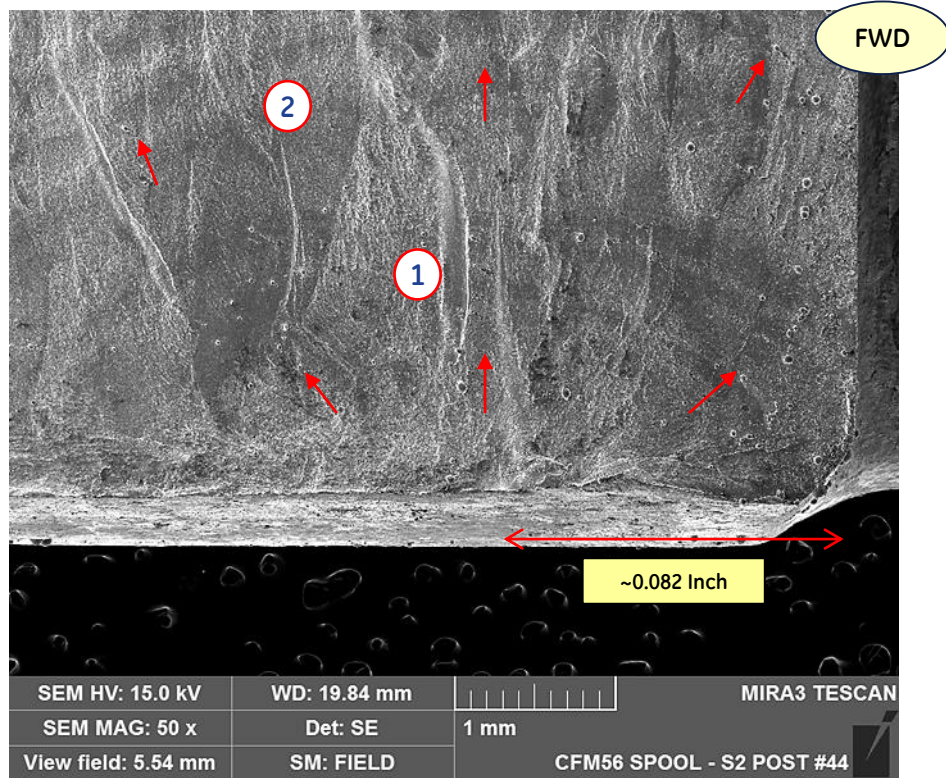
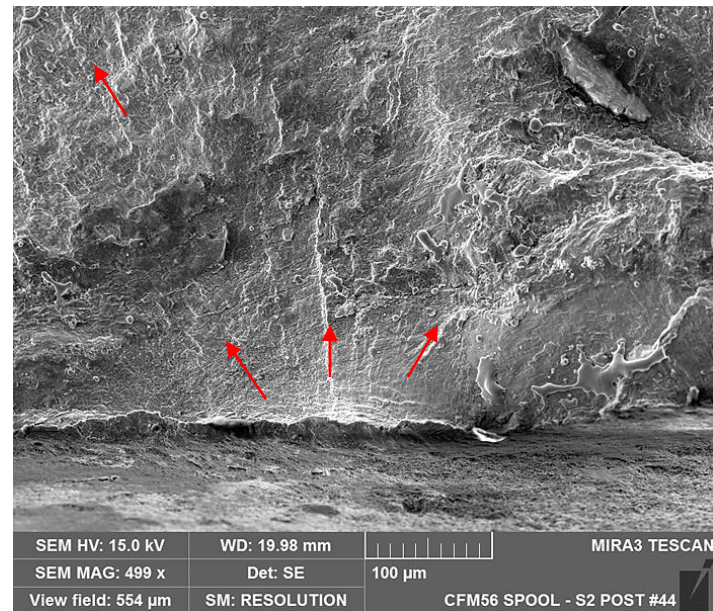
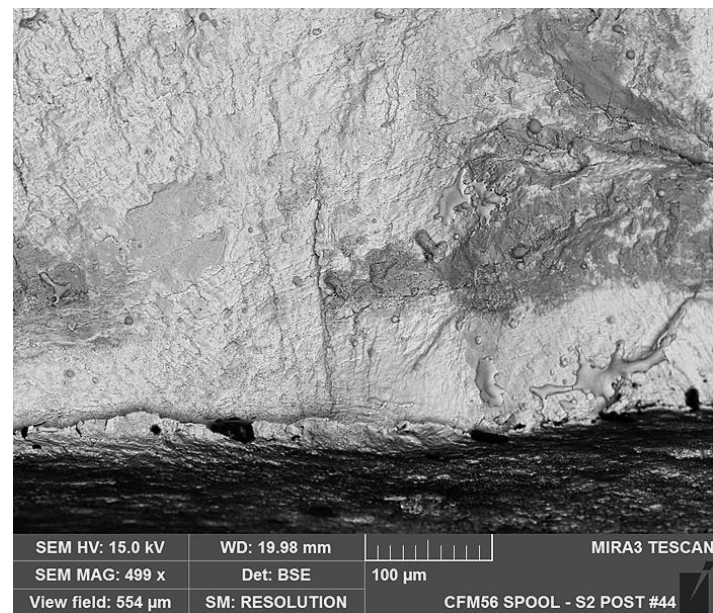
- Stg. 2 Disk Post #44 Fatigue Initiation ~0.082 Inch From Corner #1 Location - Fracture Surface Exhibited Numerous "Beachmark" Features
- No Evidence of Any Material Anomalies Located at Fatigue Origin Region

Figure 95. SEM secondary (SEI) and backscatter (BEI) images documenting origin region of Stg. 2 disk post #44 fracture surface. Arrows denote crack propagation direction. Areas 1 and 2 were examined in greater detail.

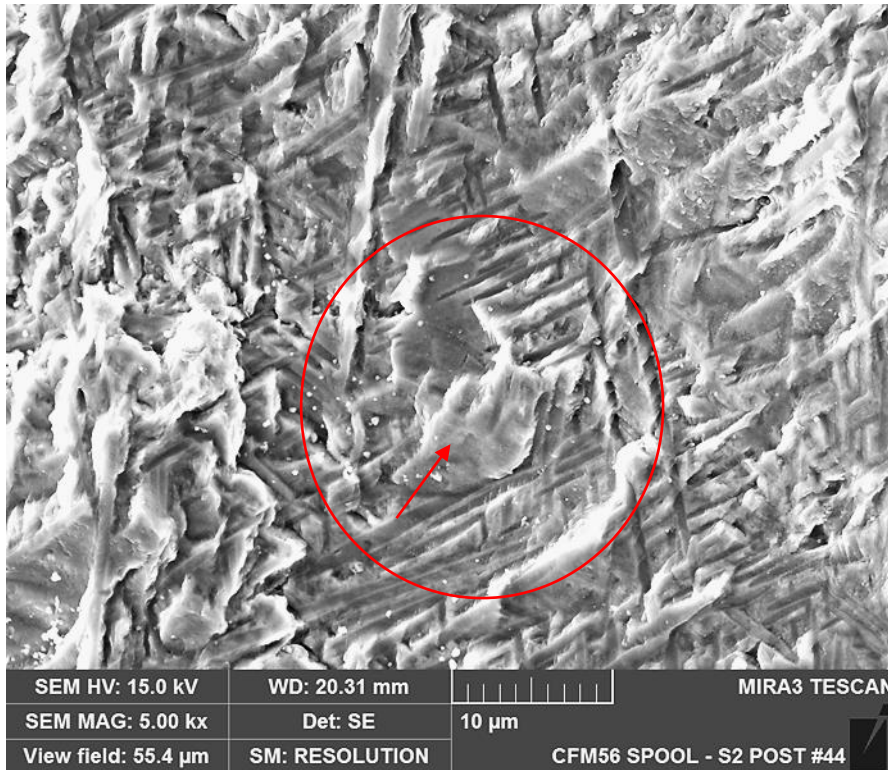
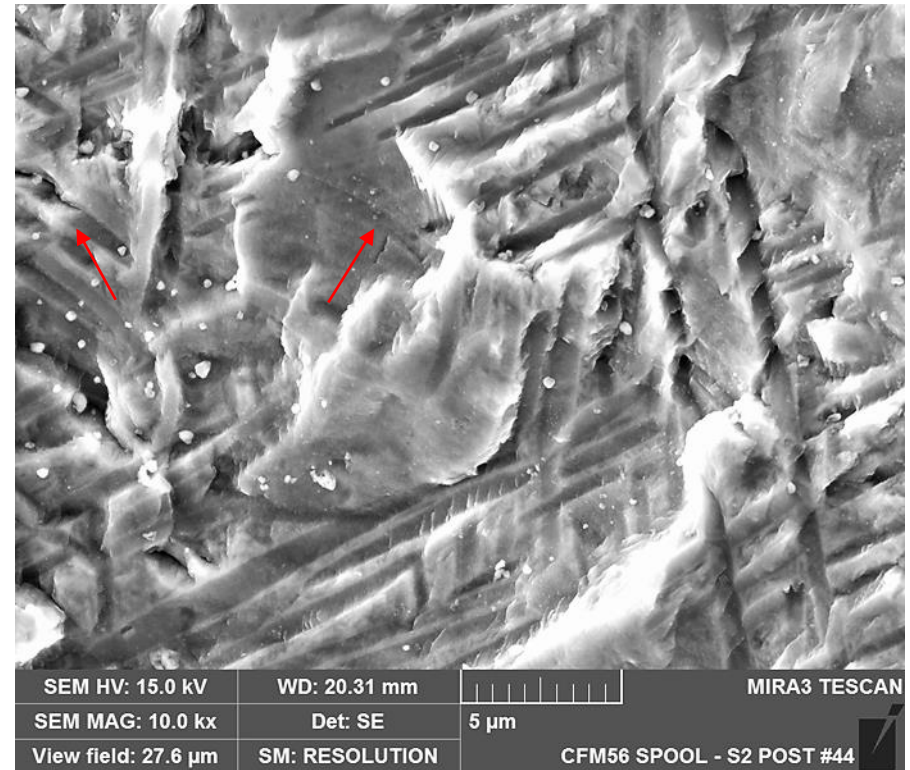
Stg. 2 Disk Post Fracture #44 - Area 1 - SEI

- Fracture Morphology Consistent With Lower Alternating Stress, High Cycle Fatigue (HCF) or Mixed-Mode LCF/HCF Crack Propagation Mechanisms – No Evidence of Coarser Fatigue Striations Observed
- Acicular Microstructure Resulting From Beta ( $\beta$ ) Processing Showing Through on Fracture

Figure 96. SEM secondary (SEI) images documenting fracture morphology at area 1 on Stg. 2 disk post #44 fracture surface. Arrows denote crack propagation direction.

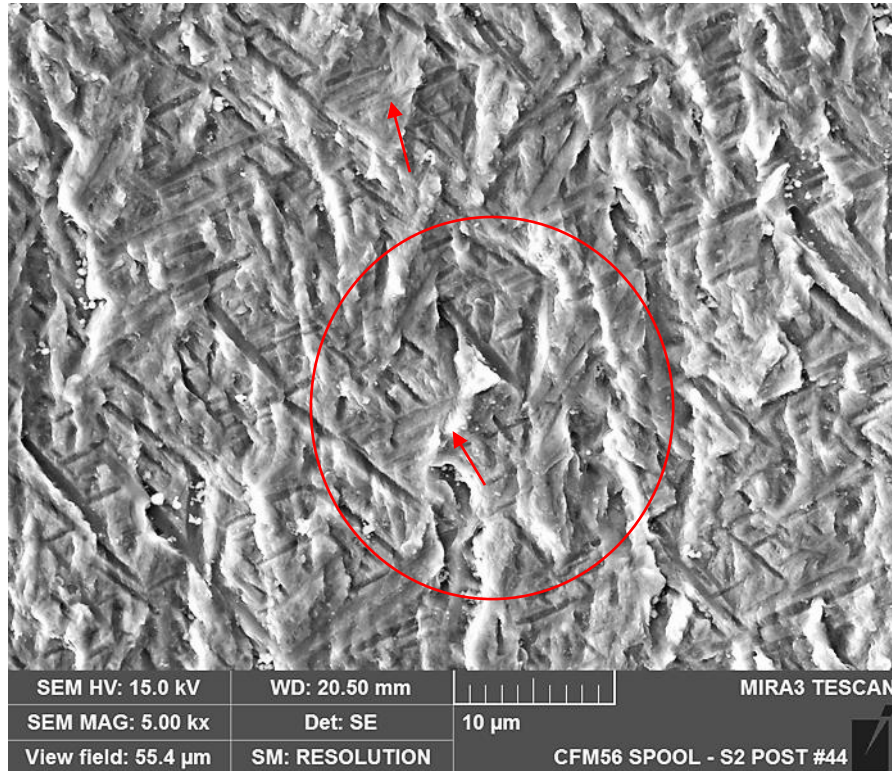
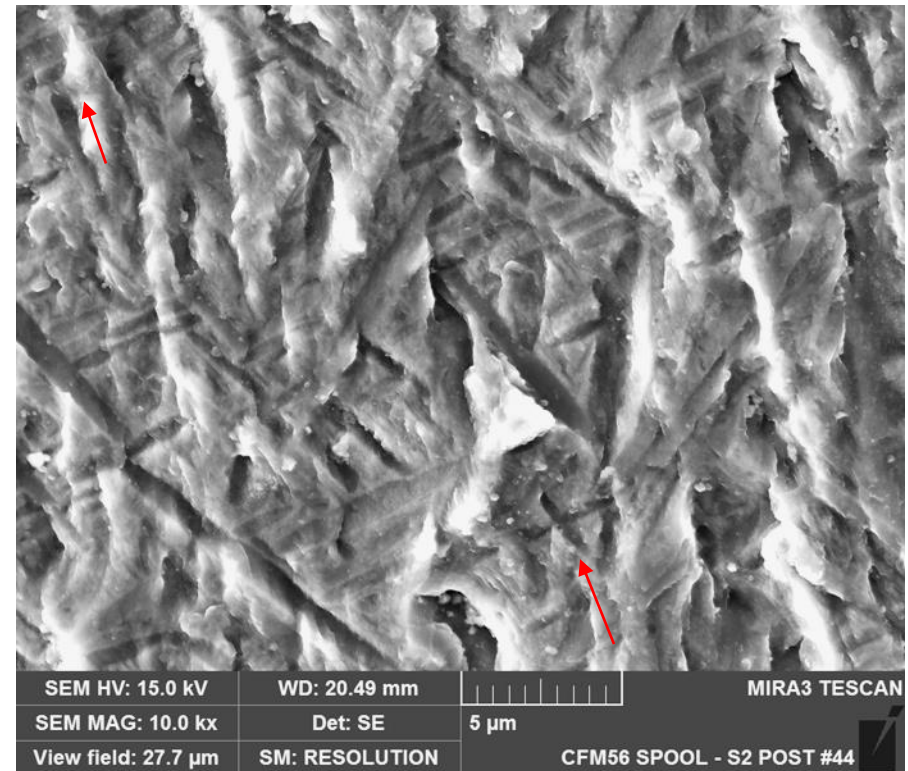
Stg. 2 Disk Post Fracture #44 - Area 2 - SEI

- Fracture Morphology Consistent With Lower Alternating Stress, High Cycle Fatigue (HCF) or Mixed-Mode LCF/HCF Crack Propagation Mechanisms – No Evidence of Coarser Fatigue Striations Observed
- Acicular Microstructure Resulting From Beta ( $\beta$ ) Processing Showing Through on Fracture

Figure 97. SEM secondary (SEI) images documenting fracture morphology at area 2 on Stg. 2 disk post #44 fracture surface. Arrows denote crack propagation direction.

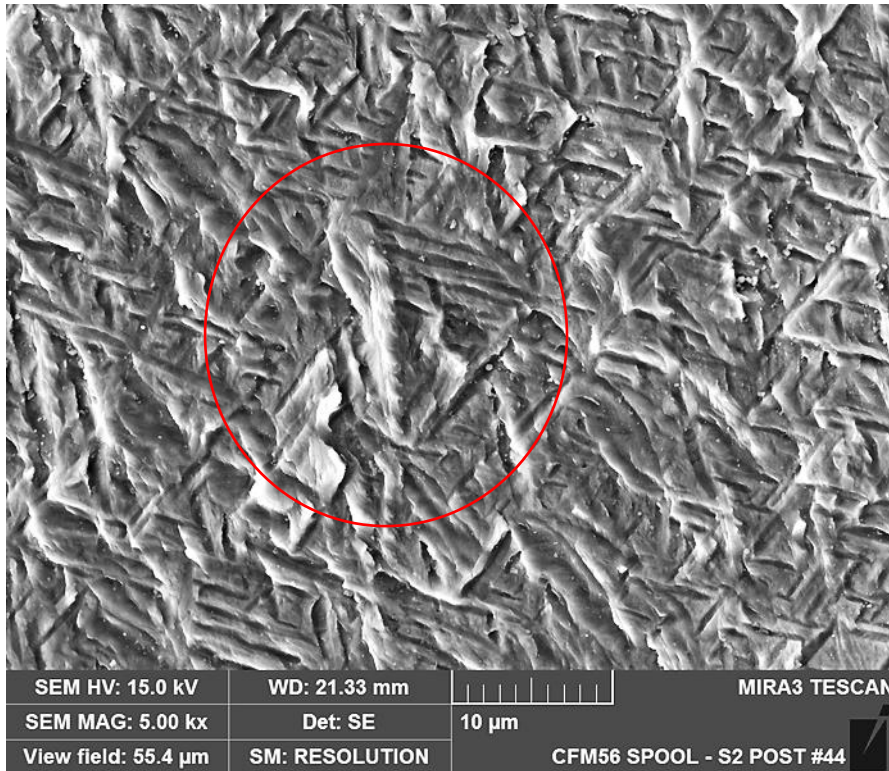
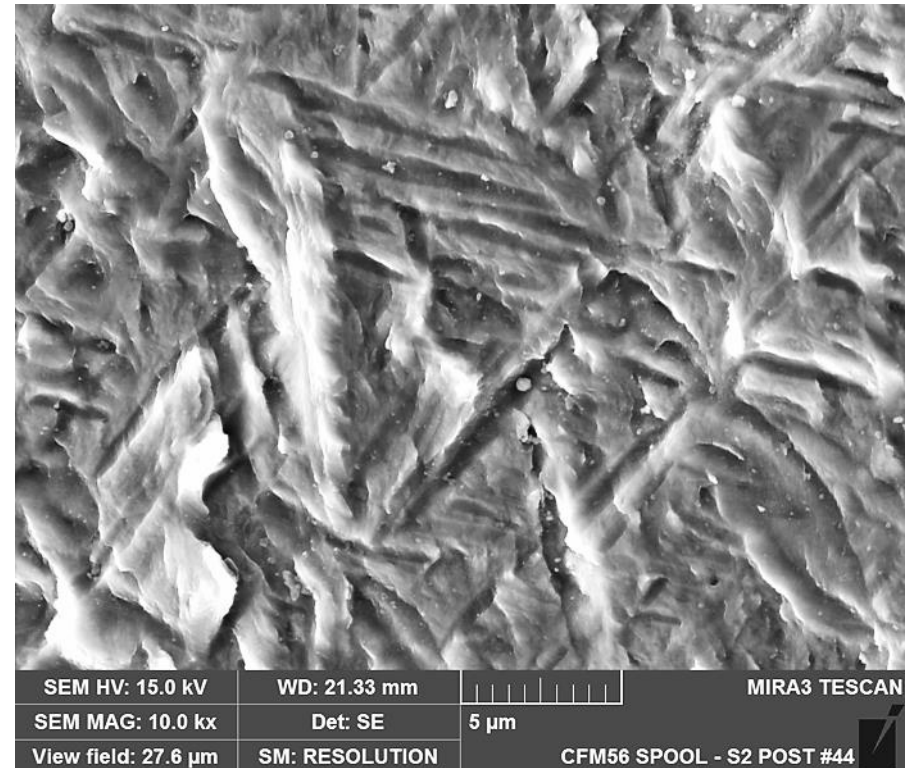
Stg. 2 Disk Post Fracture #44 - Area 3 - SEI

- Fracture Morphology Consistent With Lower Alternating Stress, High Cycle Fatigue (HCF) or Mixed-Mode LCF/HCF Crack Propagation Mechanisms – No Evidence of Coarser Fatigue Striations Observed
- Acicular Microstructure Resulting From Beta ( $\beta$ ) Processing Showing Through on Fracture

Figure 98. SEM secondary (SEI) images documenting fracture morphology at area 3 on Stg. 2 disk post #44 fracture surface. Arrows denote crack propagation direction.

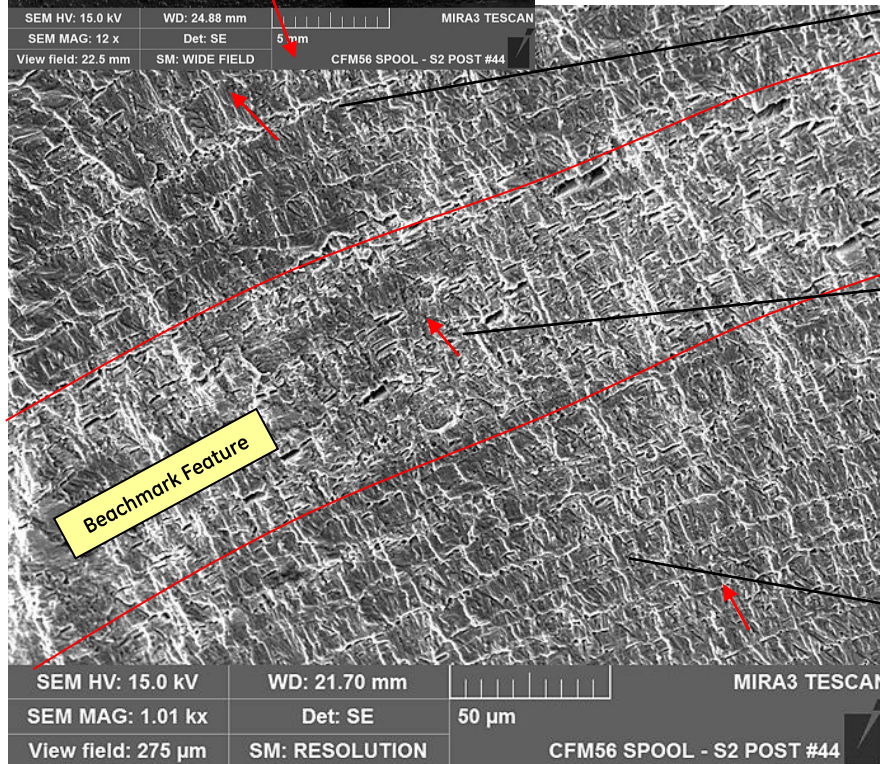
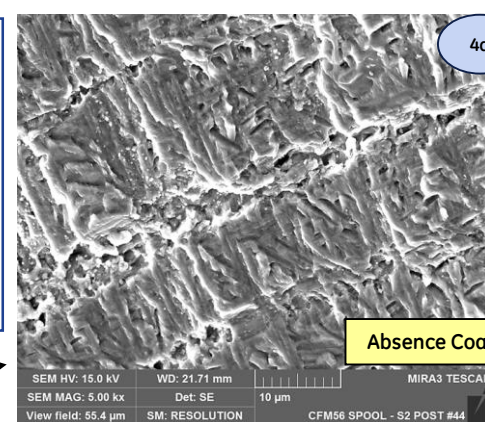
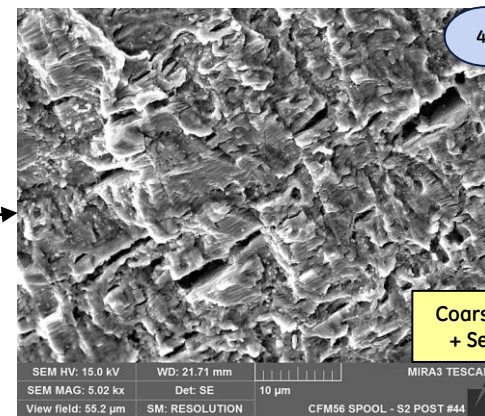
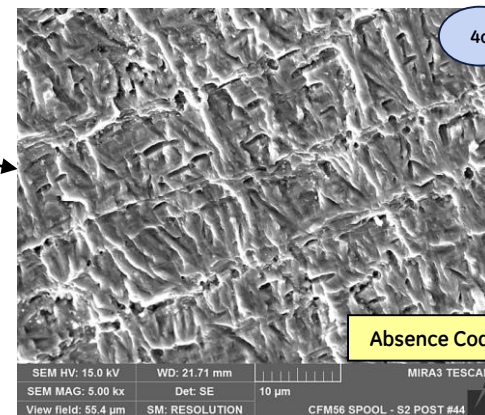
- Areas 4A and 4C Fracture Morphology Consistent With Lower Alternating Stress, High Cycle Fatigue (HCF) or Mixed-Mode LCF/HCF Crack Propagation Mechanisms
- Fracture 4B Within "Beachmark" Feature Exhibited Coarser Fatigue Striations Plus Secondary Cracking Consistent With Brief Increase in Alternating Stress

Figure 99. SEM secondary (SEI) images documenting fracture morphology at area 4 near the crack end region on Stg. 2 disk post #44 fracture surface. Arrows denote crack propagation direction. Higher alternating stress fatigue morphology observed within "beachmark" feature.

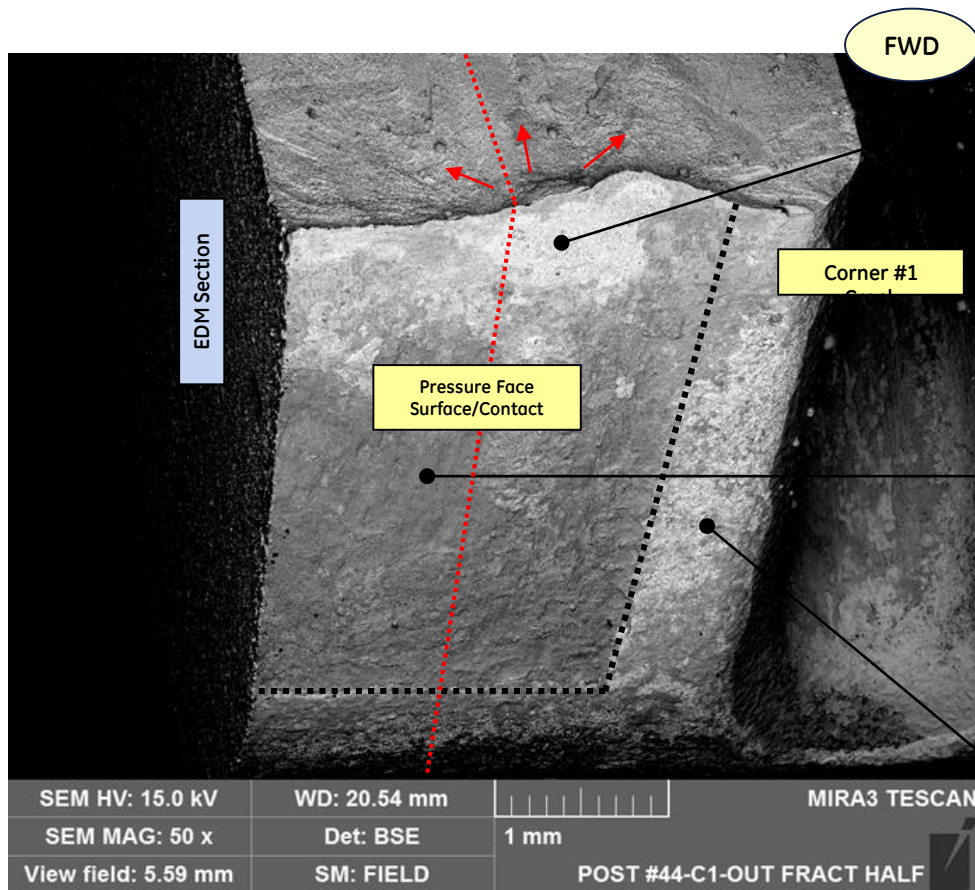
Stg. 2 Disk Post #44 – FWD Pressure Face (Corner #1) – BEI

Examination of the pressure face in the corner #1 region of Stg. 2 disk post #44 revealed heavier local contact at the fatigue origin region as shown in Figure 101. Evidence of transferred copper (Cu) from the Al-bronze coated Stg. 2 HPC blade pressure face was noted in the origin region. Original Stg. 1 disk post pressure faces are coated with moly-disulfide (both cured and brushed). Original Stg. 2 HPC Blade pressure faces also possess a cured moly-disulfide applied to the top of the aluminum bronze coating.

- Locally Heavier Pressure Face Contact With Edge of Stg. 2 HPC Blade at Corner #1 Position of Stg. 2 Disk Post #44 as Evidenced by Elevated Copper (Cu) Transfer (EDS1) From Stg. 2 HPC Blade Al-Bronze Pressure Face Coating

Figure 101. SEM backscatter (BEI) image and accompanying EDS spectra obtained from pressure face of Stg. 2 HPC Disk post #44 after lab fracture. Locally heavier contact with copper (Cu) material transfer was observed in the origin region. Red arrows denote crack propagation direction. Location of metallographic cross-section prepared through the pressure face indicated by dashed red lines.

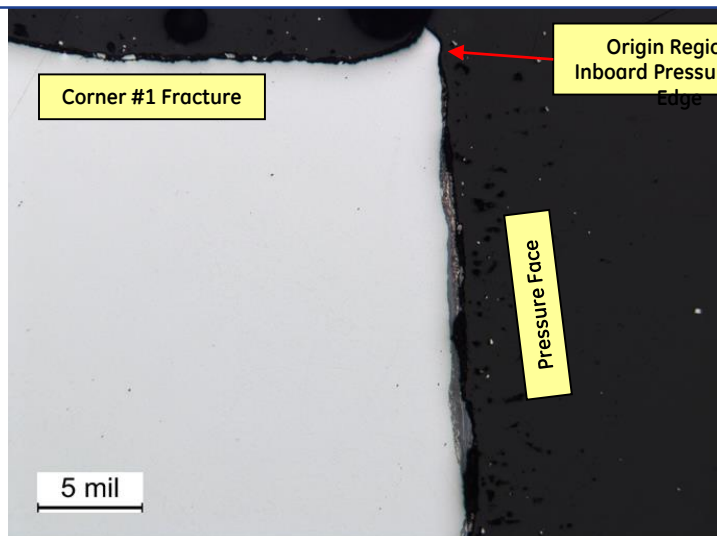
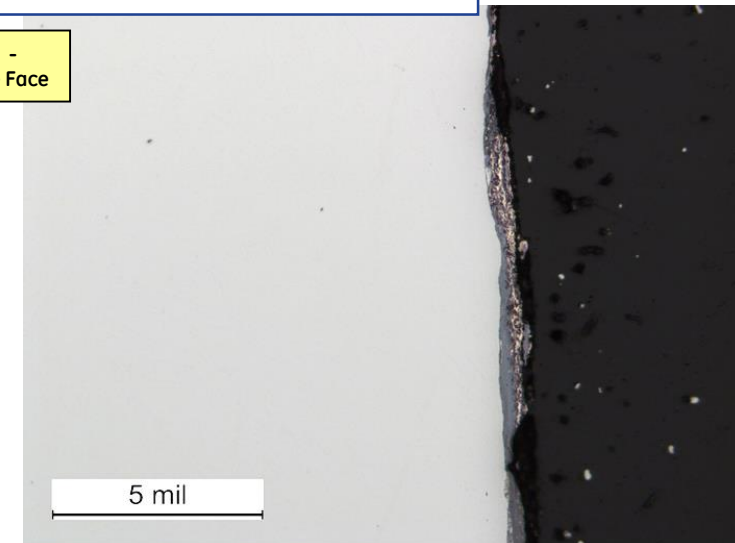
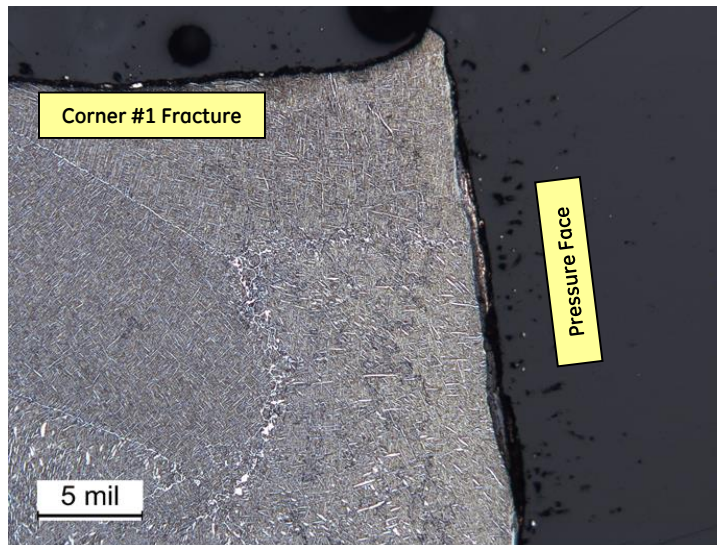
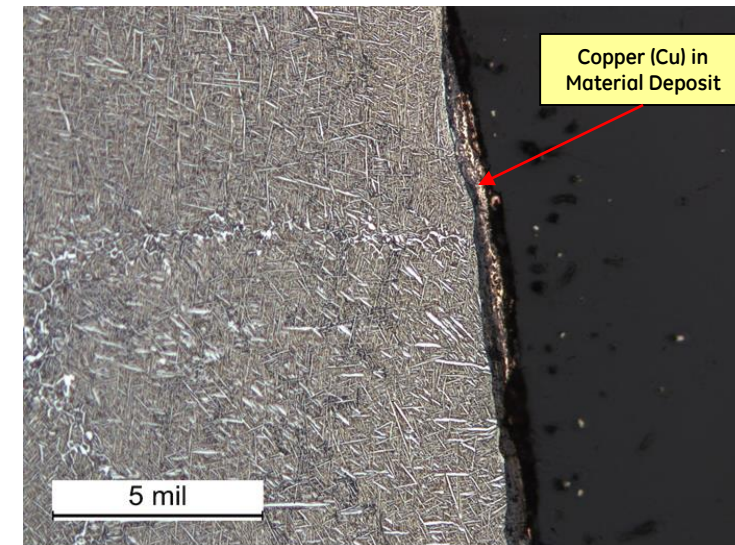
A metallographic cross-section was prepared through the fatigue origin region at Stg. 2 disk post #44 as shown in Figure 102. Transferred copper (Cu) from the aluminum-bronze coating applied to the Stg. 2 HPC Blade pressure face was observed in the origin region at the inboard edge of contact region adjacent to the corner 1 location. Transfer was attributed to greater contact pressure applied to this region during engine operation. No evidence of any material anomalies was observed at the origin region.

- Metallographic Polish Into Origin Region Located on Inboard Pressure Face Edge in Corner #1 Region - Transferred Copper (Cu) Detected in Deposit at Origin Region

Figure 102. Photomicrographs documenting metallographic cross-section prepared into pressure face of Stg. 2 disk post #44 at fatigue origin region. Etchant: Kroll's

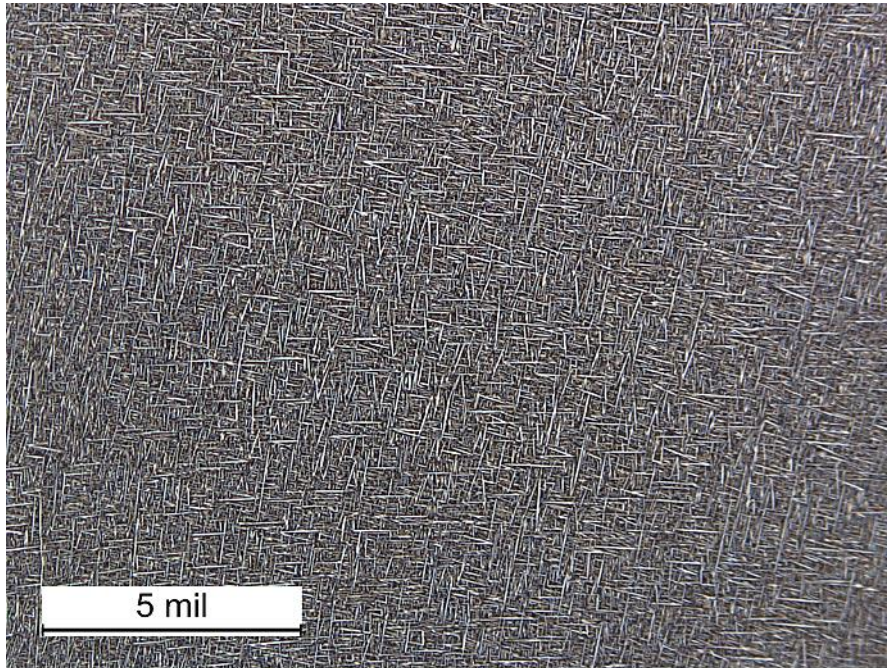
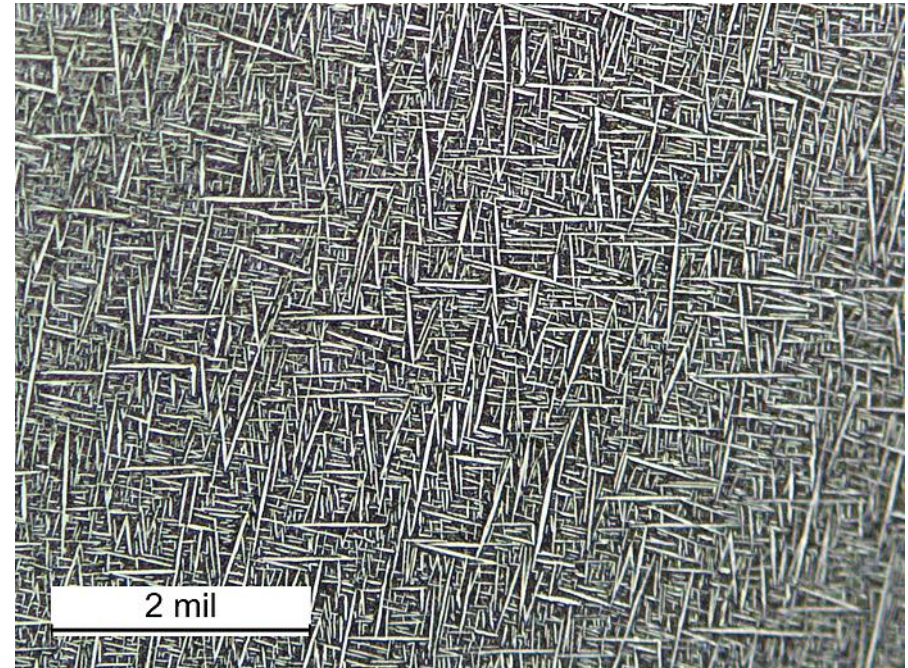
General microstructure at the Stg. 2 disk post location was comprised of acicular alpha ( $\alpha$ ) in a matrix of transformed beta ( $\beta$ ) consistent with beta ( $\beta$ ) forged Ti-17 material as required by the engineering drawing as shown in Figure 103.

- General Microstructure of Stg. 1-2 HPC Spool Consisted of Acicular Alpha ( $\alpha$ ) and Transformed Beta ( $\beta$ ) Consistent With Properly Processed Ti-17 Material

Figure 103. Photomicrographs documenting general microstructure obtained from Stg. 2 HPT disk post #44. Structure consisted of acicular alpha ( $\alpha$ ) and transformed beta ( $\beta$ ) consistent with properly processed Ti-17 material. Etchant: Kroll's

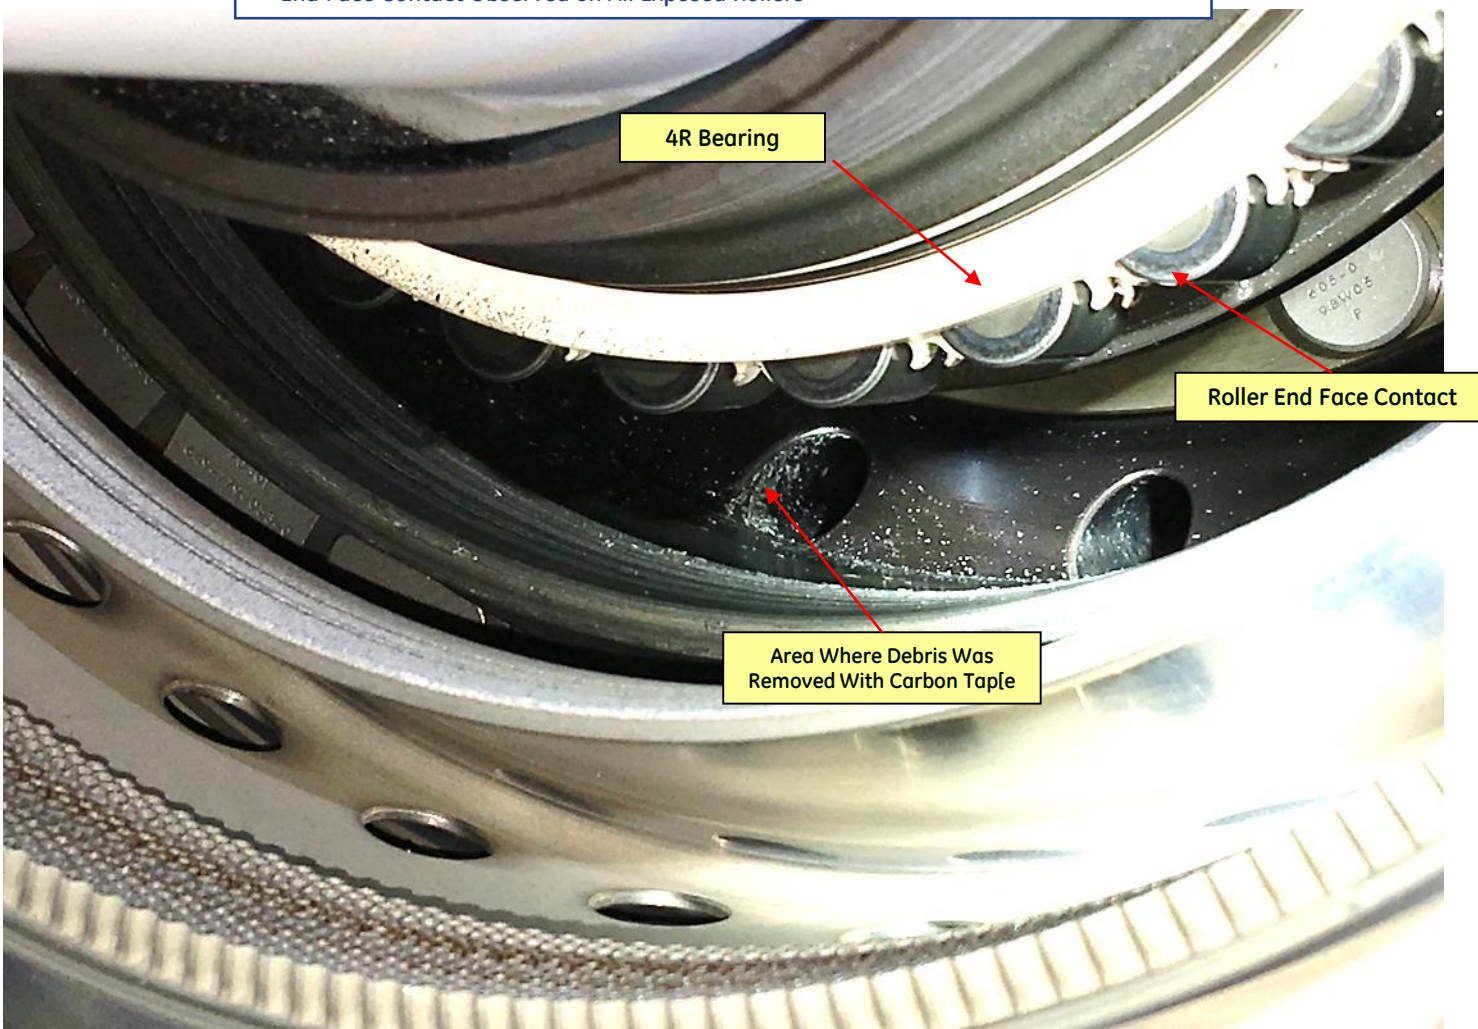
Aft Sump Region - 4R Bearing

During teardown debris was found in the vicinity of the 4R Bearing as shown in Figure 104. A sample of debris was removed with carbon tape for analysis. Debris particles and associated EDS spectra are shown in Figures 105-115. Debris consisted of RBD modified steel (4R Bearing inner race material), silver (bearing cage), unidentifiable material exhibiting elevated titanium (Ti), iron (Fe), chromium (Cr) and nickel (Ni) and aluminum (Al) with silicon (Si).

- Debris Removed With Carbon Tape in Aft Sump Adjacent to 4R Bearing
- End Face Contact Observed on All Exposed Rollers

Figure 104. Photograph documenting loose debris in the aft sump region adjacent to 4R Bearing found during engine disassembly.

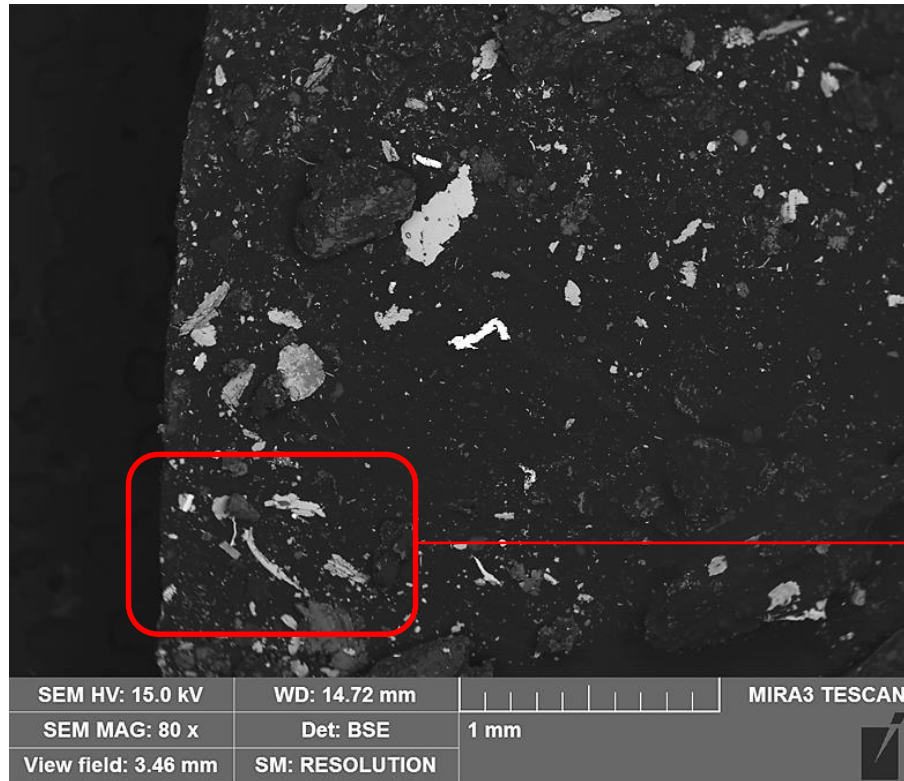
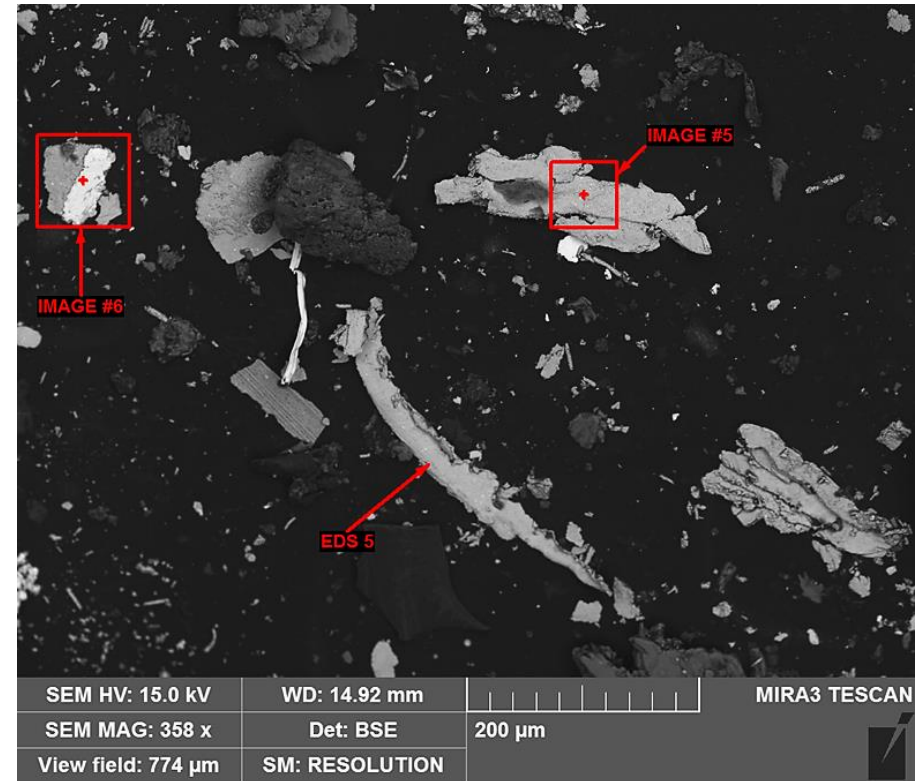
- Debris Removed With Carbon Tape in Aft Sump Adjacent to 4R Bearing
- Random Energy Dispersive Spectroscopy (EDS) Performed on Several Debris Particles

Figure 105. SEM backscatter (BEI) photograph documenting sample of loose debris in the aft sump region adjacent to 4R Bearing found during engine disassembly. EDS analysis performed on debris.

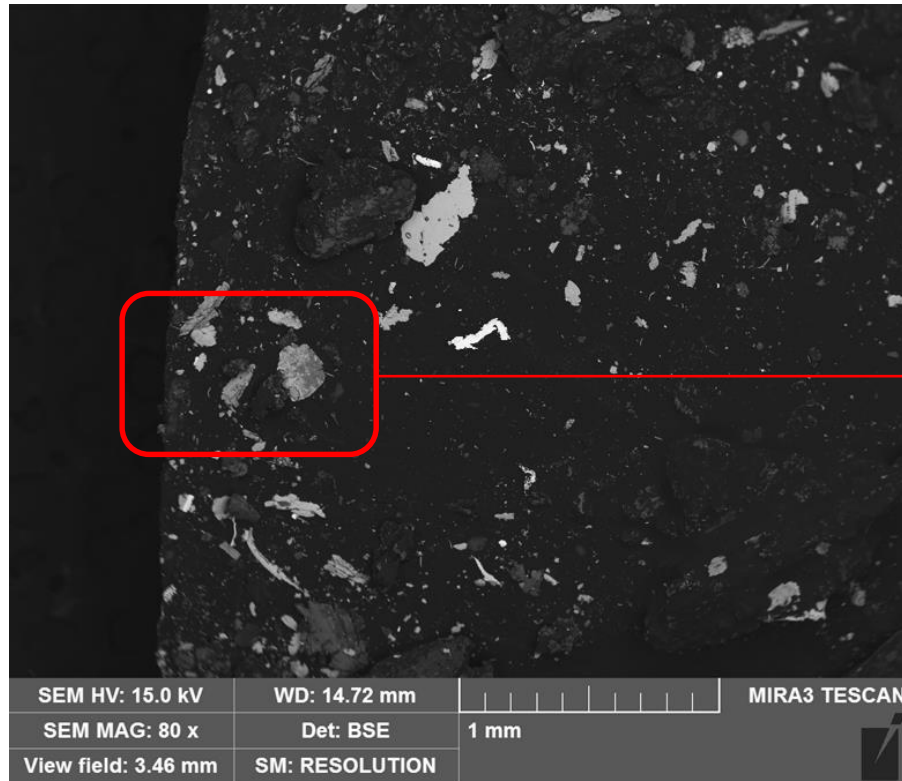
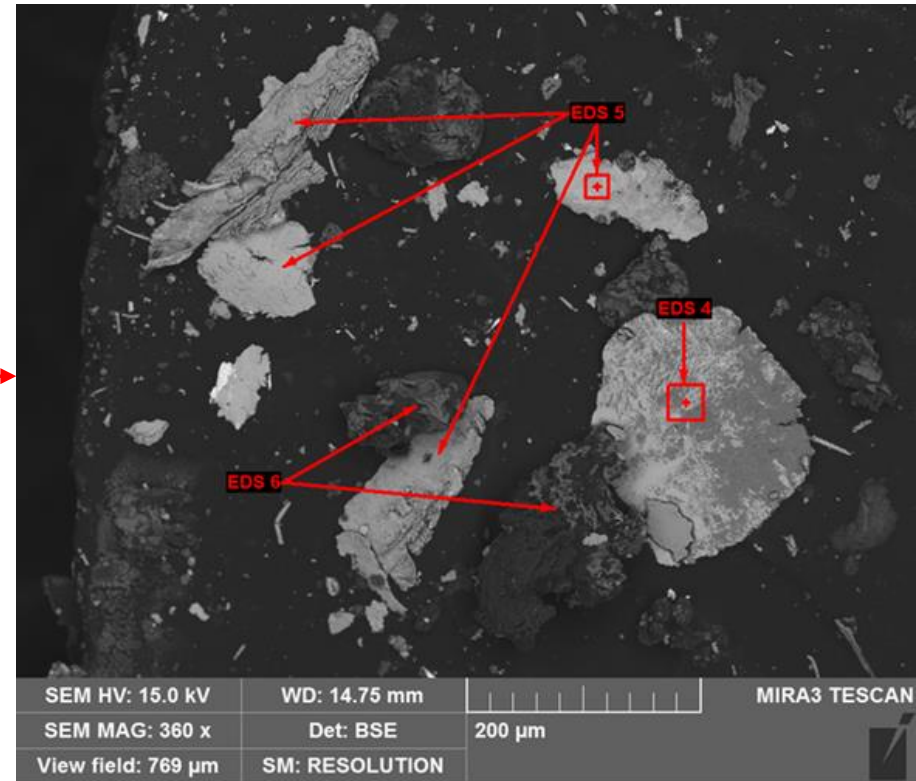
- Debris Removed With Carbon Tape in Aft Sump Adjacent to 4R Bearing
- Random Energy Dispersive Spectroscopy (EDS) Performed on Several Debris Particles

Figure 106. SEM backscatter (BEI) photograph documenting sample of loose debris in the aft sump region adjacent to 4R Bearing found during engine disassembly. EDS analysis performed on debris.

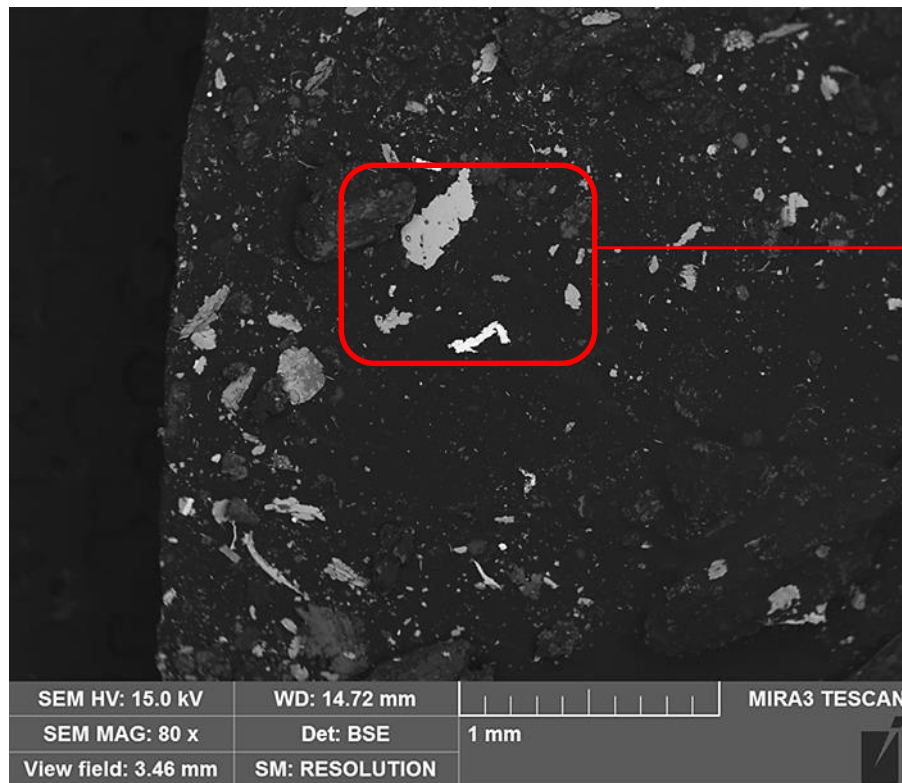
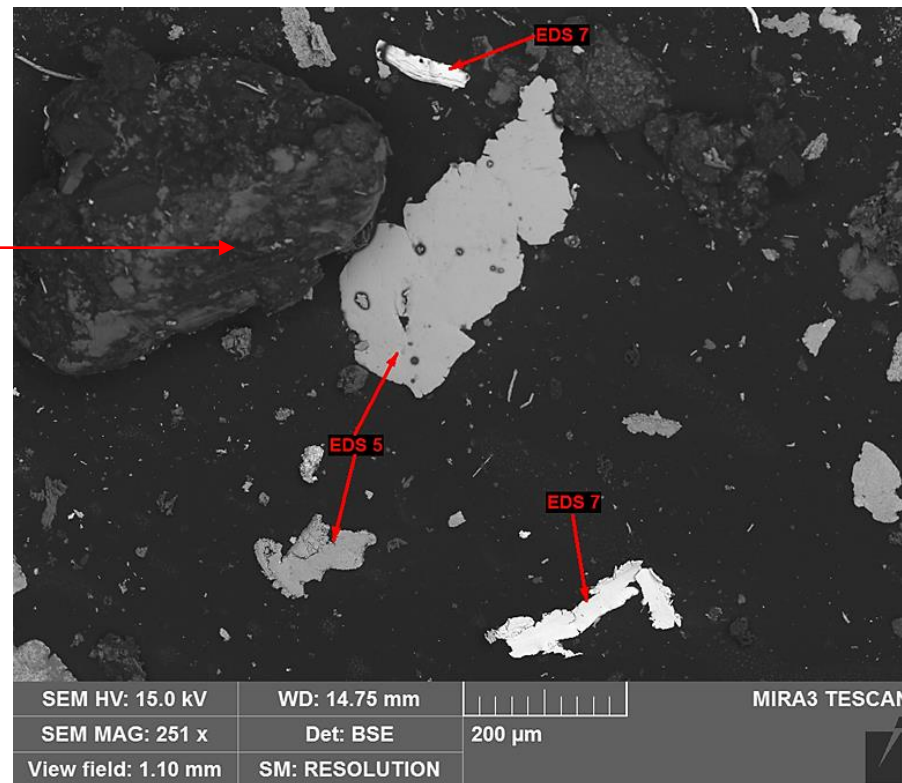
- Debris Removed With Carbon Tape in Aft Sump Adjacent to 4R Bearing
- Random Energy Dispersive Spectroscopy (EDS) Performed on Several Debris Particles

Figure 107. SEM backscatter (BEI) photograph documenting sample of loose debris in the aft sump region adjacent to 4R Bearing found during engine disassembly. EDS analysis performed on debris.
