# Metallurgical Investigation Report

## FA Log No. 18712

**METALLURGICAL EVALUATION OF  
CFM56-7B STG. 1-2 HPC SPOOL AND  
STG. 1 HPC VSV TRUNNION/LEVER  
ARM HARDWARE FROM ESN 875-  
318 OPERATED BY UNITED AIRLINES**

**Final Report Date: June 14, 2019**

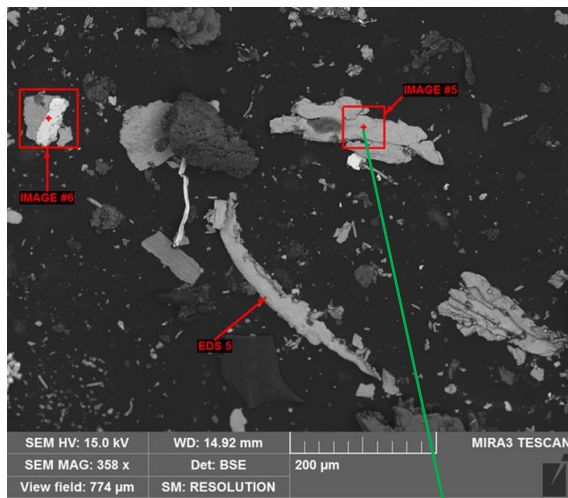
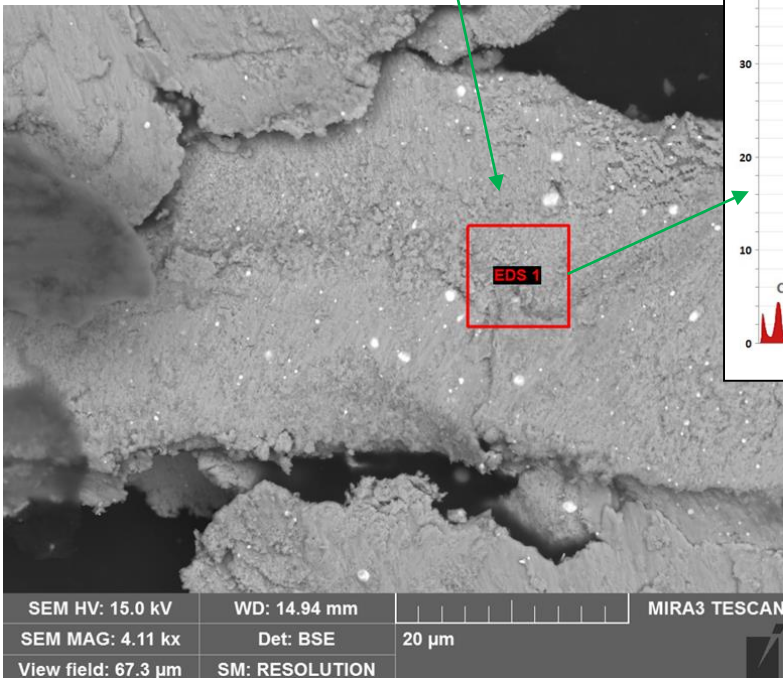
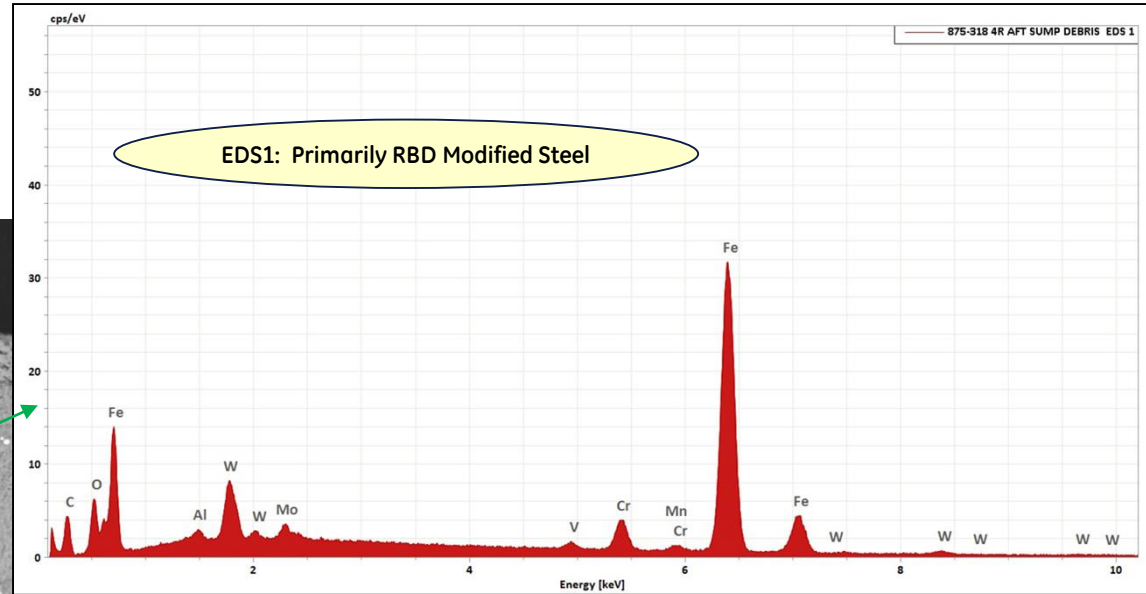
- Debris Removed With Carbon Tape in Aft Sump Adjacent to 4R Bearing
- EDS1: Primarily RBD Modified Steel (4R Bearing Inner Race Material) as Evidenced by Presence Tungsten (W)

Figure 109. SEM backscatter (BEI) photographs and accompanying EDS spectrum (EDS1) documenting debris from aft sump region adjacent to 4R Bearing found during engine disassembly.

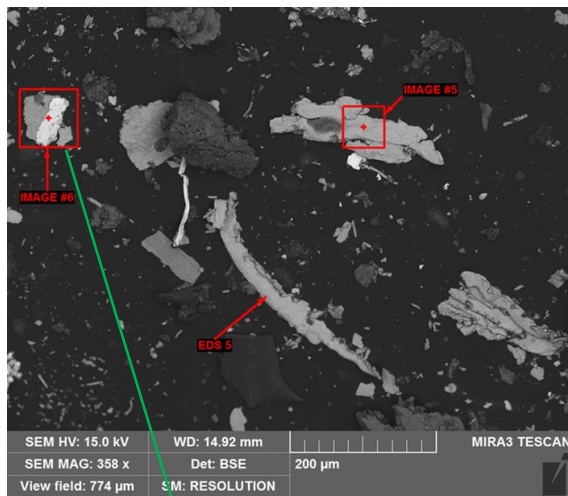
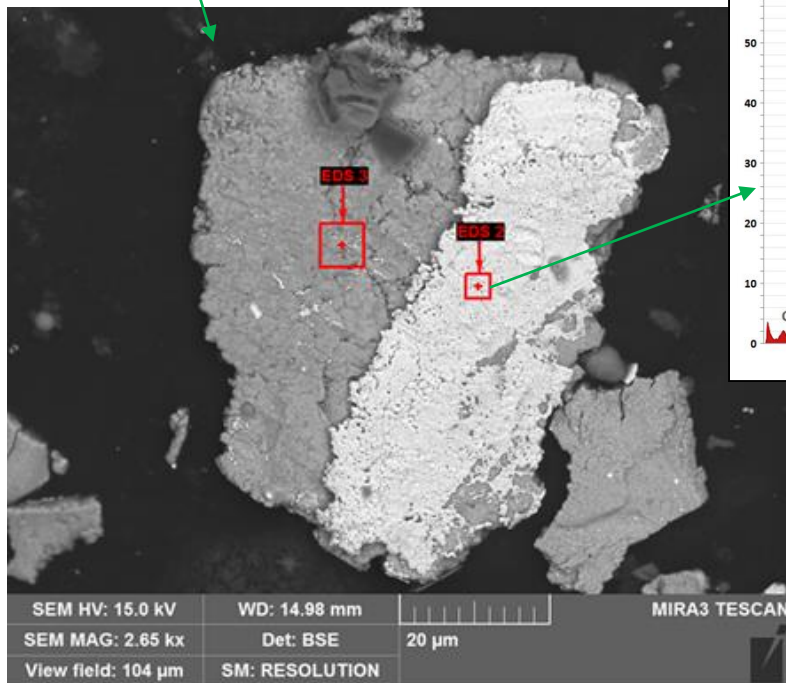
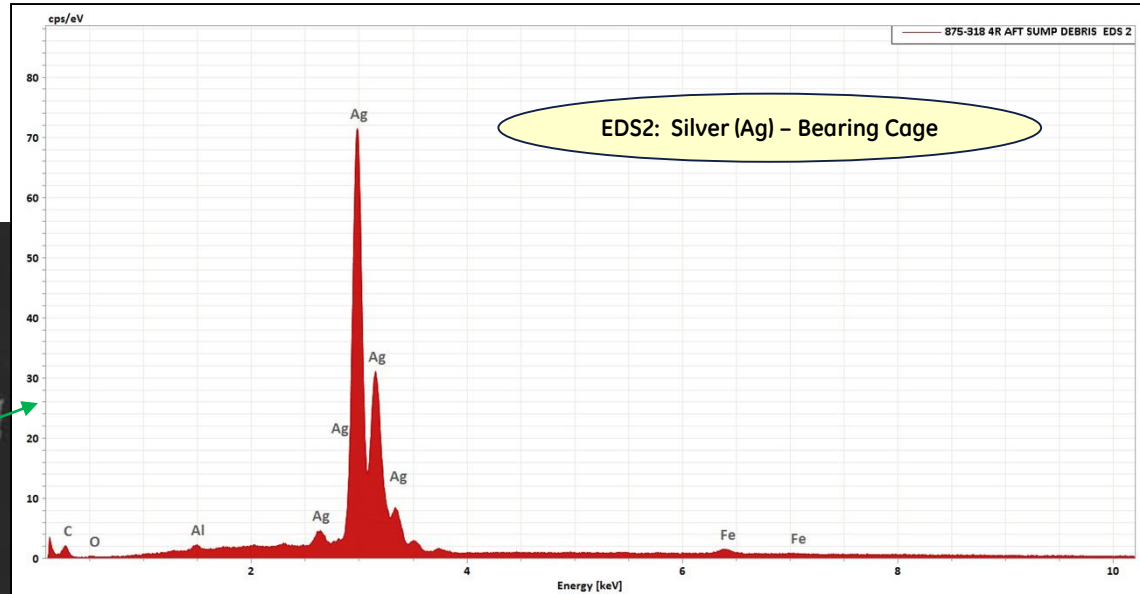
- Debris Removed With Carbon Tape in Aft Sump Adjacent to 4R Bearing
- EDS2: Silver (Ag) Likely From Bearing Cage Plating

Figure 110. SEM backscatter (BEI) photographs and accompanying EDS spectrum (EDS2) documenting debris from aft sump region adjacent to 4R Bearing found during engine disassembly.

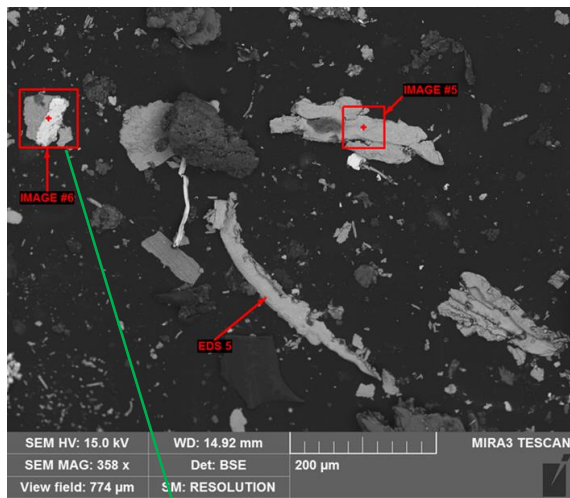
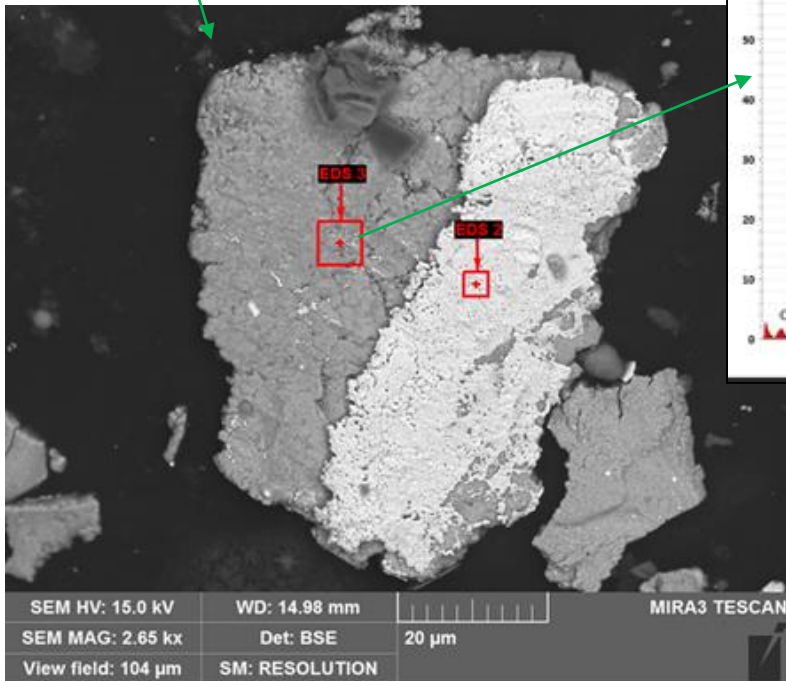
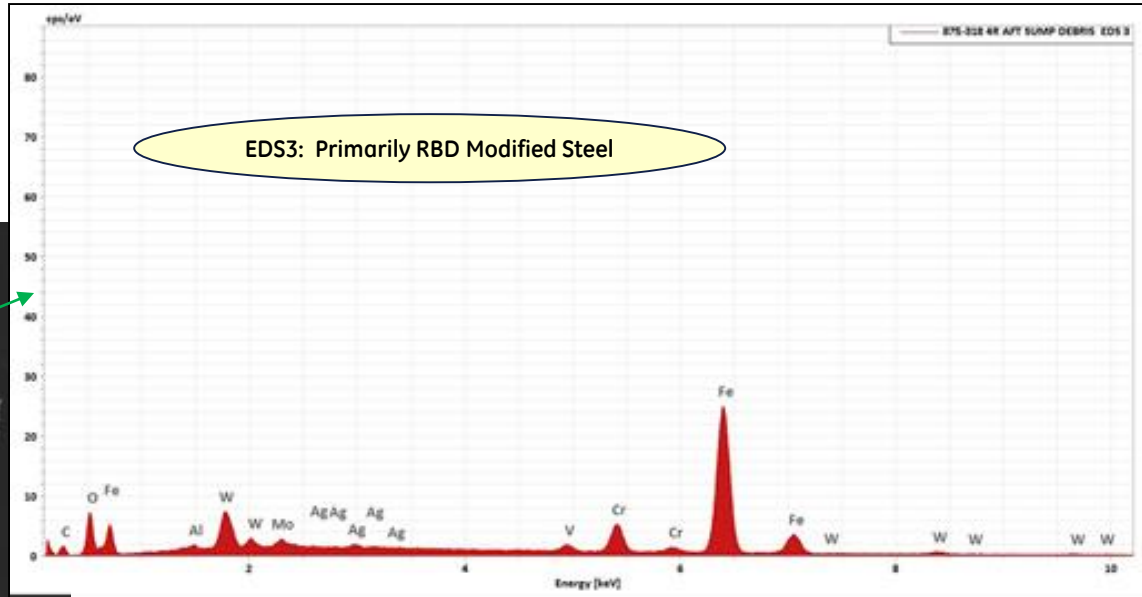
- Debris Removed With Carbon Tape in Aft Sump Adjacent to 4R Bearing
- EDS3: Primarily RBD Modified Steel (4R Bearing Inner Race Material) as Evidenced by Presence Tungsten (W)

Figure 111. SEM backscatter (BEI) photographs and accompanying EDS spectrum (EDS3) documenting debris from aft sump region adjacent to 4R Bearing found during engine disassembly.

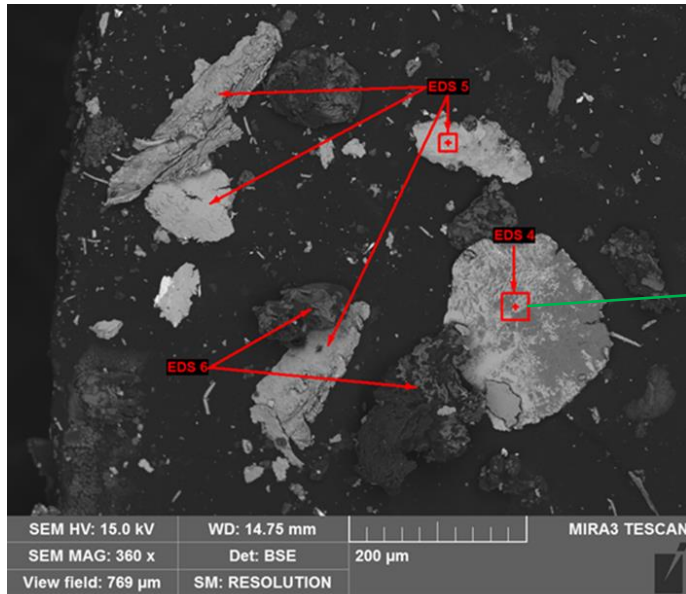
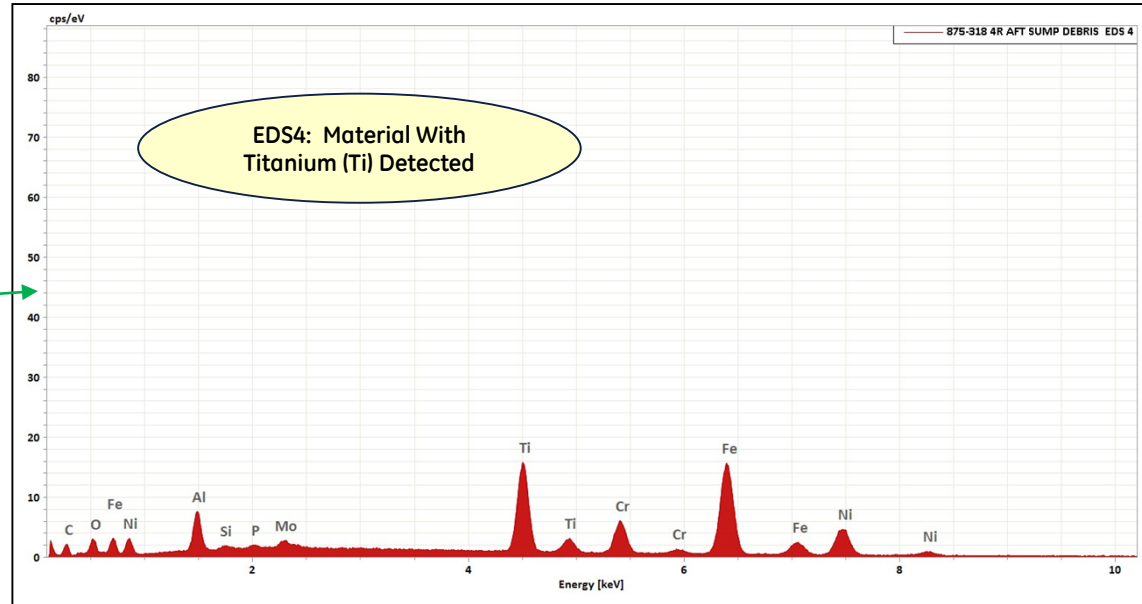
- Debris Removed With Carbon Tape in Aft Sump Adjacent to 4R Bearing
- EDS4: Titanium (Ti), Nickel (Ni), Chromium (Cr) and Iron (Fe) Detected

Figure 112. SEM backscatter (BEI) photographs and accompanying EDS spectrum (EDS4) documenting debris from aft sump region adjacent to 4R Bearing found during engine disassembly.

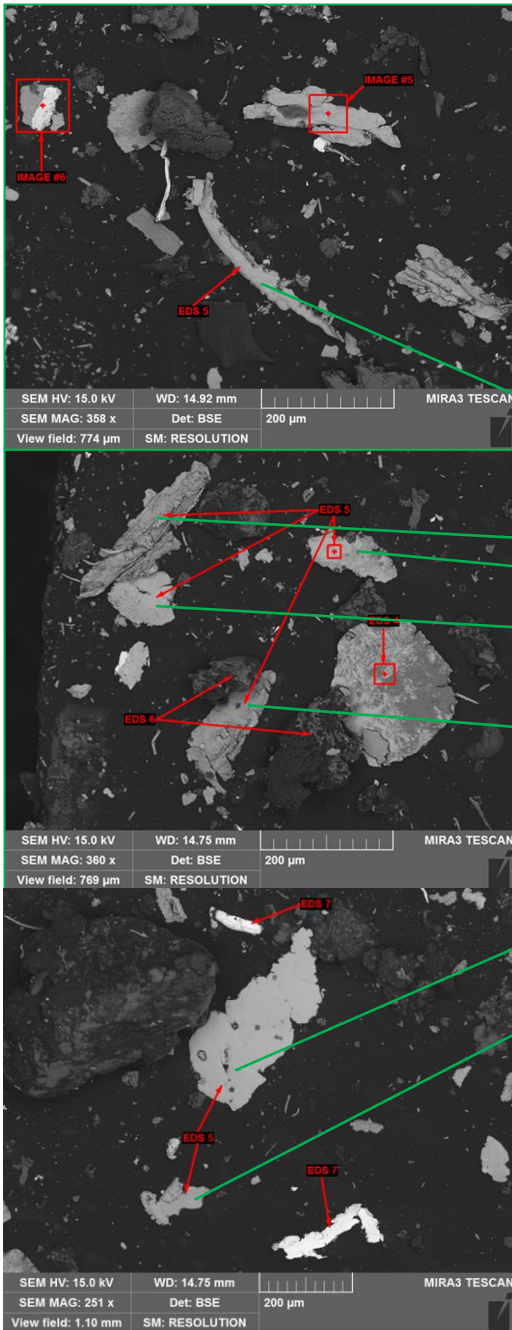
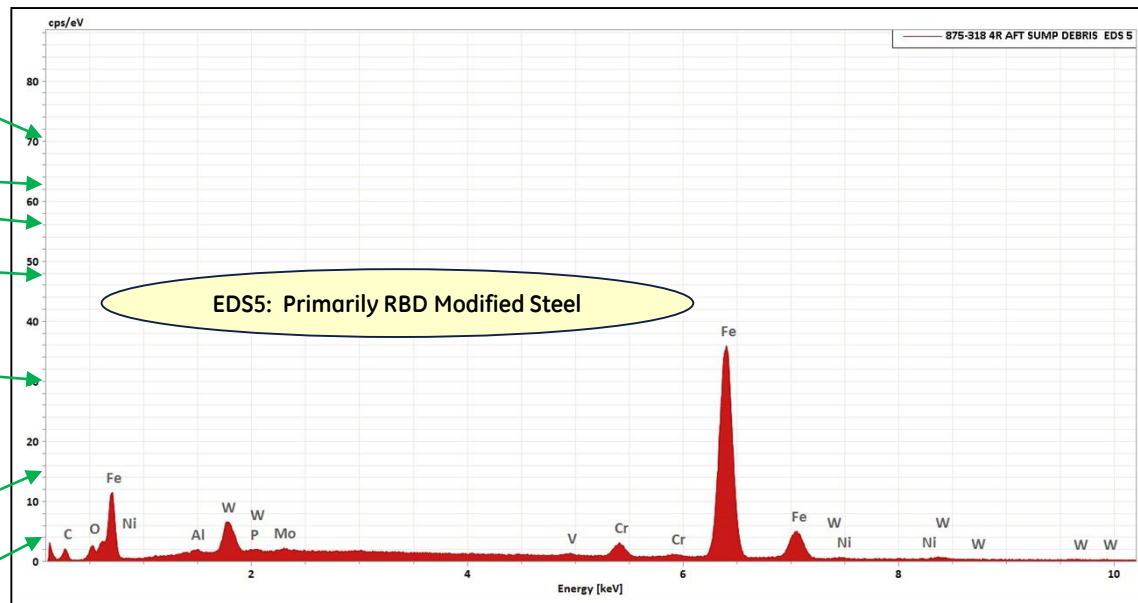
- Debris Removed With Carbon Tape in Aft Sump Adjacent to 4R Bearing
- EDS5: Primarily RBD Modified Steel (4R Bearing Inner Race Material) as Evidenced by Presence Tungsten (W)

Figure 113. SEM backscatter (BEI) photographs and accompanying EDS spectrum (EDS5) documenting debris from aft sump region adjacent to 4R Bearing found during engine disassembly.

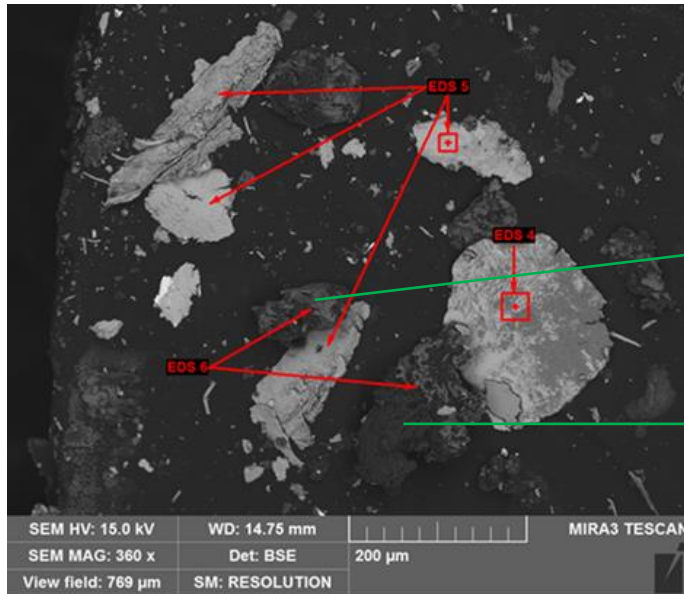
Aft Sump Debris - BEI

- Debris Removed With Carbon Tape in Aft Sump Adjacent to 4R Bearing
- EDS6: Elevated Aluminum (Al) with Silicon (Si) Detected in Darker Debris

Figure 114. SEM backscatter (BEI) photographs and accompanying EDS spectrum (EDS6) documenting debris from aft sump region adjacent to 4R Bearing found during engine disassembly.

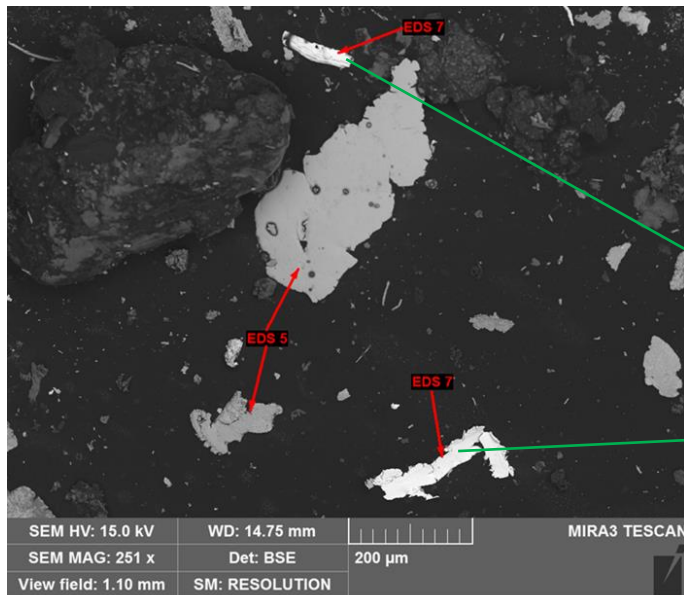
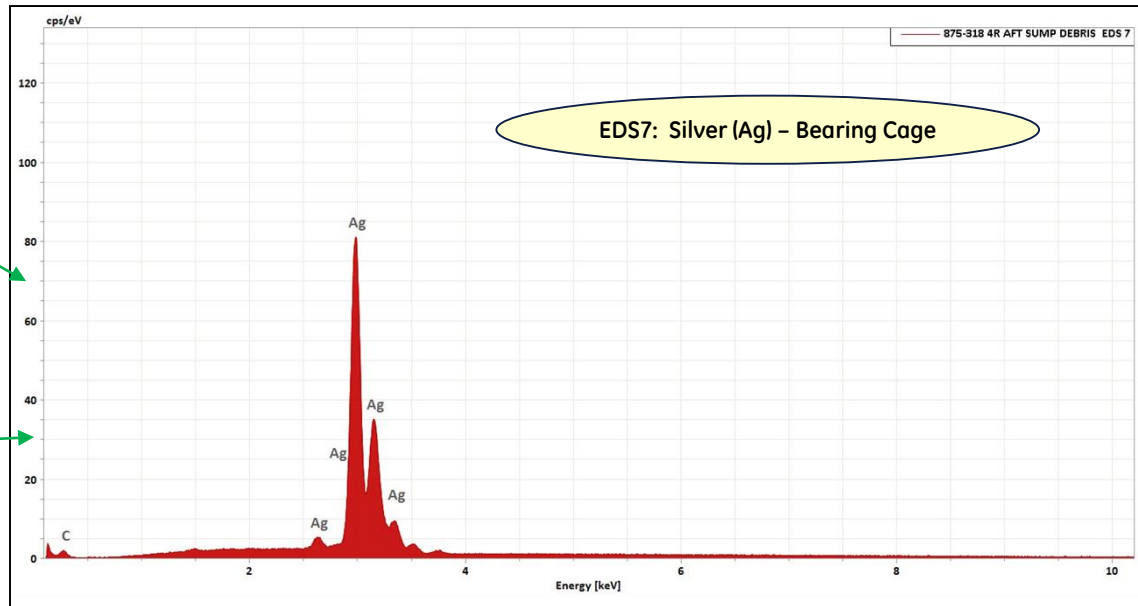
Aft Sump Debris - BEI

- Debris Removed With Carbon Tape in Aft Sump Adjacent to 4R Bearing
- EDS7: Silver (Ag) Likely From Bearing Cage Plating

Figure 115. SEM backscatter (BEI) photographs and accompanying EDS spectrum (EDS7) documenting debris from aft sump region adjacent to 4R Bearing found during engine disassembly.

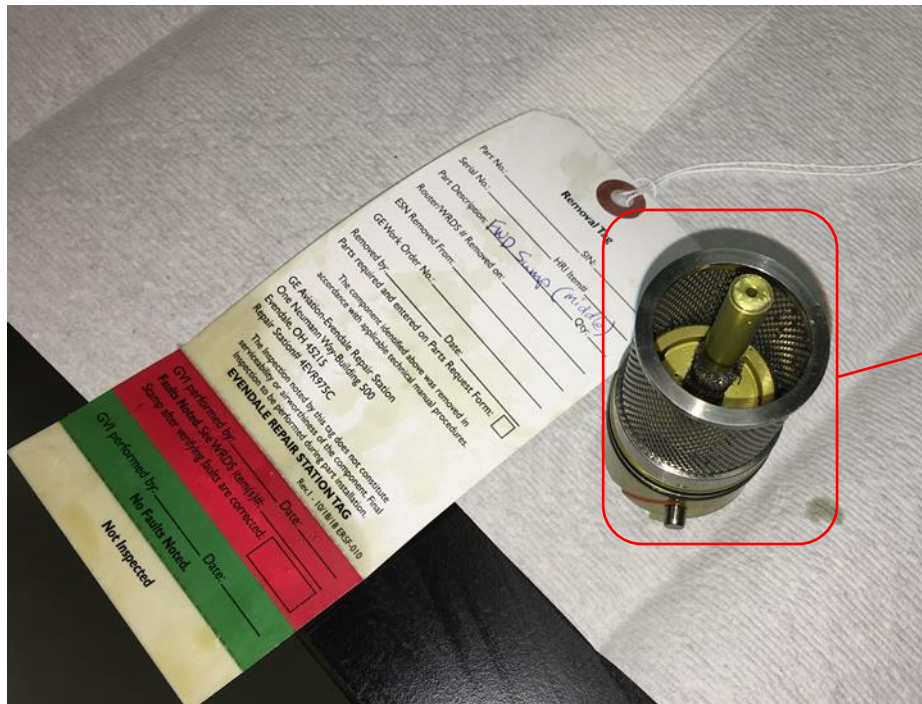
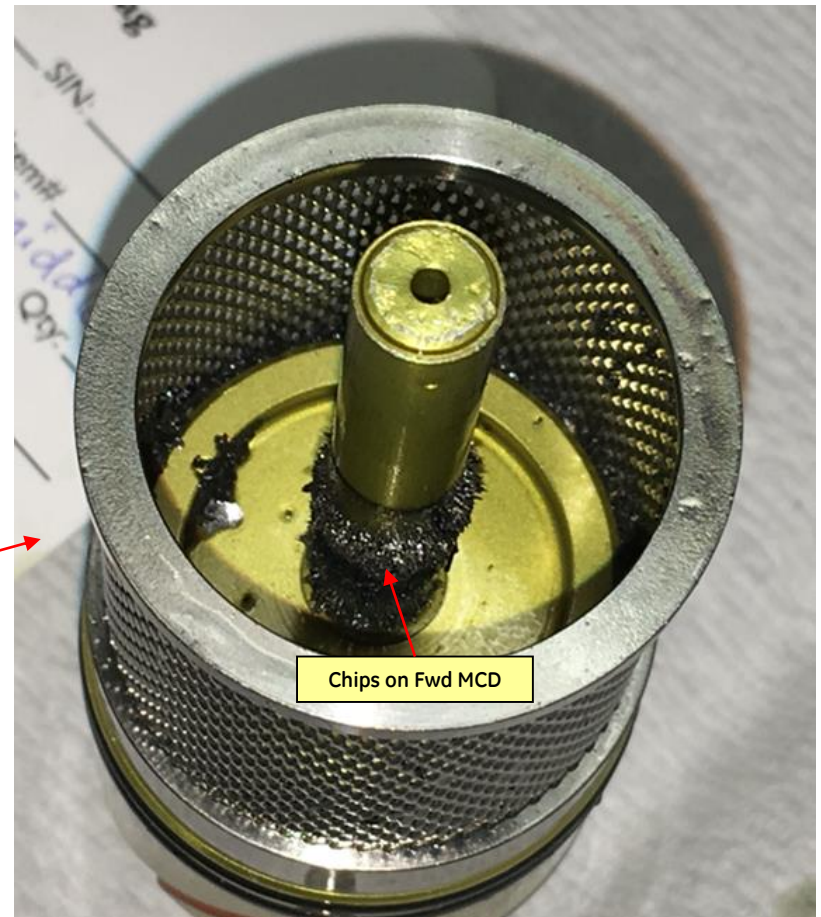
Fwd Sump MCD and Attached Debris

Photographs documenting debris attached to the forward sump chip detector are shown in Figure 116. An SEM image documenting a representative sample of debris is shown in Figure 117. Debris particles consisted of primarily M50NiL, 17-4 and/or 15-5 PH and 4340/9310 low alloy steel. No evidence of RBD modified steel was detected.

- Debris Attached to Forward Sump Magnetic Chip Detector (MCD)

Figure 116. Photographs documenting debris on the forward MCD found during engine disassembly.

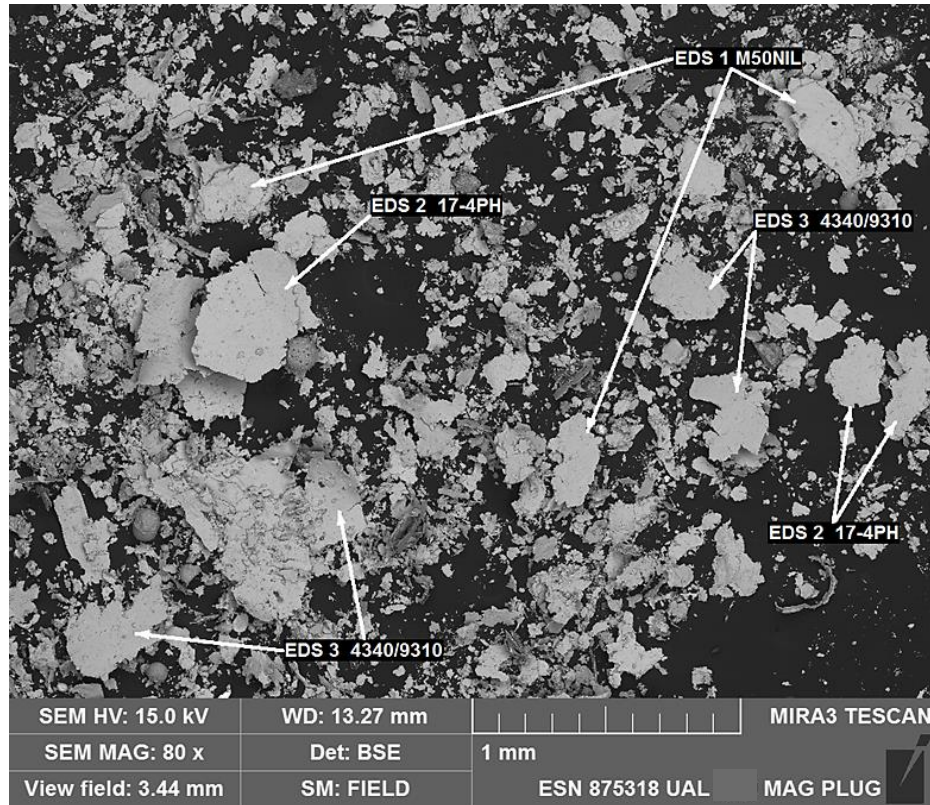
Fwd Sump MCD Debris

- EDS1: M50NiL Detected in Debris
- EDS2: 17-4 PH Steel in Debris
- EDS3: 4340/9310 Low Alloy Steel in Debris
- No RBD Modified Steel Detected

Figure 117. SEM backscatter (BEI) photographs and accompanying EDS spectrum (EDS1, EDS2 and EDS3) documenting debris from forward sump MCD.
