**NATIONAL TRANSPORTATION SAFETY BOARD**  
**Office of Aviation Safety**  
**Washington, D.C. 20594**

**POWERPLANT GROUP CHAIRMAN'S FACTUAL REPORT**  
**NTSB No: ENG19IA029**

Aircraft: Airbus A220-300 (MSN 55030), HB-JCM, Swiss International Air Lines, Flight LX348

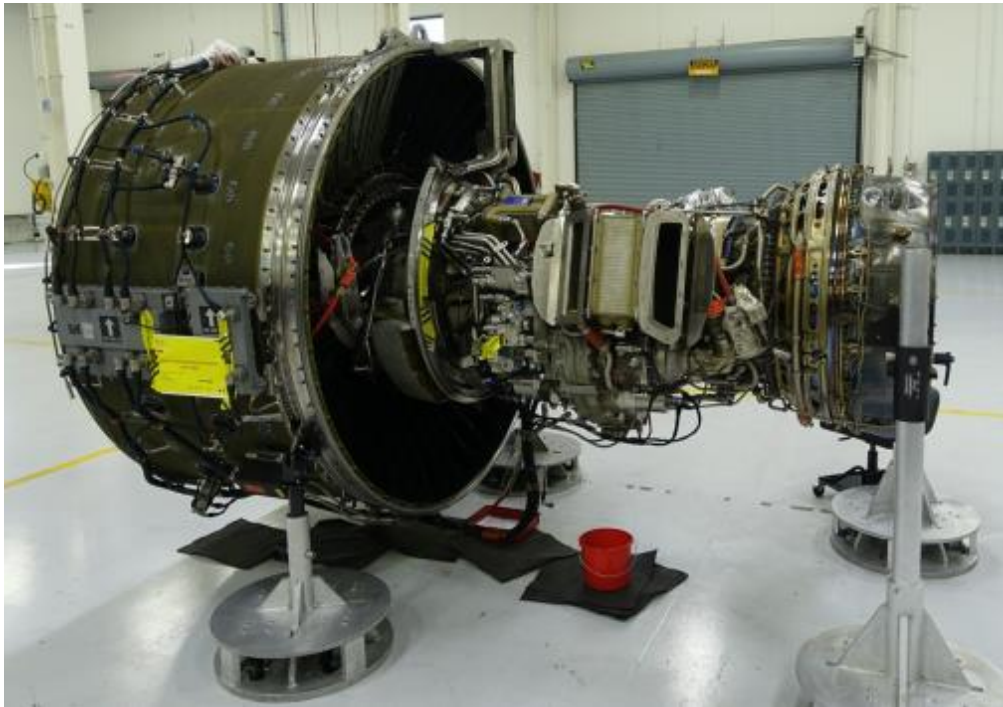
**Photo 6- Left Side of Engine, as Received**

The engine was secured in work pedestals and the quick engine change hardware and buyer furnished equipment were removed when the investigation team arrived (**Photos 6, 7, and 8**). A BSI of the engine was completed prior to the teams' arrival to assist in teardown workscope development. The loose debris that was collected in the nacelle after the event flight landed at CDG was bagged and shipped with the engine for examination. One of the loose fragments had features that appeared to be consistent with the separated LPC IBR 1 (**Photo 9**).

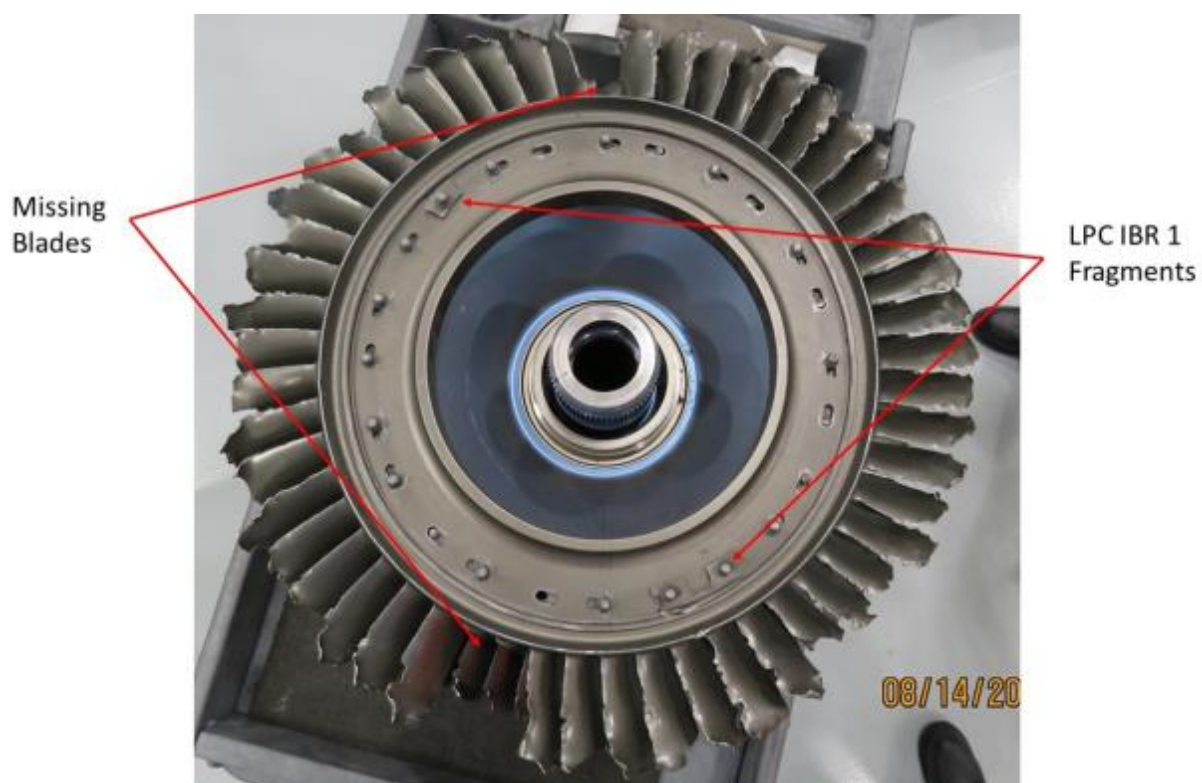
**Photo 18- LPC IBR 2, Forward Side**

Most of the LPC IBR 1 was separated and missing. The LPC S1 stator vanes were separated and missing from the 6 to 3 o'clock positions. The remaining stator vanes appeared to be folded against the case inner surface (**Photo 17**). The LPC IBR 2 had three blades fractured and separated at the blade root. Of the three fractured blades, two were consecutive and the third was on the opposite side of the rotor (~140 degrees apart). Two small fragments of the IBR 1 flange remained fastened to the IBR 2. Three IBR 1-to-IBR 2 attaching bolts were missing and five were sheared of the 24 total bolts (**Photo 18**). The remaining IBR 2 blades exhibited leading and trailing edge impact damage/tearing and material loss, most concentrated near the blade tips. The LPC S2 stator vanes were all present but exhibited leading and trailing edge impact damage and deformation (**Photo 19**). The LPC IBR 3 blades were all present but had leading edge and trailing edge impact damage (**Photo 20**). The LPC hub had no visible damage. What remained of the IBR 1 outer air seal had rub damage and was missing material. The No. 2 bearing was not removed from the housing, but visible ball bearings were oil wetted and could be spun smoothly by hand.

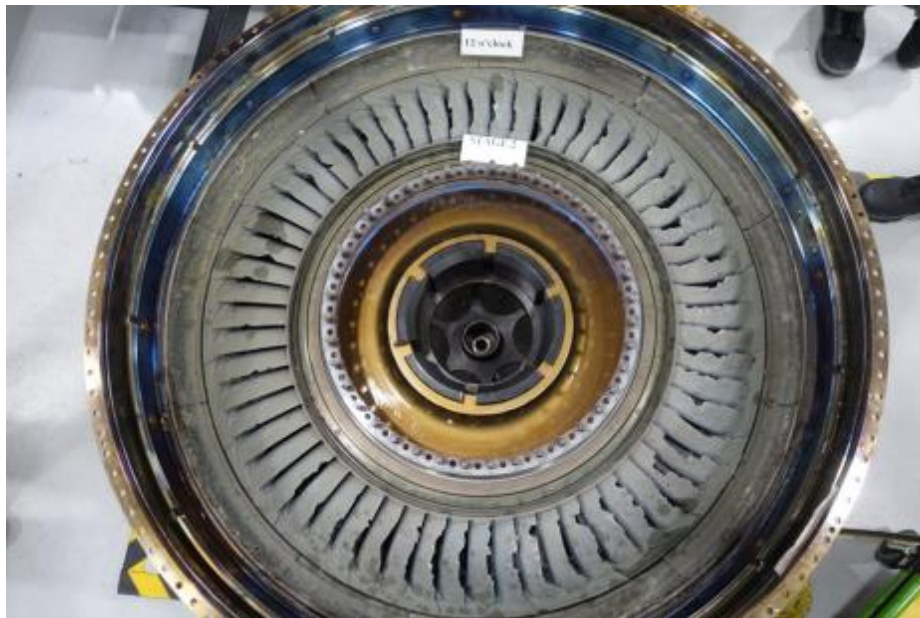
**Photo 24- LPT S2 Vanes**

The LPT shaft was removed and there were no indications of rub damage or unusual wear marks (**Photo 23**). The LPT S1 blades were complete but exhibited minor impact damage to the blade leading edges and more severe impact damage/tearing on the trailing edges. The LPT S2 vanes had both leading and trailing edge impact damage (**Photo 24**). The LPT S2 blades were fractured at about the  $\frac{1}{3}$  spanwise location and the blade fracture surfaces were jagged and coarse (**Photo 25**). According to Columbus Engine Center, the blades appeared green rather than the brown color typically observed on similar service run engines. The LPT S3 vanes had leading and trailing edge impact damage (**Photo 26**). The LPT S3 blades were uniformly fractured about the midspan and the blade fracture surfaces were jagged and coarse (**Photo 27**). The LPT S2 and S3 blade outer air seals and vane inner air seals exhibited rub damage and were missing material. The seals in both areas had to be cut or chiseled during disassembly of the LPT. The No. 5 and No. 6 bearings were both oil wetted and could be spun smoothly by hand.

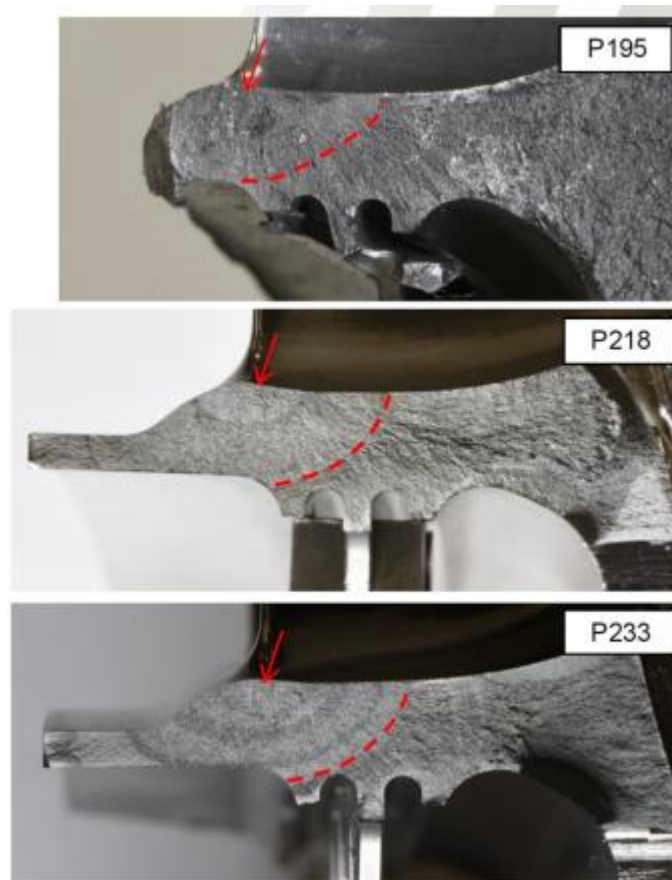
**Photo 33- LPC IBR 1 Crack/Fracture Surfaces**

The SWISS incident on July 25, 2019 was the first of three Airbus A220-300 PW1524G-3 and one PW1521G-3 LPC IBR 1 separation events. Following the recovery and materials analysis of the IBR 1 from ESN P736195 (the second reported event – see Section 6.1 for details), P&W released a service bulletin (SB) SB PW1000G-A-72-00-0125-00A-930A-D that was mandated by FAA airworthiness directive (AD) 2019-19-11 that required operators to perform recurrent BSIs of the LPC IBR 1. The inspections identified two additional LPC IBR 1 crack findings (**Photo 32**). The hardware from the two LPC IBR 1 BSI crack findings were sent to the P&W MPE Lab for analysis and the crack type and origin location were consistent with the findings from ESN P736195 (**Photo 33**). A summary of the fracture findings are listed below in **Table 2**. A detailed discussion of corrective actions is covered later in this report.

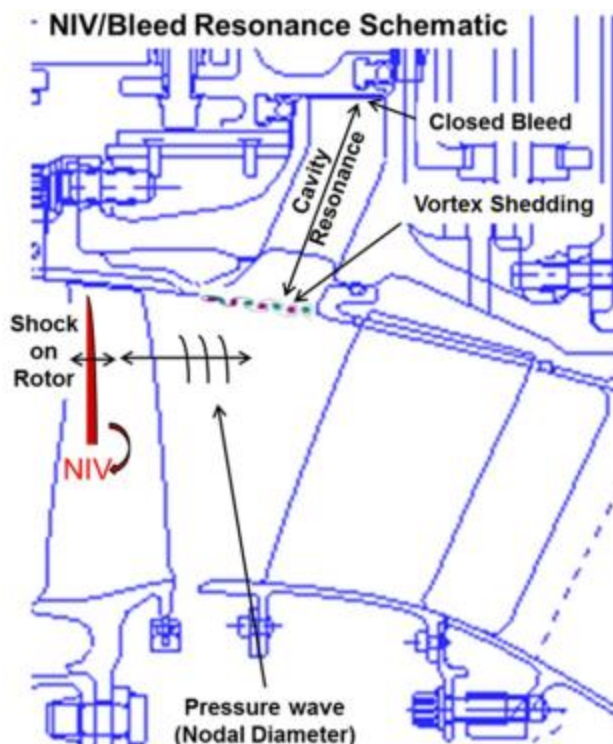
Multiple analytical methods, including two-dimensional (2D) computational fluid dynamics (CFD), acoustic testing, and instrumented flight testing identified a coupled LPC IBR 3 and IBR 1 instability caused by an acoustic coincidence with the 2.5 bleed valve cavity. At high engine N1 speeds, the IBR 3 blade tips generate vortices/turbulent airflow that then pass over the 2.5 bleed valve cavity located immediately aft of the LPC IBR 3. Given the right conditions, the turbulent airflow created an acoustic tone as it passed over the 2.5 bleed valve cavity that excited a LPC IBR 3 blade 1<sup>st</sup> bending mode normal to the blade chord (**Figure 4**). The LPC IBR 1 shares a system mode at the same frequency as IBR 3 and through a mechanically coupled response the vibration transferred through the IBR stack and excited an IBR 1 blade stiffwise bending mode parallel to the blade chord. The LPC IBR vibration response is not an integer multiple of engine speed and is referred to as non-integral vibration (NIV).

**Figure 4- Engine LPC Diagram Identifying the IBR 3 / 2.5 Bleed Valve Acoustic Interaction**

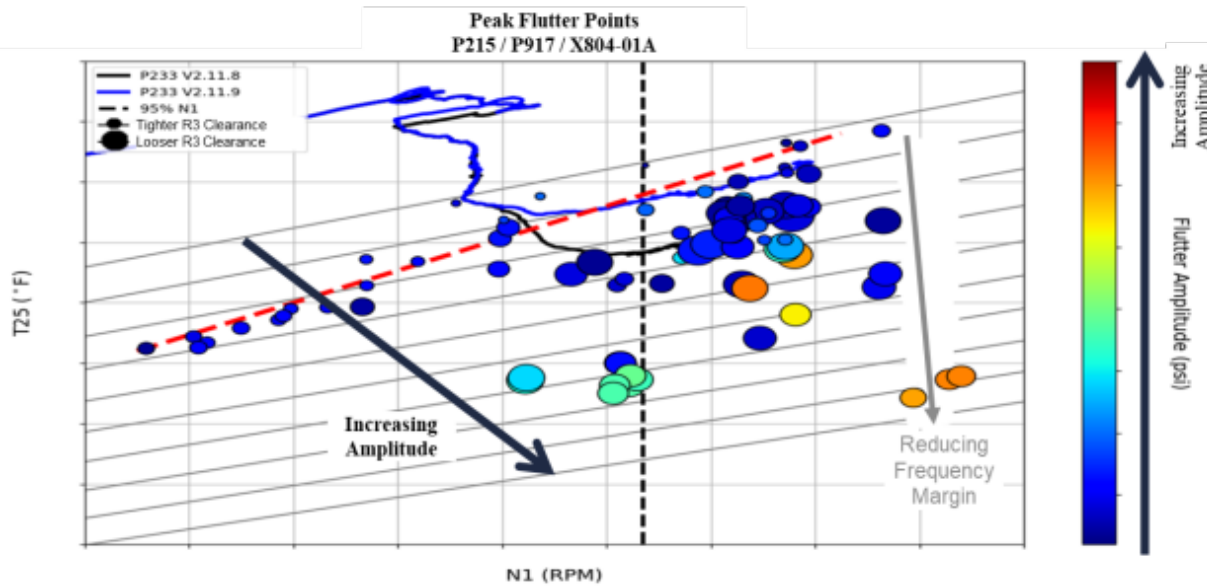
**Frequency Margin-** Frequency margin is the margin between the IBR 3 blade 1<sup>st</sup> bending mode and the 2.5 bleed duct acoustic mode. As the margin is reduced, or the 2.5 bleed acoustic frequency moves closer to the IBR3 mode frequency, a flutter boundary is reached. Further reduction in margin results in a stronger response. The frequency margin is directly affected by the engine N1 speed and the air temperature at the 2.5 bleed valve (referred to as T25). The translation of the IBR 3 blade 1<sup>st</sup> bending mode from the rotating to static reference is determined by the engine N1 speed. The T25 temperature is a variable that determines the speed of sound<sup>7</sup>, and therefore sets the 2.5 bleed valve acoustic resonance frequency. Test points collected and plotted in **Figure 7** below show that flutter onset was more common and flutter amplitude was greater as frequency margin decreased, T25 temperature decreased, and engine N1 speed increased.

**Figure 7- Plot of Peak Flutter Points and Effect of Temperature, N1, and Frequency Margin**

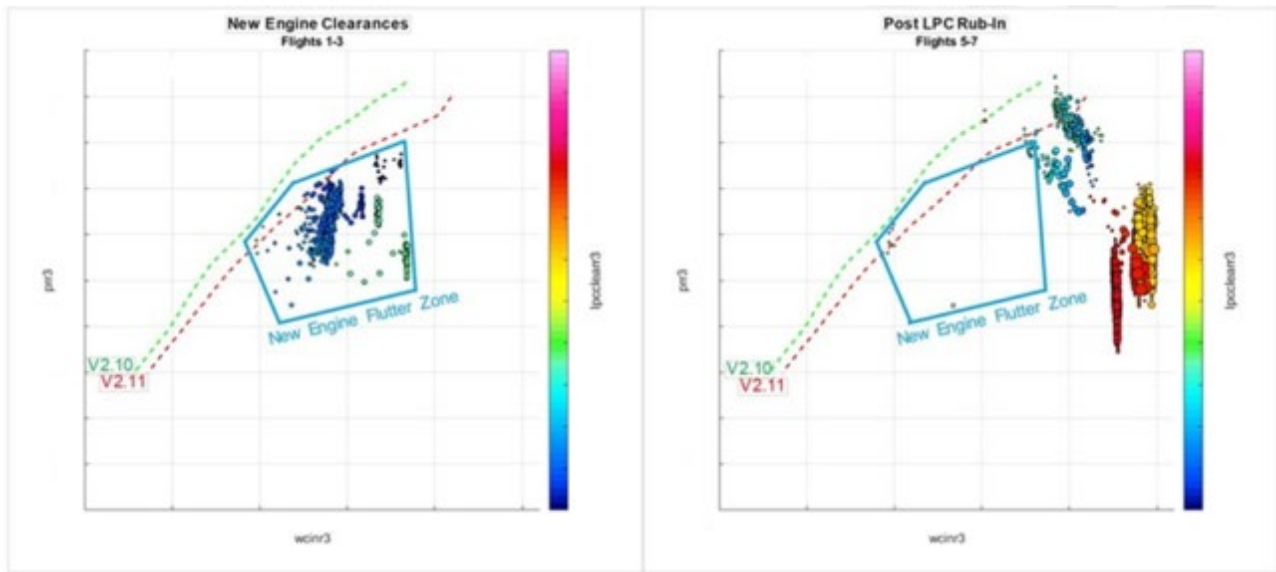
LPC IBR Blade Tip Clearance- Tighter clearances between the LPC IBR blade tips and the outer air seals created unsteady loading at the blade tip region and resulted in stronger acoustic coupling/flutter response. After a rub in period, the clearance increases, and the occurrence of flutter onset is reduced (**Figure 8**). The figure below shows the engine operating line for new engine (flights 1-3) on the left and post rub-in flights (flights 5-7) on the right. The green dashed line is the operating line for EEC software V2.10 software and the red line is the operating line for the EEC software V2.11.7 or 2.11.8. that was installed on all event engines

**Figure 8- LPC IBR 3 Flutter Response (L) New Engine, (R) Post LPC Rub-In**

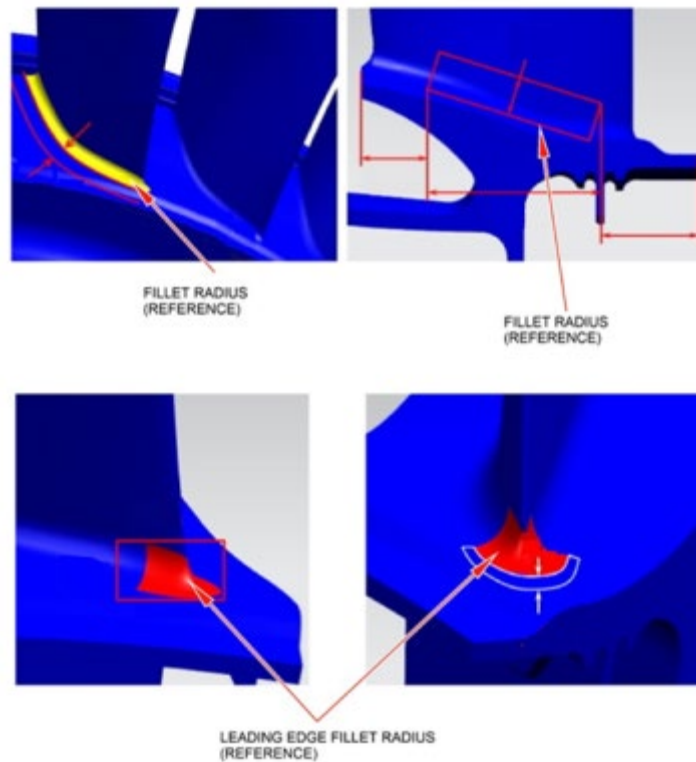
**Figure 11- Service Bulletin LPC IBR 1 Inspection Figure**

On September 23, 2019, P&W released SB PW1000G-A-72-00-0125-00A-930A-D, “Engine - Module, Low Pressure Compressor (LPC) - Repetitive Borescope Inspection of the LPC Module” applicable to PW1500G series engines. The SB was released as compliance category 3- do in 50 cycle intervals since receipt of the service bulletin and every 50 cycles until the engine exceeds 300 cycles since new or do in 50 cycles intervals until the engine exceeds 300 more cycles since installation of EEC software V2.11.7.2. The SB instructs borescope operators to examine: all 29 LPC 1<sup>st</sup> stage IBR blade tips as well as the leading edge for any signs of damage and the 1<sup>st</sup> stage axial LPC rotor blade root leading edge root fillet and to the platform and the convex side of the IBR 1 root fillet to the platform for signs of damage, specifically cracking (**Figures 10 and 11**). The FAA issued airworthiness directive (AD) 2019-19-11 on September 26, 2019, effective immediately, to mandate the SB repetitive inspection. The original SB and AD included a visual VSV stem/lever arm inspection for misalignment that was removed from subsequent revisions. P&W also released SB PW1000G-A-72-00-0127-00A-930A-D in tandem with a recommendation to inspect extended operations (ETOPS<sup>9</sup>) engines every 4 cycles. Airbus A220/PW1500G ETOPS operations were not taking place in the United States or Canada at the time of the incident events.

The visual inspections resulted in two visual crack findings in the same location as the IBR 1 recovered from the second SWISS LPC failure. In response to the crack findings the FAA issued AD 2019-21-11 on October 29, 2019, effective immediately. The AD adjusted the LPC inspection interval on the higher thrust rated variants of the PW1500G series engines (PW1524G, PW1524G-3, PW1525G, and PW1525G-3) installed as zero time spares to 15 cycles, recurrent every 15 cycles until the engine reached 50 cycles. After the engine reached 50 engine cycles since new, the inspection interval was increased to every 50 cycles until the engine reached 300 cycles since new<sup>10</sup>. The other PW1500G engine model variants were required to continue LPC inspections at 50 hour intervals in accordance with the original SB/AD instructions.
