**NATIONAL TRANSPORTATION SAFETY BOARD**  
**Office of Aviation Safety**  
**Washington, D.C. 20594**

**POWERPLANTS GROUP CHAIRMAN'S FACTUAL REPORT**  
**NTSB No: ENG19IA034**

Aircraft: Swiss International Air Lines, Airbus A220-300, Registration Number HB-JCA,

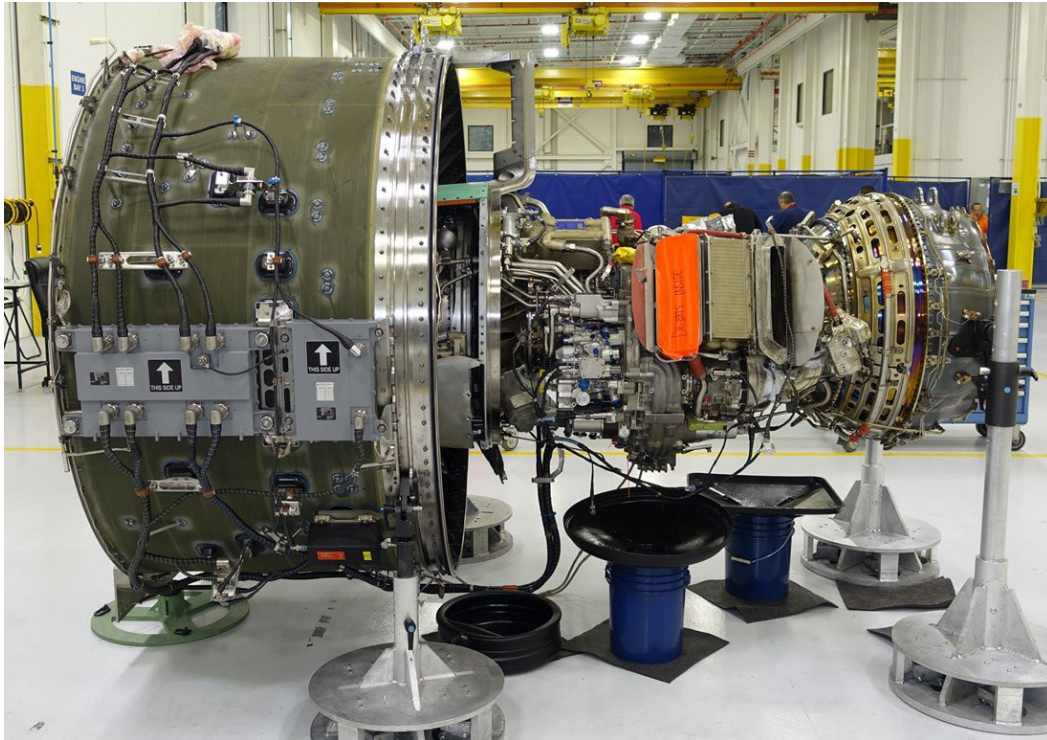
**Photo 1- Left Side of Engine, as Received**

When the investigation team arrived, the engine was secured in work pedestals. SWISS were given authorization to remove quick engine change hardware and buyer furnished equipment prior to engine shipment (**Photos 1, 2 and 3**). A BSI was also completed before the team arrived, in preparation for the teardown. According to CEC mechanics, during initial checks both the N1, N2, and Nf (fan) spools were seized and could not be rotated by hand.

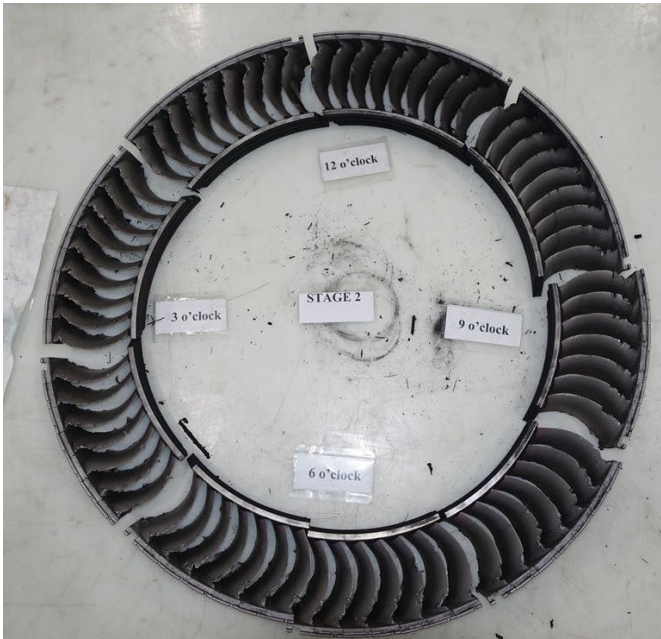
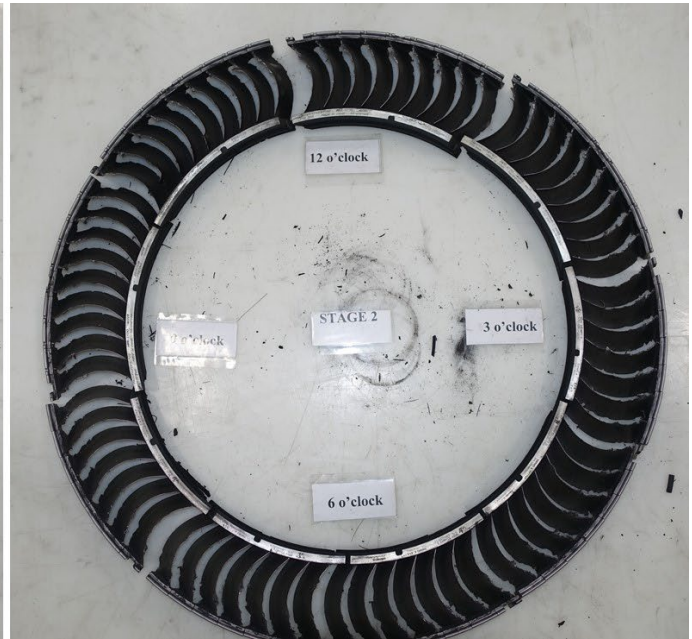
**Photo 13- LPC S2 Stator (L) Forward Side, (R) Aft Side**

The LPC S1 stator vanes were missing from the 2 to 12 o'clock positions. The 12 remaining stator vanes exhibited deformation, and only the outer section of the vane airfoils remained attached and were folded over against the outer diameter platform (**Photo 12**). The LPC IBR 2 had one blade separated and missing near the blade root. The remaining blades exhibited both leading and trailing edge impact damage, including gouges and missing material along the blade span. The IBR 2 blades tips were bent opposite the direction of rotation. A small section of the IBR 1 bolt flange, including four flange bolts (tie rods) remained secured to the IBR 2. Multiple LPC tie rod bolts were broken (bolt heads snapped off). The LPC S2 stator vanes were all present but exhibited leading and trailing edge impact damage and deformation most concentrated along the outer half of the vane span (**Photo 13**). The LPC S2 stator inner diameter rubber air seal exhibited contact wear. The LPC IBR 3 blades were all complete but had minor leading and trailing edge impact damage (**Photo 14**). The LPC hub had no visible damage. The CEC mechanics removed the No. 2 bearing support from the No. 2 bearing housing and the bearing appeared oil wetted. The bearing was initially difficult to rotate, but after further disassembly and separation from the No. 2 bearing housing, the bearing spun smoothly (**Photo 15**). The No. 2 bearing damper did not appear shiny (matte) over an estimated 270 degrees.

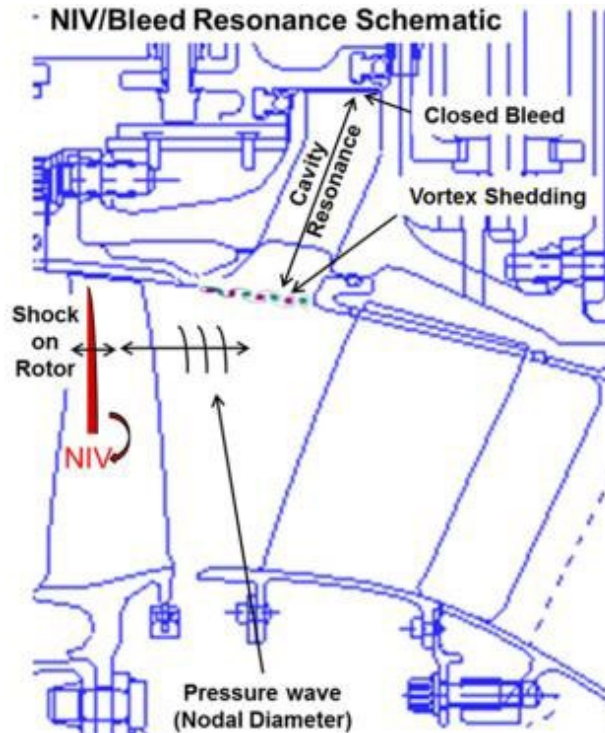
Multiple analytical methods, including two-dimensional (2D) computational fluid dynamics (CFD), acoustic testing, and instrumented flight testing identified a coupled LPC IBR 3 and LPC IBR 1 instability caused by an acoustic coincidence with the 2.5 bleed valve cavity. At high engine N1 speeds, the IBR 3 blade tips generate vortices/turbulent airflow that then pass over the 2.5 bleed valve cavity located immediately aft of the LPC IBR 3. Given the right conditions, the turbulent airflow created an acoustic tone as it passed over the 2.5 bleed valve cavity that excited a LPC IBR 3 blade 1<sup>st</sup> bending mode normal to the blade chord (**Figure 4**). The LPC IBR 1 shares a system mode at the same frequency as IBR 3 and through a mechanically coupled response the vibration transferred through the IBR stack and excited an IBR 1 blade stiffwise bending mode parallel to the blade chord. The LPC IBR vibration response is not an integer multiple of engine speed and is referred to as non-integral vibration (NIV).

**Figure 3- Engine LPC Diagram Identifying the IBR 3 / 2.5 Bleed Valve Acoustic Interaction**

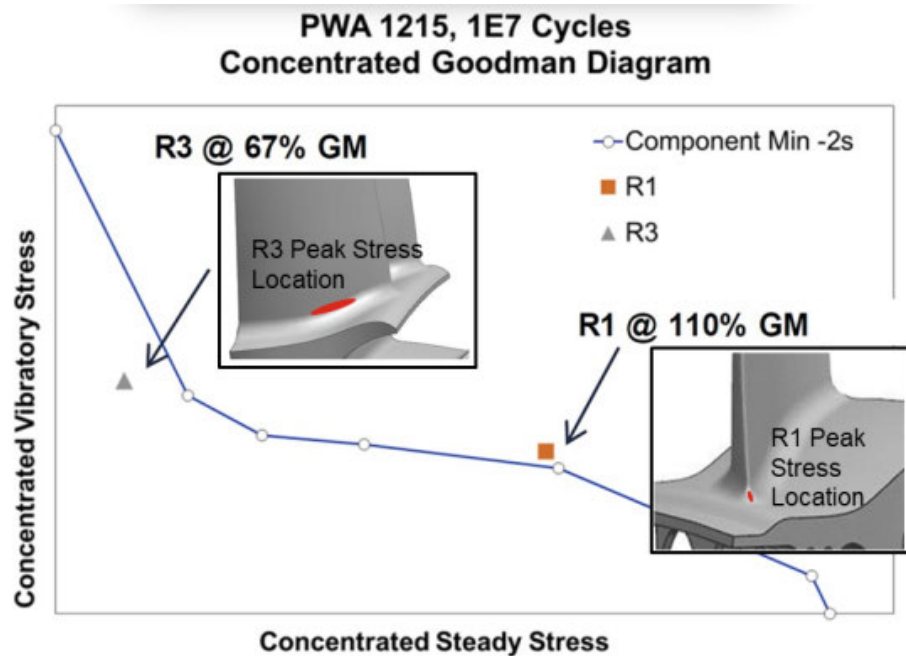
Test data from the original engine certification process was re-evaluated to factor in the additional stress on the LPC IBRs caused by the acoustic coincidence. The highest stress location/critical area for the LPC IBR 3 1<sup>st</sup> bending mode and IBR 1 stiffwise bending mode was identified by finite element analysis (FEA). When the additional stress caused by the blade flutter response was applied to the Goodman diagram<sup>7</sup> for each IBR stage, IBR 3 was still within material limits (calculated value below the stress curve), but the IBR 1 combined stress exceeded the material fatigue limit (calculated value above the stress curve) (**Figure 5**).

**Figure 4- LPC IBR 3 and IBR 1 Goodman Plots**

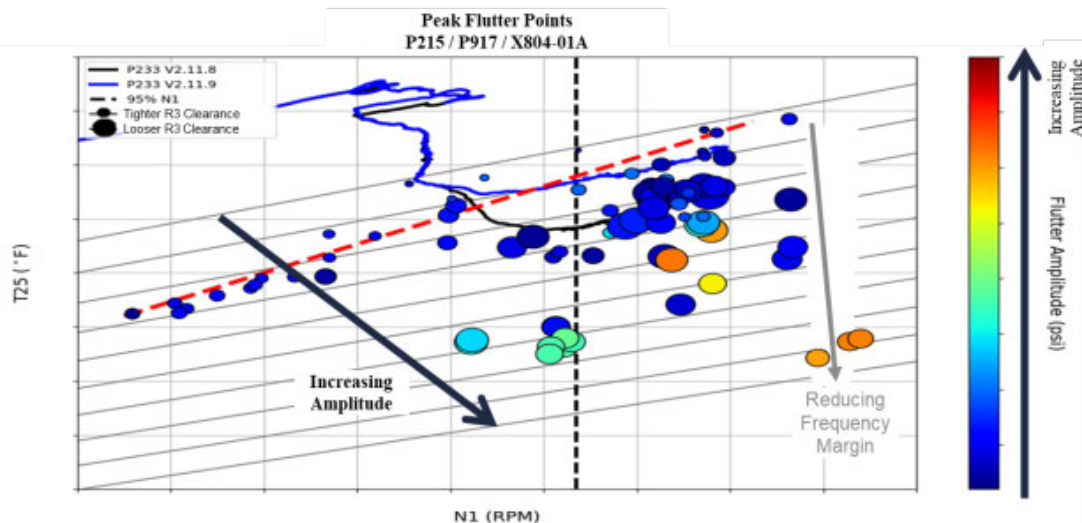
**Frequency Margin-** Frequency margin is the margin between the LPC IBR 3 blade 1<sup>st</sup> bending mode and the 2.5 bleed duct acoustic mode. As the margin is reduced, or the 2.5 bleed acoustic frequency moves closer to the IBR 3 mode frequency, a flutter boundary is reached. Further reduction in margin results in a stronger response. The frequency margin is directly affected by the engine N1 speed and the air temperature at the 2.5 bleed valve (referred to as T25). The translation of the IBR 3 blade 1<sup>st</sup> bending mode from the rotating to static reference is determined by the engine N1 speed. The T25 temperature is a variable that determines the speed of sound<sup>9</sup>, and therefore sets the 2.5 bleed valve acoustic resonance frequency. Test points collected and plotted in **Figure 7** below show that flutter onset was more common and flutter amplitude was greater as frequency margin decreased, T25 temperature decreased, and engine N1 speed increased.

**Figure 7- Plot of Peak Flutter Points and Effect of Temperature, N1, and Frequency Margin**

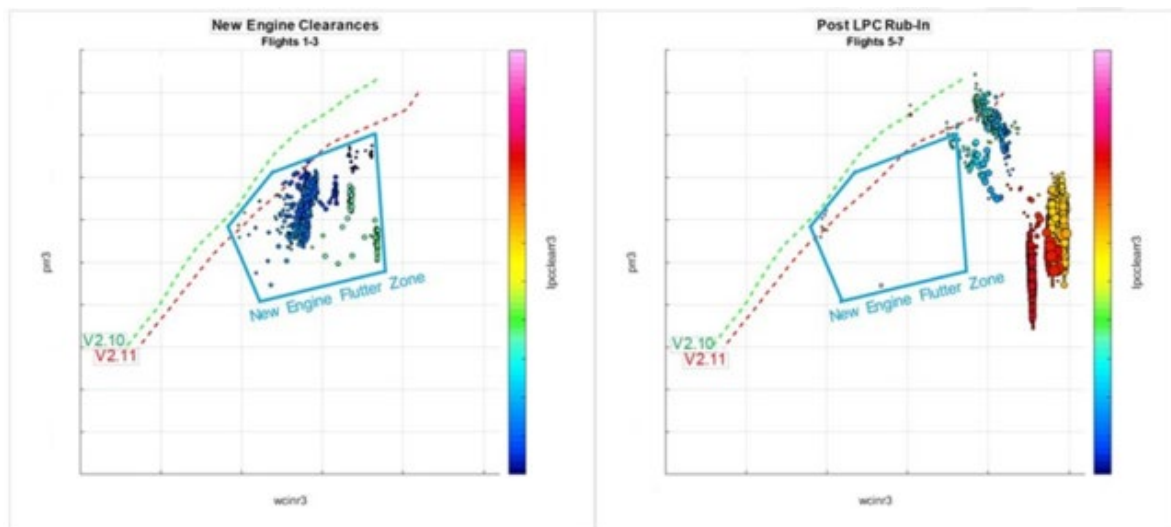
LPC IBR Blade Tip Clearance- Tighter clearances between the LPC IBR blade tips and the outer air seals created unsteady loading at the blade tip region and resulted in stronger acoustic coupling/flutter response. After a rub in period, the clearance increases, and the occurrence of flutter onset is reduced (**Figure 8**). The figure below shows the engine operating line for new engine (flights 1-3) on the left and post rub-in flights (flights 5-7) on the right. The green dashed line is the operating line for EEC software V2.10 and the red line is the operating line for the EEC software V2.11.7 or 2.11.8. that was installed on all event engines

**Figure 8- LPC IBR 3 Flutter Response (L) New Engine, (R) Post LPC Rub-In**

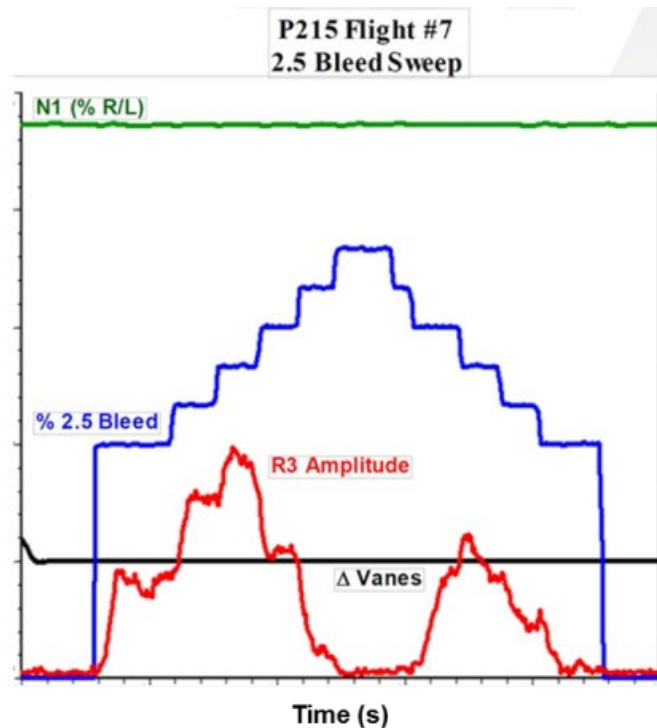
To further support the 2.5 bleed valve acoustic resonance hypothesis, a flight test point was performed where the 2.5 bleed valve was incrementally cycled open and closed while the LPC vanes were held in a fixed closed position at a constant engine N1 speed. The plots from the flight test showed that opening and closing the 2.5 bleed valve in these conditions resulted in increased LPC IBR 3 pressure fluctuations and correlated flutter response (**Figure 9**).

**Figure 9- 2.5 Bleed Valve Influence on Flutter Onset**

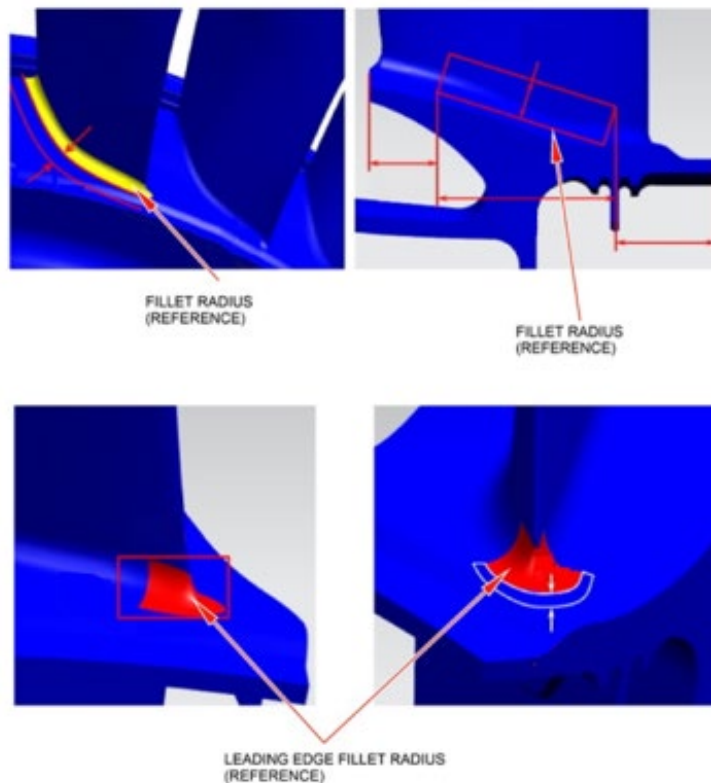
**Figure 11- Service Bulletin LPC IBR 1 Inspection Figure**

On September 23, 2019, P&W released SB PW1000G-A-72-00-0125-00A-930A-D, “Engine - Module, Low Pressure Compressor (LPC) - Repetitive Borescope Inspection of the LPC Module” applicable to PW1500G series engines. The SB was released as compliance category 3- do in 50 cycle intervals since receipt of the service bulletin and every 50 cycles until the engine exceeds 300 cycles since new or do in 50 cycles intervals until the engine exceeds 300 more cycles since installation of EEC software V2.11.7.2. The SB instructs borescope operators to examine: all 29 LPC IBR 1 blade tips and leading edge surfaces for signs of damage. Operators are also instructed to inspect the IBR 1 blade fillet radius near the platform on the leading edge, and both the pressure and suction sides of the blade for signs of damage, specifically cracking (**Figures 10 and 11**). The FAA issued AD 2019-19-11 on September 26, 2019, effective immediately, to mandate the SB repetitive inspection. The original SB and AD included a visual variable stator vane (VSV) stem/lever arm inspection for misalignment that was removed from subsequent revisions. P&W also released SB PW1000G-A-72-00-0127-00A-930A-D in tandem with a recommendation to inspect extended operations (ETOPS<sup>11</sup>) engines every 4 cycles. Airbus A220/PW1500G ETOPS operations were not taking place in the United States or Canada at the time of the incident events.

The BSIs mandated by the AD 2019-19-11 identified LPC IBR 1 cracks on two additional engines. The IBR 1 cracks originated at the same approximate location as the crack documented on the recovered IBR 1 fragment from ESN P736195 (incident engine detailed in this report). In response to the crack findings, the FAA issued AD 2019-21-11 on October 29, 2019, effective immediately. The AD adjusted the LPC inspection interval on the higher thrust rated variants of the PW1500G series engines (PW1521G, PW1521G-3, PW1524G, PW1524G-3, PW1525G, and PW1525G-3) installed as zero time spares to 15 cycles, recurrent every 15 cycles until the engine reached 50 cycles. After the engine reached 50 engine cycles since new, the inspection interval was increased to every 50 cycles until the engine reached 300 cycles since new<sup>12</sup>. Other PW1500G engine model variants were required to continue LPC inspections at 50 hour intervals in accordance with the original SB/AD instructions.
